ASBESTOS RENOVATION SURVEY

**VA CANTEEN RELOCATION PROJECT
VA SIERRA NV HEALTH CARE SYSTEM
BUILDING 1 – GROUND FLOOR
1000 LOCUST STREET
RENO, NEVADA**

Converse Project No. 11-23705-01

August 15, 2011

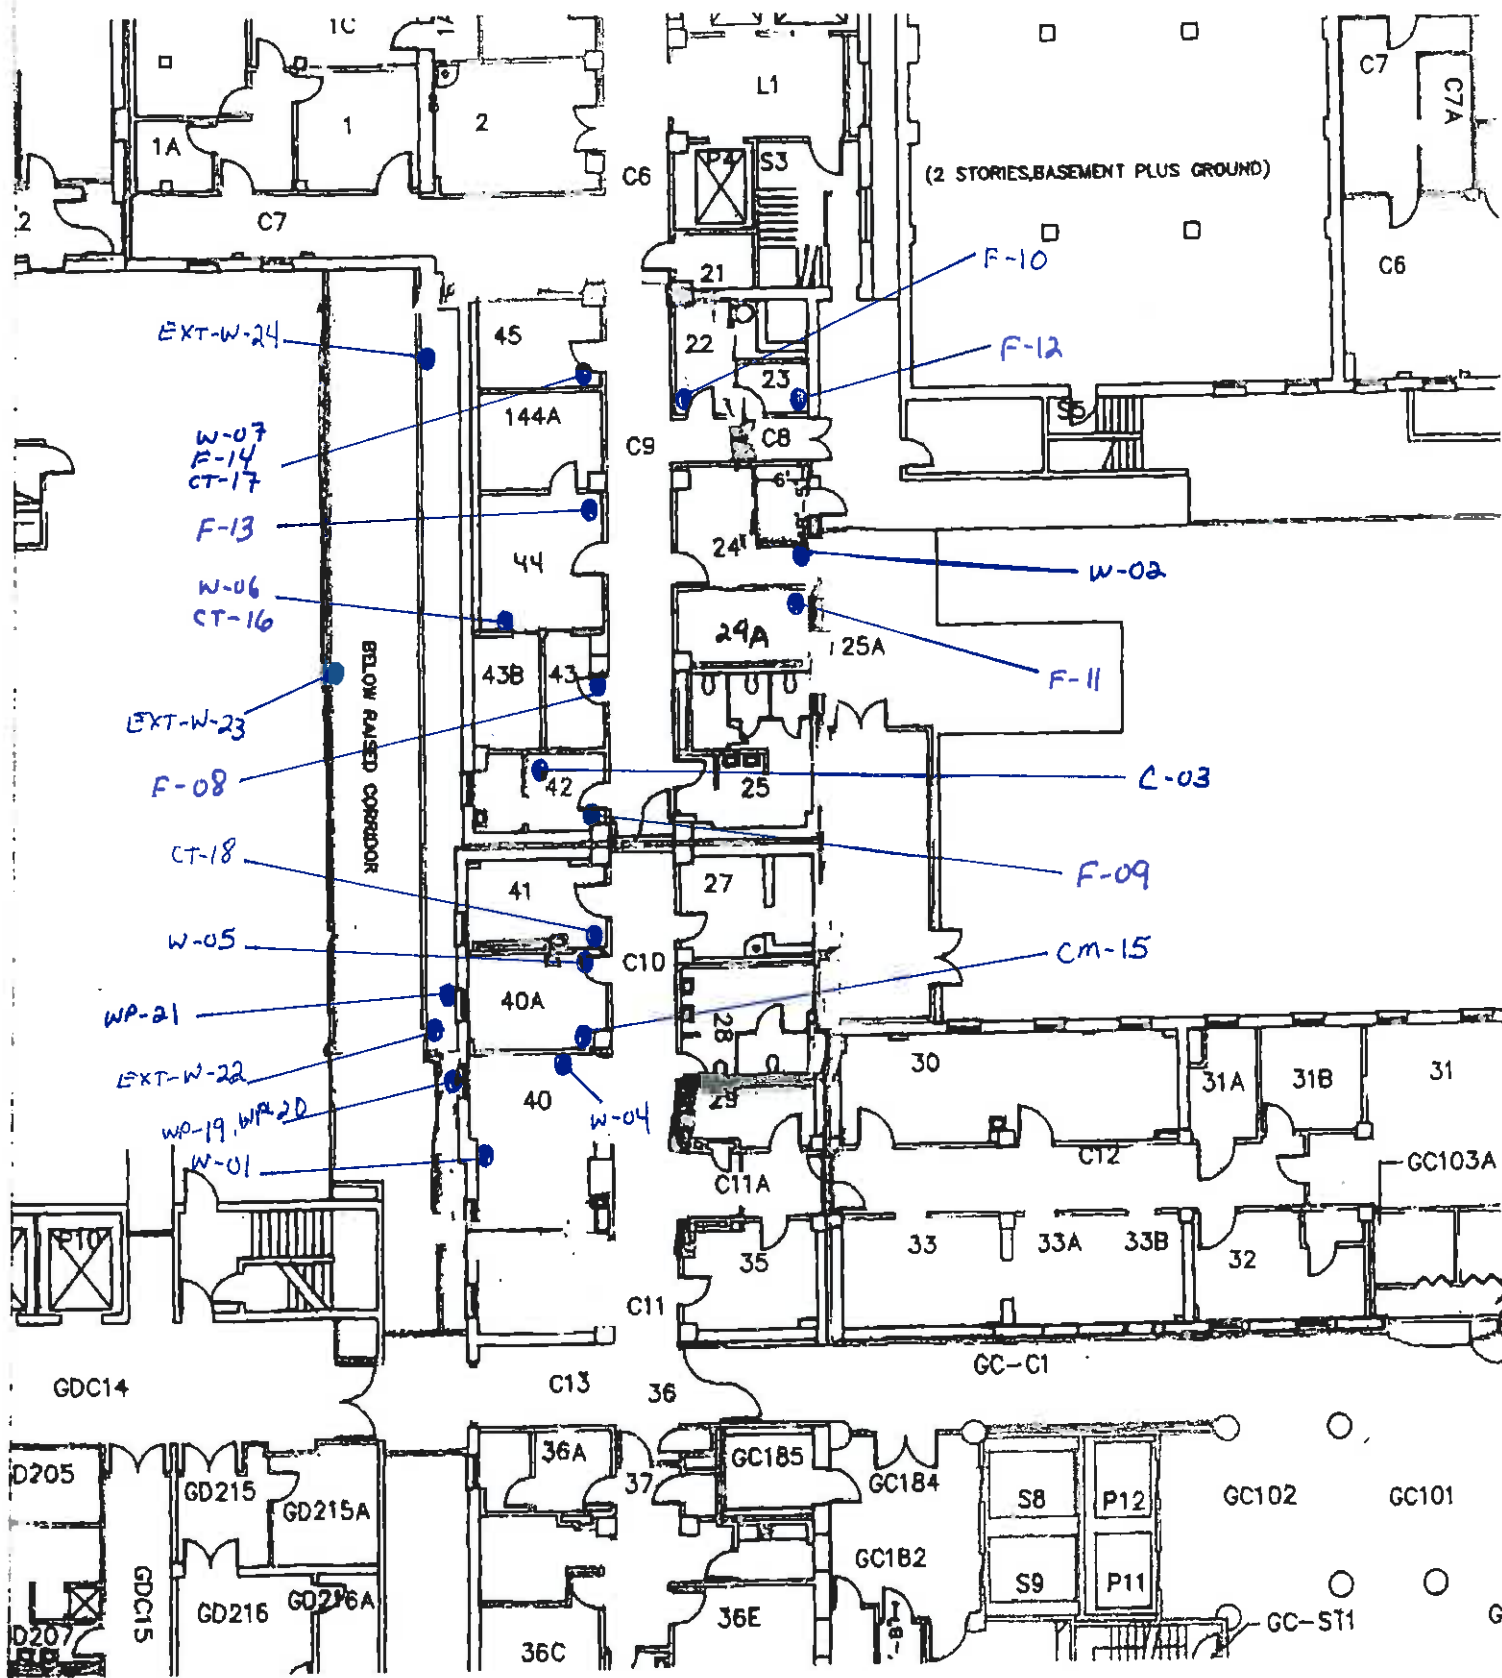
Bulk Sample Location Diagram

MATERIAL TYPE	PERCENTAGE ASBESTOS AND FRIABILITY	MATERIAL LOCATION	APPROXIMATE AREA (Square Feet)
Pipe Run Insulation (TSI)	20-55% Chrysotile 1% Amosite <1% Crocidotile Category I RACM	Appeared to be typical to various areas of pipe run insulation (TSI) located above ceilings and in wall cavities. It must be noted that this material was not tested due to previous positive testing. Also additional TSI may be present in wall cavities and pipe chases which were not accessible.	≈ 600 l.f.
Green 9" x 9" Floor Tile	1-3% Chrysotile Category I Non-Friable	Appeared to be typical to the flooring located in the entry to the area designated as 23 on the attached sample location diagram.	≈ 40 s.f.
Tan 12" x 12" Floor Tile	1-3% Chrysotile Category I Non-Friable	Appeared to be typical to the flooring located in the areas designated as 22, 24, 24A, 42, C8 and C9 on the attached sample location diagram.	≈ 730 s.f.

Black Floor Tile Mastic	5-20% Chrysotile Category II Non-Friable	Appeared to be typical to the flooring located in the areas designated as 22, 23, 24, 24A, 42, C8 and C9 on the attached sample location diagram.	≈ 770 s.f.

- Approximately 40 square feet (s.f.) of Green 9" x 9" Floor Tile which appeared to be typical to the flooring located in the area designated as 23 on the attached sample location diagram.
- Approximately 730 s.f. of Tan 12" x 12" Floor Tile which appeared to be typical to the flooring located in the areas designated as 22, 24, 24A, 42, C8 and C9 on the attached sample location diagram.
- Approximately 770 s.f. of Black Floor Tile Mastic which appeared to be typical to the areas designated 22, 23, 24, 24A, 42, C8 and C9 on the attached sample location diagram.
