ATTACHMENT 1
PICTURES

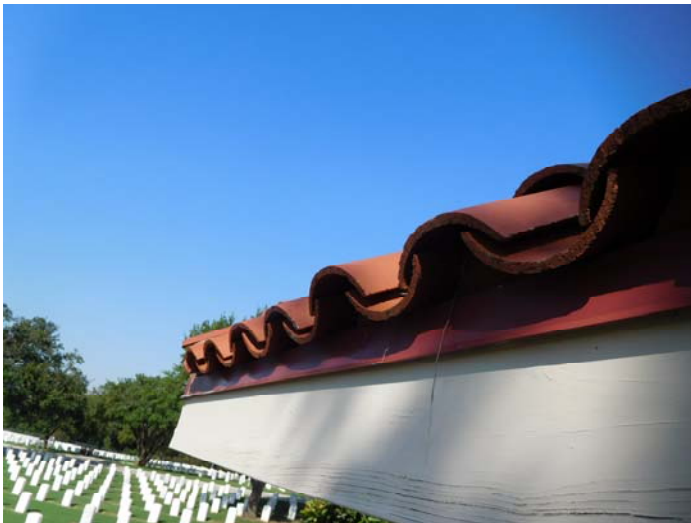
Figure 13: Example of trim board, flashing and eave

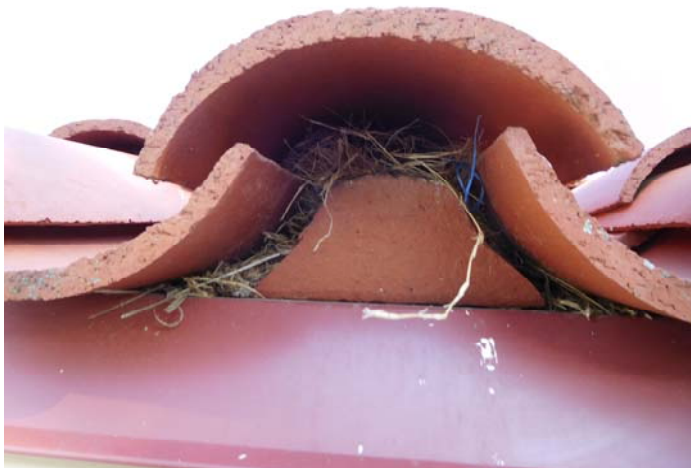
Figure 20: Example of eave closure with debris

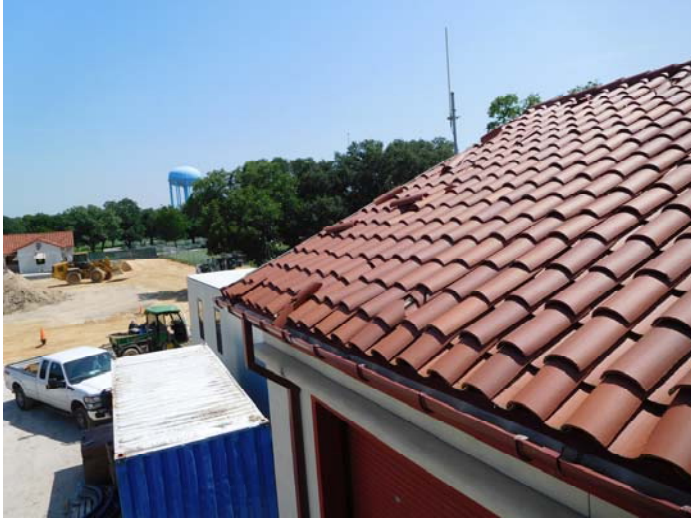
Figure 26

* Note: All pictures of Flag Storage Building were taken on the West side; the East side has similar damage.
