VAMC MEDICAL CENTER NATIONAL SOLDIERS HOME HISTORIC DISTRICT BUILDING 2: STABILIZATION OF B-WING

PROJECT INFORMATION AND SUMMARY OF EXISTING CONDITIONS

SCOPE OF WORK

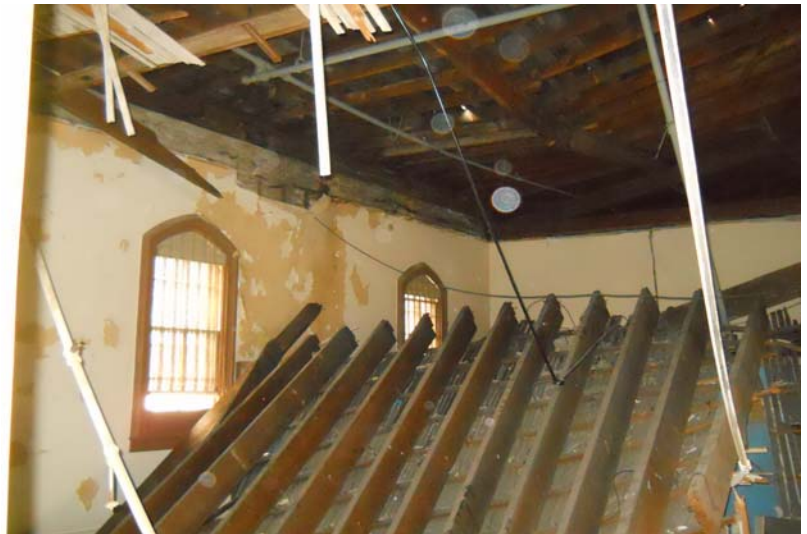
COLLAPSED ROOF ON SECOND FLOOR FROM EAST

Remove collapsed second floor truss and repair it as necessary for reinstallation, along with original purlins. Where feasible, repair of structural members will be with in-kind materials and possible supplemental members as needed, such as gussets and bearing supports at walls. Supplemental members will be constructed of contemporary materials.

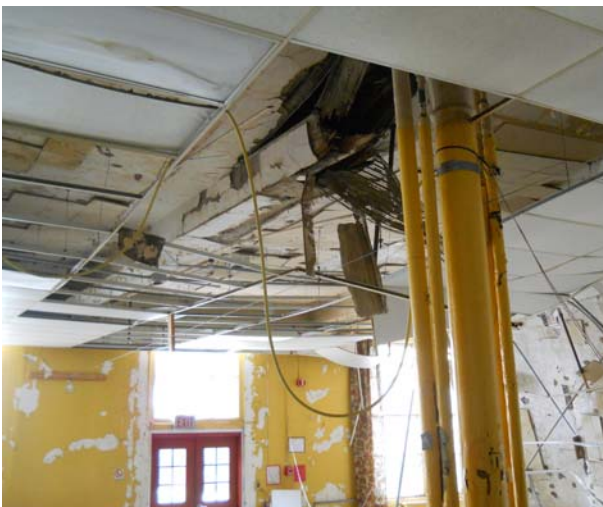
PARTIALLY COLLAPSED FIRST FLOOR TRUSS FROM NORTHEAST

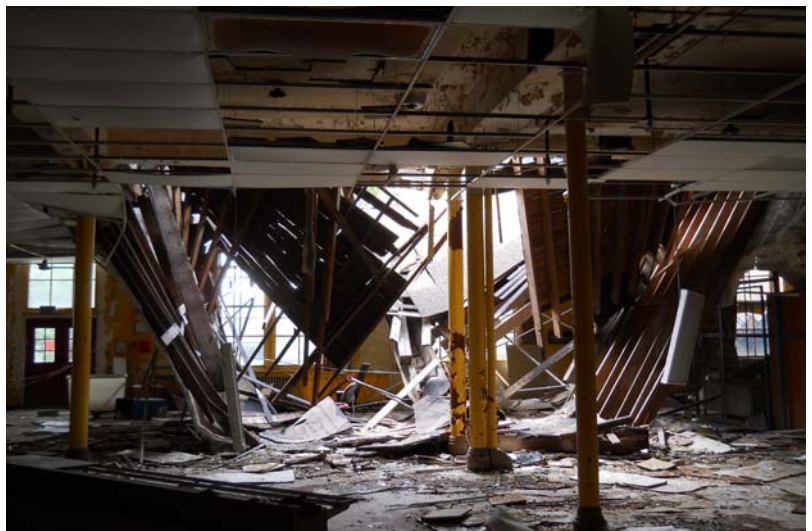
COLLAPSED ROOF ON FIRST FLOOR FROM NORTH

Replace first floor trusses that have collapsed with new trusses of contemporary construction and known load-bearing capacity.

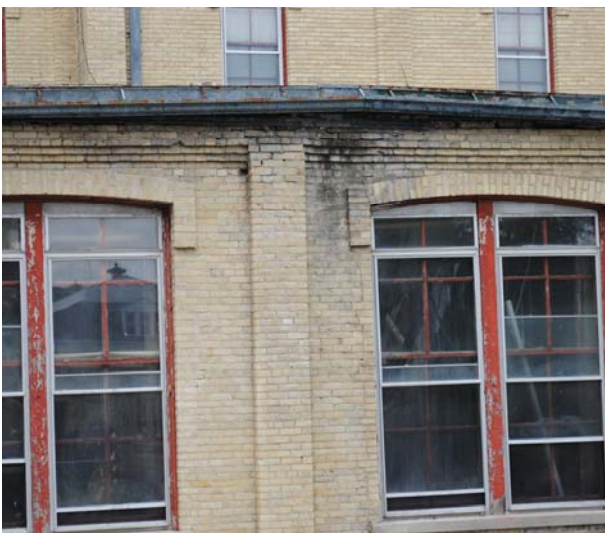
MASONRY DAMAGE ON SOUTH

Repair brick wall damaged by thrust of collapsing trusses, reinstall bricks where beam pockets were opened, and repair other parts of brick cornice that exhibit deflection or damage. Bricks will be repaired using original or salvaged, matching brick and mortar no harder than ASTM, Type O, using white Portland cement and river sand to match the appearance of the original.

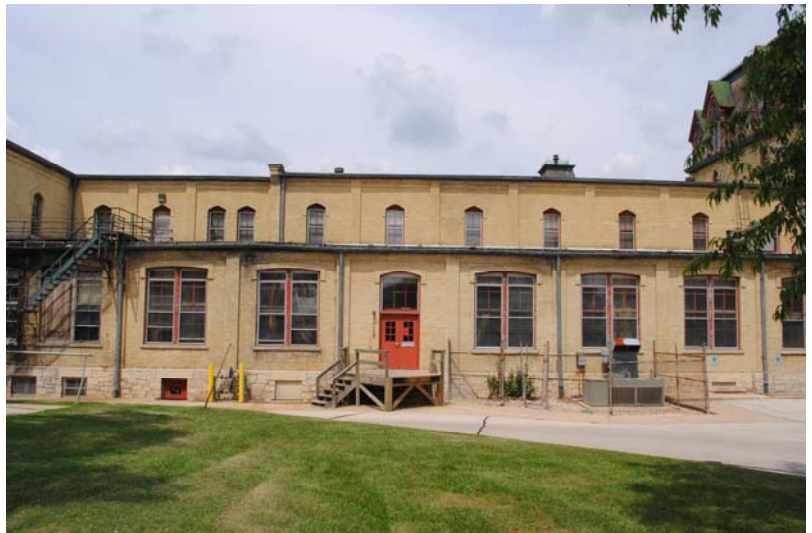
SOUTH MASONRY WALL DAMAGED BY FALLING TRUSS
