**LIMITED MOLD, ASBESTOS AND
LEAD-CONTAINING PAINT SURVEY REPORT**

**Bay Pines VA Medical Center
Building 100 5C Rooms 119 and 122
10000 Bay Pines Boulevard
Bay Pines, Florida 33744**

VRG Project No.: 16950-90018

January 2017

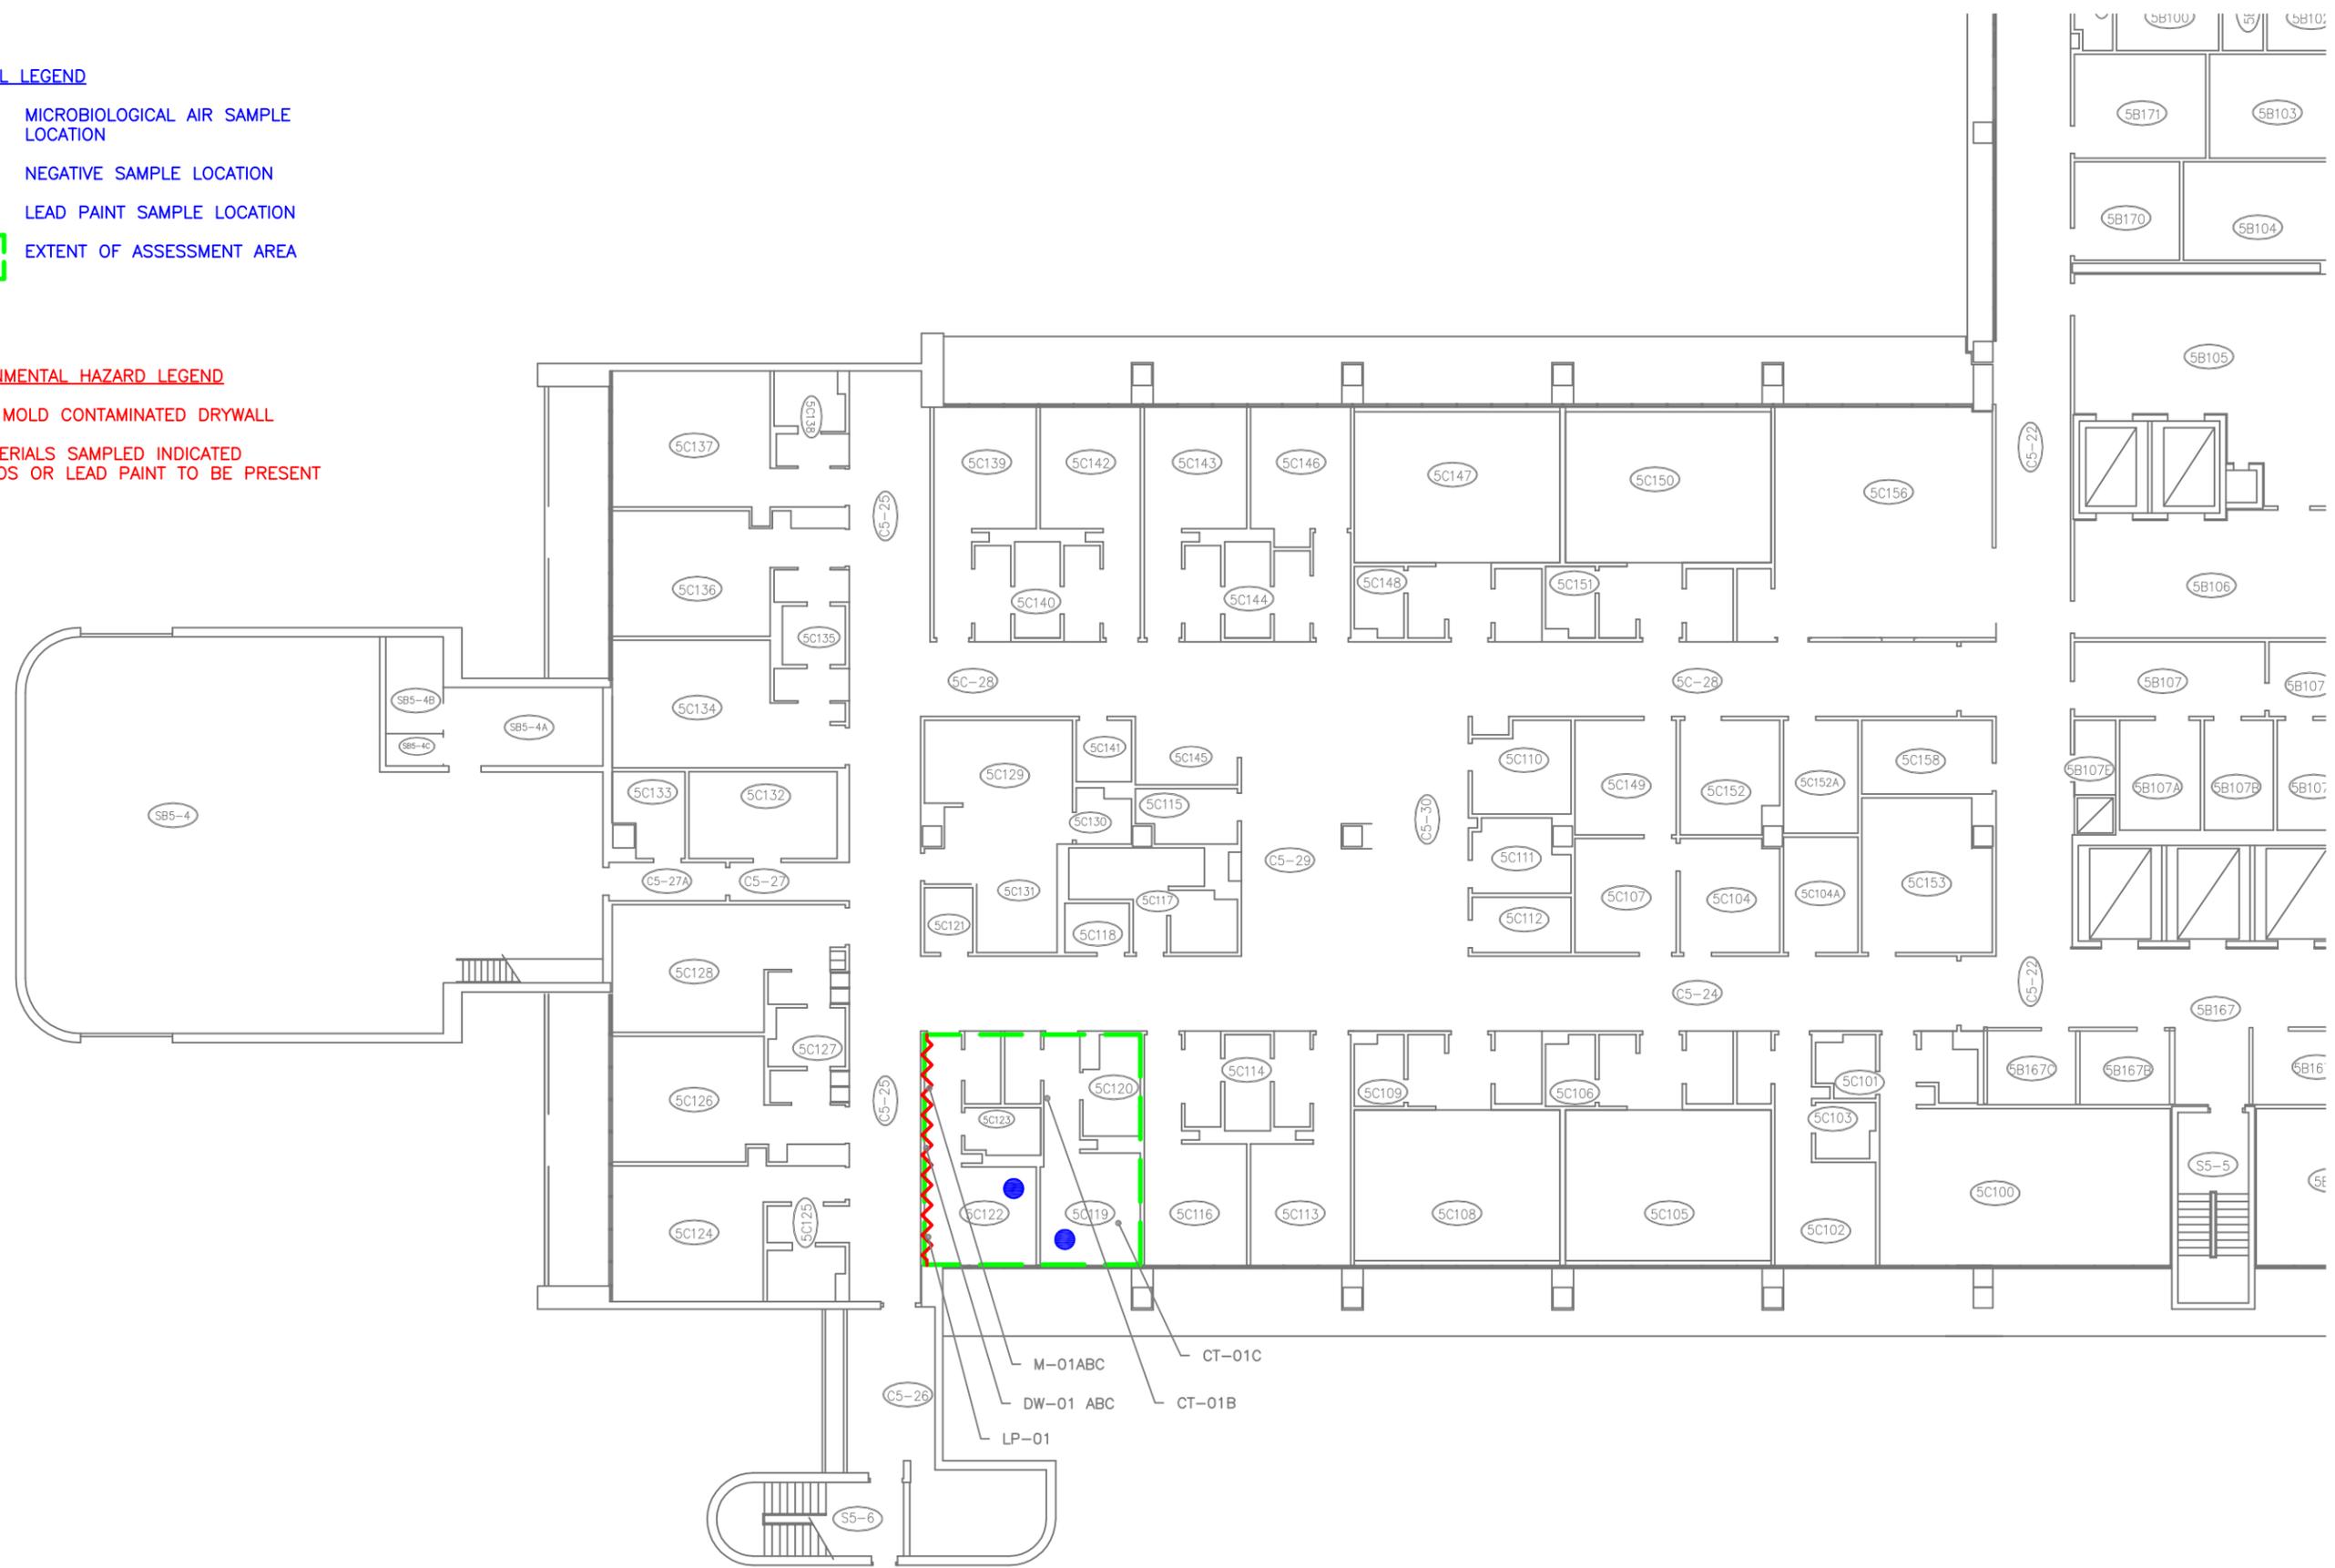
DRAWN VPH
CHECKED JR
DATE 01/27/2017
JOB NO. 16950-90018
SCALE N.T.S.
GLE CAD NO. 16950-90018
SHEET AS-1 OF 1 SHEET(S)

- ~ MOLD CONTAMINATED DRYWALL
- NO MATERIALS SAMPLED INDICATED ASBESTOS OR LEAD PAINT TO BE PRESENT

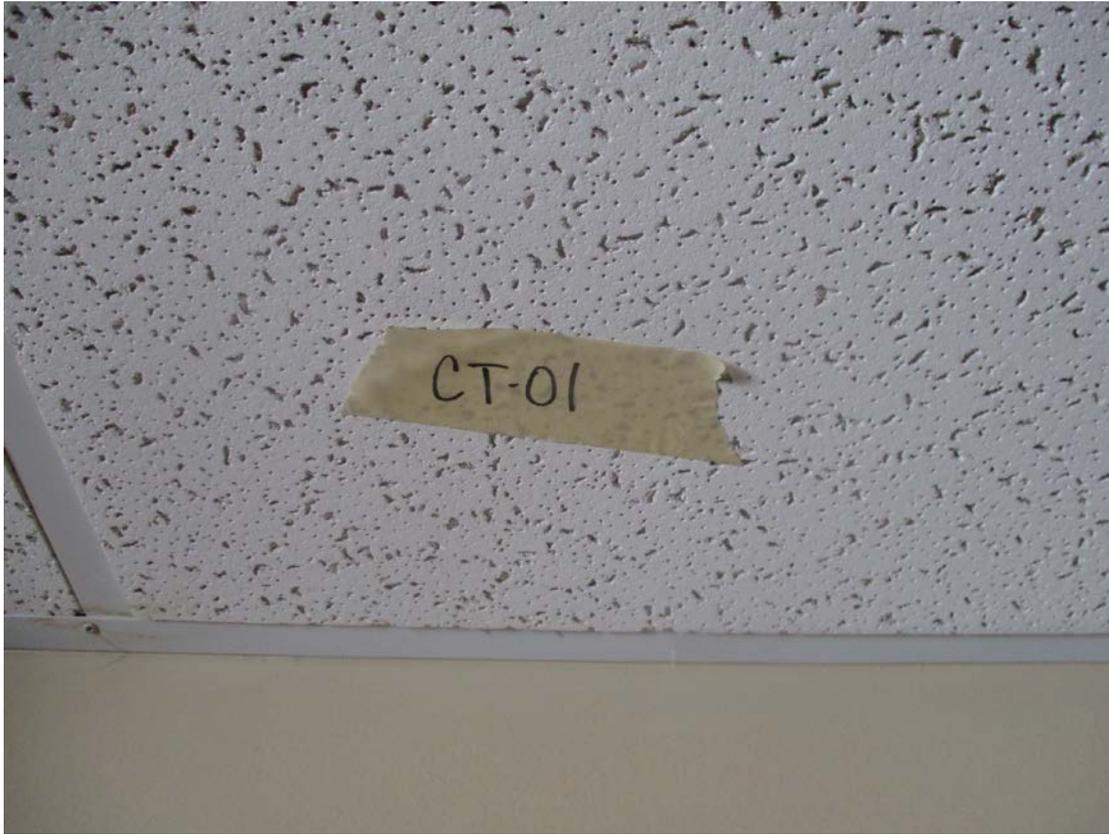
Upper Photo: CT-01: 2x2 Fissured Ceiling Tile

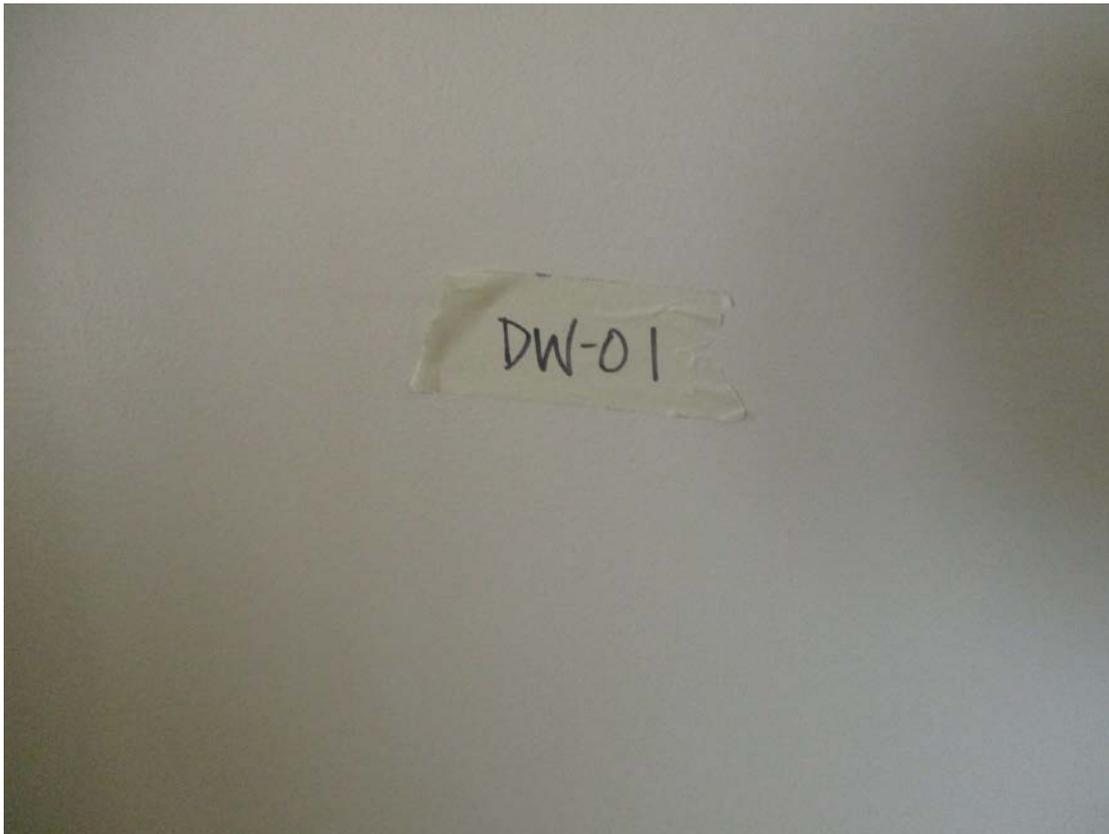
Lower Photo: DW-01: Drywall

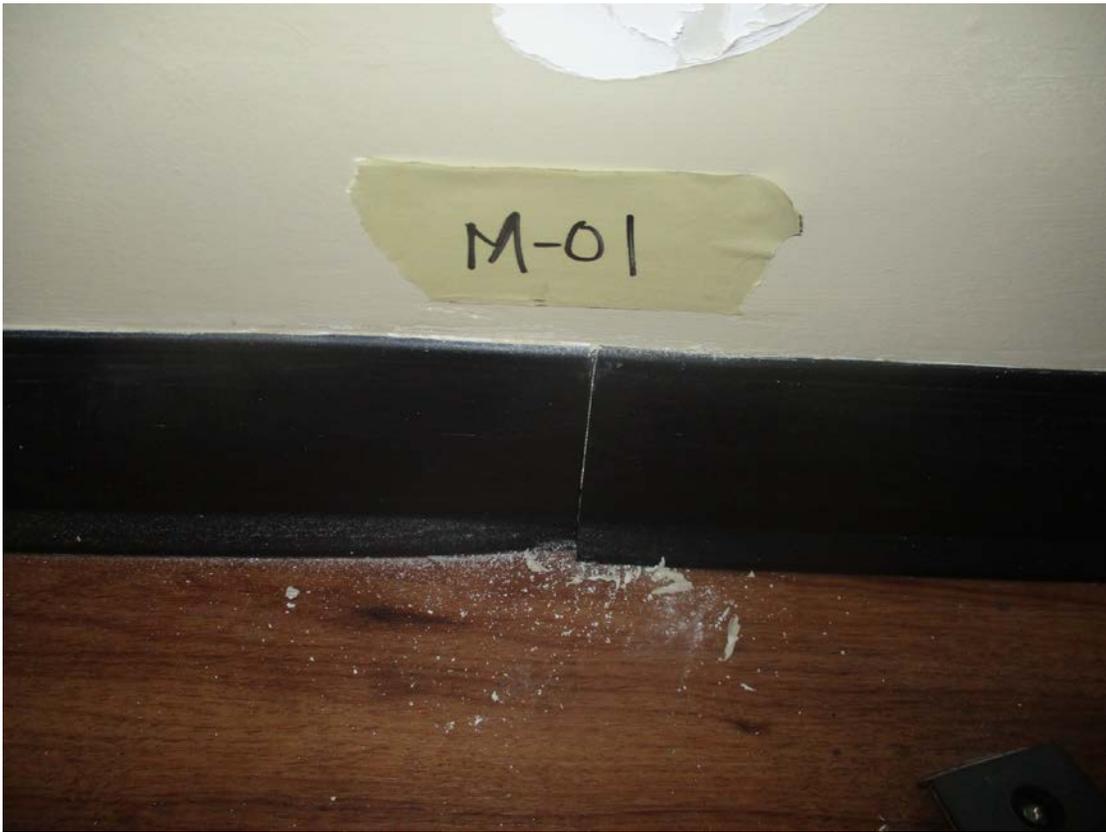
Upper Photo: M-01: Cove Base and Adhesive

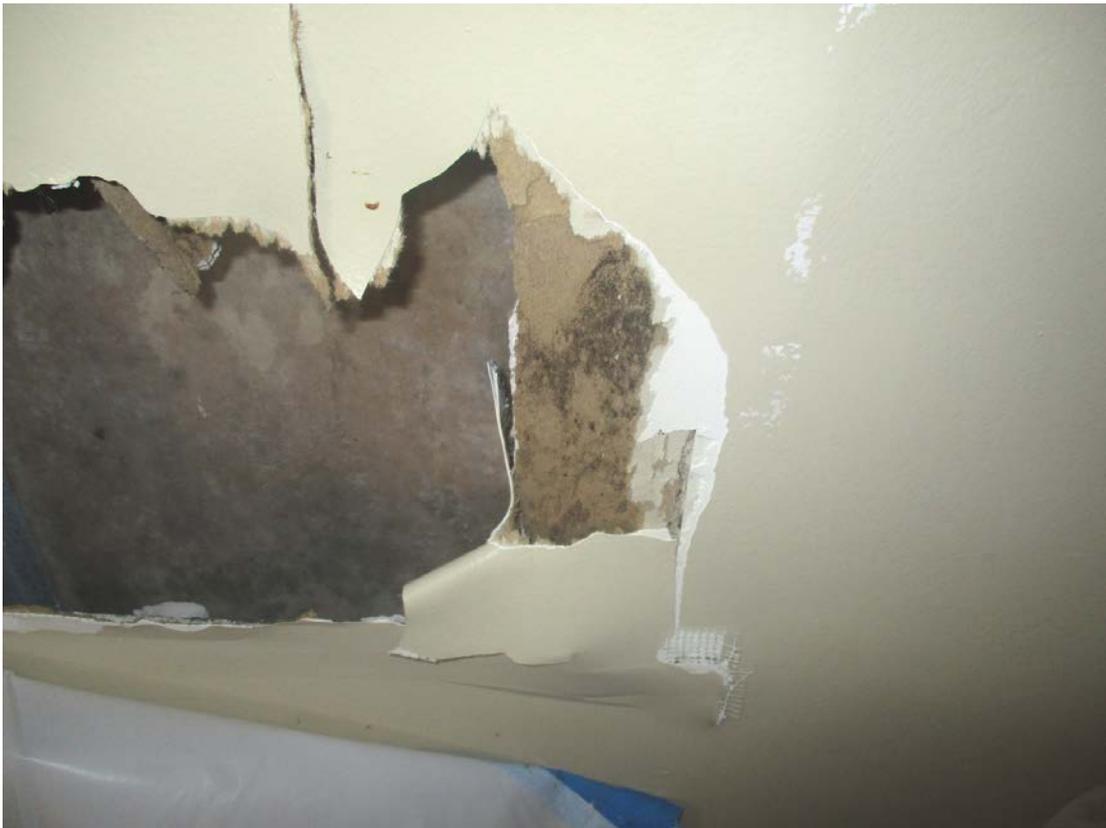
- Room 122 – Within the exposed wall cavity.

1. Mold was observed within an exposed wall cavity in Room 5C-122. Although the mold contamination appears to be isolated, the extent of the contamination will not be known until additional areas have been exposed.
2. Slightly elevated spore count levels of *Aspergillus/Penicillium* were detected in the air samples collected from both 5C-119 and 5C-122.

Lower Photo: Wall with Mold Contamination in 5C-122

1. All mold affected drywall be properly removed and disposed of by a licensed environmental remediation company utilizing properly trained and equipped personnel.
2. Secure the rooms from unauthorized entry and isolate from existing HVAC systems. Scrub the air with HEPA equipped air filtration machines.

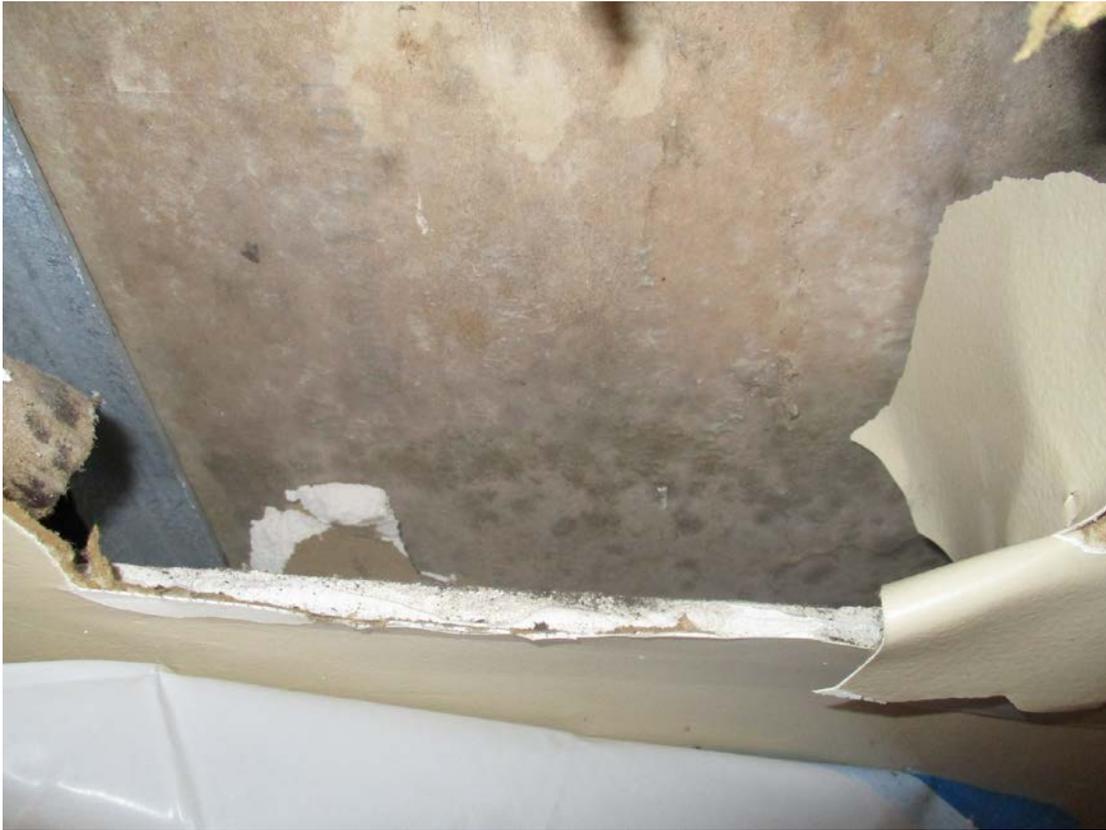
Upper Photo: Wall with Mold Contamination in 5C-122
