TANK VAULT INTERIOR

TANK VAULT REPAIRS

528A8-17-802

SD-1

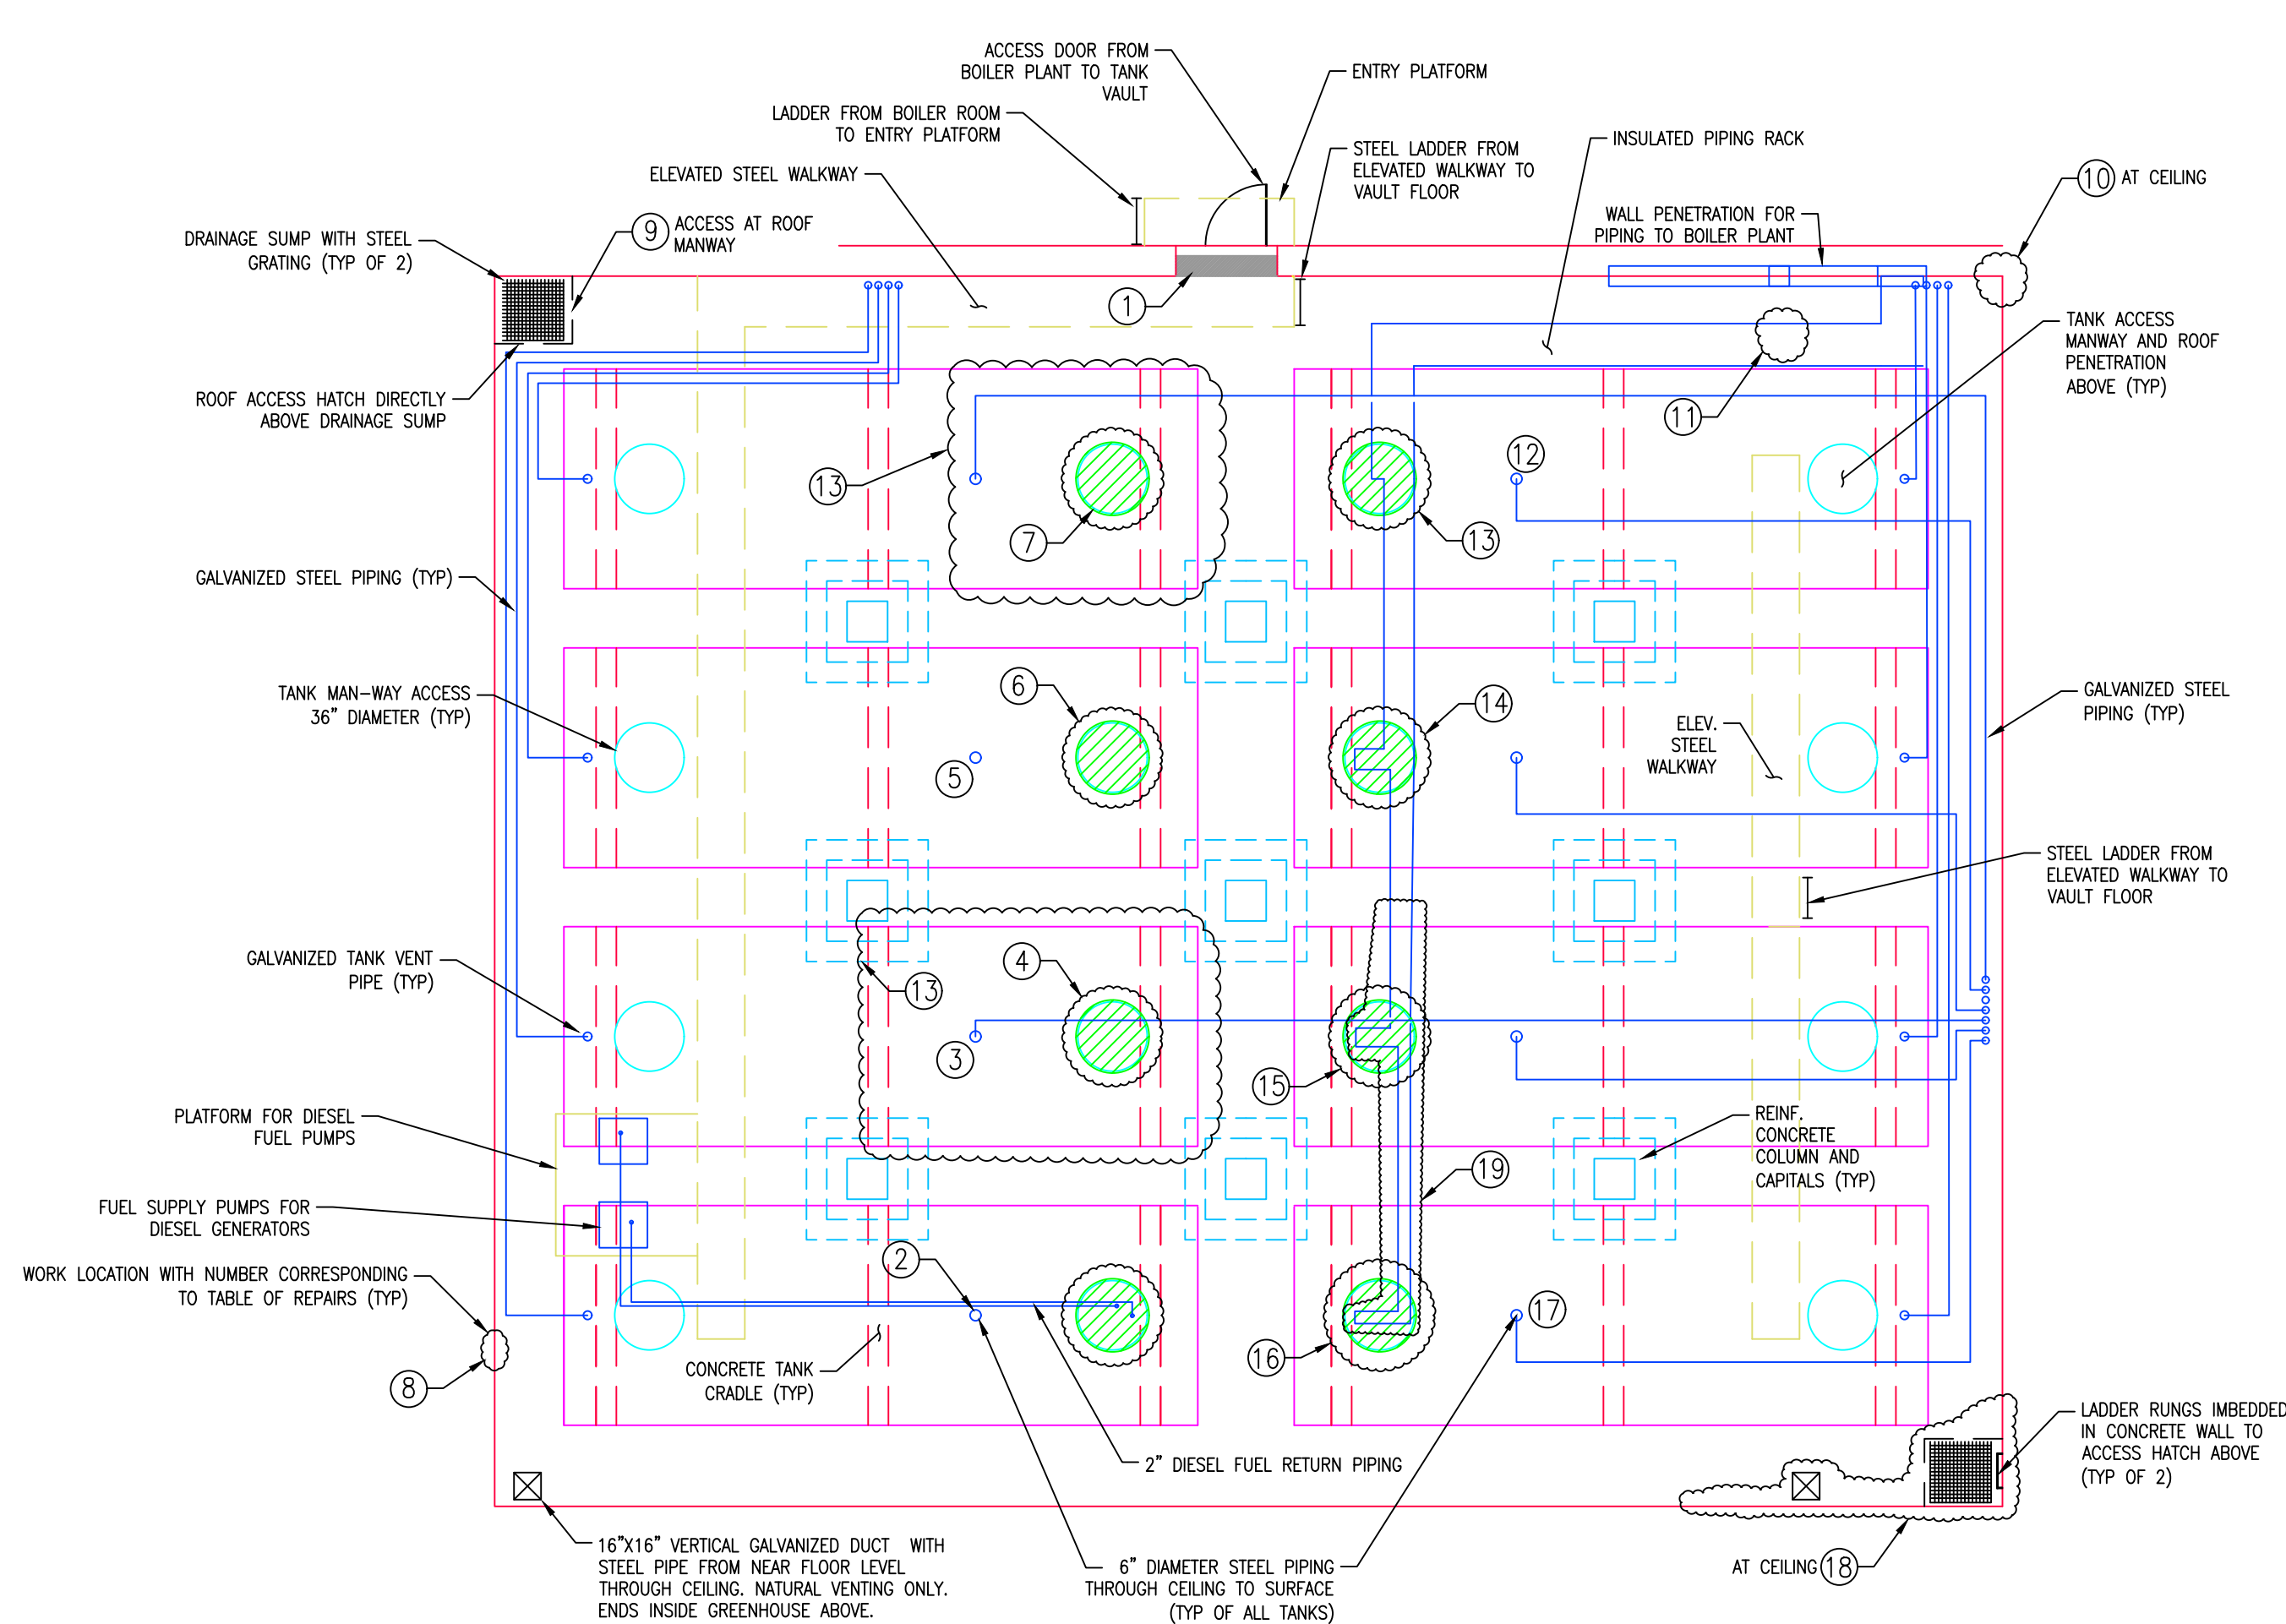
2
SD1
CEILING VIEW: EXISTING CONDITIONS
AND PROPOSED WORK INSIDE VAULT
SCALE: 1/8"= 1'

DEFECT NO.	CONDITION/TYPE OF REPAIR	EST. QUANT.	REPAIR DESCRIPTION
①	THE THRESHOLD AT THE ACCESS DOOR FROM THE BOILER ROOM HAS DETERIORATED.	5 LF	GRIND SUBSTRATE SO THAT THE FINISHED SURFACE ELEVATION WILL MATCH EXISTING DOOR FRAME ELEVATION. FILL VOIDS WITH CEMENTITIOUS MATERIAL. ATTACH GALVANIZED, SKID-RESISTANT STEEL PLATE OVER REPAIRED AREA.
②	PATCH ROOF PENETRATION FOR FILL PIPE	+2 SQFT	REMOVE LOOSE CONCRETE AND REPAIR/SEAL WITH CEMENTITIOUS MATERIAL.
③	PATCH ROOF PENETRATION FOR FILL PIPE	+2 SQFT	REMOVE LOOSE CONCRETE. CLEAN AREA AND REPAIR/SEAL WITH CEMENTITIOUS MATERIAL.
④	SPALLING AND EXPOSED REINFORCING STEEL AROUND ACCESS COVER	+12 SQFT	REMOVE ALL SPALLED AND/OR LOOSE CONCRETE ON INSIDE OF VAULT. SEE ALSO DETAIL 1/SD2, APPLICABLE TO OTHER FRAME AS WELL. REMOVE AND REPLACE CORRODED REINFORCING STEEL PER NOTES 1/SD-2. CLEAN ANY REMAINING EXPOSED REINFORCING STEEL. FILL VOID SMOOTH WITH CEMENTITIOUS MATERIAL.

⑤	REMOVE UNUSED FILL PIPE	+4 SQFT	REMOVE UNUSED STEEL PIPE. TANK IS NO LONGER IN USE AND THE PIPE HAS BEEN CUT NEAR THE ROOF LINE. FILL VOID SMOOTH WITH CEMENTITIOUS MATERIAL.
⑥	MINOR SPALLING AROUND FRAME.	+3 SQFT	REMOVE ALL SPALLED AND/OR LOOSE CONCRETE. CLEAN REMAINING CONCRETE AND EXPOSED REINFORCING STEEL. FILL VOID SMOOTH WITH CEMENTITIOUS MATERIAL.
⑦	MINOR SPALLING AROUND FRAME.	+1 SQFT	REMOVE ALL SPALLED AND/OR LOOSE CONCRETE. CLEAN REMAINING CONCRETE AND EXPOSED REINFORCING STEEL. FILL VOID SMOOTH WITH CEMENTITIOUS MATERIAL.
⑧	STEEL PIPE CHASE, PARTIALLY FILLED. NEEDS TO BE SEALED.	+9 SQFT	PIPES ARE CUT AT WALL. CUT PIPES GREATER THAN 6" INTO THE WALL. CLEAN OUTSIDE OF PIPE. CLEAN REINFORCING STEEL AND REPLACE WHERE NEEDED. FILL VOID SMOOTH WITH CEMENTITIOUS MATERIAL.
⑨	SPALLING AROUND AROUND MANWAY HATCH	+8 SQFT	REMOVE ALL SPALLED AND/OR LOOSE CONCRETE. CLEAN REMAINING CONCRETE AND EXPOSED REINFORCING STEEL. FILL VOID SMOOTH WITH CEMENTITIOUS MATERIAL.

⑩	SPALLING AND LEAKAGE AT INTERFACE OF TANK VAULT WALL AND BOILER PLANT WALL	+40 SQFT	REMOVE LOOSE CONCRETE AND CLEAN. FILL VOID SMOOTH WITH CEMENTITIOUS MATERIAL.
⑪	DEFECT IN ROOF POUR LEFT EXPOSED REINFORCING STEEL	+3 SQFT	REMOVE ALL SPALLED AND/OR LOOSE CONCRETE. CLEAN REMAINING CONCRETE AND EXPOSED REINFORCING STEEL. FILL VOID SMOOTH WITH CEMENTITIOUS MATERIAL.
⑫	PATCH ROOF PENETRATION FOR FILL PIPE	+2 SQFT	REMOVE ALL SPALLED AND/OR LOOSE CONCRETE. CLEAN REMAINING CONCRETE AND EXPOSED REINFORCING STEEL. FILL VOID SMOOTH WITH CEMENTITIOUS MATERIAL.
⑬	PORTIONS OF TANKS 1, 2 AND 5 (INCLUDING RISERS AND LIDS) HAVE RUSTED DUE TO LEAKAGE FROM ABOVE	+400 SQFT	CLEAN PORTIONS OF STEEL TANKS AND ACCESS LIDS. RE-PAINT WITH TOP COAT BEING BLACK WITH FLAT FINISH. NOTE SAFETY REQUIREMENTS FOR THIS WORK.
⑭	SPALLING AROUND AROUND MANWAY HATCH	+10 SQFT	REMOVE ALL SPALLED AND/OR LOOSE CONCRETE. CLEAN REMAINING CONCRETE AND EXPOSED REINFORCING STEEL. FILL SMOOTH WITH CEMENTITIOUS MATERIAL.

⑮	SPALLING AROUND AROUND MANWAY HATCH	+20 SQFT	REMOVE ALL SPALLED AND/OR LOOSE CONCRETE. CLEAN REMAINING CONCRETE AND EXPOSED REINFORCING STEEL. FILL VOID SMOOTH WITH CEMENTITIOUS MATERIAL.
⑯	SPALLING AROUND AROUND MANWAY HATCH	+10 SQFT	REMOVE ALL SPALLED AND/OR LOOSE CONCRETE. CLEAN REMAINING CONCRETE AND EXPOSED REINFORCING STEEL. FILL VOID SMOOTH WITH CEMENTITIOUS MATERIAL.
⑰	PATCH ROOF PENETRATION FOR FILL PIPE	+2 SQFT	REMOVE SPALLING AND/OR LOOSE CONCRETE. CLEAN REMAINING CONCRETE AND EXPOSED REINFORCING STEEL. FILL VOID SMOOTH WITH CEMENTITIOUS MATERIAL.
⑱	SPALLING AROUND AROUND MANWAY HATCH, VENT	+70 SQFT	REMOVE ALL SPALLED AND/OR LOOSE CONCRETE. CLEAN REMAINING CONCRETE AND EXPOSED REINFORCING STEEL. SEE ALSO SHEET SD2 FOR WORK RELATED TO HATCH ON THE TOPSIDE. FILL VOIDS SMOOTH WITH CEMENTITIOUS MATERIAL.
⑲	PIPE INSULATION DAMAGED AT TANKS 6 AND 8	+70 LF	REMOVE DAMAGED INSULATION (FOIL FACE FIBERGLASS) WRAPPED AROUND PIPES. REPLACE WITH FIBERGLASS PIPE COVERING WITH FACTORY APPLIED ALL-SERVICE JACKET VAPOR BARRIER AND SELF-SEALING LAPS TO A POINT BETWEEN TANKS 6 AND 8. LEAVE NO EXPOSED PIPE.
