## Limited Asbestos Inventory Summary

To:	Michael A. Ciofani AIA NCARB
From:	Jeff Senn and Robert Peschel – Sigma
Project Number:	13204
Date:	May 22, 2012
RE:	VA Medical Center – Milwaukee, WI VA Project 695-12-117 Building 112 Replace Generator

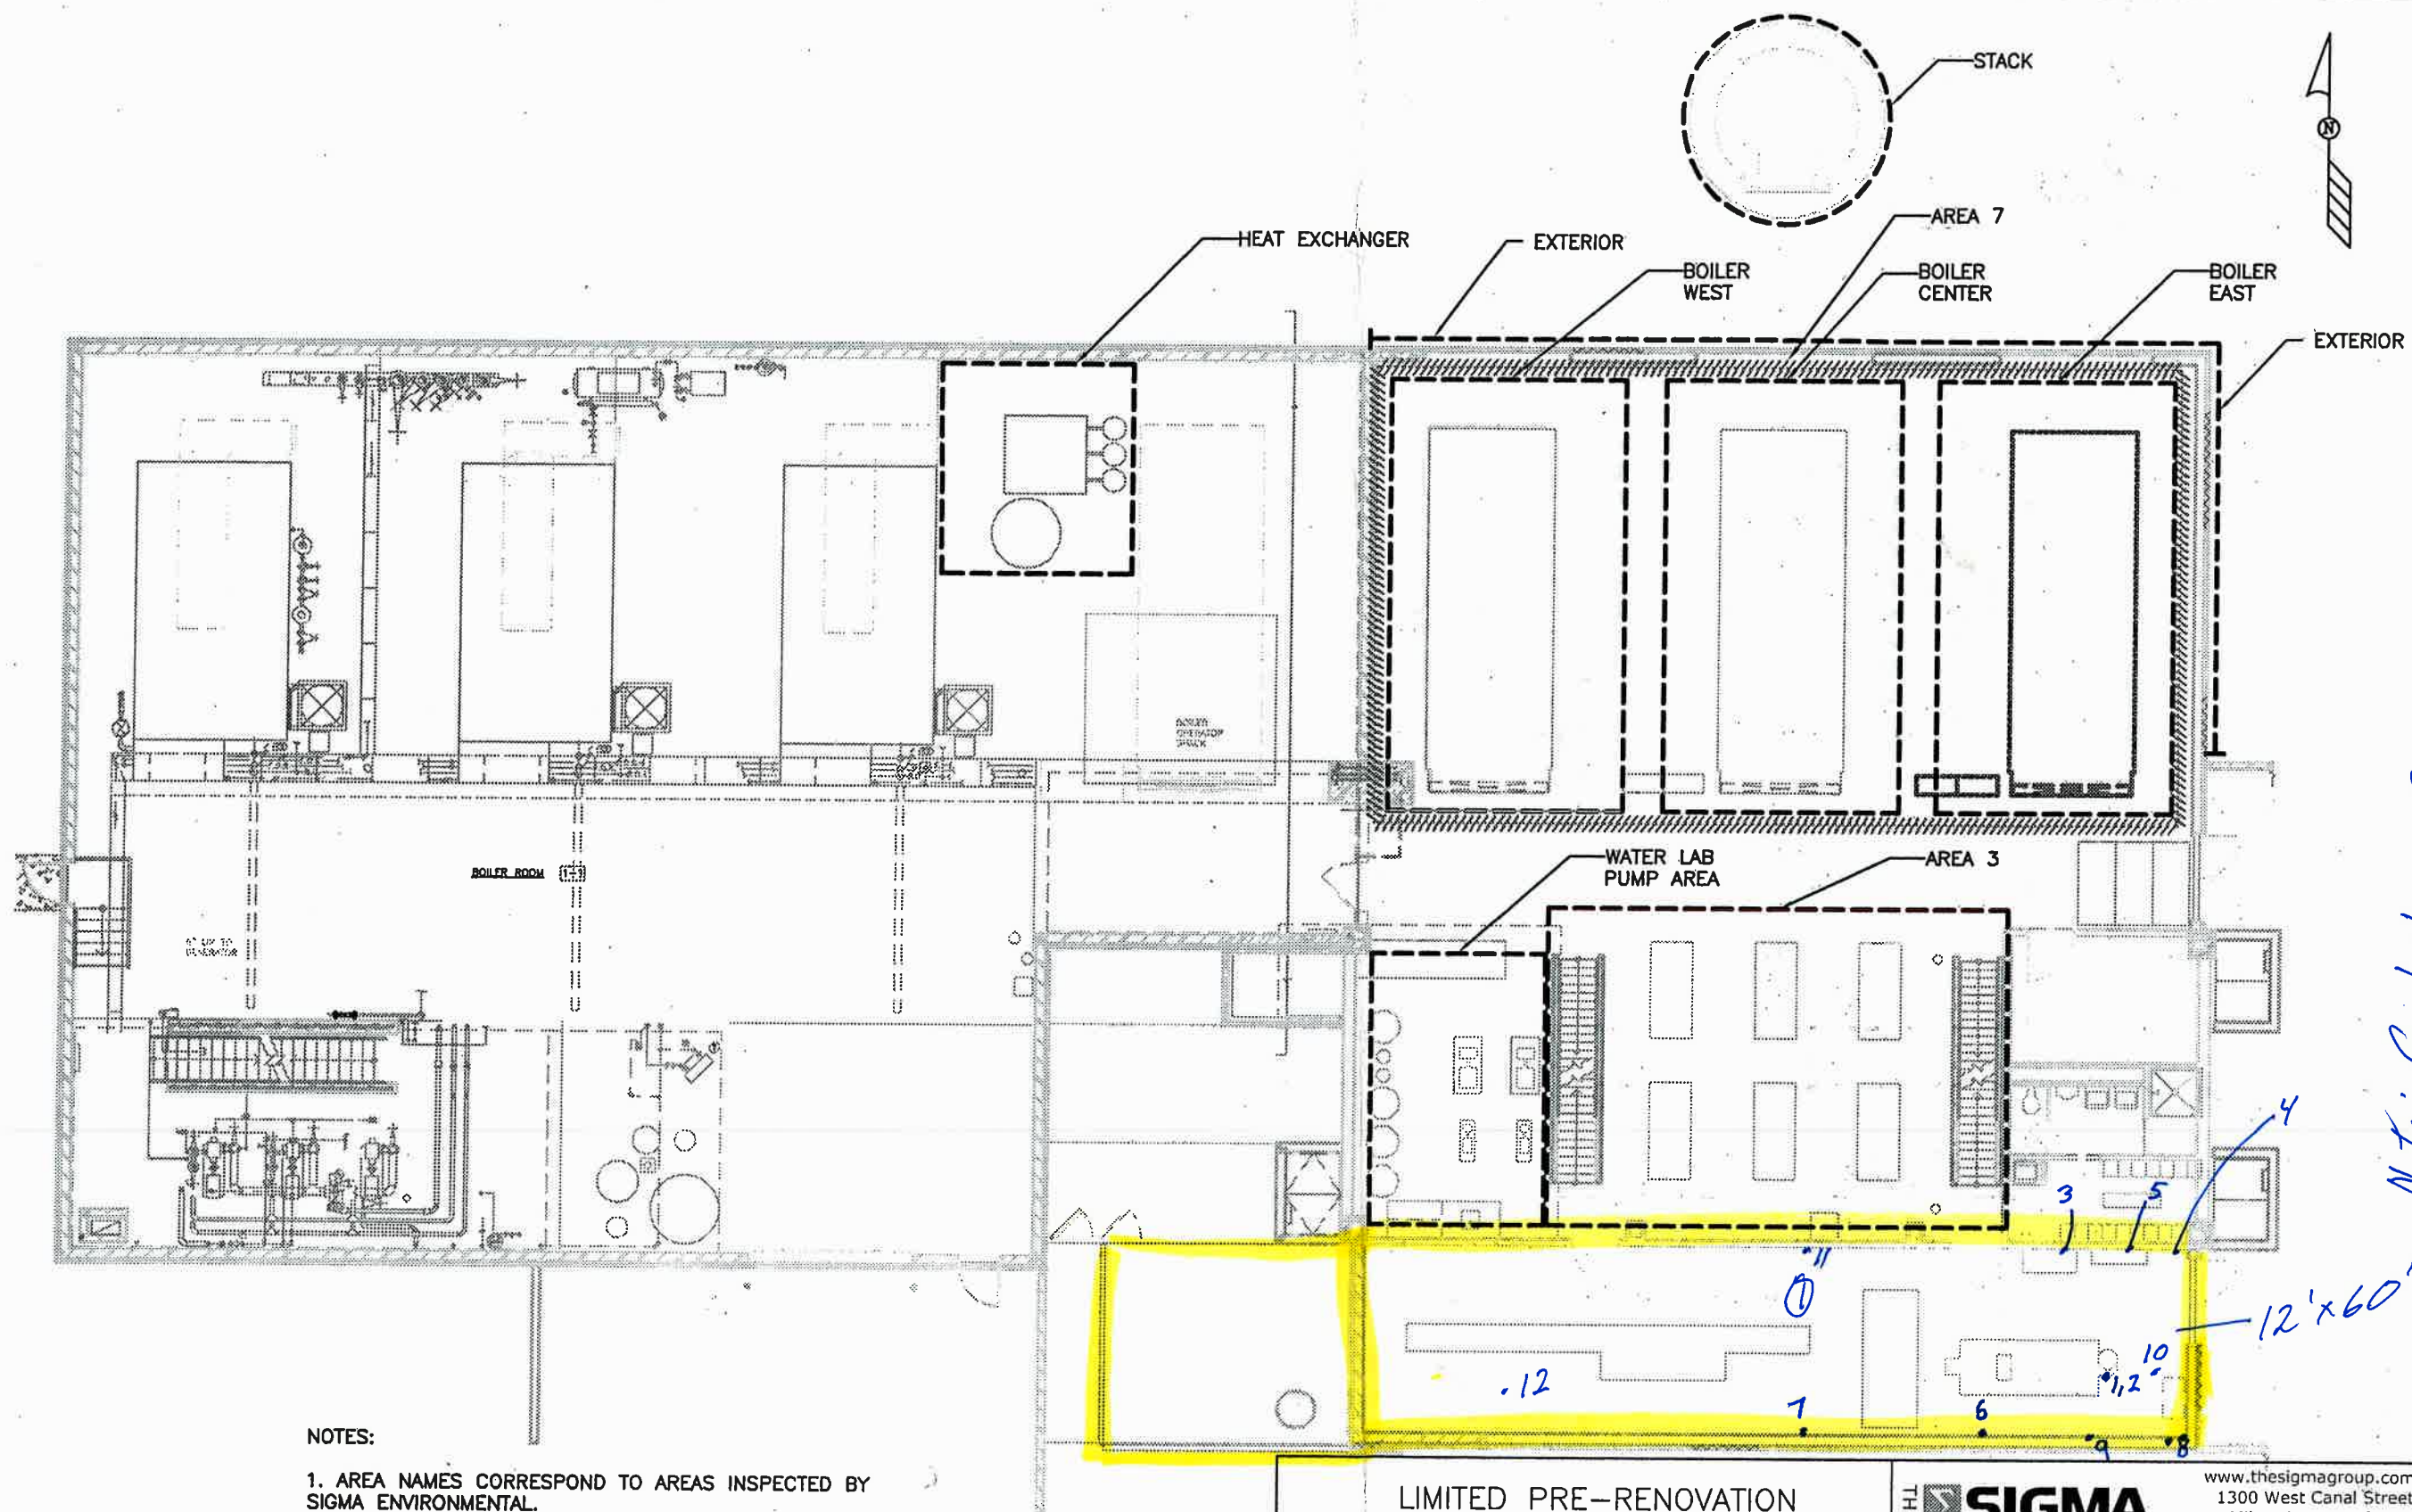
**Figure 1 – Limits of Inspection**

Sigma inspected areas within Building 112 as indicated on Figure 1 provided in Attachment 2 for suspect ACBMs. The following materials were evaluated by Sigma for the presence of asbestos.
