Veterans Affairs Medical Center Bldg. 137  
HAMPTON, VIRGINIA  
CRAWLSPACE ASBESTOS INSPECTION  
SAMPLE LOCATION DIAGRAM

## Crawl Space Management Plan

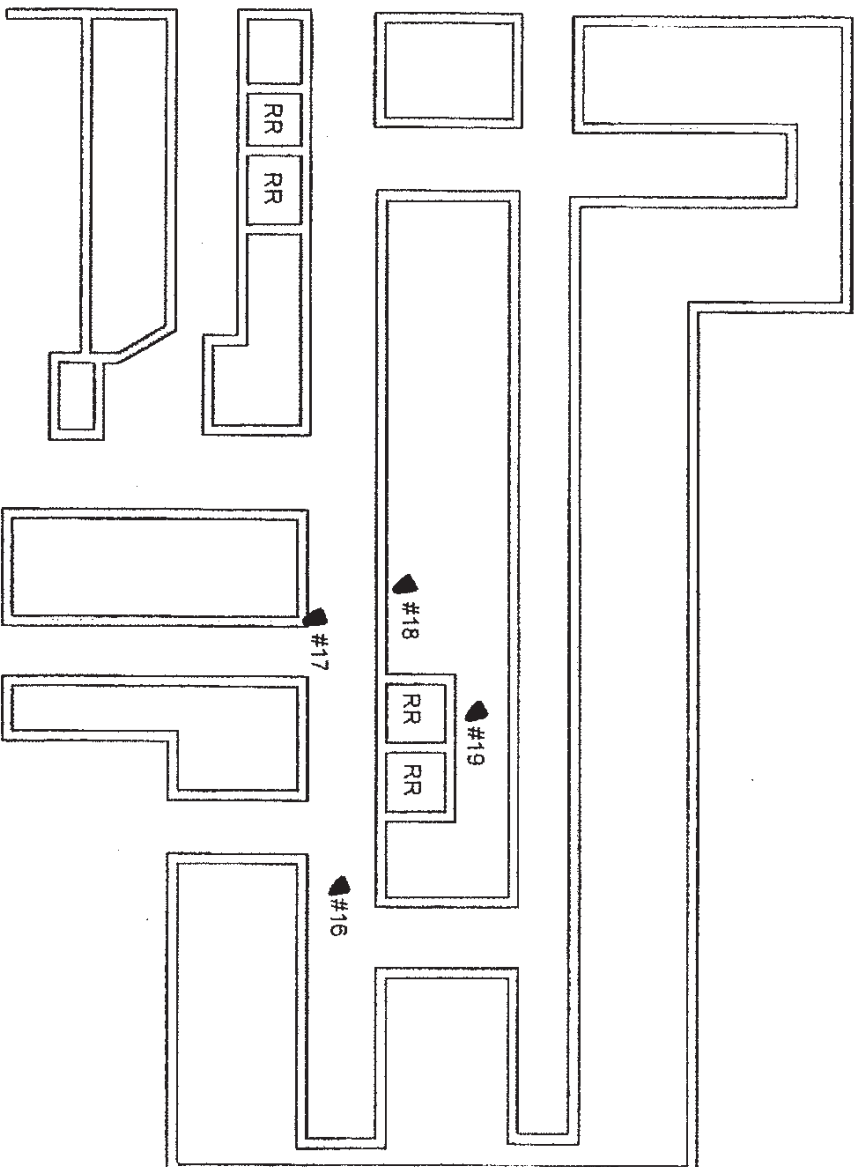
- ▲ Positive Sample # 16 (elbow/pipe)
- ▲ Positive Sample # 17 (elbow/pipe)
- ▲ Positive Sample # 18 (debris/soil)
- ▲ Positive Sample # 19 (debris/soil)
