CLASSIFICATION CODE *	C
SUBJECT *	Architect-Engineering (A-E) Services Replace Air Handling Unit (AHU) 2
GENERAL INFORMATION	
CONTRACTING OFFICE'S * ZIP-CODE	32608
SOLICITATION NUMBER *	VA248-17-R-1382
BASE NOTICE TYPE	SRCSGT

1.0 Executive Summary

The scope of the project is to complete a detailed feasibility study for the replacement of AC-2 and AC-3 and their associated systems. The assessment portion of the project found AC-2 and AC-3 in extremely poor condition with replacement over 30 years overdue and failure imminent.

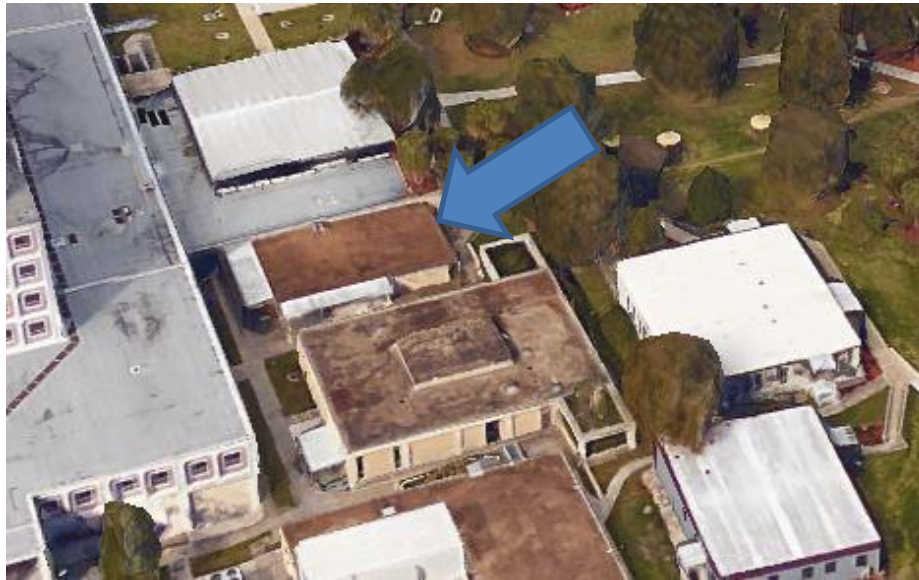
In the M&A report the only location suggested for the replacement unit is the current location for building 8 with their recommendation being removal of building 8. This is location has potential, however, there are several other options which should be considered including the roof of building 8 and the second floor roof of the main building.

Photo 4-1: Aerial photograph showing location where 2005 Moses & Associates HVAC Feasibility Report proposed locating a new replacement AC-2 air handling unit.
