1.0 Executive Summary

The scope of the project is to complete a detailed feasibility study for the replacement of AC-2 and AC-3 and their associated systems. The assessment portion of the project found AC-2 and AC-3 in extremely poor condition with replacement over 30 years overdue and failure imminent.

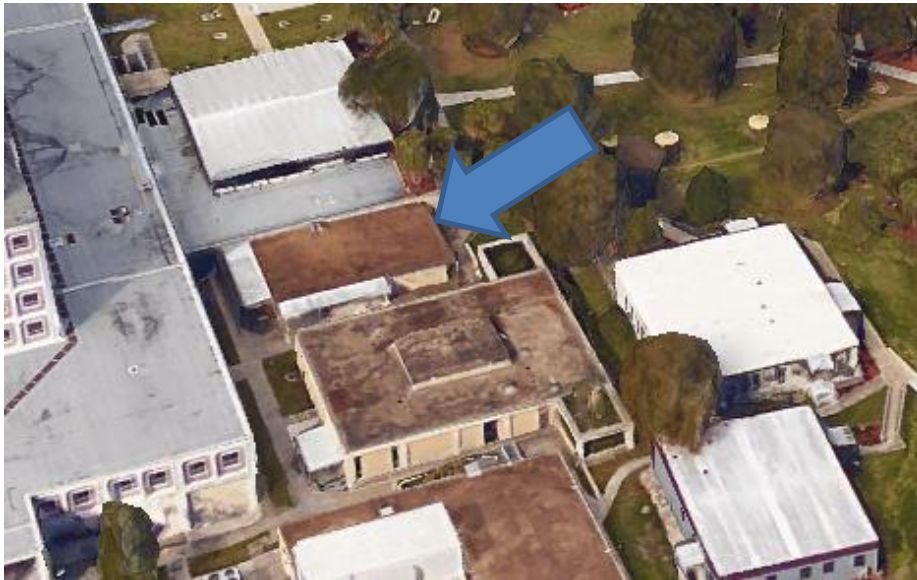
In the M&A report the only location suggested for the replacement unit is the current location for building 8 with their recommendation being removal of building 8. This is location has potential, however, there are several other options which should be considered including the roof of building 8 and the second floor roof of the main building.

Photo 4-1: Aerial photograph showing location where 2005 Moses & Associates HVAC Feasibility Report proposed locating a new replacement AC-2 air handling unit.
