**TARGETED SURVEY
FOR ASBESTOS BUILDING 7
SCI 1E & 1W
VA MEDICAL CENTER
MEMPHIS, TN**

June 25, 2016

MICHAEL F. DURBIN, CIH
DURBIN ENVIRONMENTAL CONSULTANTS, INC.
2201 POTOMAC PLACE
LAWRENCEVILLE, GEORGIA 30043
(770) 601-7791

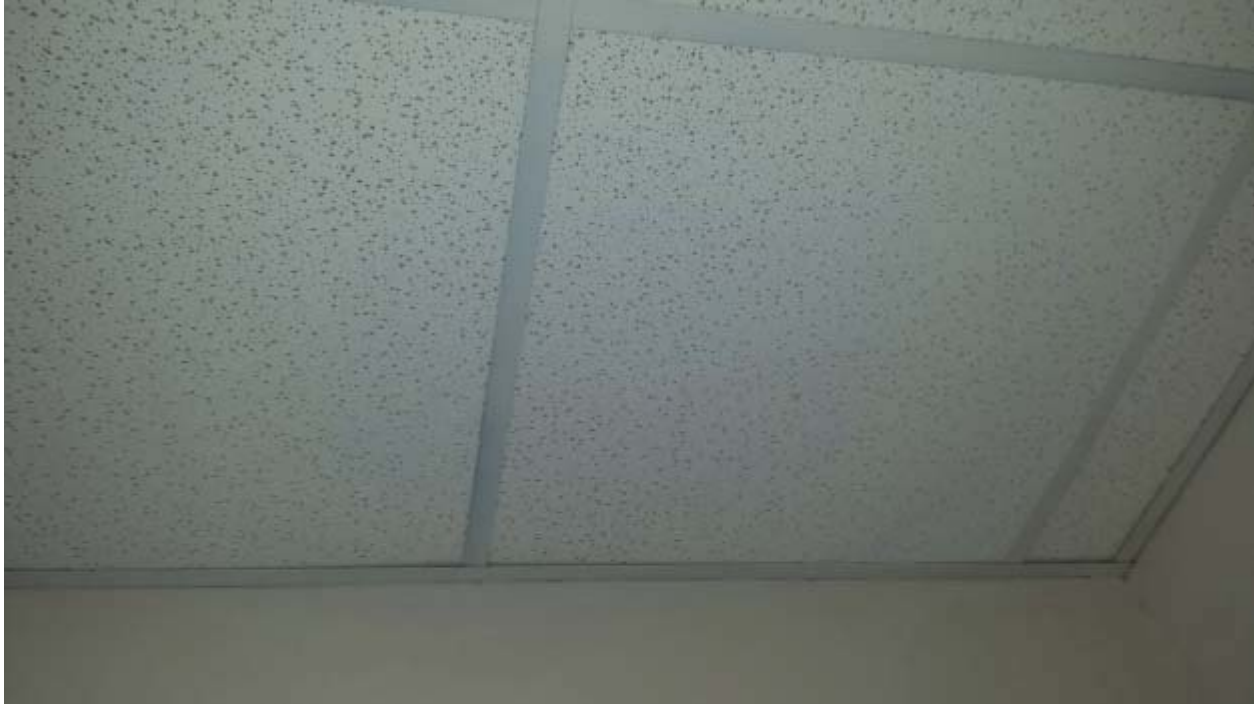
1. White 2' X 2' Ceiling Tile, Small Gouges and Pinholes (HM #1)

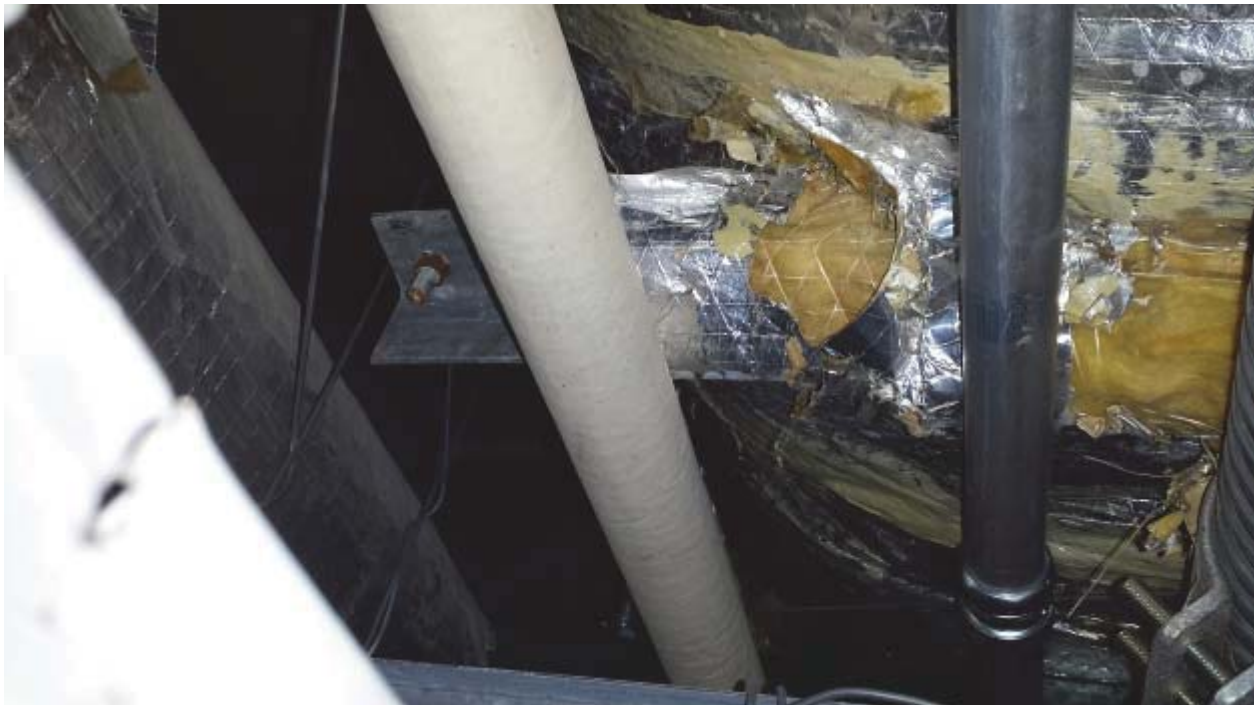
2. Brown/Beige Duct Sealant on Foil Wrapped Duct Insulation with Fiberglass (HM #2)

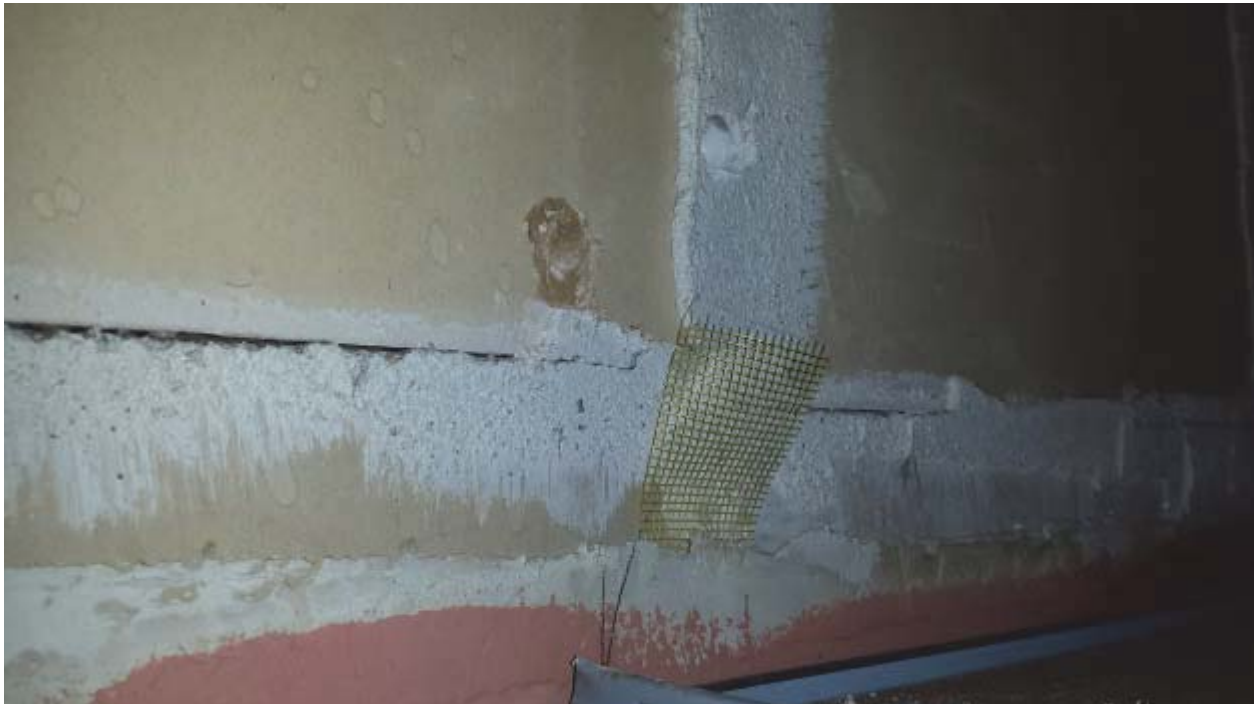
3. Drywall and Drywall Joint Compound (HM #3)

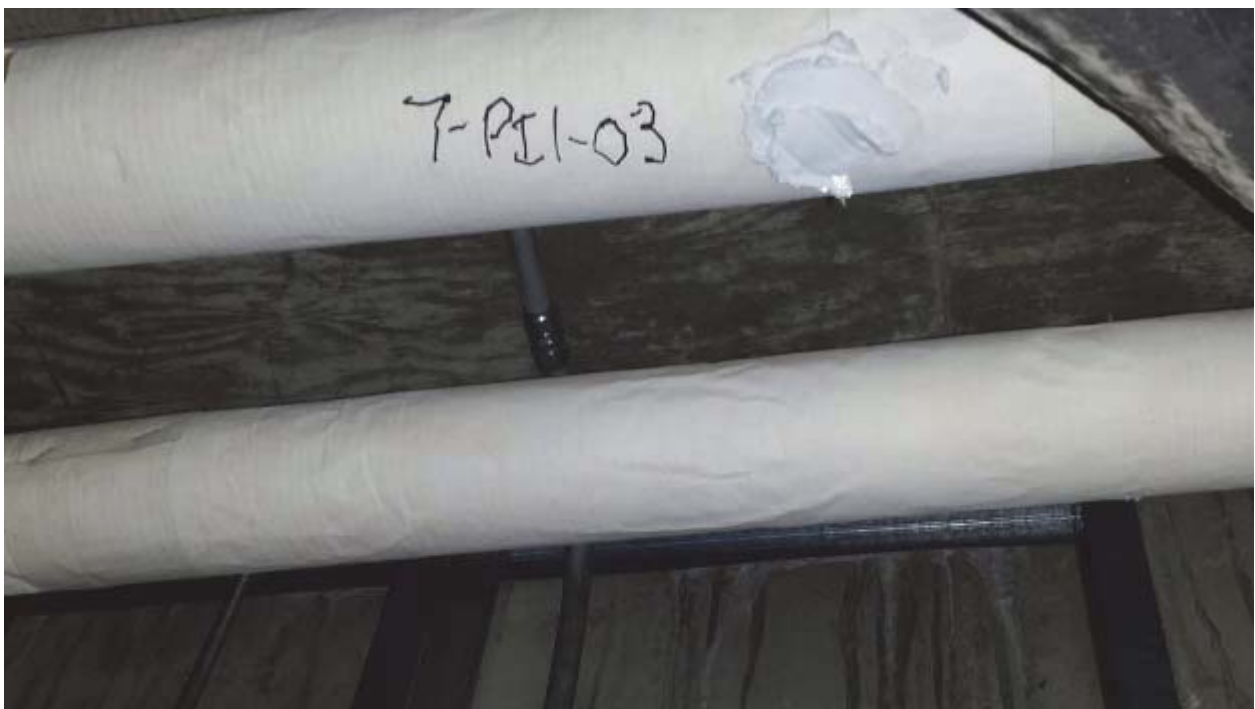
4. Paper Wrapped Pipe Insulation, Fiberglass Confirmation (HM #4)
