Main Entrance – North East - outbound Side Lane

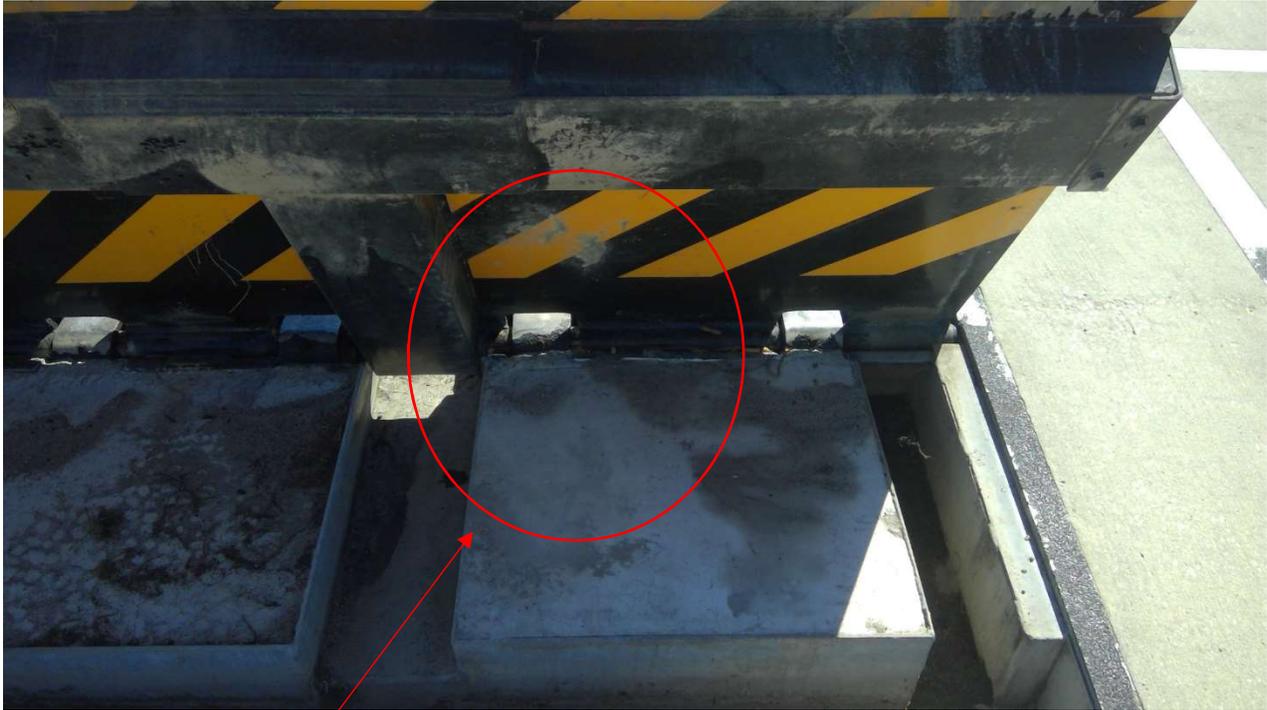
Concrete was poured too high during installation resulting in the plate not resting properly in the down position and also damaging the paint and the galvanizing coating

Resolution: grind the concrete down, touch up paint with yellow and black paint

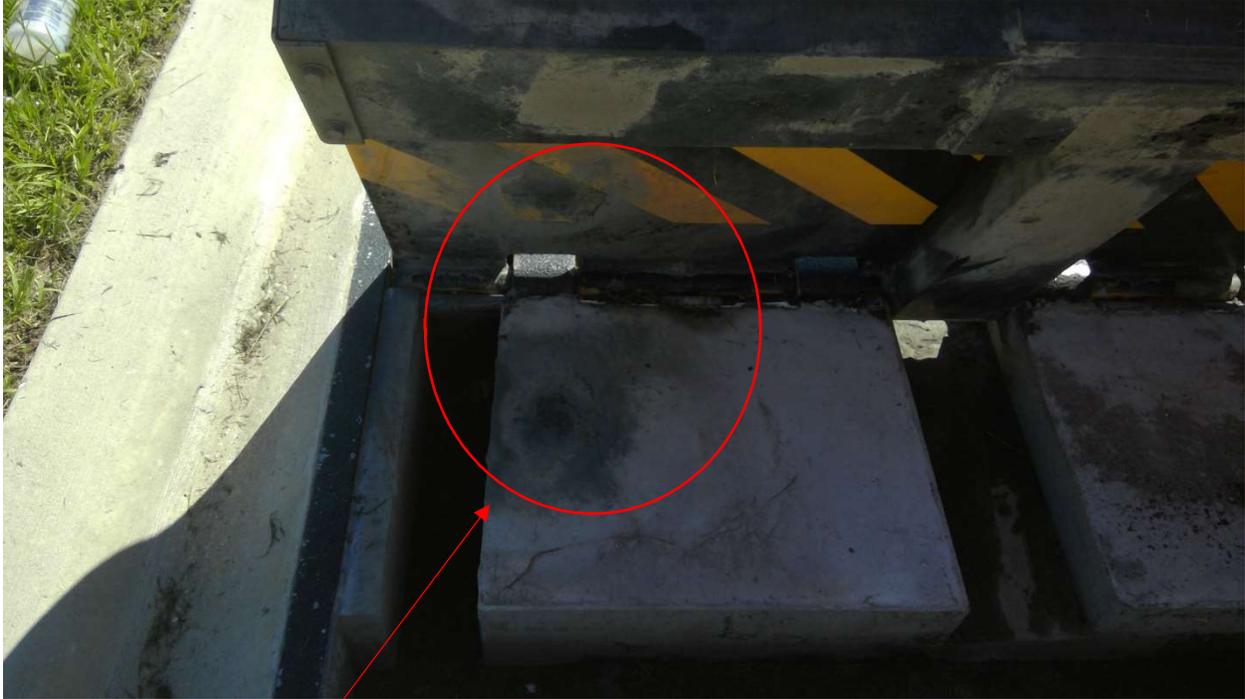
Concrete was poured too high during installation resulting in the plate not resting properly in the down position and also damaging the paint and the galvanizing coating

Resolution: grind the concrete down, touch up paint with yellow and black paint

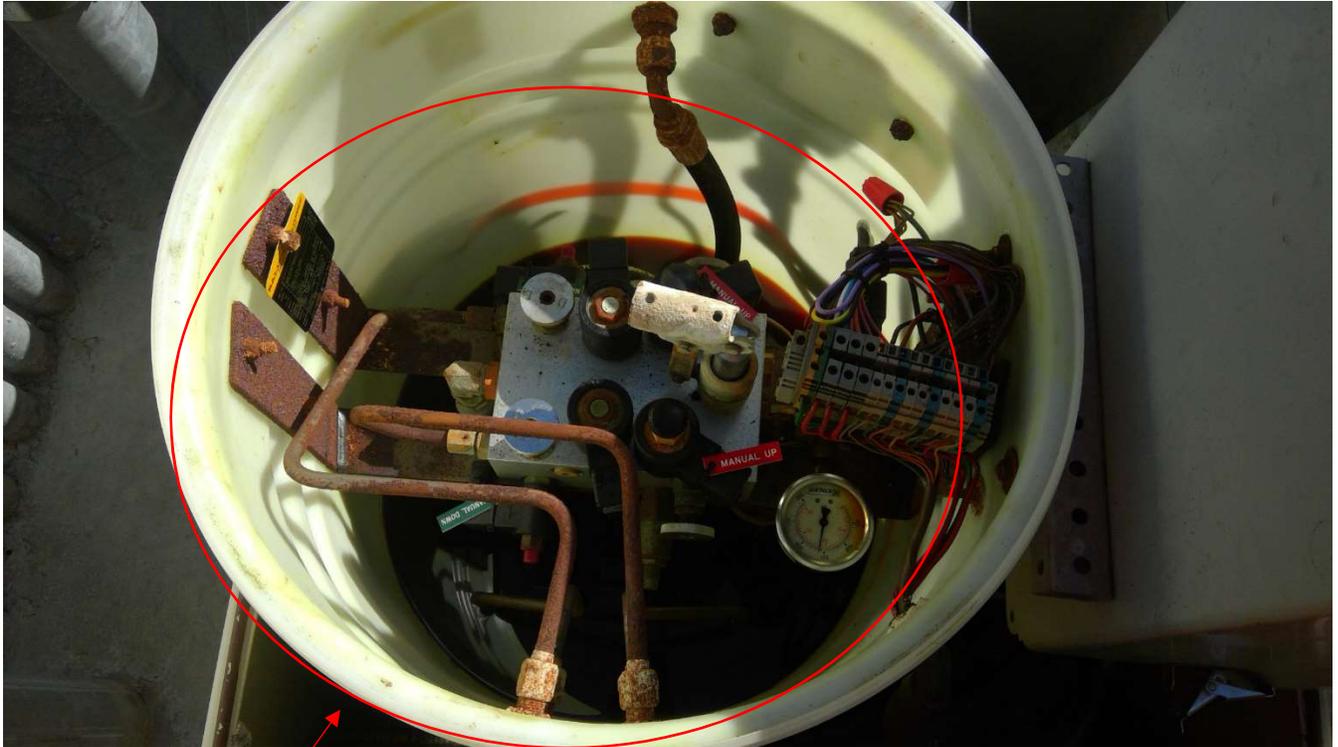
Main Entrance - Side/Middle – Power Unit

Hydraulic unit is complete disrepair. All the lines, hand pump, mounting, fitting are in a major state of degradation. It is suggested to replace the entire power unit before putting the barrier system into operation. The hydraulic lines should be replaced. The hydraulic cylinder needs to be taken apart and cleaned also.

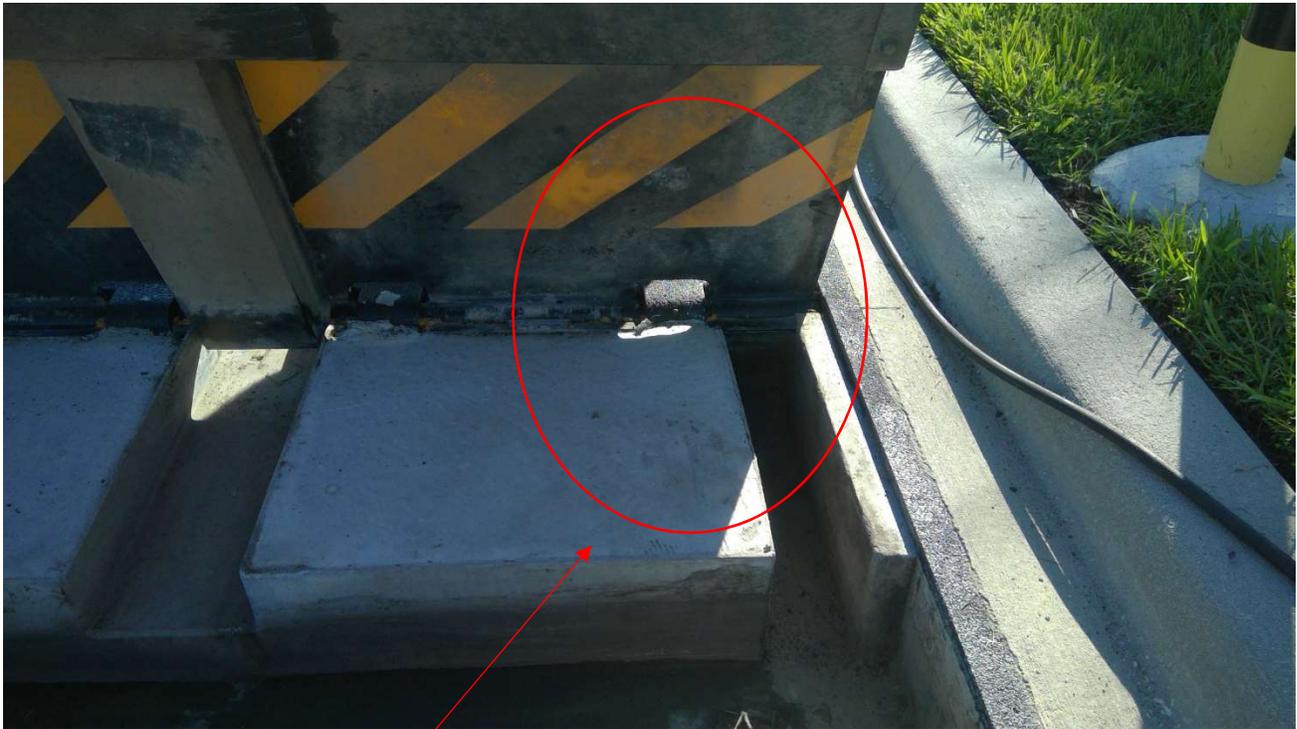
Concrete was poured too high during installation resulting in the plate not resting properly in the down position and also damaging the paint and the galvanizing coating

Resolution: grind the concrete down, touch up paint with yellow and black paint

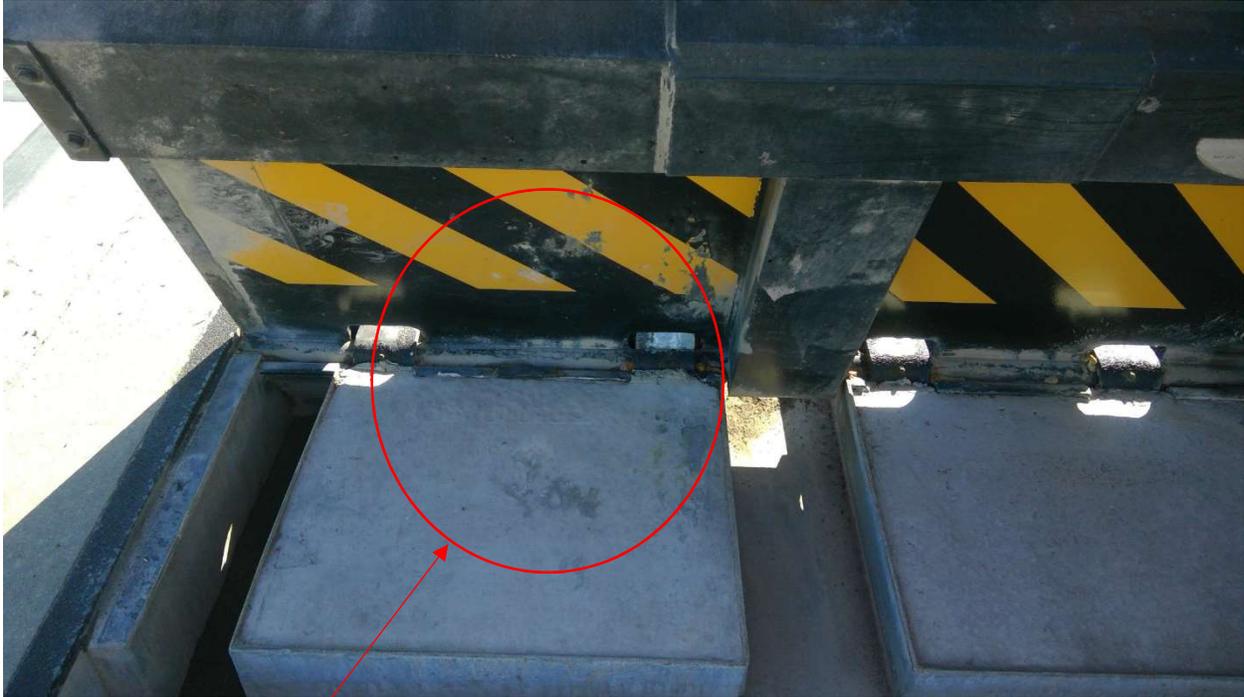
Concrete was poured too high during installation resulting in the plate not resting properly in the down position and also damaging the paint and the galvanizing coating

Resolution: grind the concrete down, touch up paint with yellow and black paint
