Warehouse Service Entrance - Outbound Side Lane

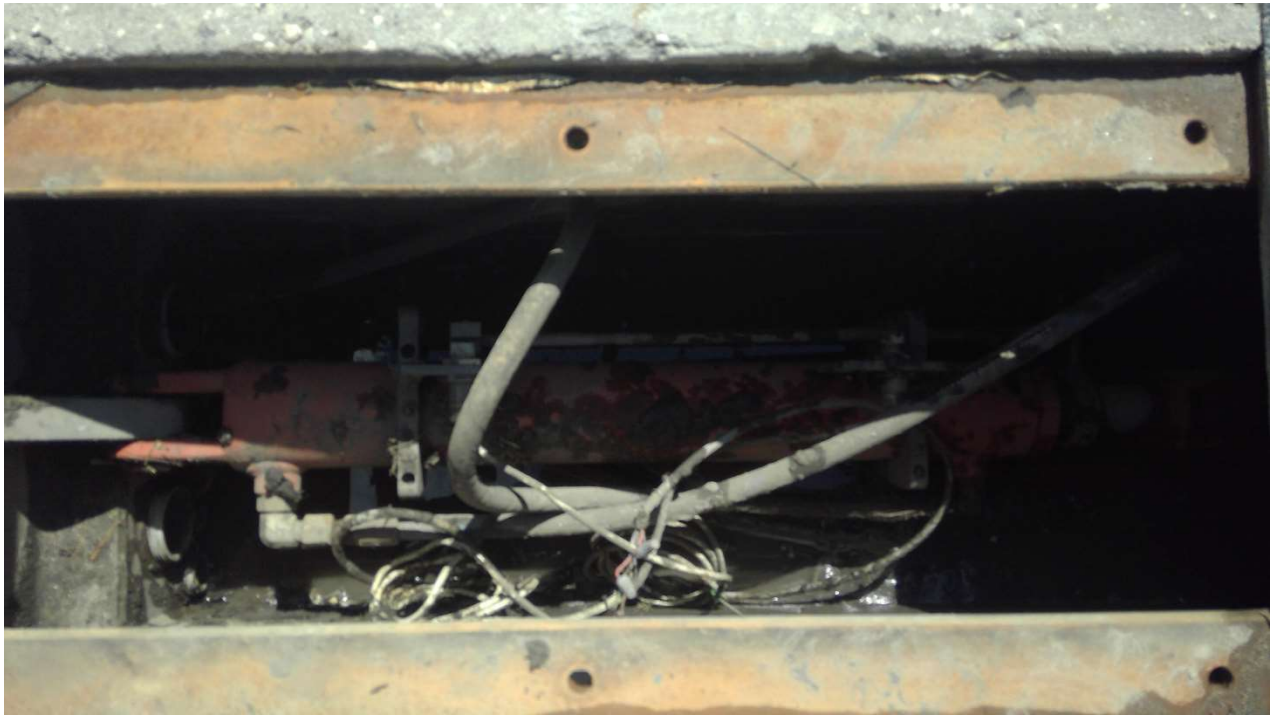
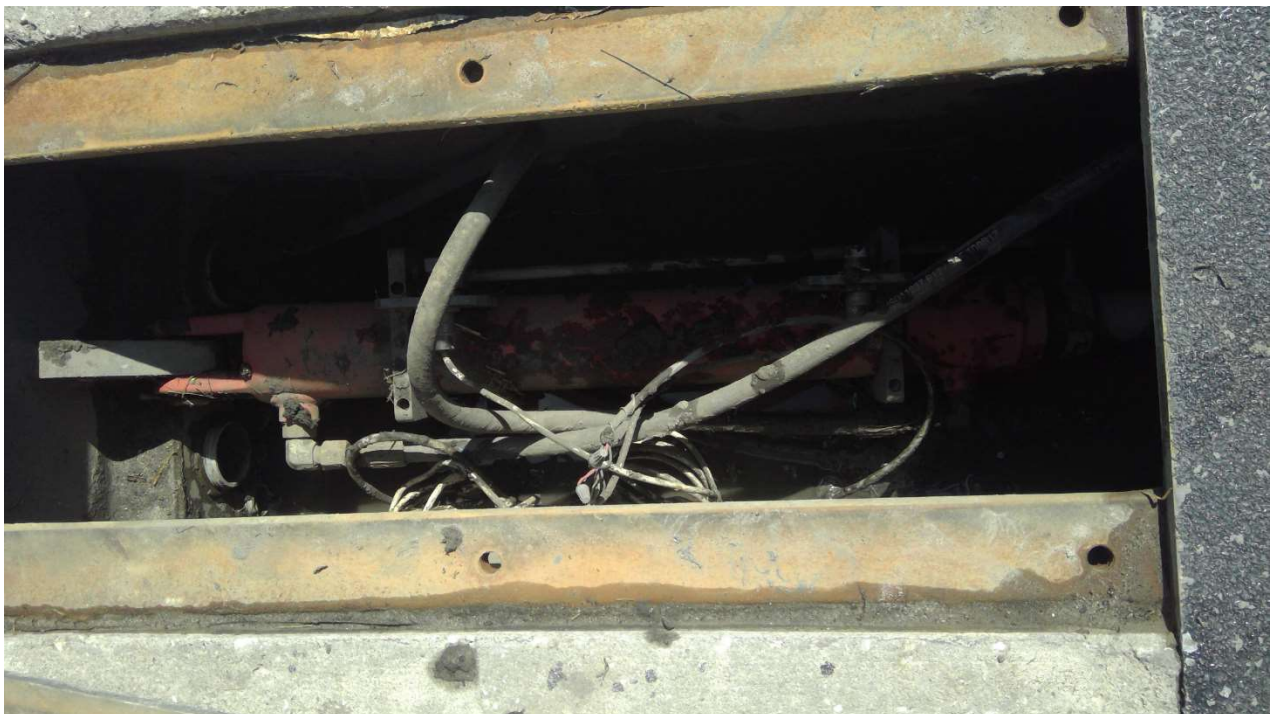
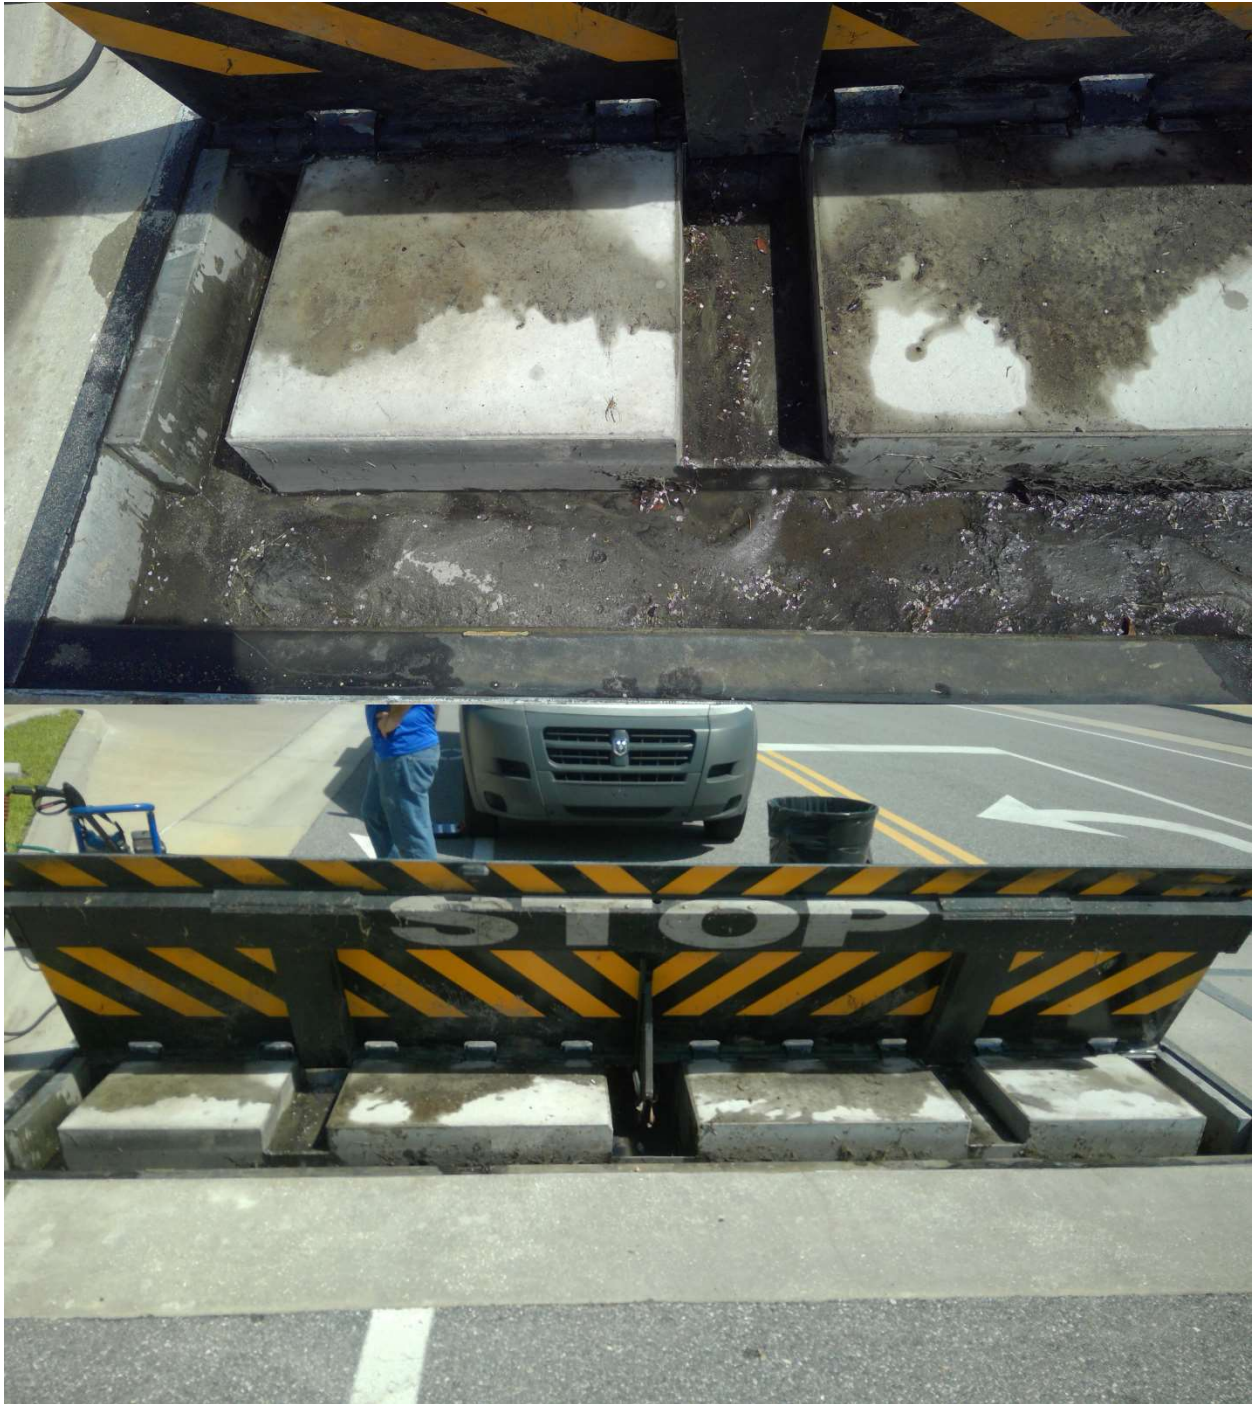
-Limit Sensors wiring is damaged not properly terminated for below grade application. The cable should be shortened, terminations should be soldered, adhesive heat shrunk, and cable sleeved Lead in cables are damaged and need replaced with shielded cable

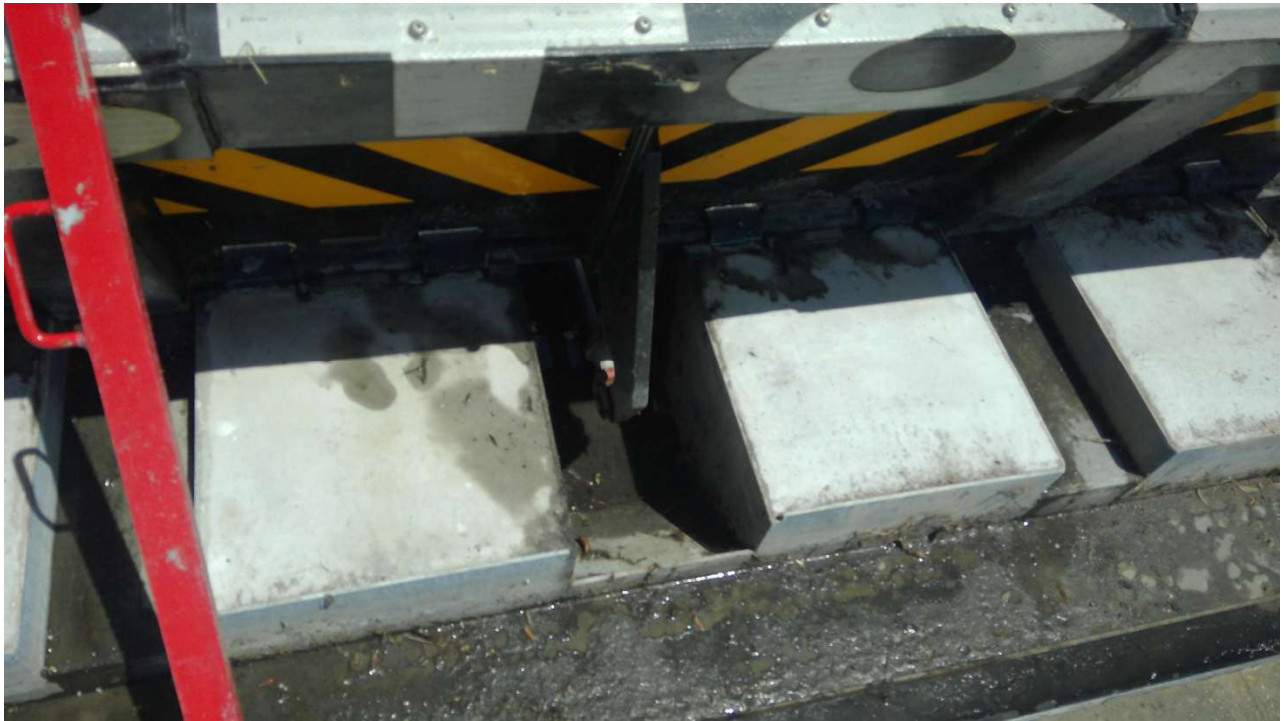
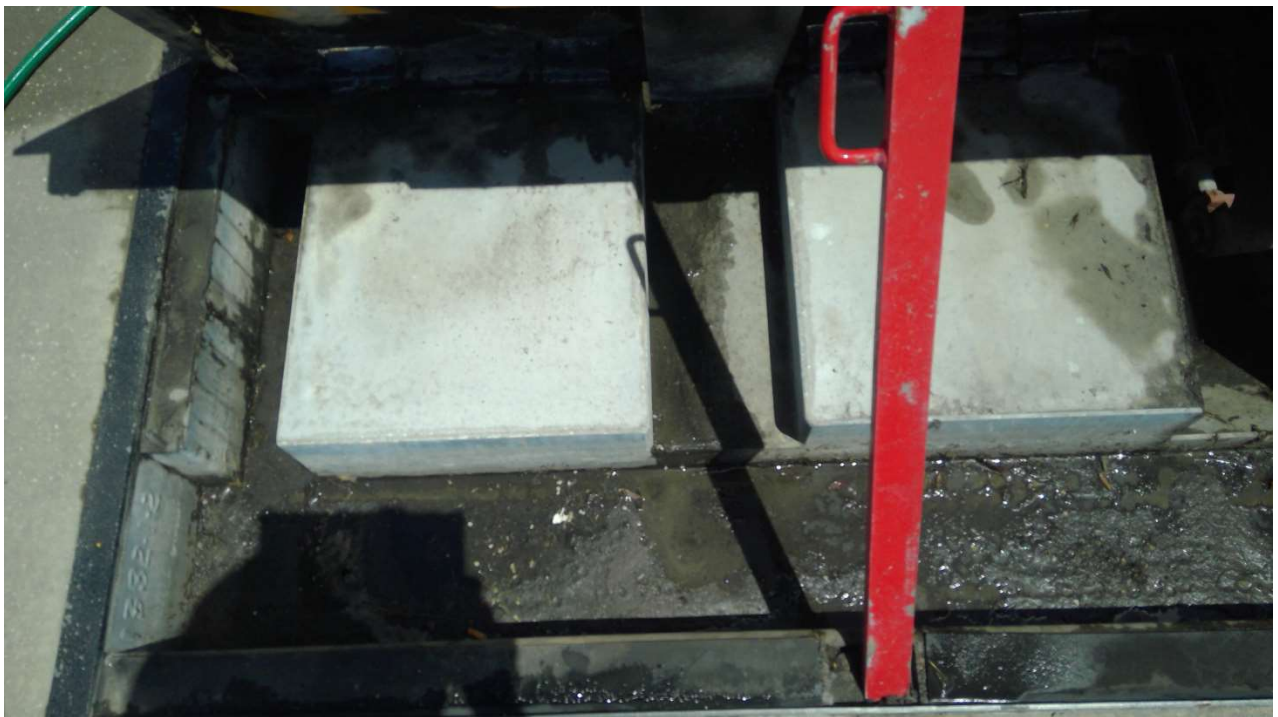
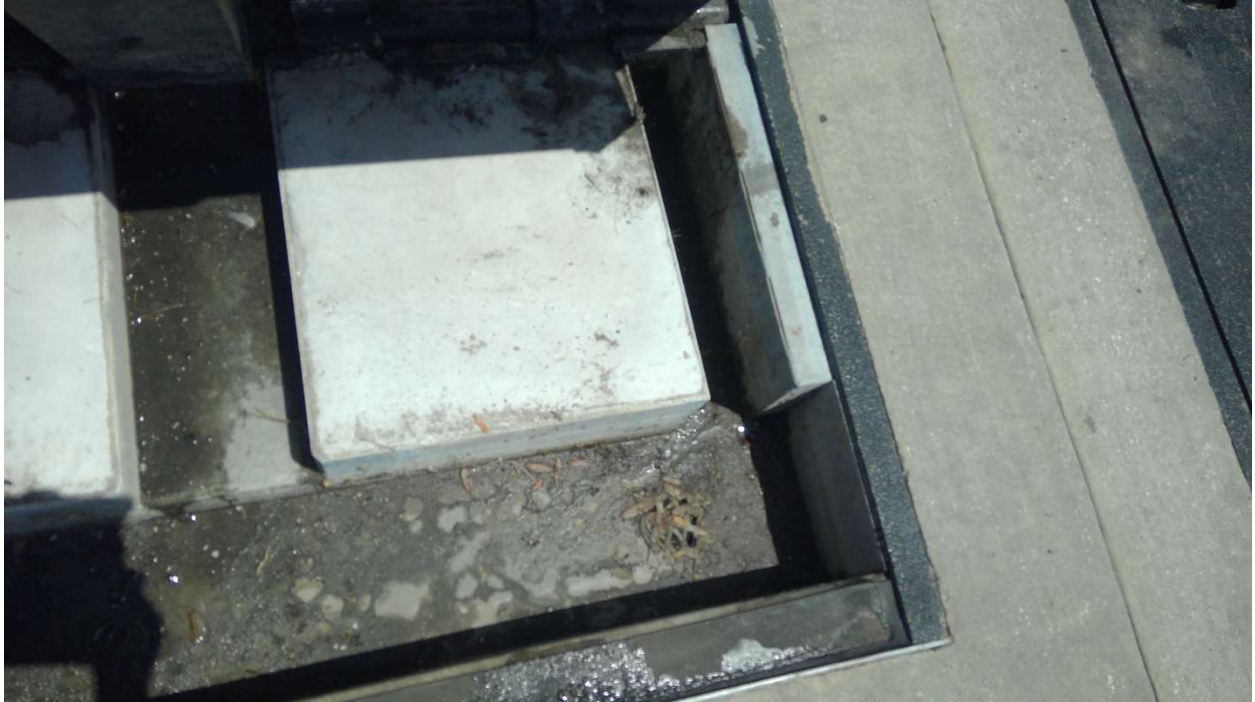
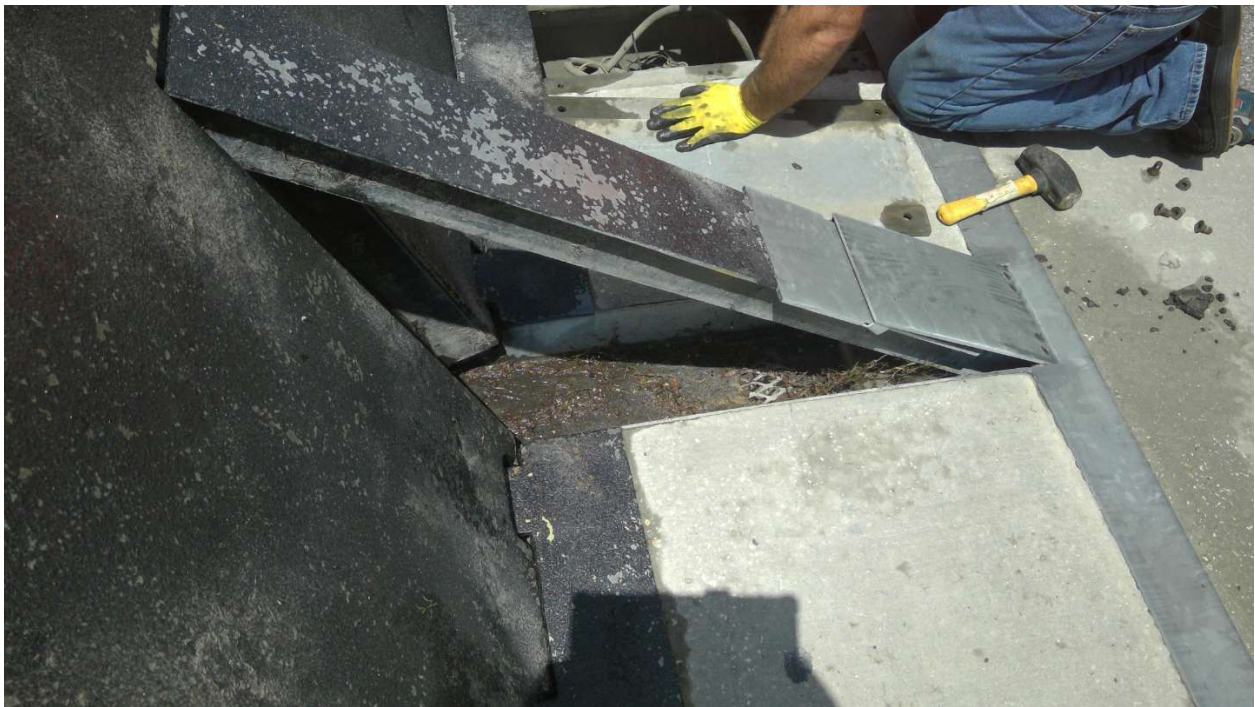
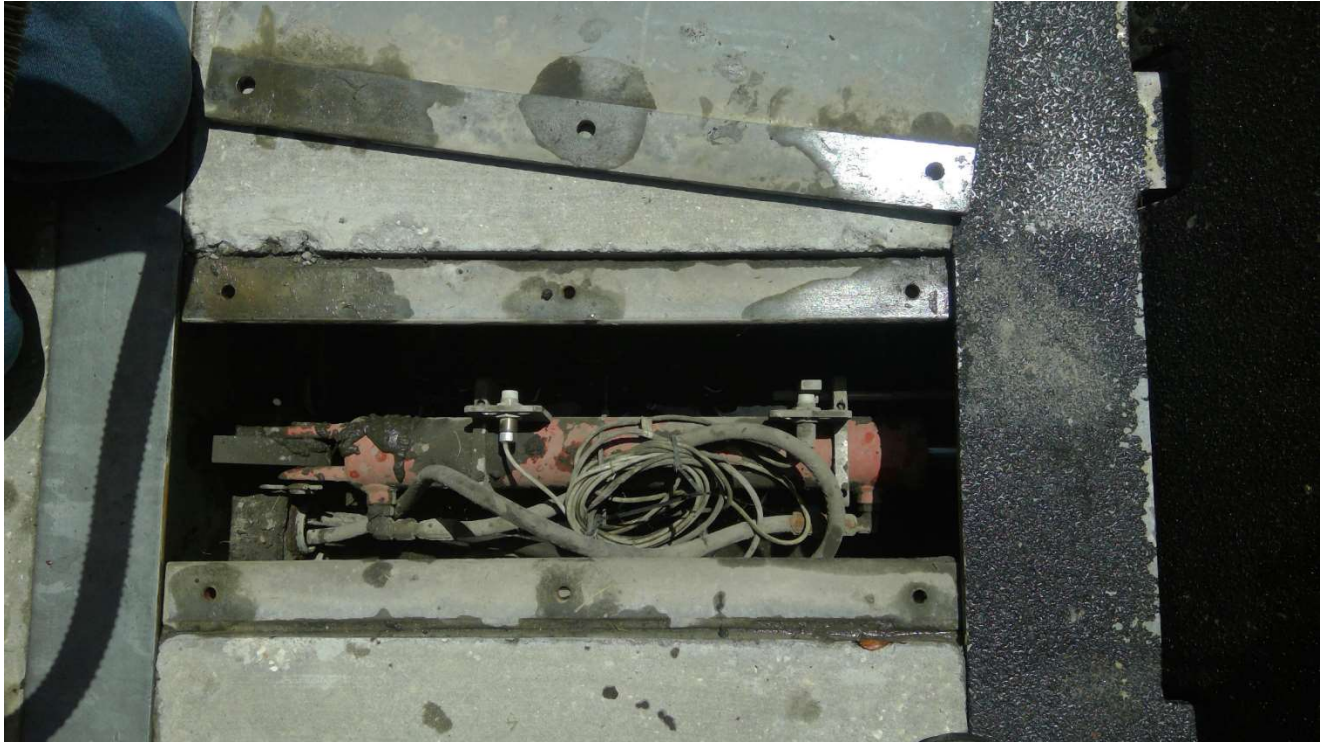
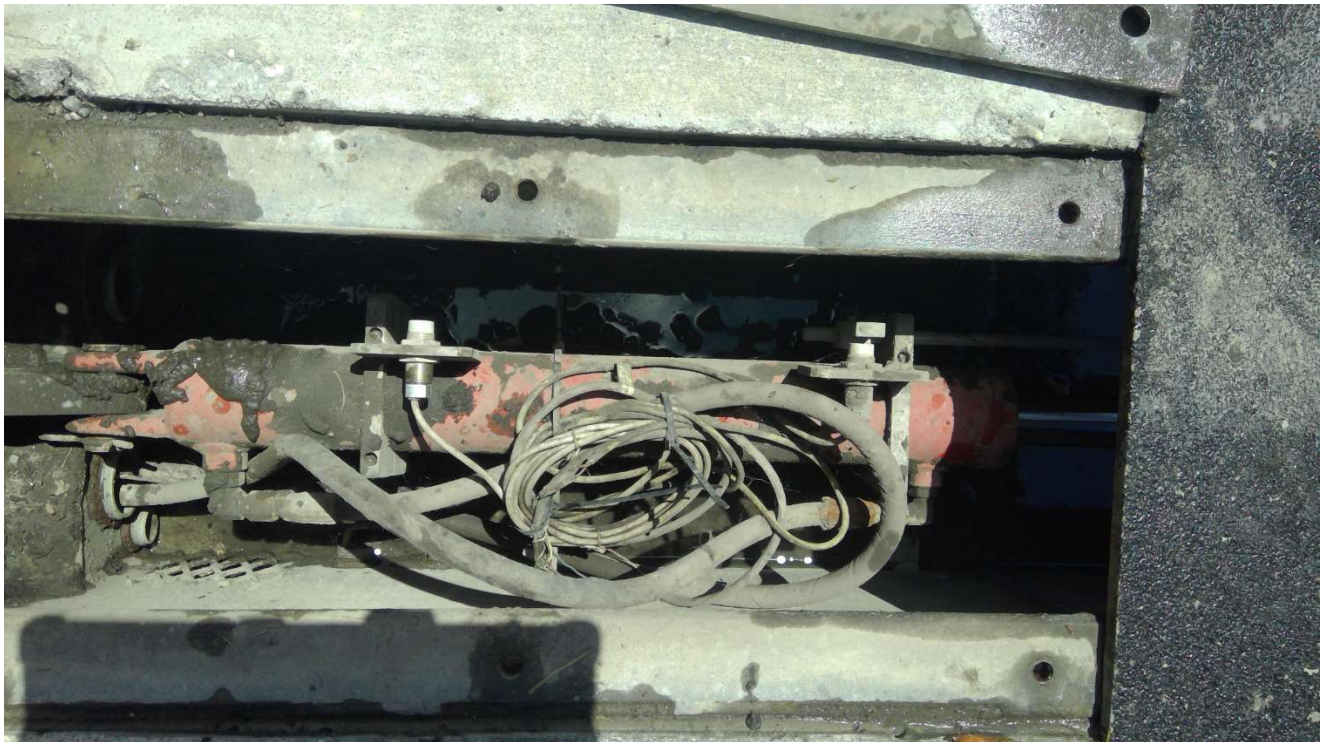
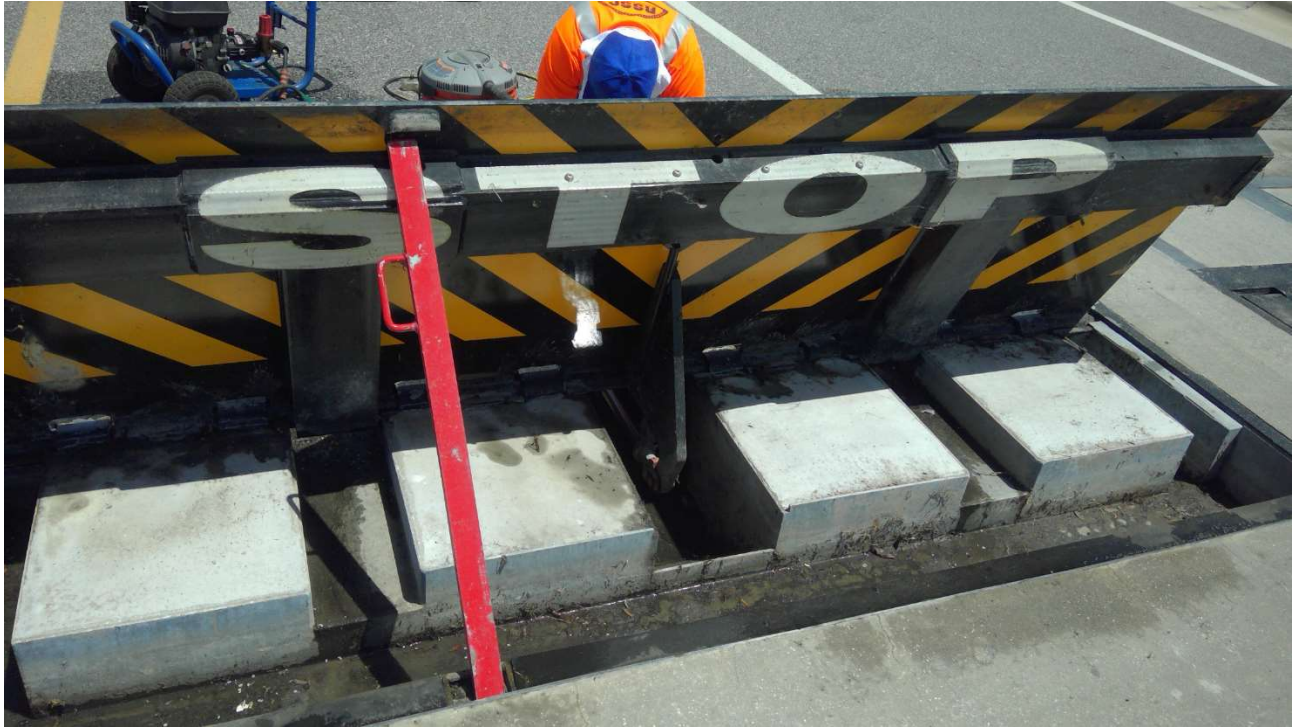
Warehouse Service Entrance - Middle Lane

- Limit Sensors wiring is damaged and not properly terminated for below grade application. The cable should be shortened, terminations should be soldered, adhesive heat shrunk, and cable sleeved
- Hose needs replaced and rerouted. We moved it back slightly to avoid rubbing.

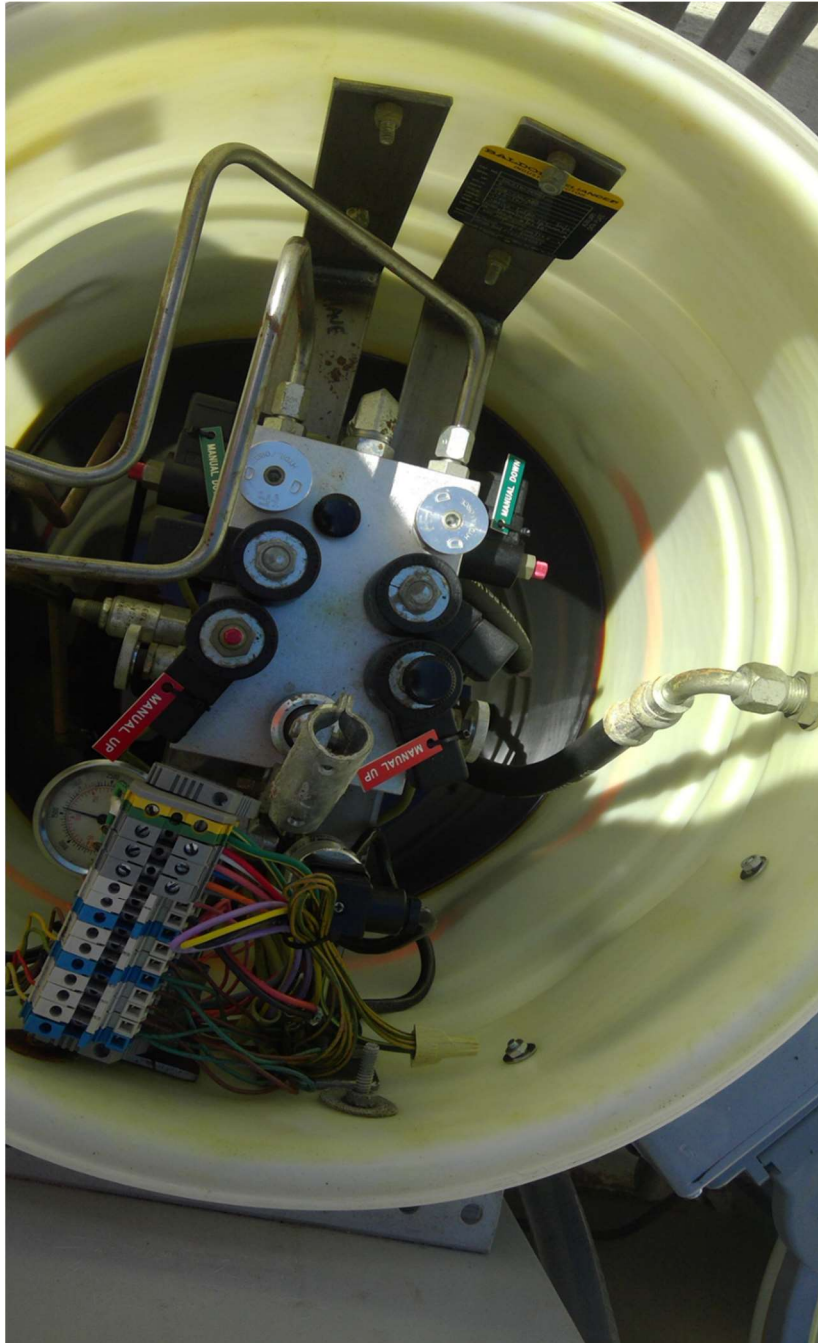
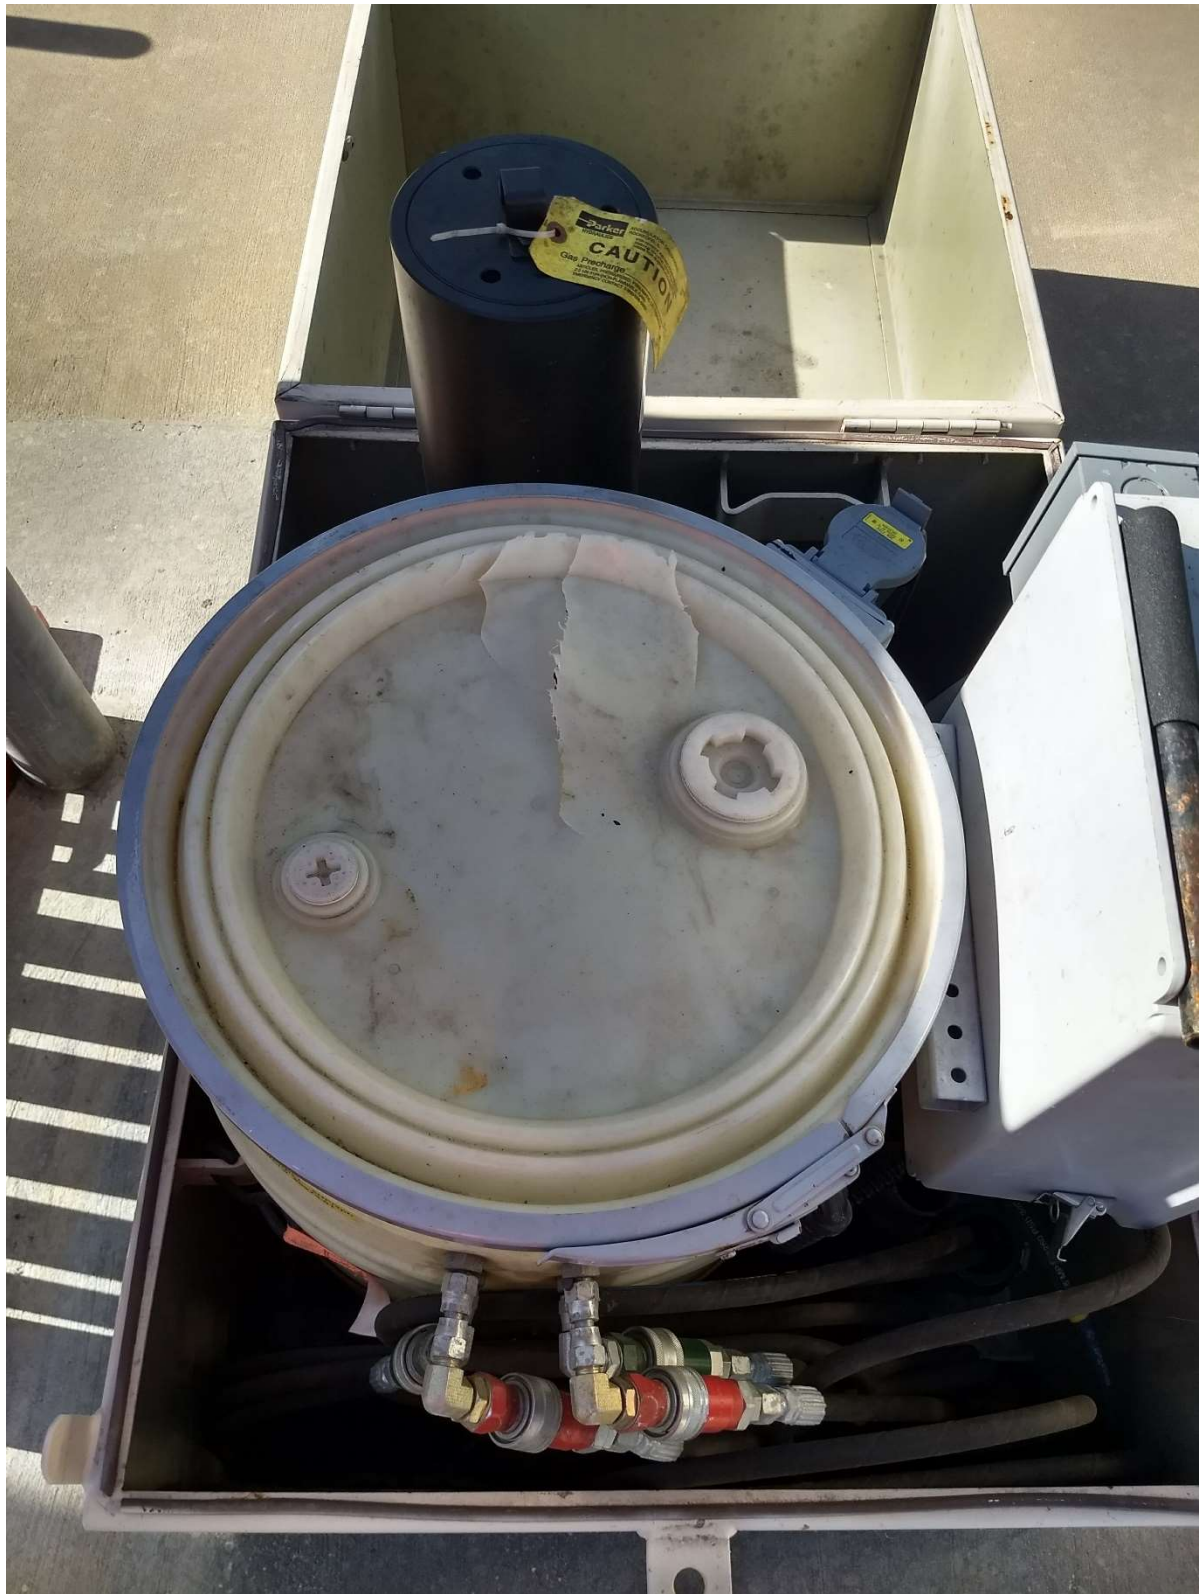
Ware Service Entrance - Left/Middle – Power Unit

- Hydraulic oil is extremely dirty. The oil, suction strainer needs to be replaced. The hydraulic hoses need to be blown out and flushed. The hydraulic drum needs to be wiped and cleaned thoroughly
- Eliminate the un-necessary secondary layer of PLC control
- Noticeable rusting and paint chipping is on the outdoor enclosure. The chipping spots at a minimum needs to be touched up. Full painting is suggested.
- Lid is cracked, replace with OEM reservoir lid

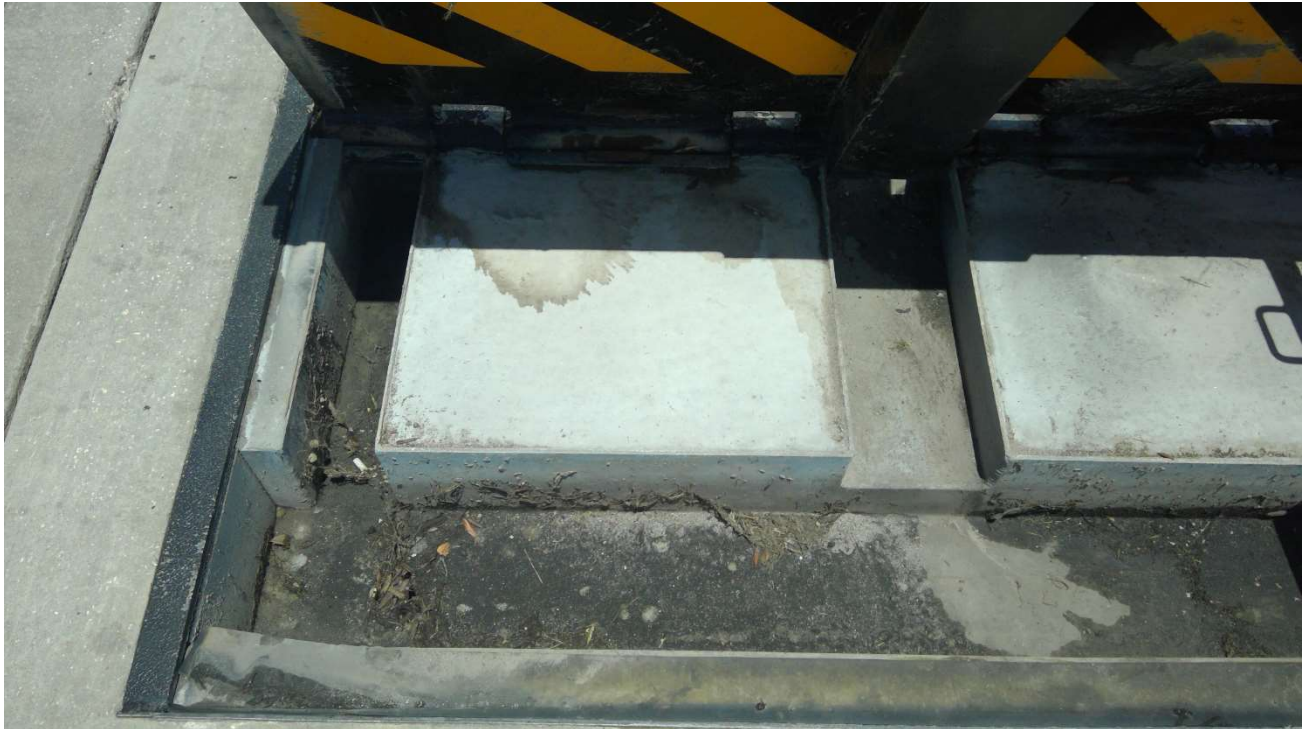
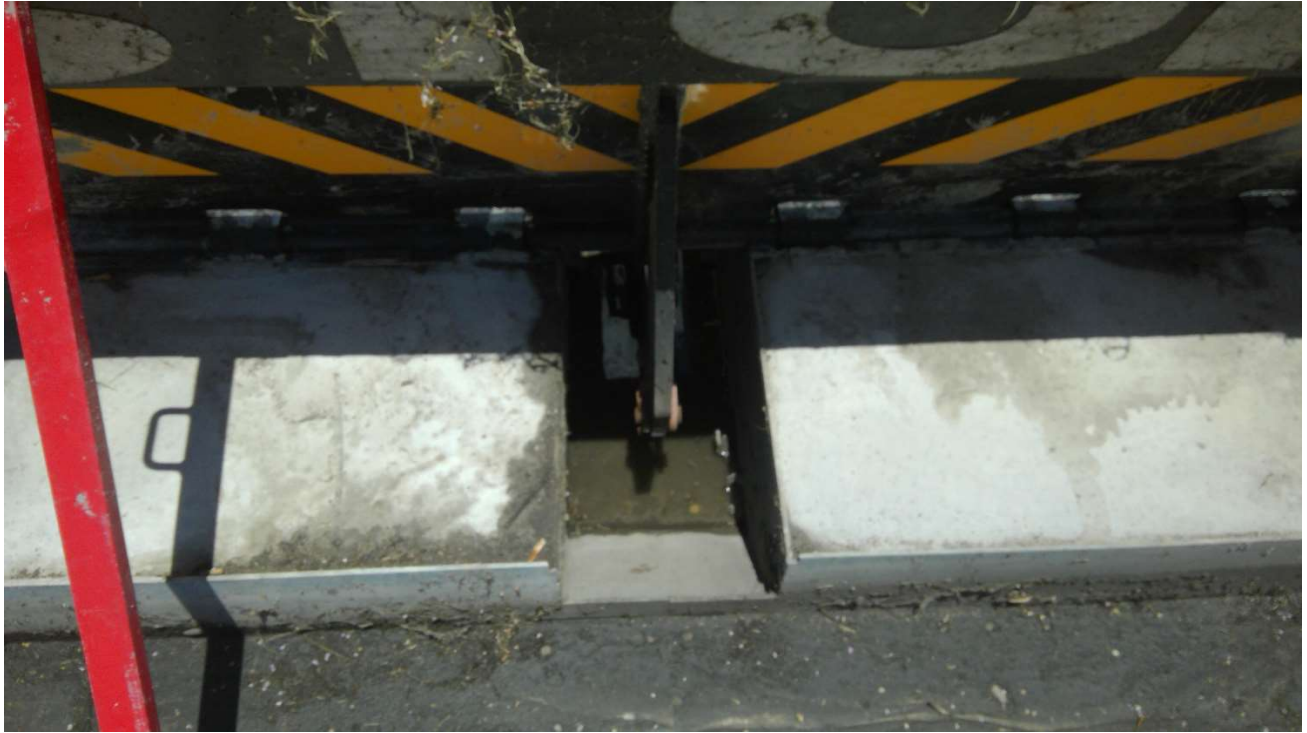
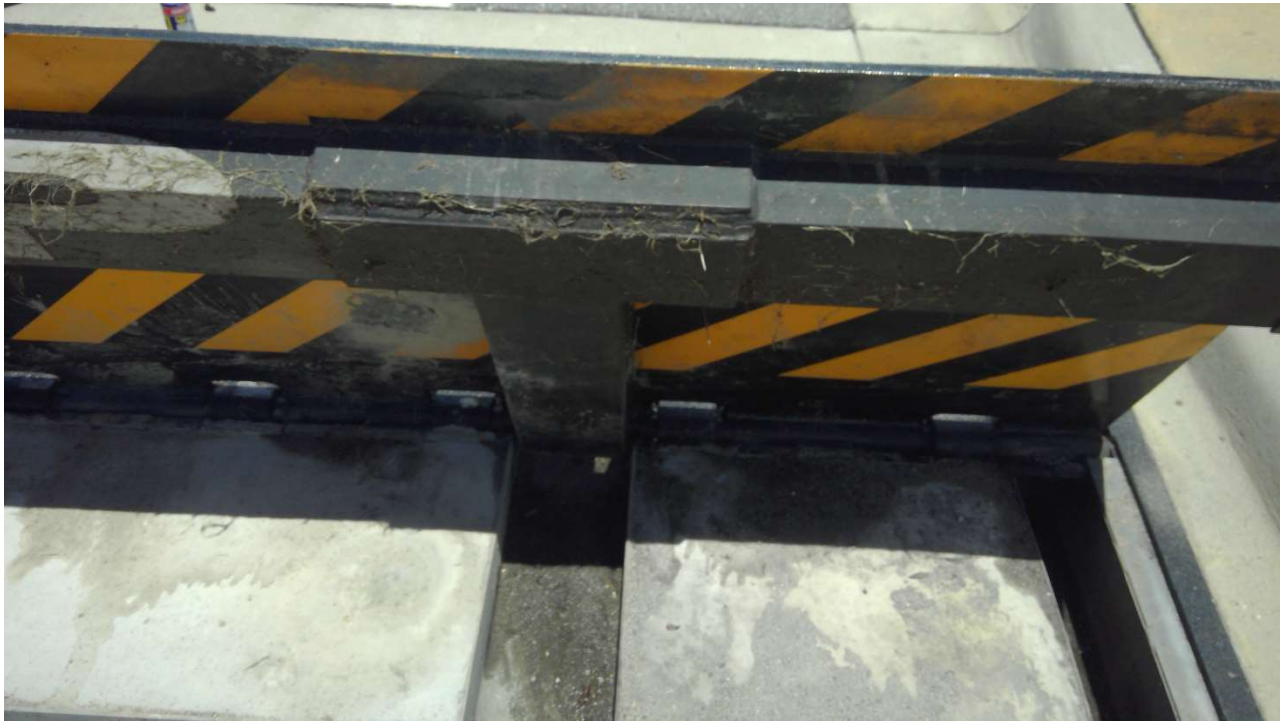
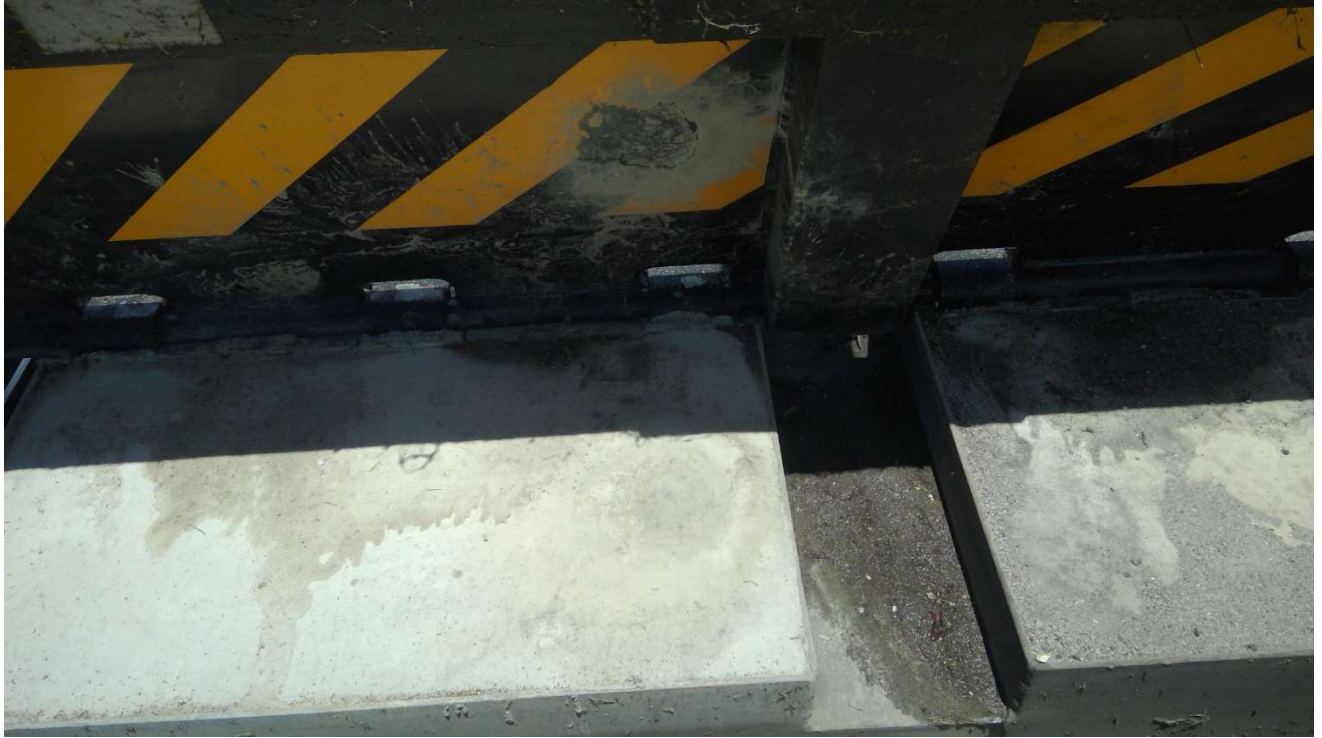
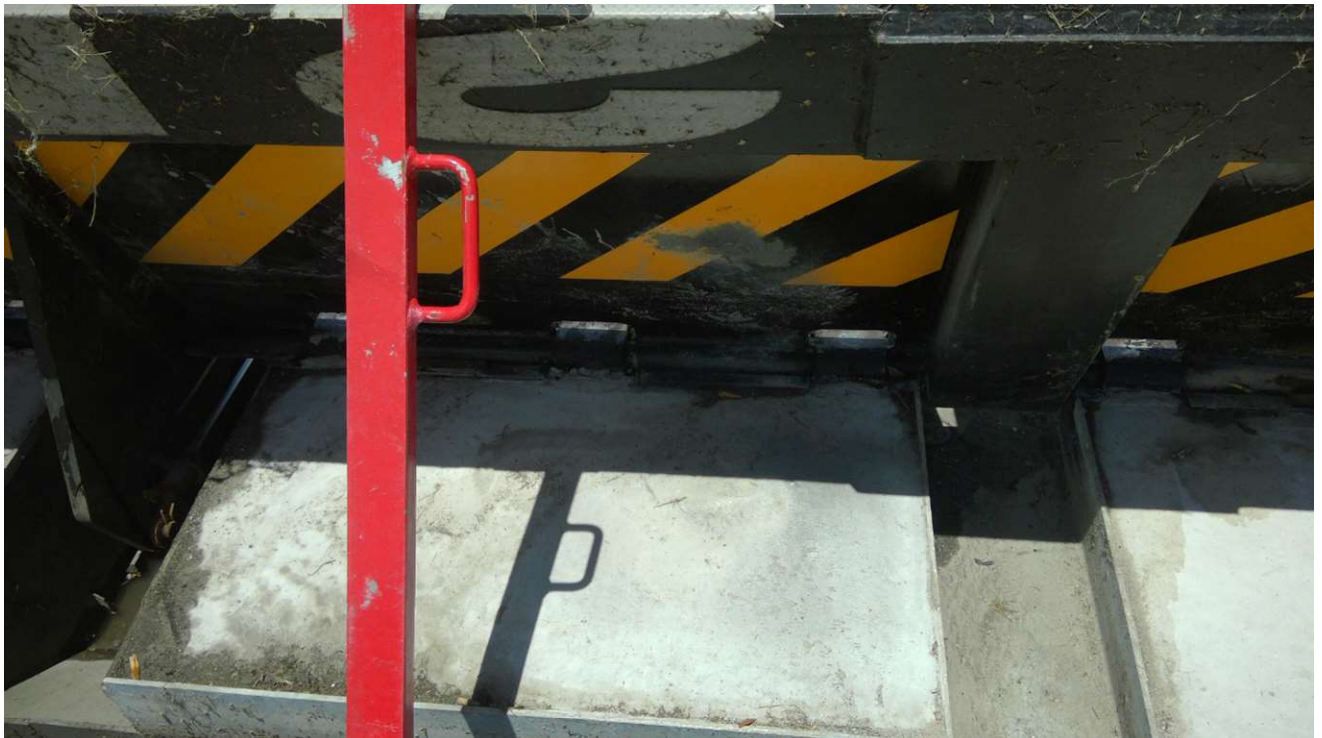
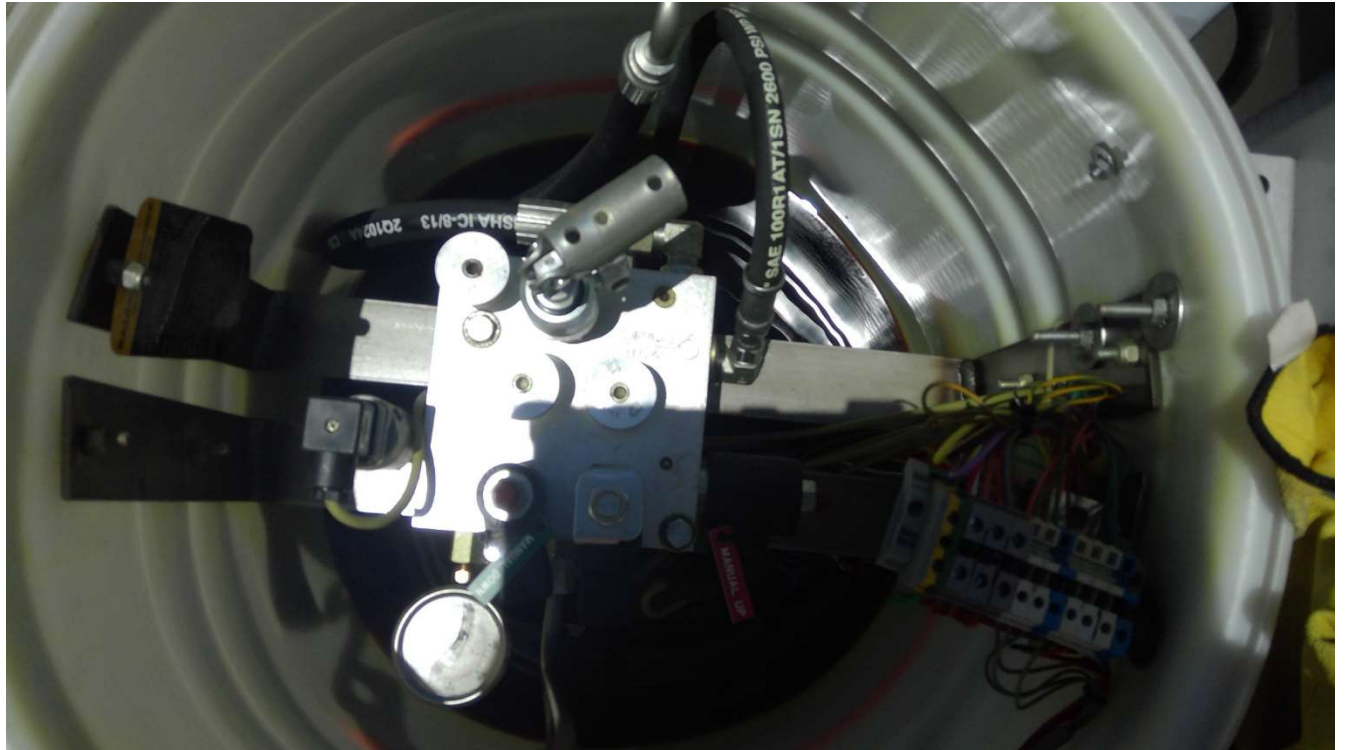
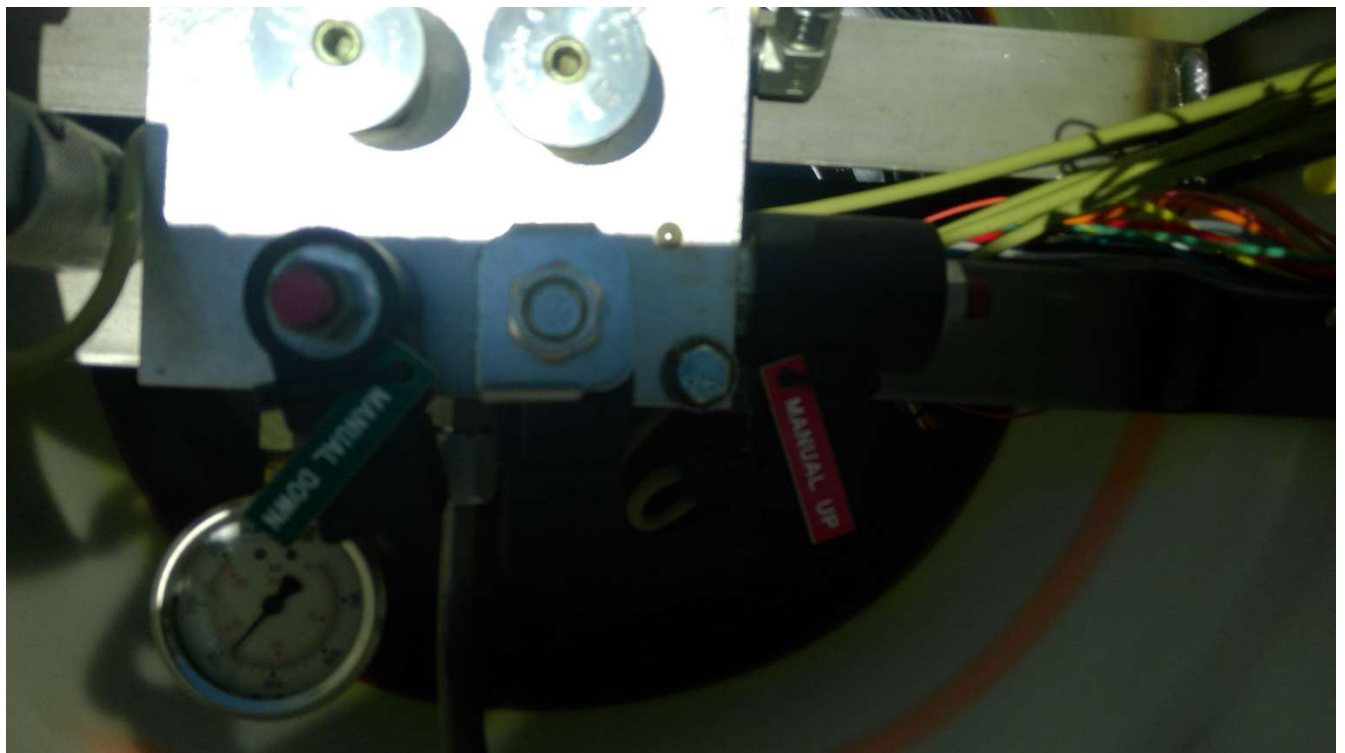
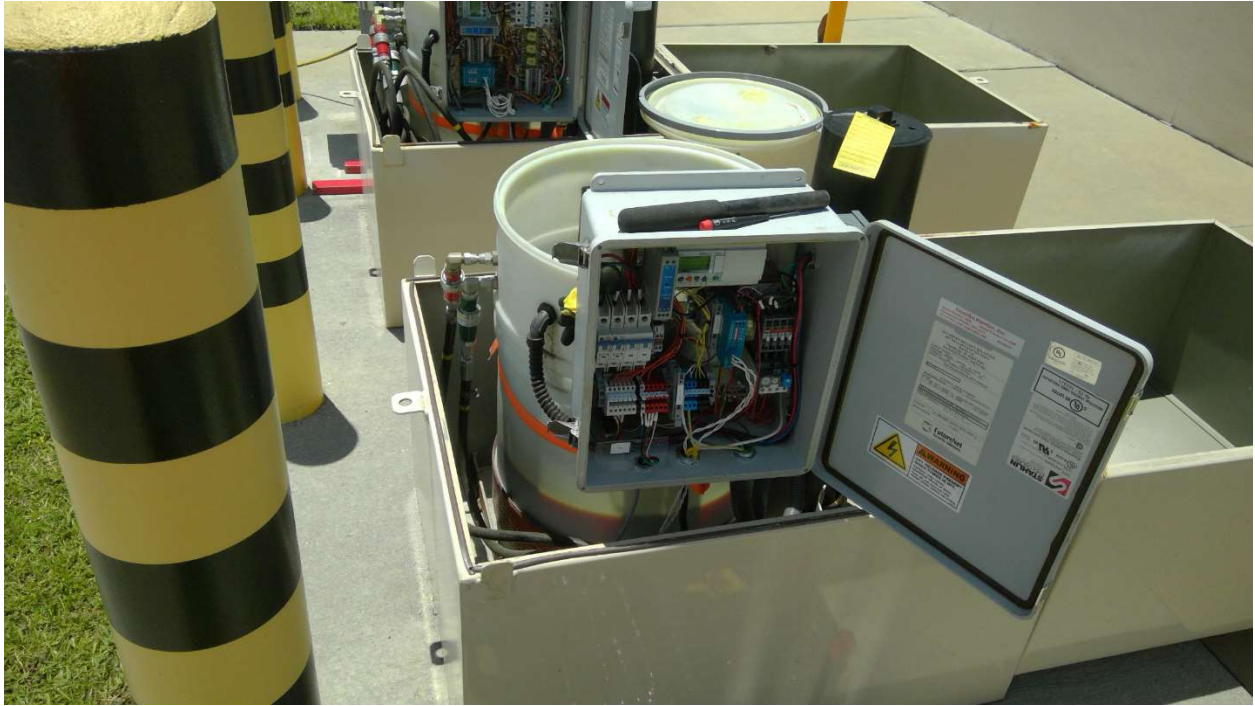
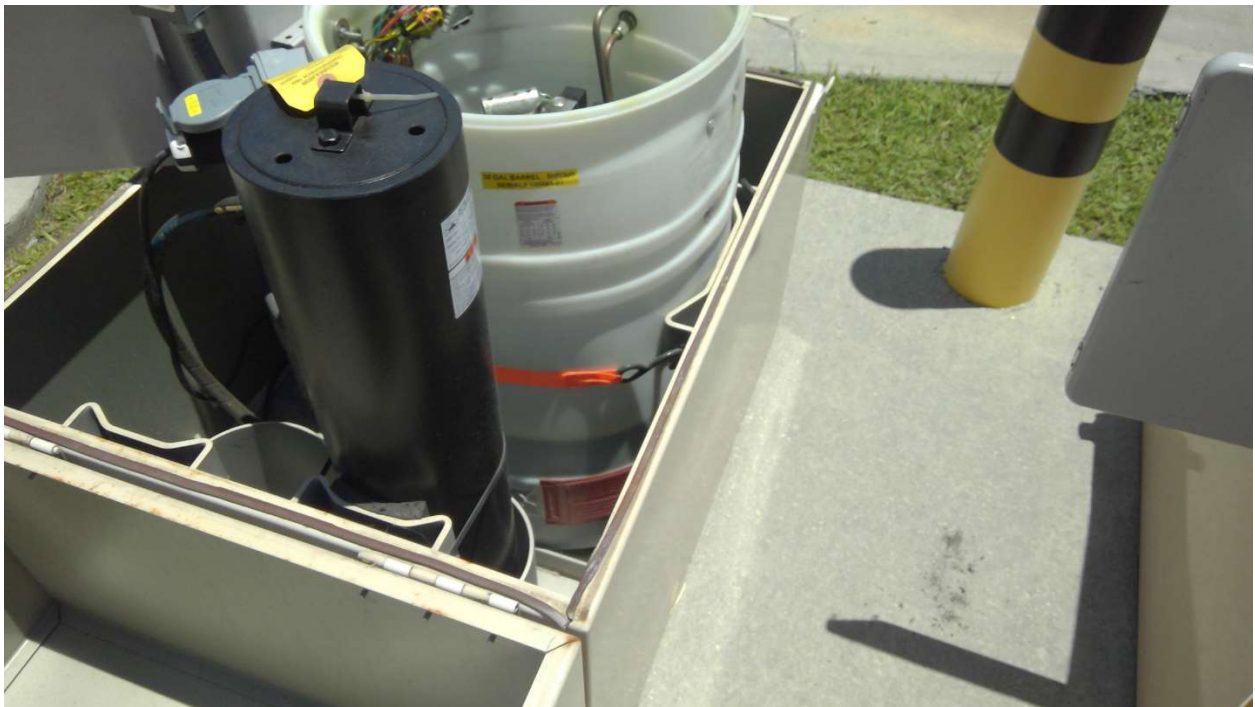
Warehouse Service Entrance - Inbound Side Lane

- Hydraulic oil is extremely dirty. The oil, suction strainer needs to be replaced. The hydraulic hoses replaced and shortened up. The hydraulic drum needs to be wiped and cleaned thoroughly
- Eliminate the un-necessary secondary layer of PLC control
- Front Rubber pad starting to come off. Needs to be replaced
- Concrete pad under the barrier needs to be repaired.
- Limit Sensors wiring is not properly terminated for below grade application. The cable should be shortened, terminations should be soldered, adhesive heat shrunk, and cable sleeved
- limit wire damaged replace with shielded cable
- Noticeable rusting and paint chipping is on the outdoor enclosure. Full painting is suggested.
