Warehouse Service Entrance - Outbound Side Lane

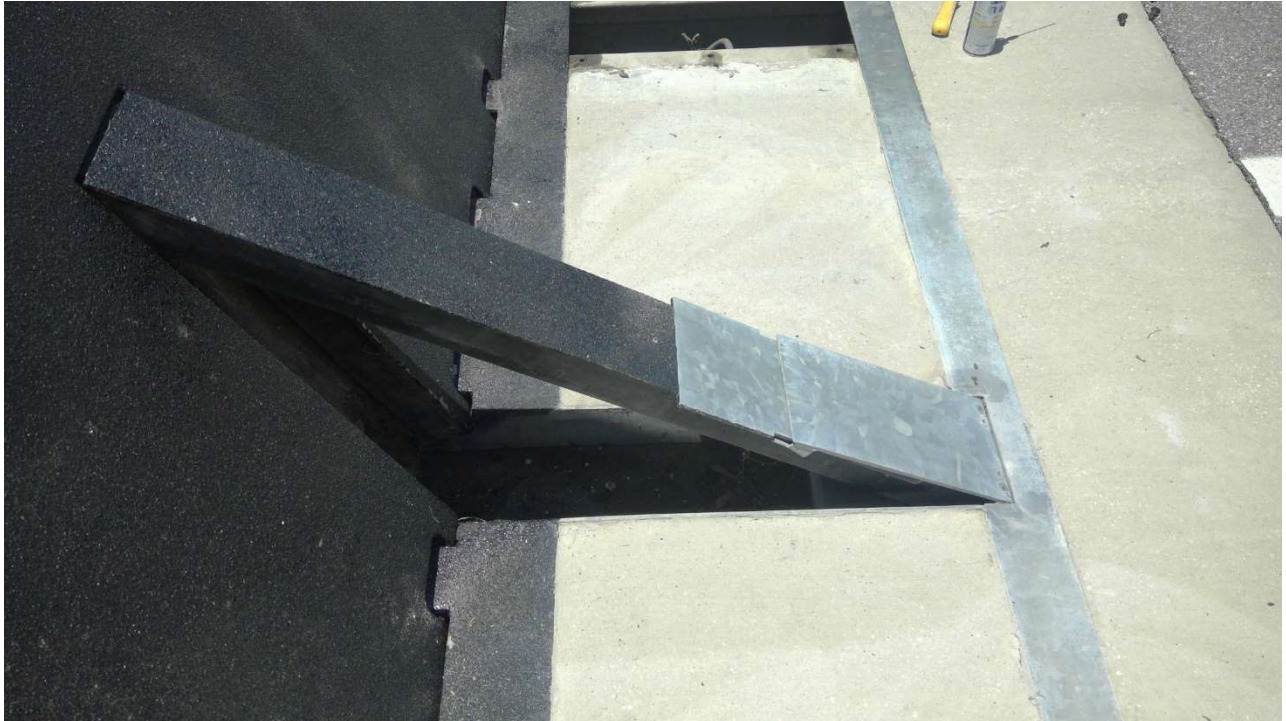
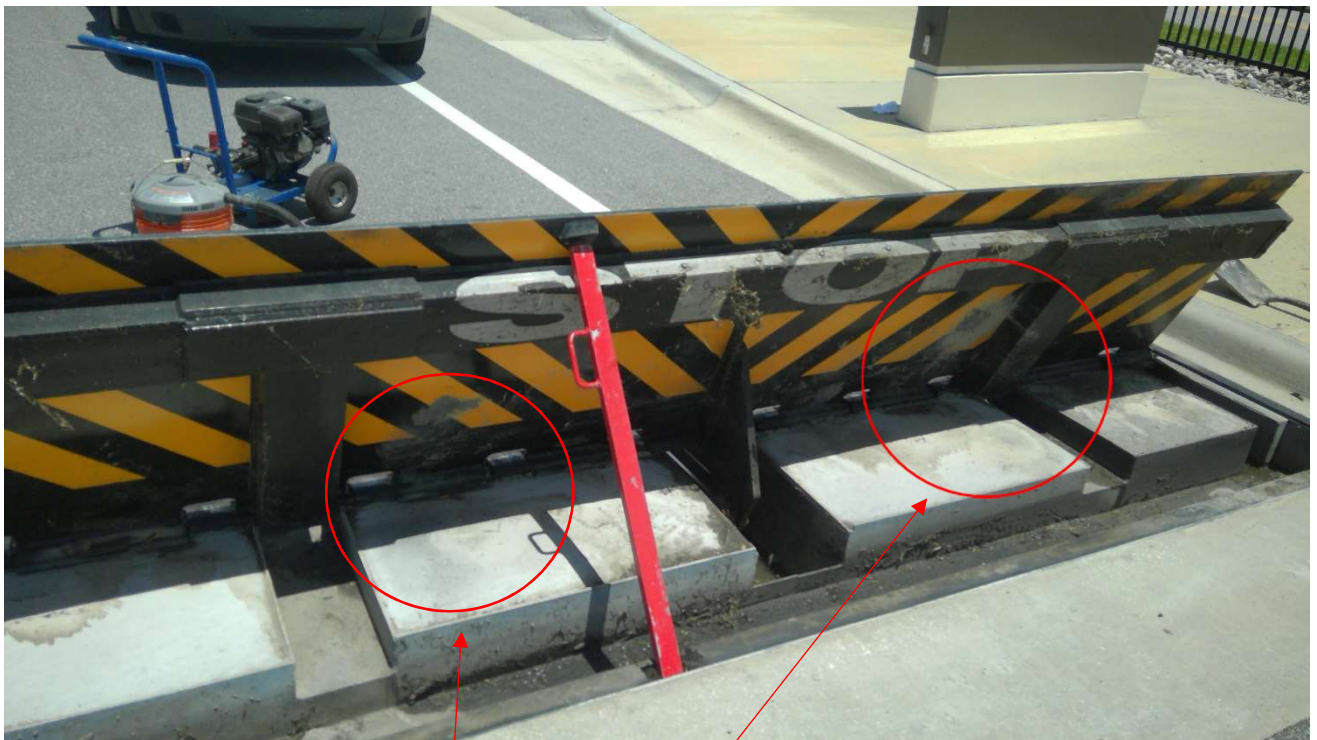
Concrete was poured too high during installation resulting in the plate not resting properly in the down position and also damaging the paint and the galvanizing coating

Resolution: grind the concrete down, touch up paint with yellow and black paint
