SURVEY

## exterior survey

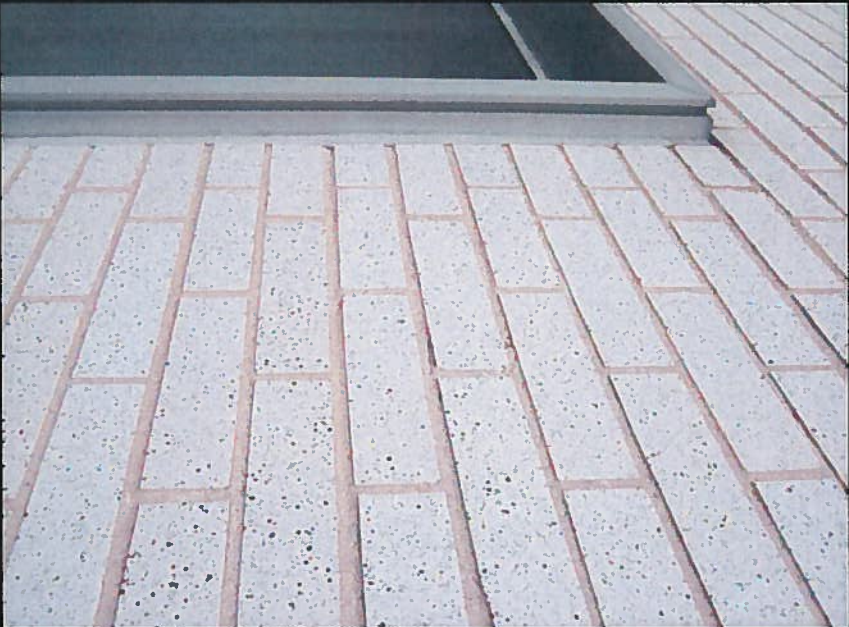
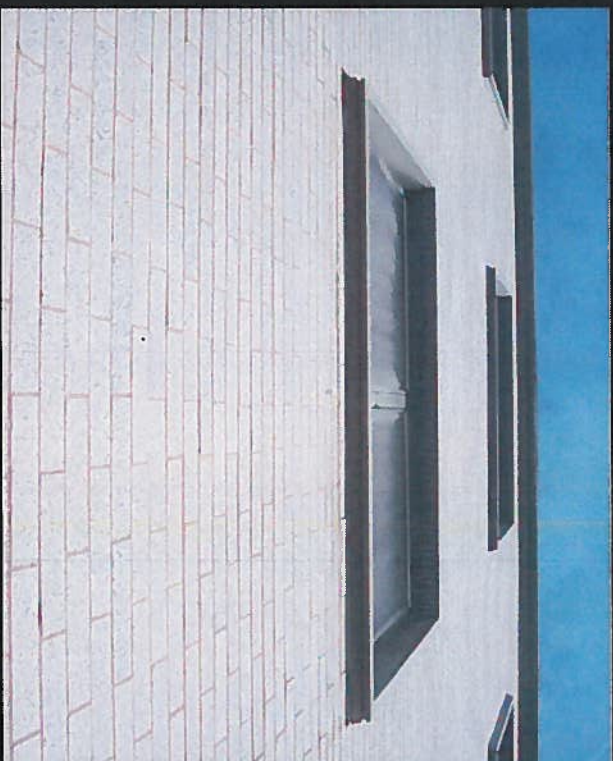
- Generally good condition
- Varying uniformity in joints creates illusion of bulges
- Minimal instances of mortar spalling

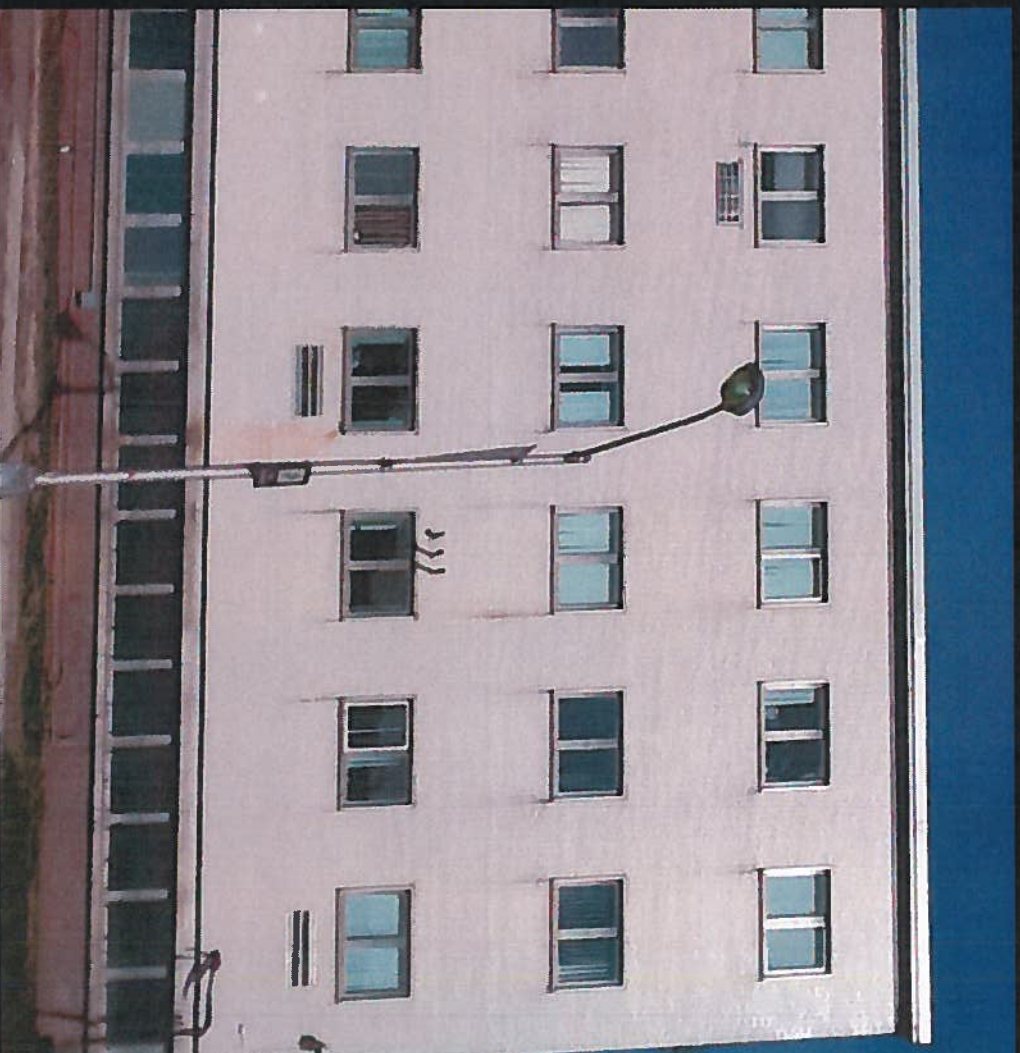
- Façade in need of cleaning
- Staining at corners of sills

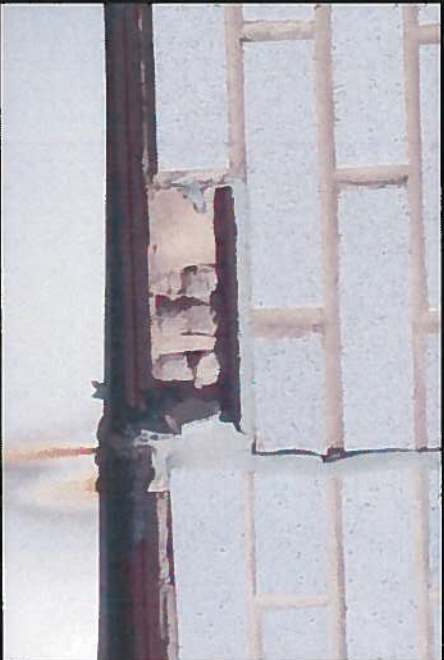
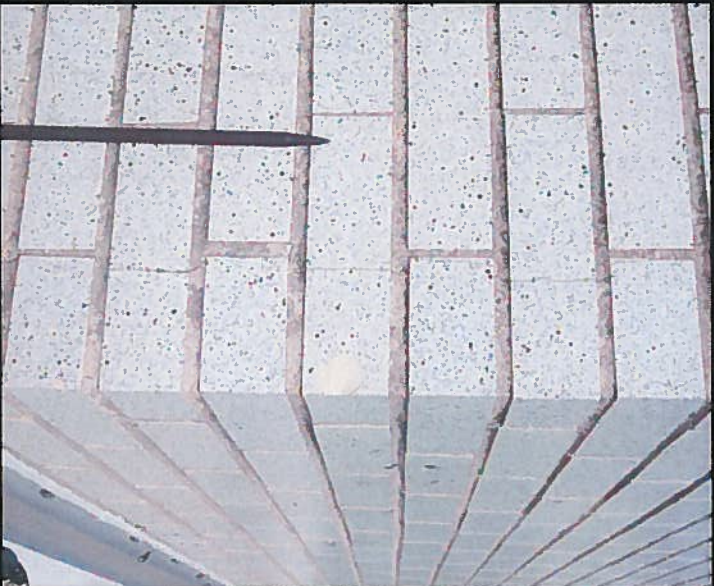
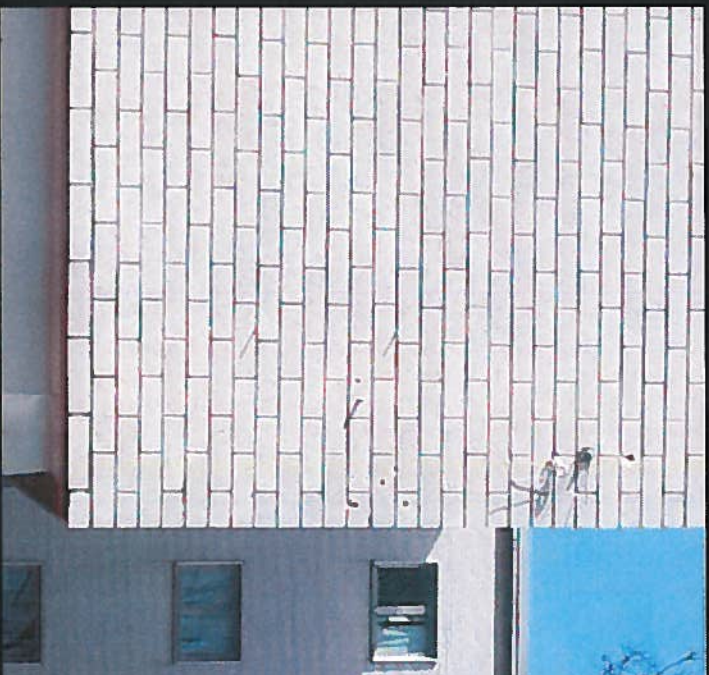
- Vertical cracks at some corners of masonry veneer:
- too few relieving angles
- self weight transfer to bottom
- not a safety concern
- Pits and holes from former exterior attachments

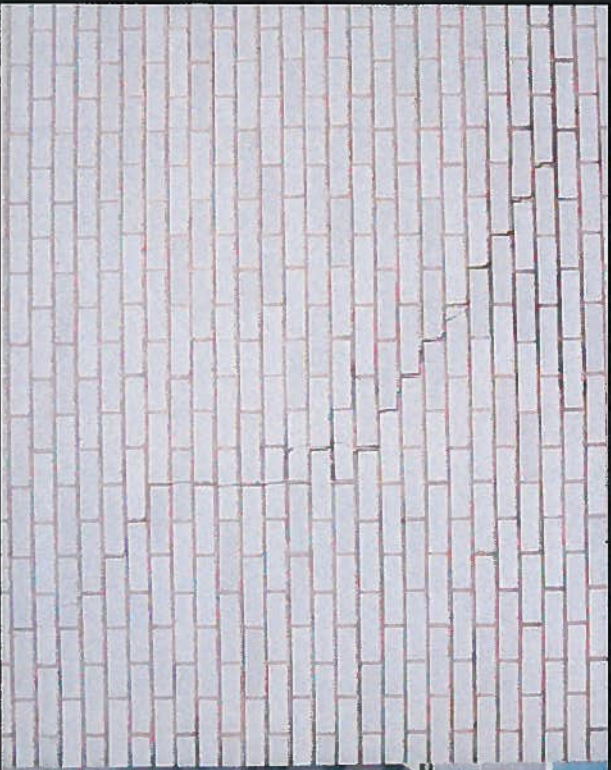
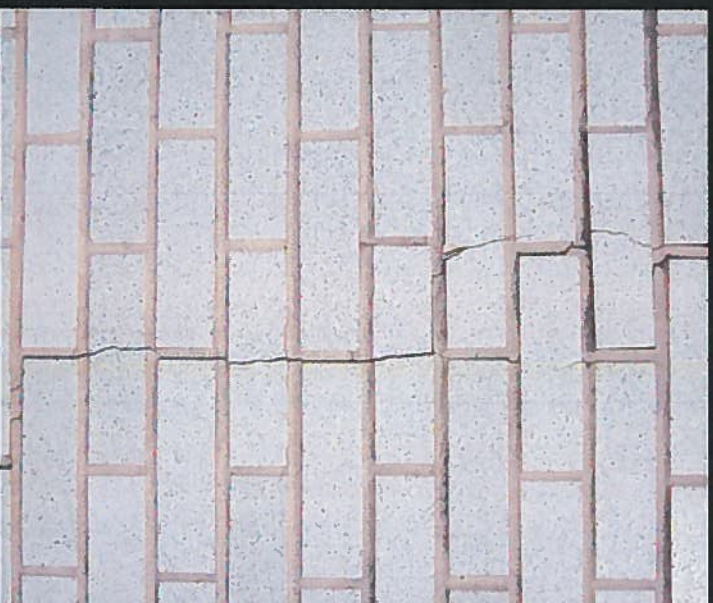
- Step cracking in penthouse façade
- Requires further investigation

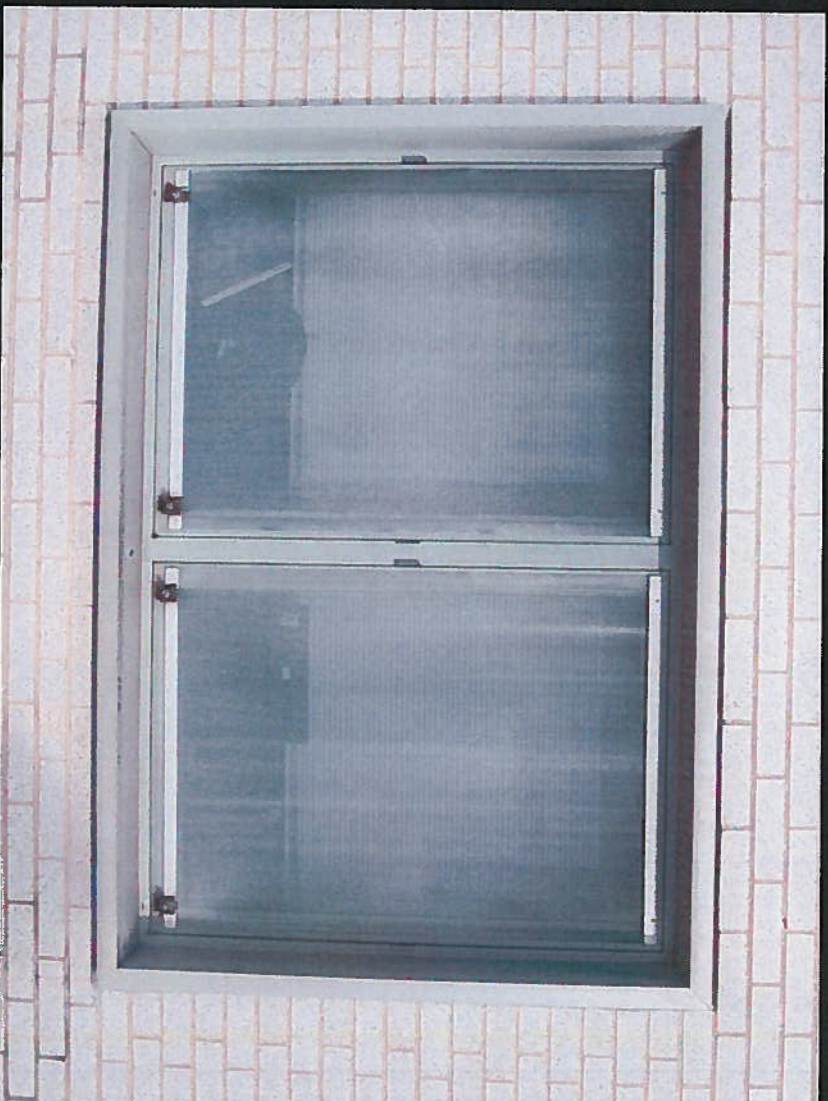
- Typical 5' -6" x 4' masonry opening
- Aluminum frame
- Single pain glass
- Exterior screen
- Interior vertical blinds

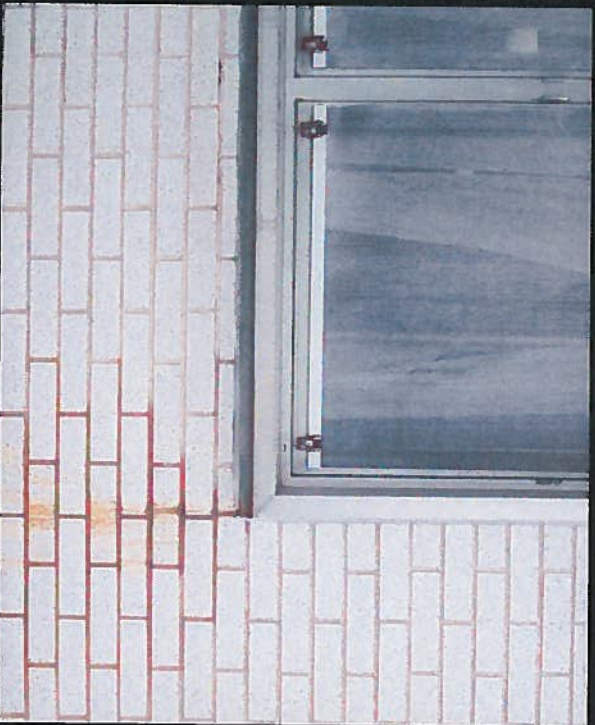
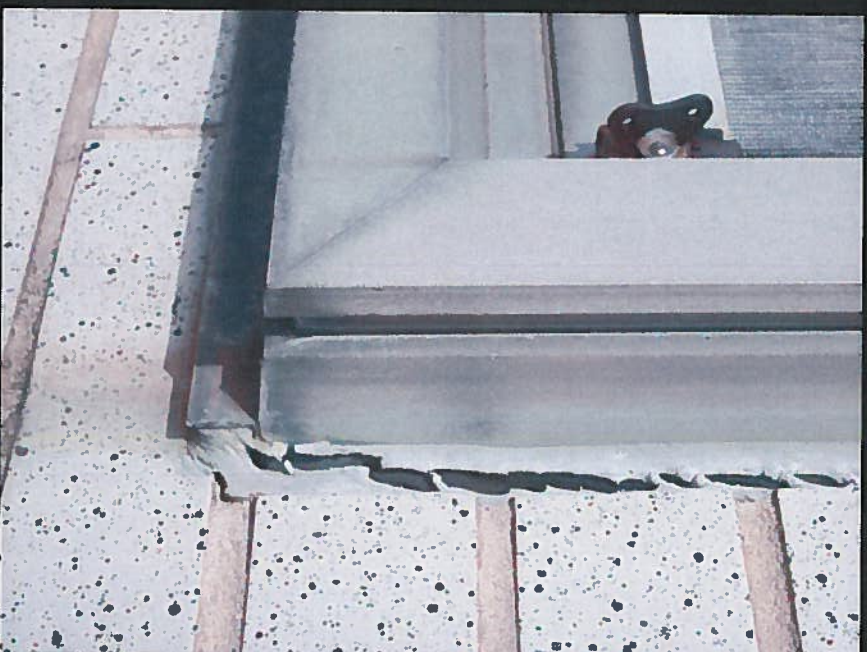
- Caulking is pulling away – exposing gaps in some instances
- Water drainage is creating staining
- Interior water damage is currently being assessed

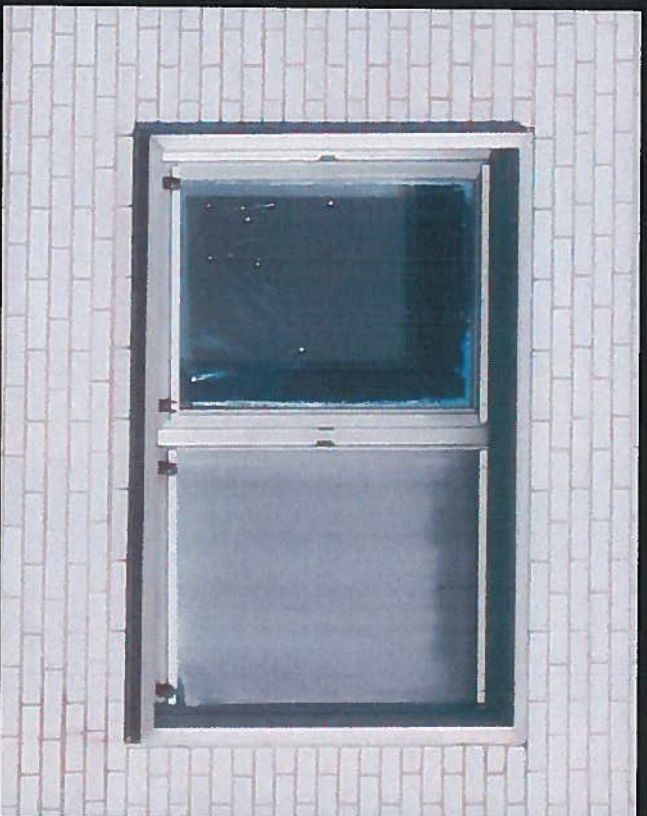
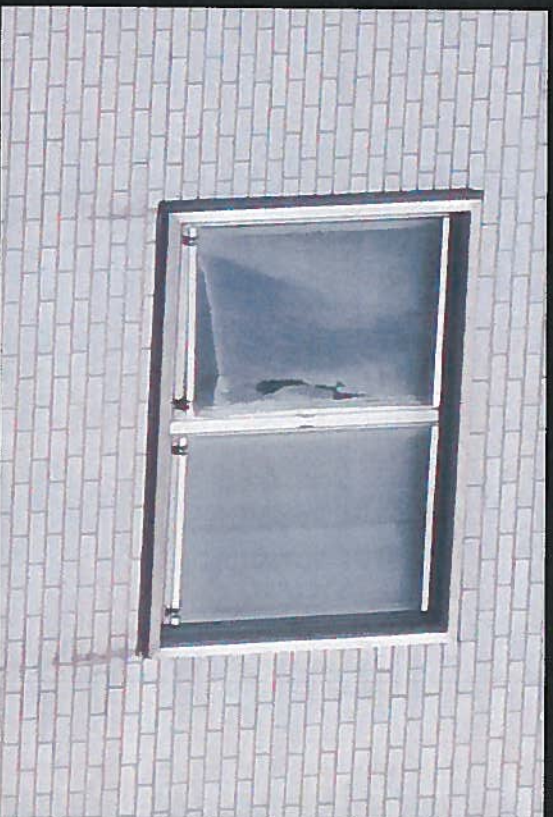
- Screens are frequently torn or missing

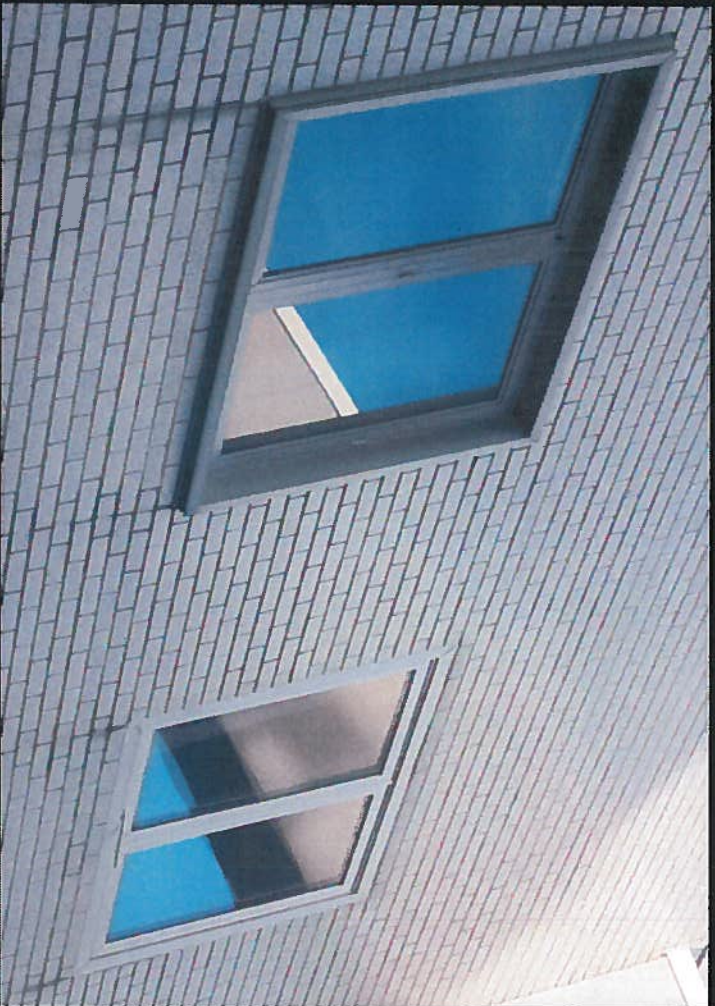
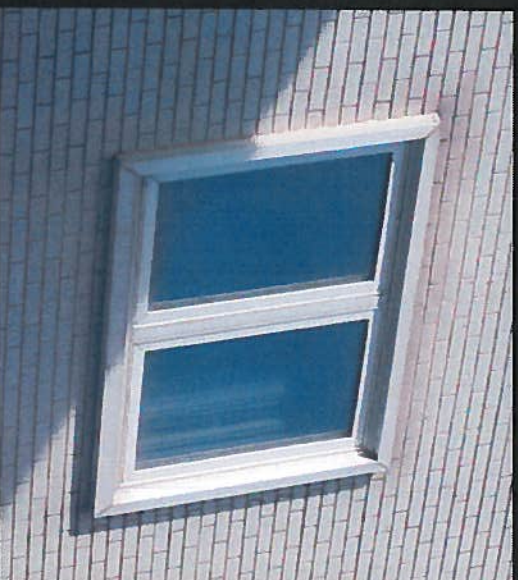
- Lack of uniformity in window replacement

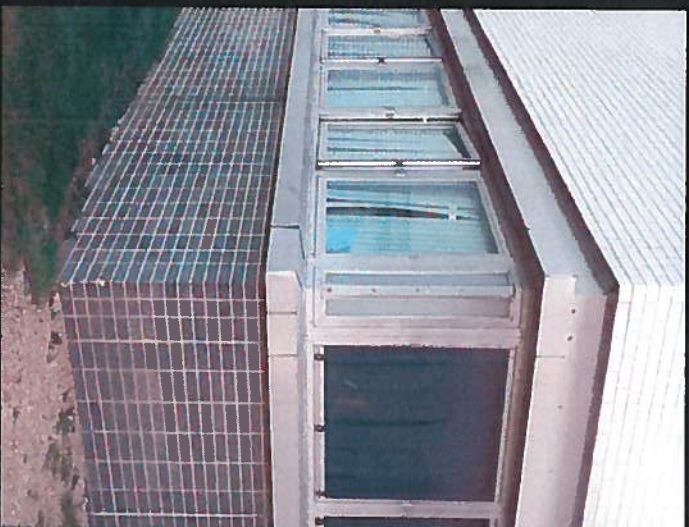
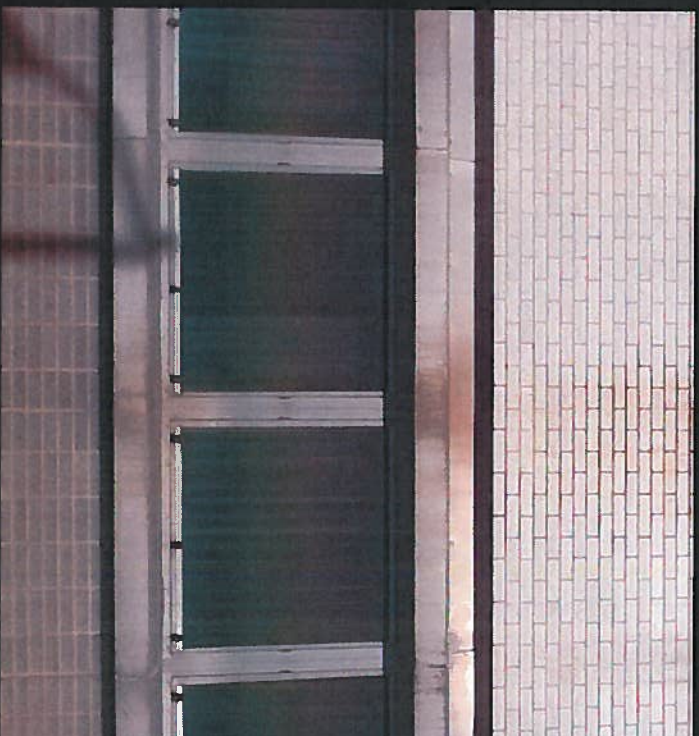
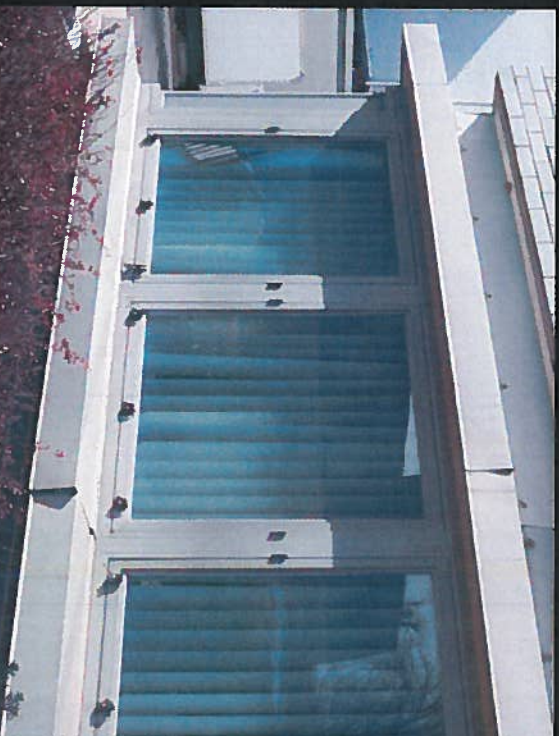
- Flashing shows signs of buckling
- Flashing shows signs of rusting / staining
- Staining / streaking onto tile at base
- Single pain glazing
- Vertical blinds

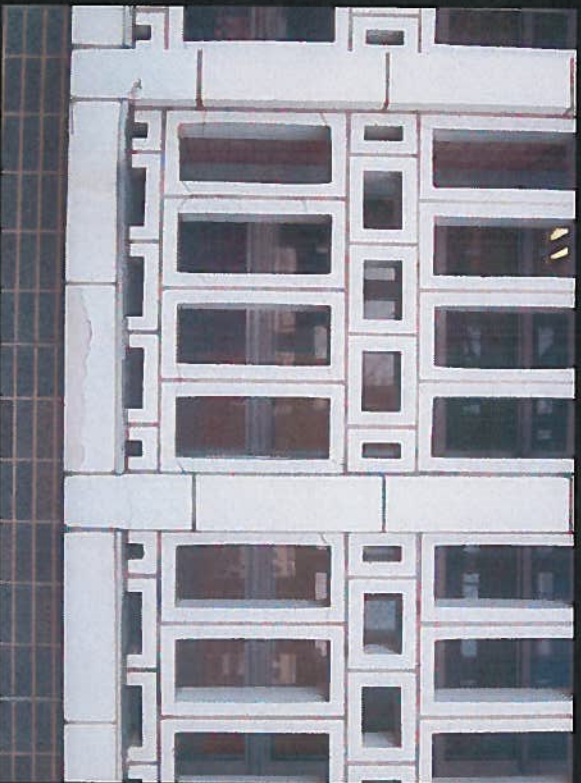
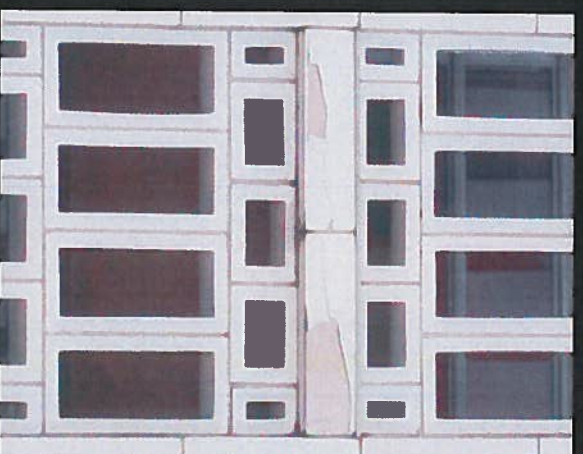
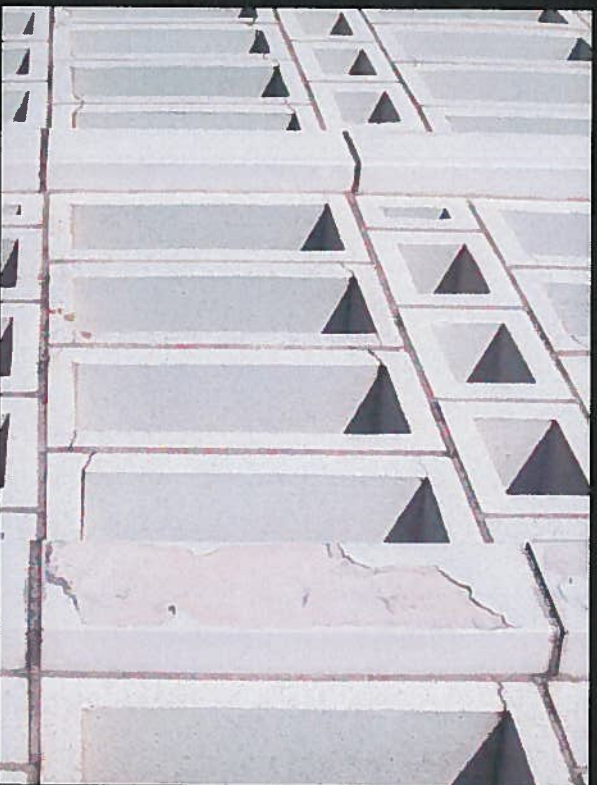
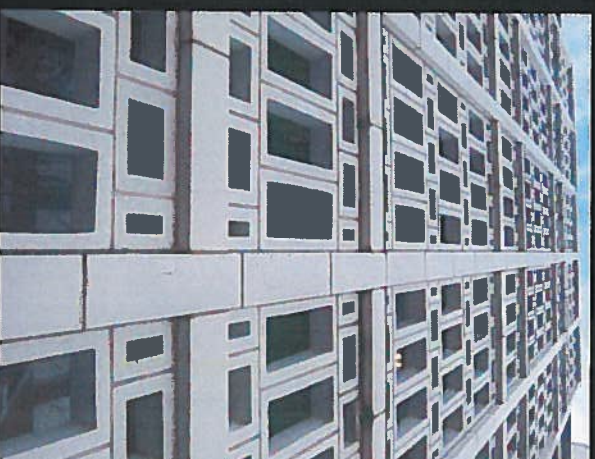
- Precast sunscreen is spalling
- Flaking and cracking of exterior glaze due to moisture penetration and seismic event
- Cracks do not appear to be into tile units themselves
- Integral system would make spot replacement difficult

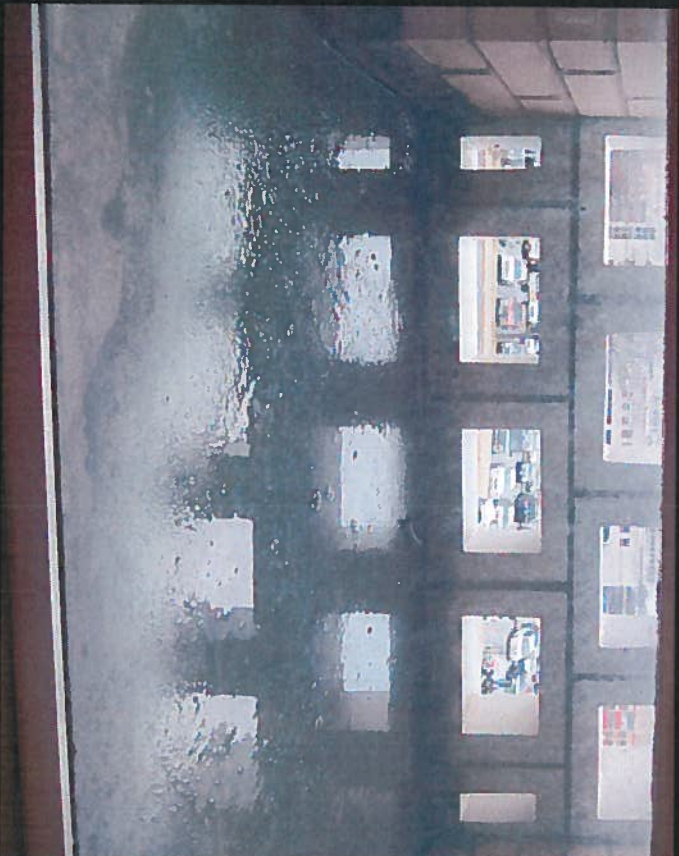
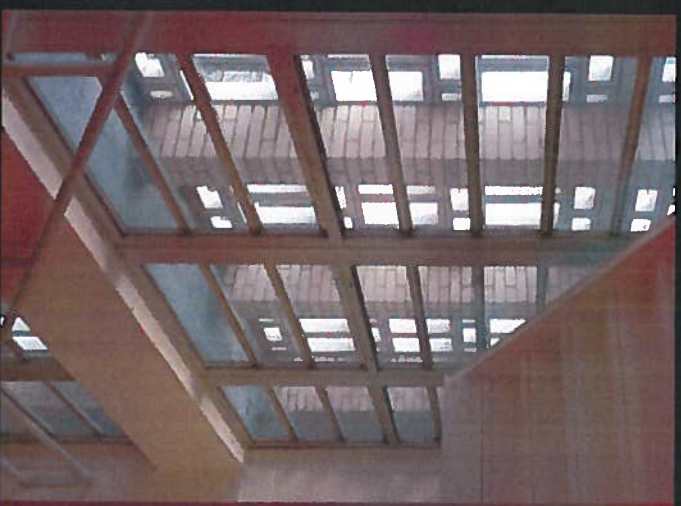
- Interior ponding / moisture build-up on interior beam
- Interior paint has signs of blistering due to humidity
- Some cracks in glass
- Single pain glazing
- Maintenance / cleaning difficulties due to accessibility
