## Limited Asbestos Inventory Summary

To:	Michael A. Ciofani AIA NCARB
From:	Jeff Senn and Robert Peschel – Sigma
Project Number:	13205
Date:	May 22, 2012
RE:	VA Medical Center – Milwaukee, WI VA Project 695-12-119 Building 113 Replace Switchgear

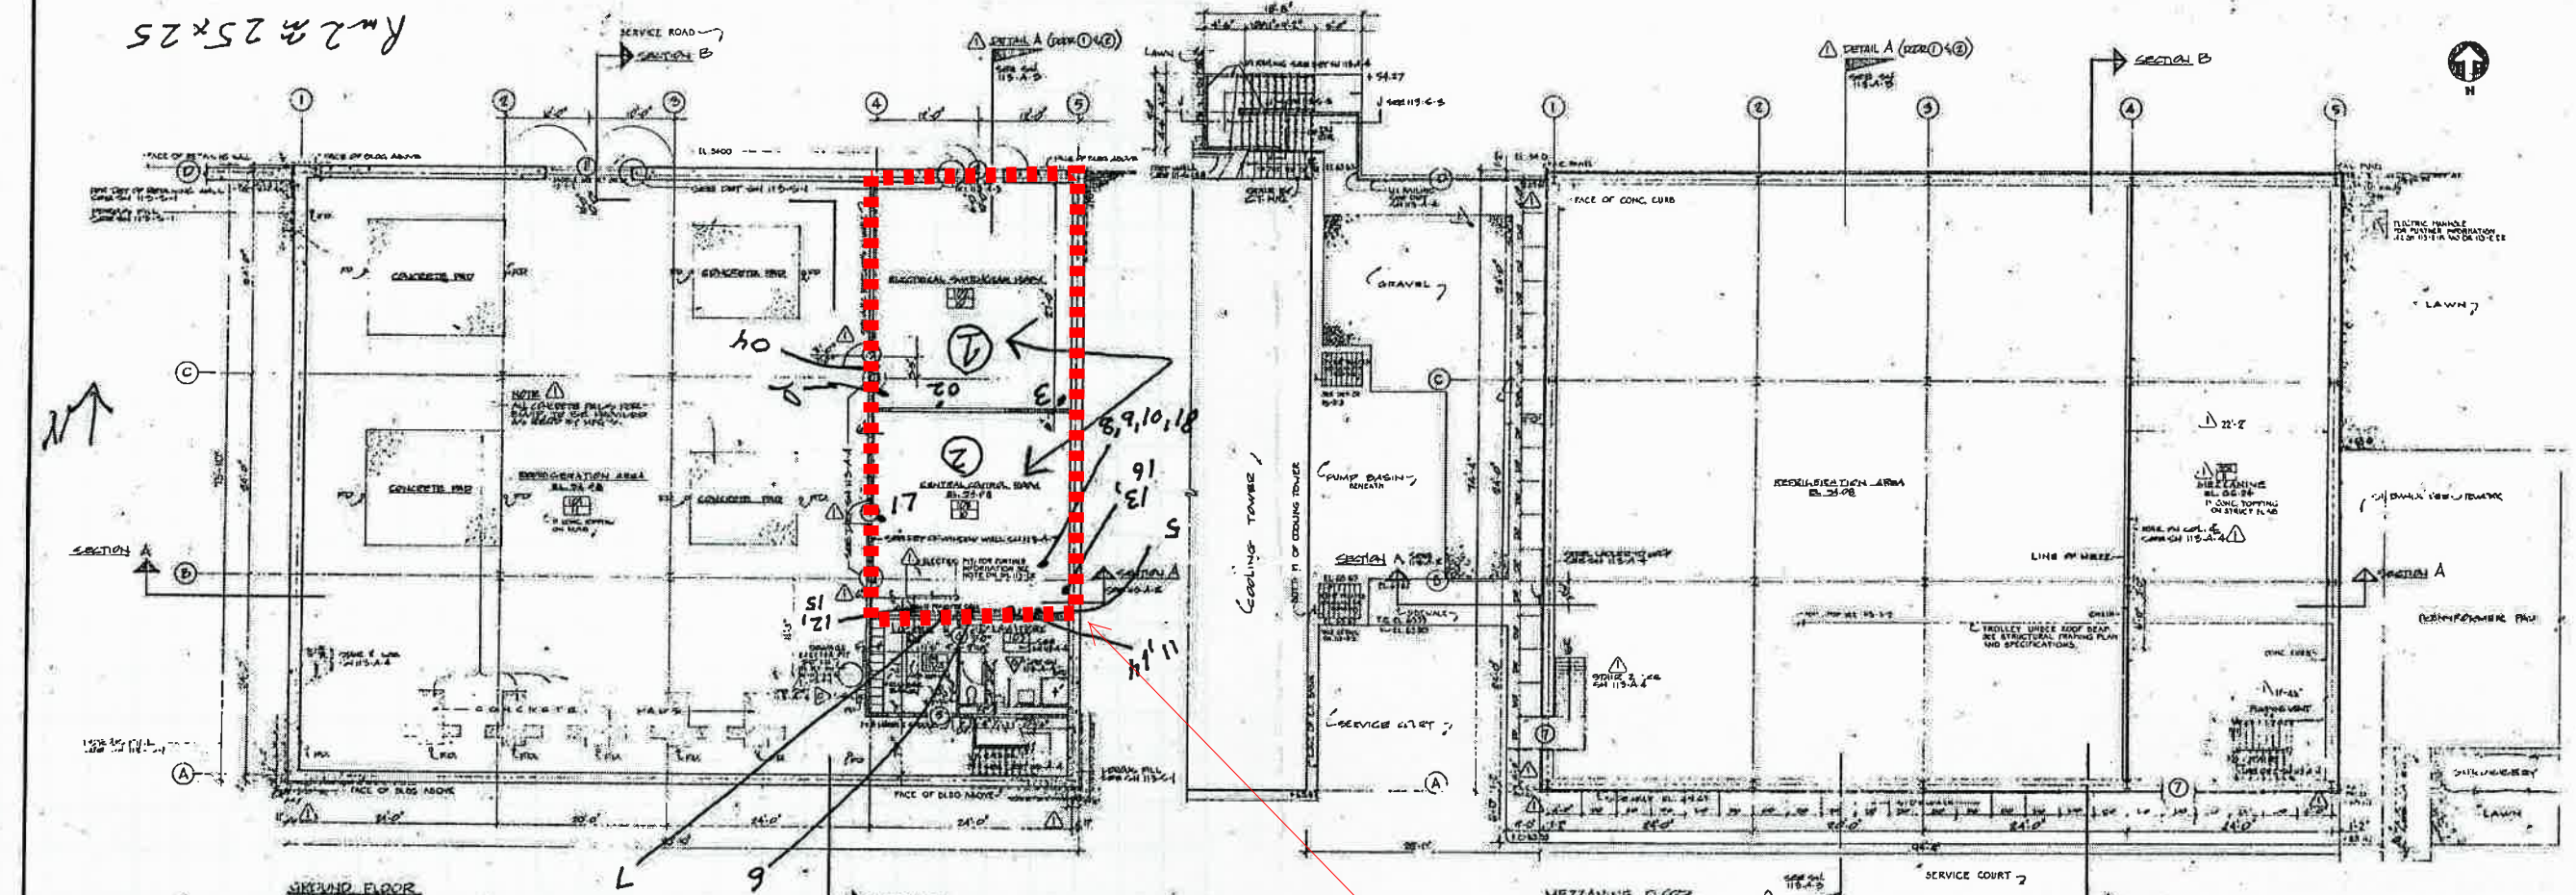
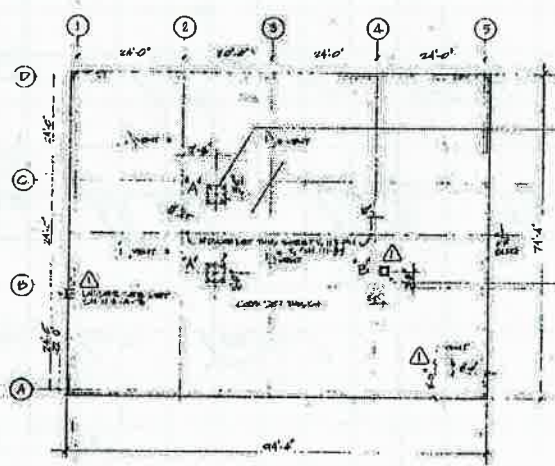
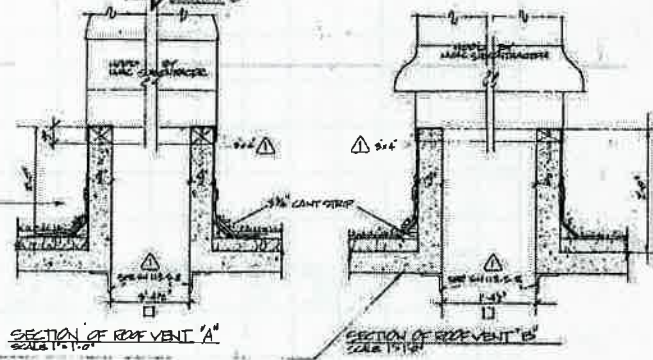
**Figure 1 – Limits of Inspection**

Sigma inspected areas within Building 113 as indicated on Figure 1 provided in Attachment 2 for suspect ACBMs. The following materials were evaluated by Sigma for the presence of asbestos.

Rm 2 25x25  
Rm 1 25x25

Limits of Inspection

18 Samples
