Denver VAMC - Building 4

Site Assessment for Asbestos

Contract # VA259-17-P-5180

**September 15, 2017
(Revised)**

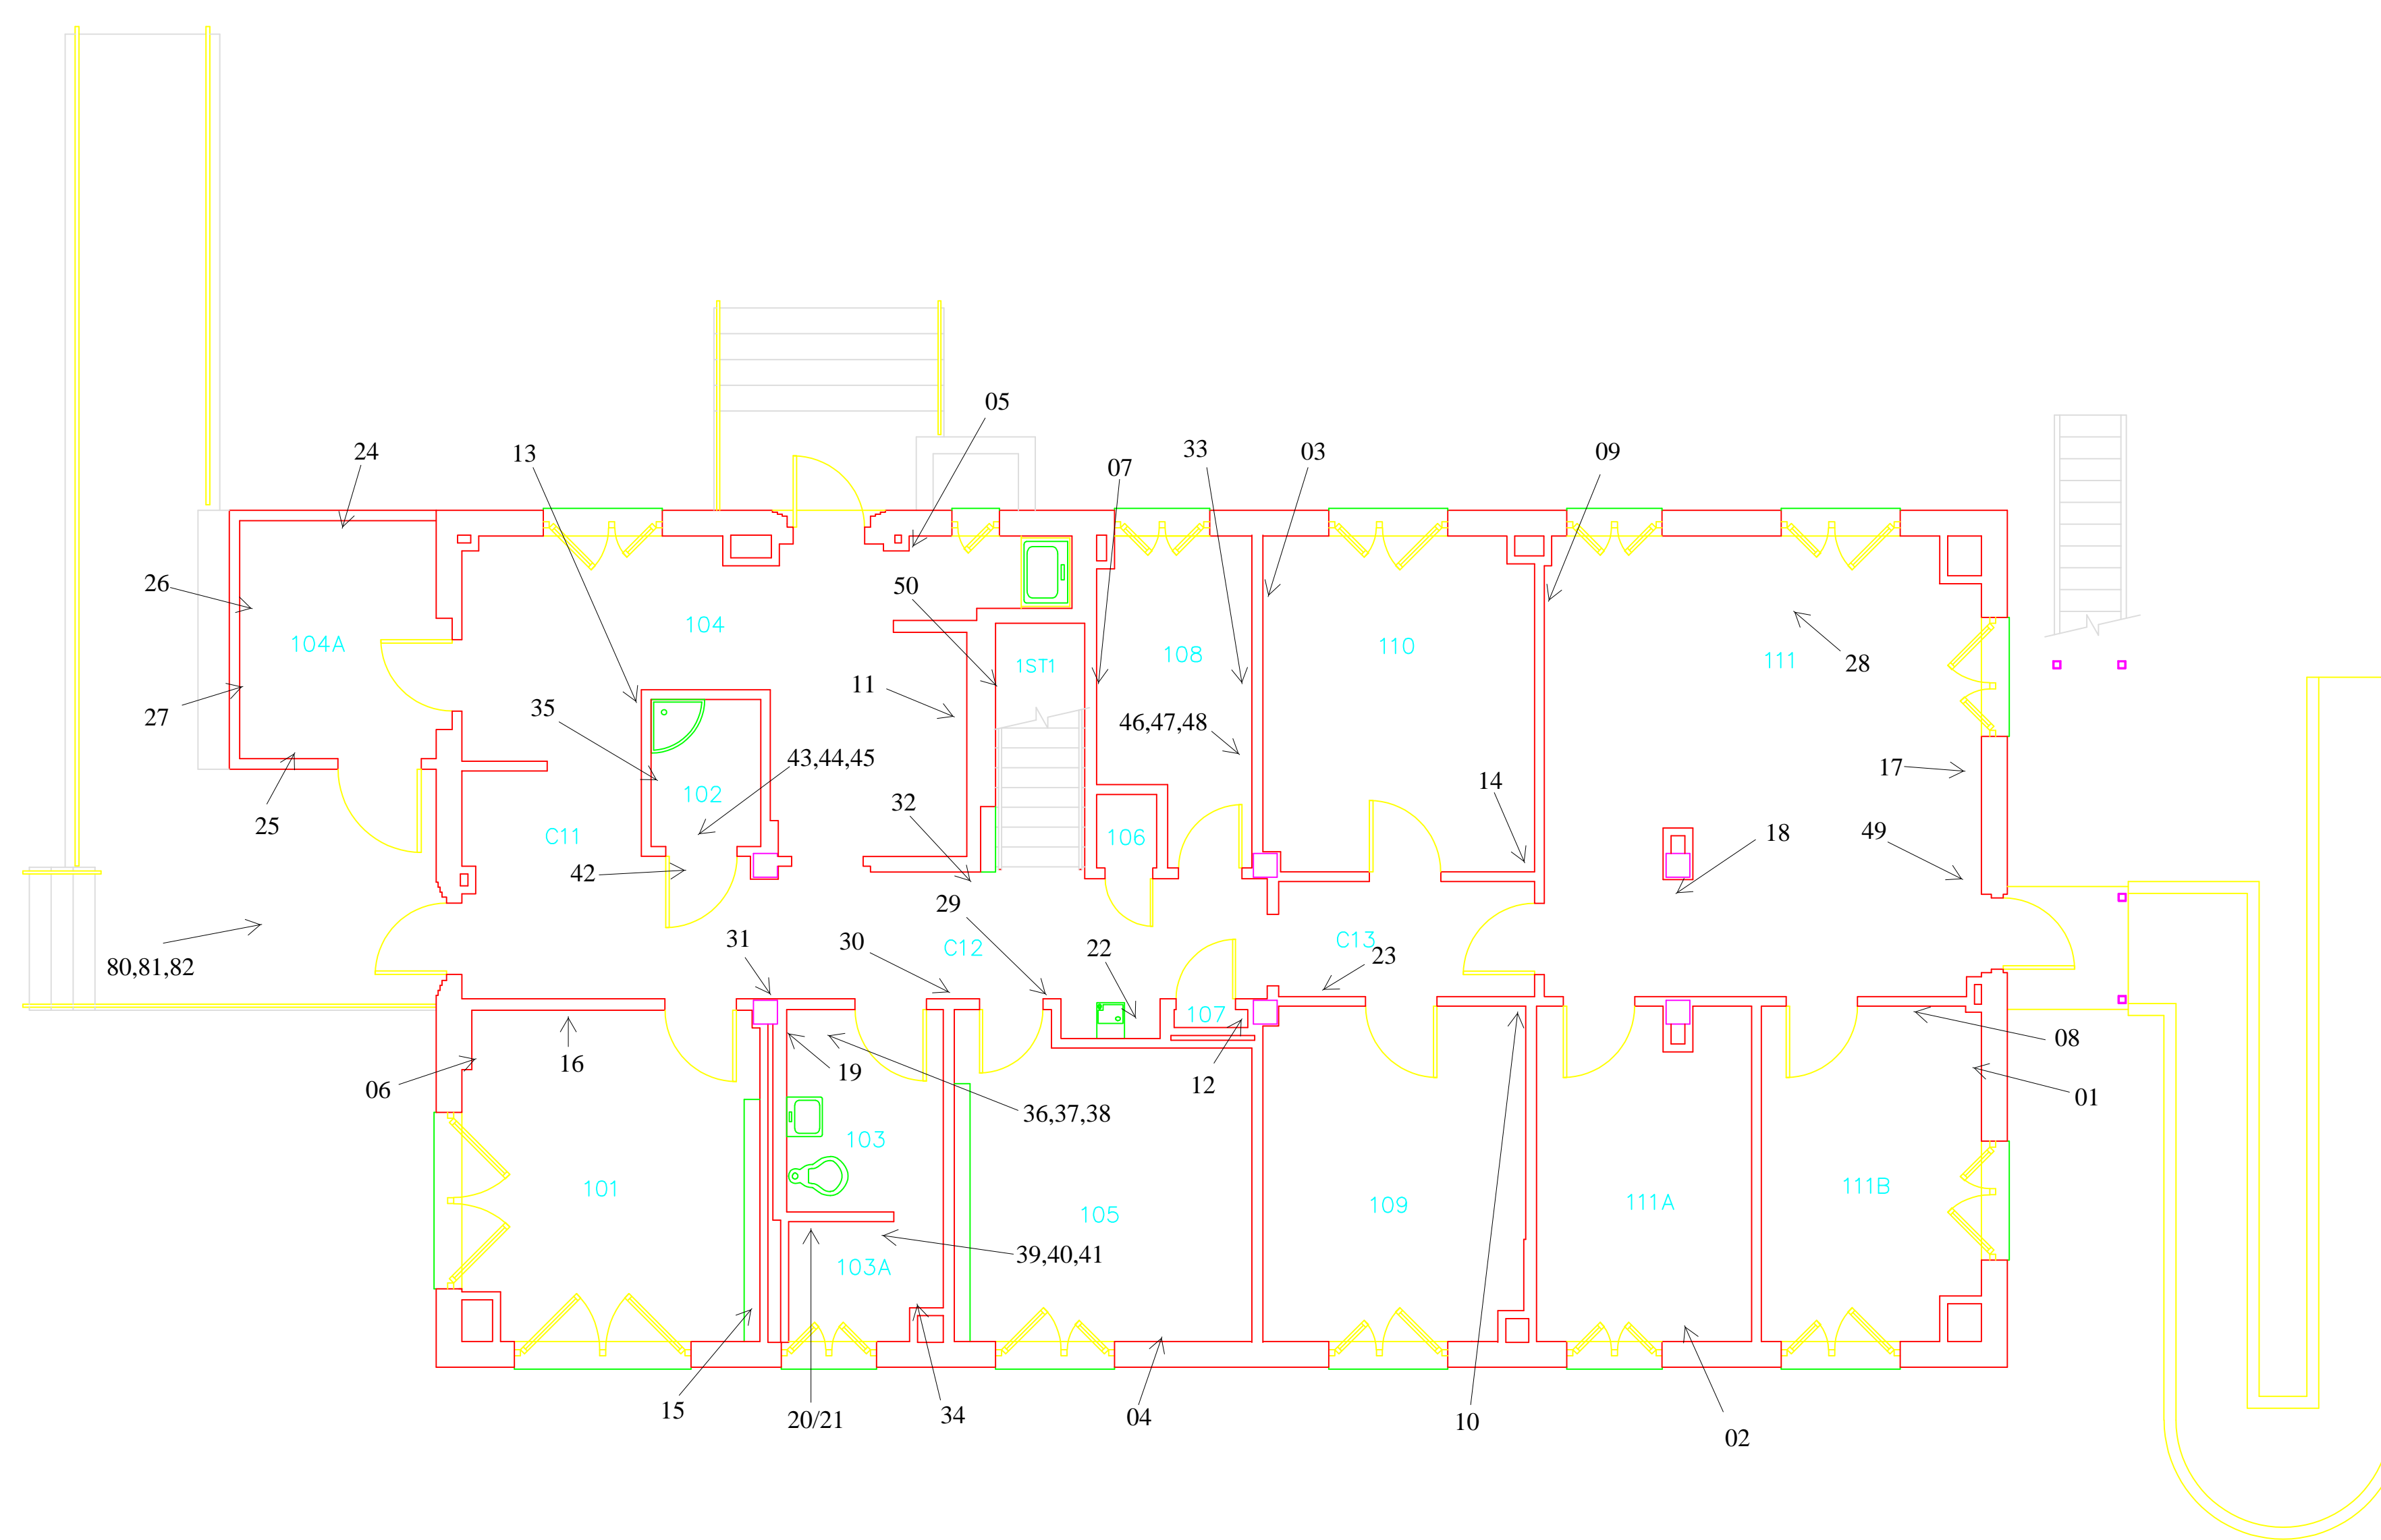
BLDG #4 - 1st FLOOR
 SCALE: 1/4" = 1'- 0"

78 and 79 are roof samples

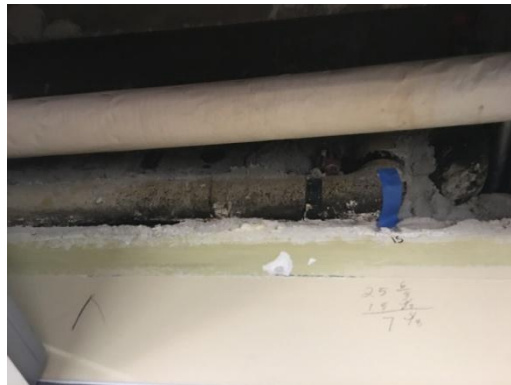
Sample Number	Sample Description	Sample Location	Quantity (ft²)
4-1-TSI 15	White TSI Hardpack Fitting	1 st Floor- Room 101- Ceiling in Northeast Corner of Room	2

The only regulated ACM identified was sample 4-1-TSI 15 which was approximately 2 linear feet of thermal systems insulation (TSI). Only half of the TSI was exposed and the remainder was contained in the wall system covered with light concrete. NOTE: In our opinion, at some time in the buildings life cycle, asbestos was removed. This TSI was left because it was imbedded in concrete and only a relatively small amount was visible. It is anticipated that the structural walls will be remaining during this interior renovation. It is possible that if a structural wall is demolished, the demolition may reveal another TSI location that may need to be removed.

Asbestos Containing TSI- Sample 15

The cost estimate to remove this regulated material is \$ ##### including permitting with Colorado Department of Public Health and Environment (CDPHE). This work must be done by a licensed General Abatement Contractor (GAC).

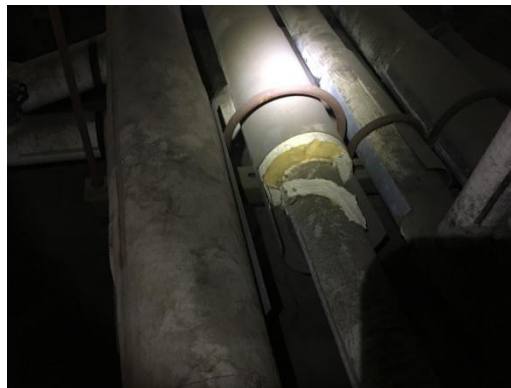
Non- ACM Insulation- Crawlspace

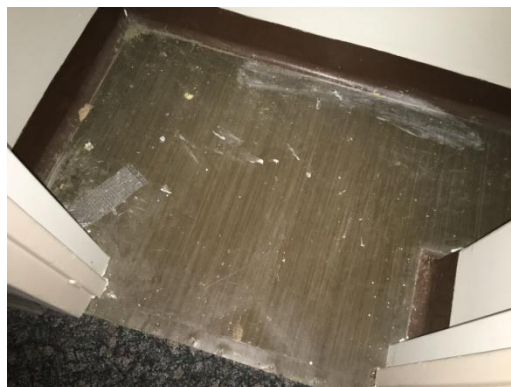
Non-ACM Flooring- 2nd Floor- Throughout
