Healthy Buildings International
Western Region
25381 Commercentre Drive #150
Lake Forest, CA 92630
o: 949.450.1111
f: 949.450.1120
info@healthybuildings.com

Summary of Findings

3350 La Jolla Village Drive

Healthy Buildings was asked to examine the internal environment following a past incidence of flooding on the 2nd Floor (2W) and the interstitial space above the 2nd Floor at 3350 La Jolla Village Drive in San Diego, CA on October 16 and 17, 2017. During our inspection it was observed that some areas that had already been documented as impacted by Citadel Environmental (field observation and moisture measurements taken on August 7 and 8, 2015) were under containment and it appeared that remediation had already taken place. Listed below is a summary of our findings from the inspected areas on the 2nd Floor (2W) and the interstitial space above the 2nd Floor. It should be noted that during our inspection we were unable to do intrusive/destructive testing due to positively identified asbestos containing material (ACM) per historical documentation provided by the Veterans Affairs San Diego Healthcare System (VASDHS).

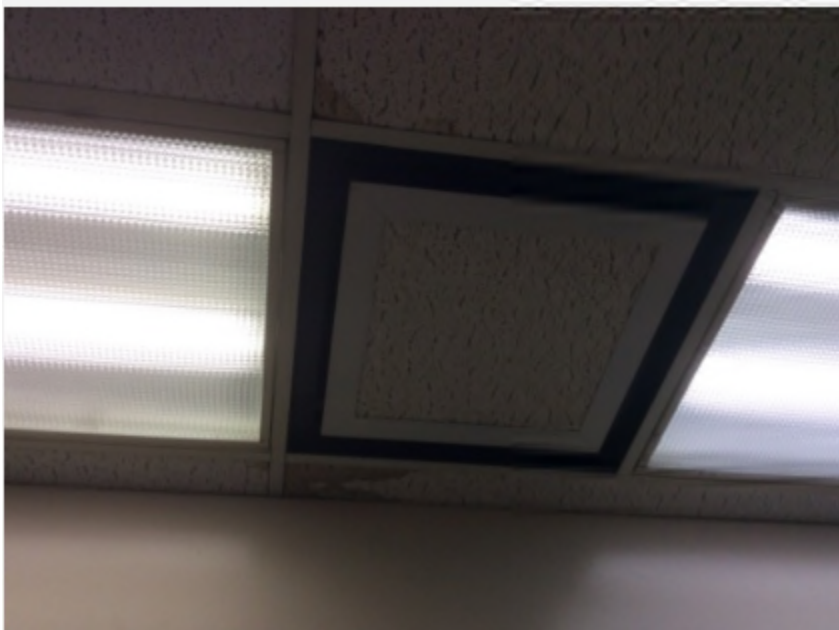
Room 2018 – visibly stained ceiling tiles

- Room 2125
- Any ceiling tiles that have visible moisture staining should be removed and replaced. The particular areas of concern are:
 - Room 2018
 - Room 2077

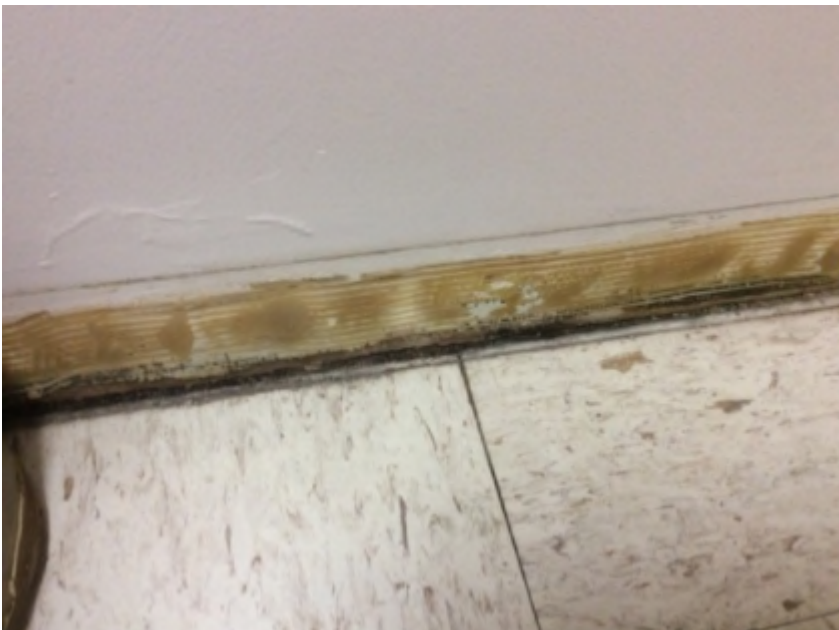
Room 2126 – visible suspect staining on the south wall.

- Since the source of the water is Category 3 “black water”, all porous materials wetted by the flooding incident should ideally be removed and the area thoroughly cleaned. We recommend removal of wetted porous substrates in the following locations:

- Room 2126 – suspect staining on the south wall
 - Room A2022.1 – visible historical moisture damage on drywall ceiling outside Room A2022.1 (visible from interstitial space).

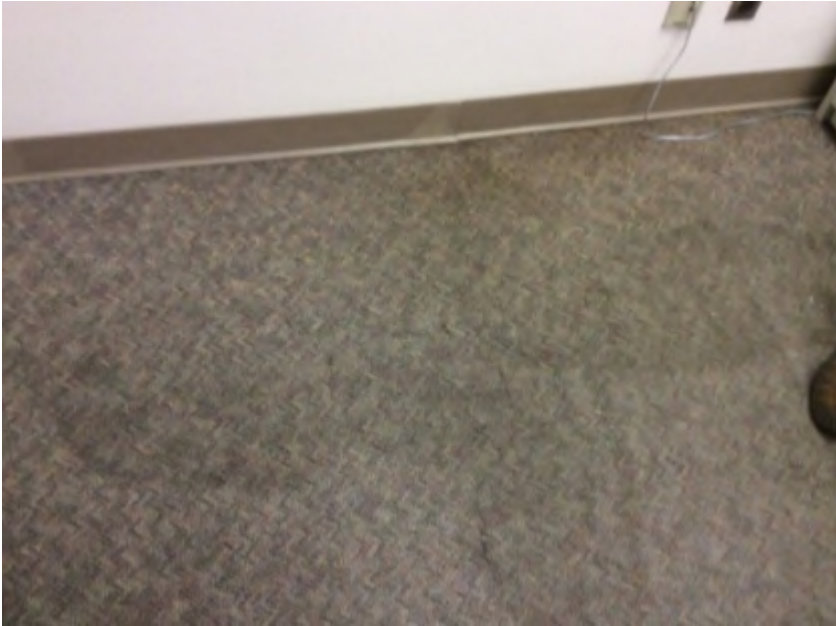
Room 2125 – visible moisture damage on the carpet.

- Room 2103 – east wall
 - Room 2071 – north wall
- The carpet in the following areas of the building was found to be affected by the flood. All wetted carpet and padding should ideally be removed and replaced. The particular area of concern is:

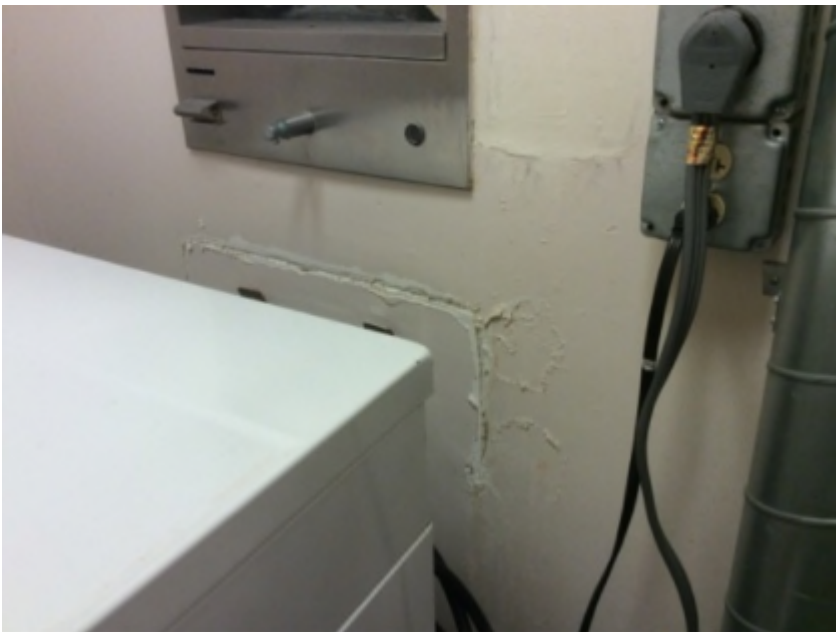
Room 2103 – appears there has been historical moisture damage on the east wall from the washing machine and does not appear to be from the flood incident.

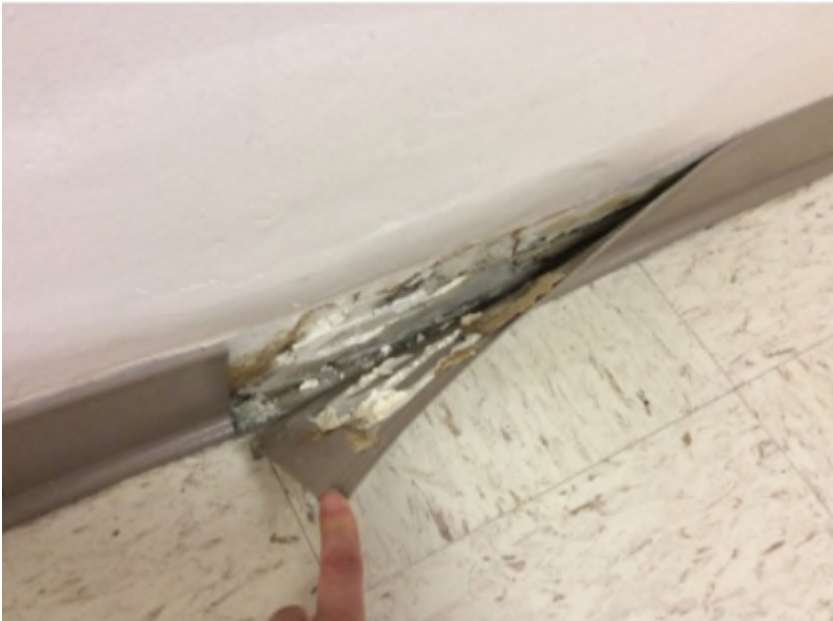
2nd Floor Corridor Outside Room 2099 – visible moisture damage and suspect staining.

- Room 2069A – suspect staining on the east and west wall.
 - Room 2034 – suspect staining on the south and east wall.
 - 2nd Floor Corridor Outside Room 2099 – visible historical moisture damage and suspect staining on the south wall.

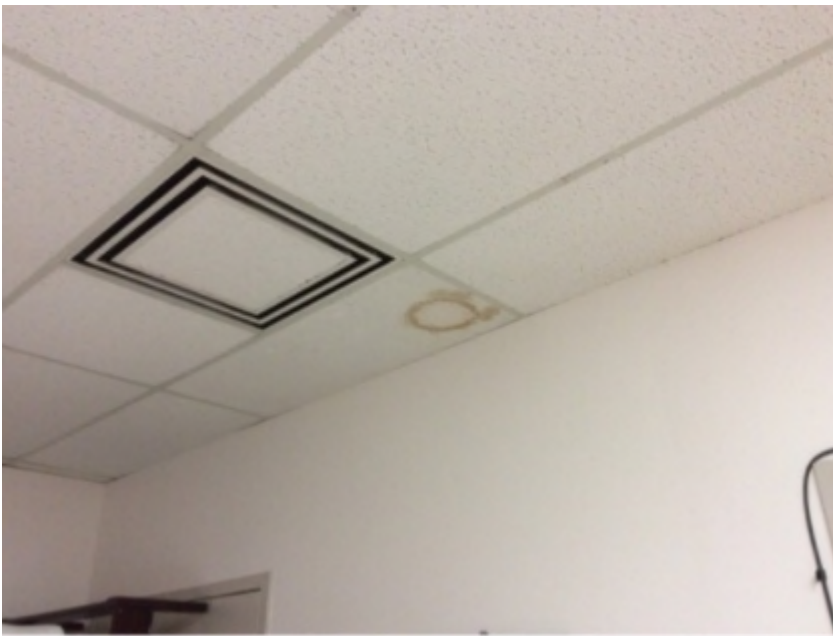
Room 2077 – Stained ceiling tiles.

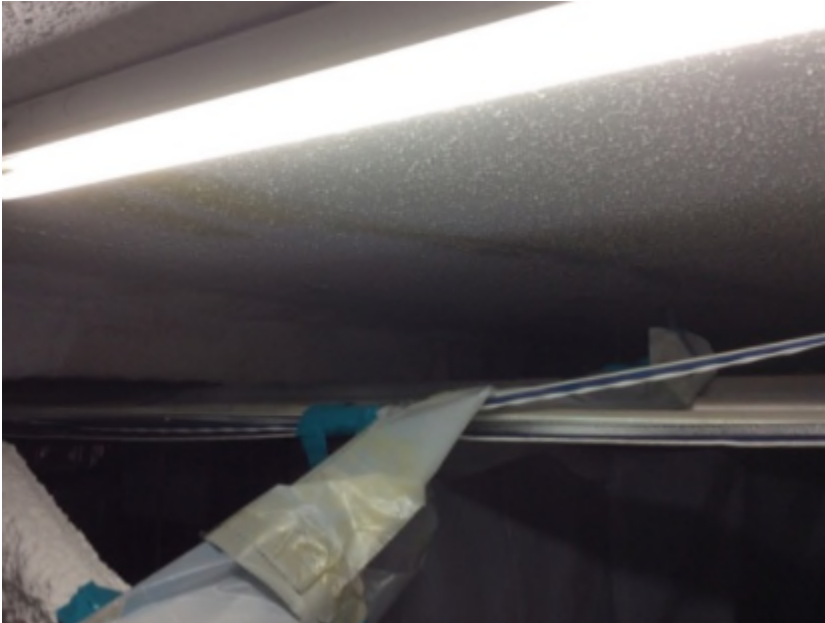
Room A2022.1 – Visible moisture damage on ceiling outside Room A2022.1 (visible from interstitial space).

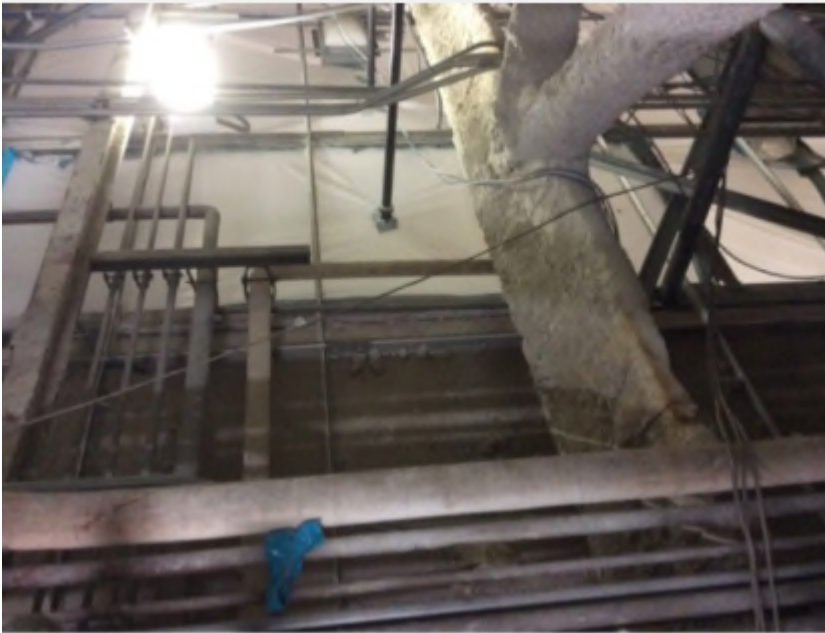
Visible fireproofing debris and stained fireproofing in the interstitial space).

- We recommend any areas on the 2nd Floor that have already had remediation conducted or still require remediation that the fireproofing above that areas be abated due to intrusion of black water onto the fireproofing in the interstitial space above the 2nd Floor (2W). During our inspection we noted visible staining of the fireproofing in the following areas.

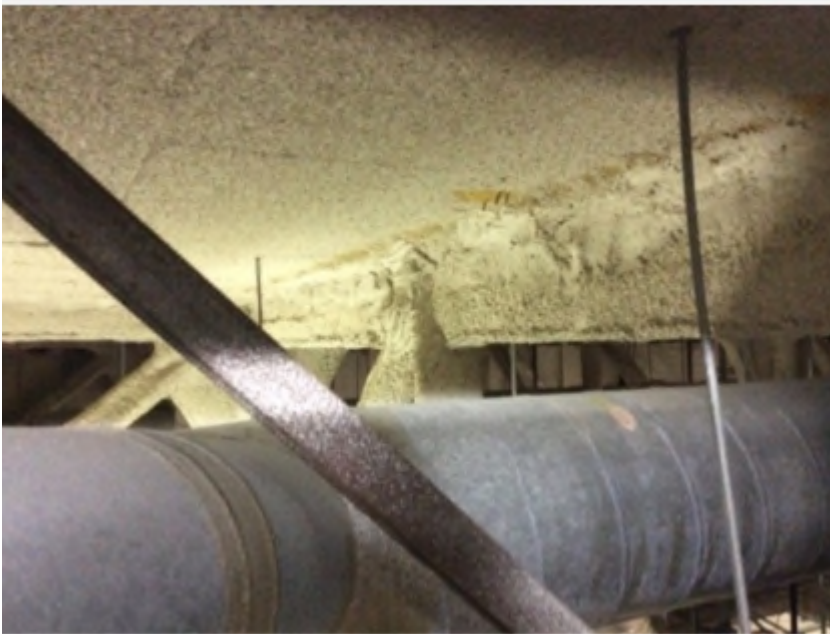
Visible stained fireproofing above Room 2085 and Room 2086.

- Above Rooms 2085, 2086 and 2024
- We recommend that any building material (ceiling tiles, fireproofing, drywall, etc.) that were noted to have been initial impacted by the flood per Citadel Environmental initial field observations and report should be removed.

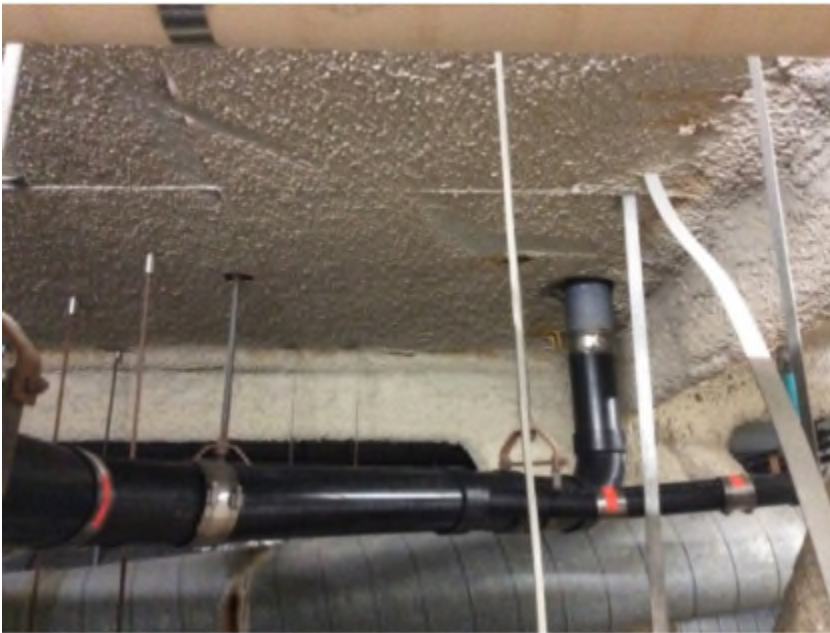
Visible stained fireproofing above Room 2024.

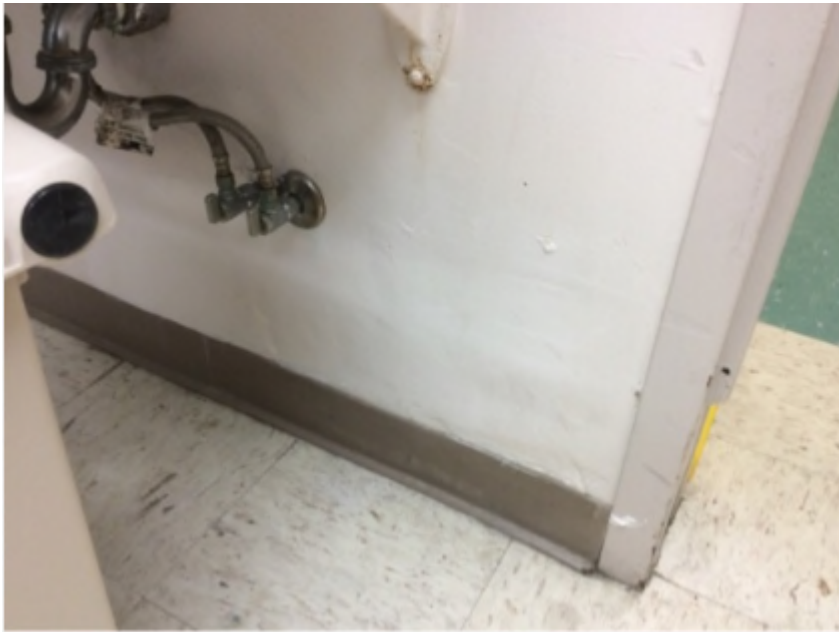
Room 2071 – Appears there has been historical moisture damage on the north wall from the sink and not the flood incident.

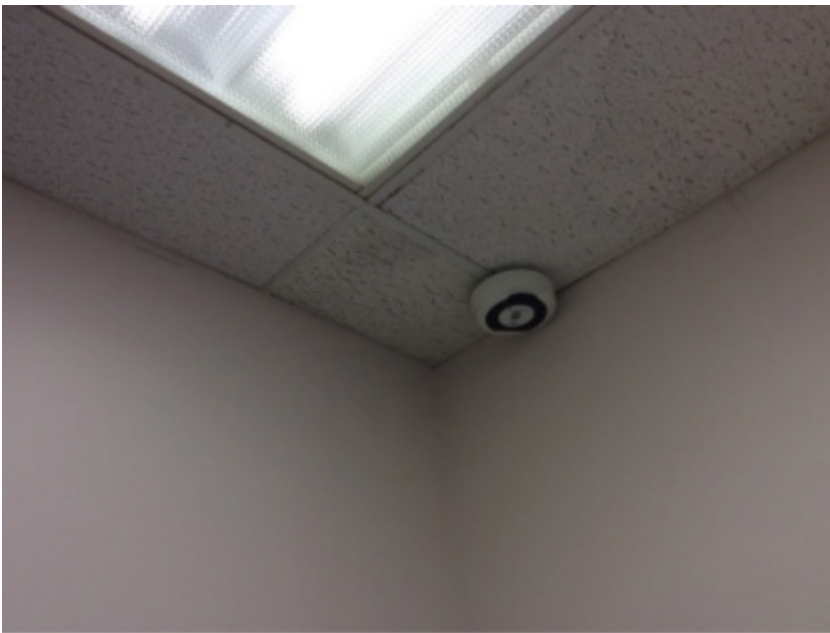
Room 2071 – stained ceiling tile.

- Room 2071
 - Room 2070

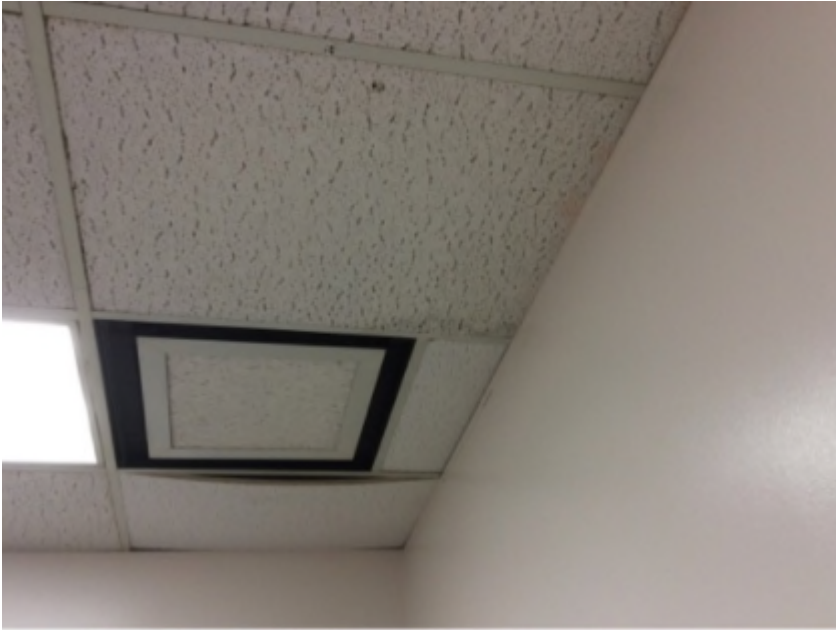
Room 2070 – stained ceiling tile.

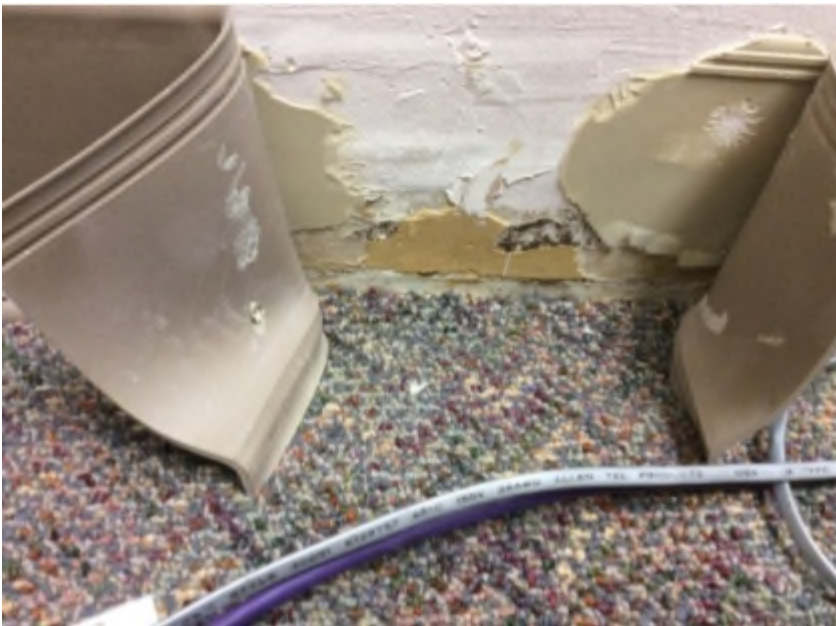
Room 2069A – suspect staining on the east and west wall.

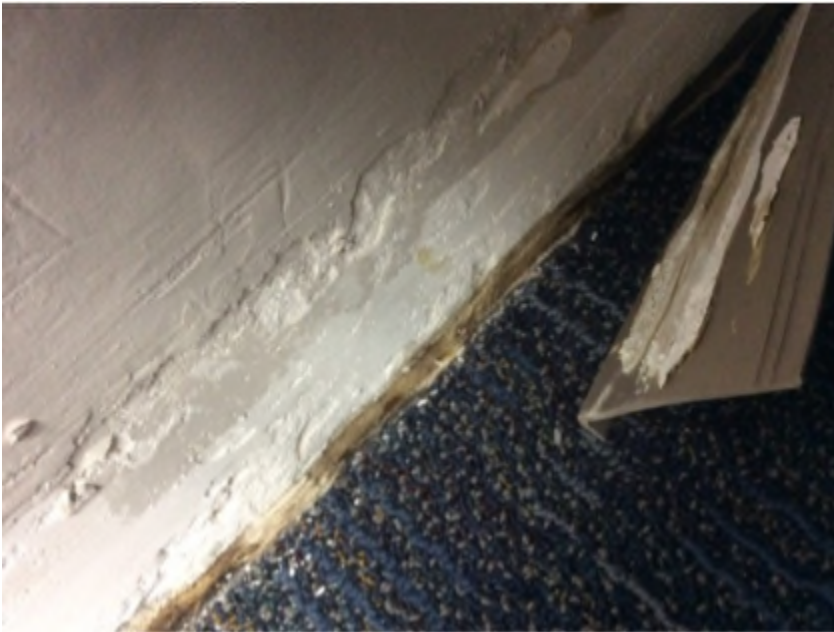
Room 2034 – suspect staining on the south and east wall.
