Occupational Health, Safety &
Environmental Consultants

July 03, 2012

Subject: Hazardous Materials Survey Report
Level 1, Level 9, Penthouse Mechanical Room Upgrade- VA Medical Center
Philadelphia, PA
Colden Project **12289**

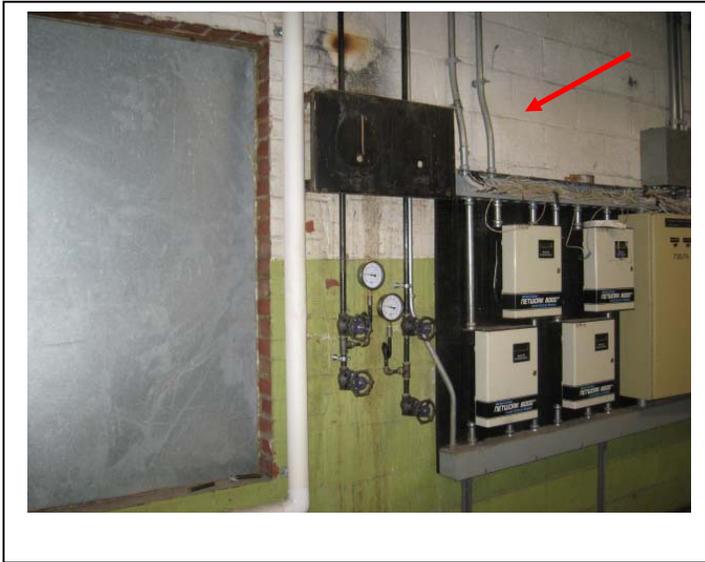
The concentration of lead in the paint samples were below the lead paint threshold of 0.5% by weight with the exception of the white paint on the walls and the air-handling unit duct work in the north penthouse mechanical room, the beige with orange and blue base paint on the metal door frame of office A917 on level 9 and the beige paint on the wooden wall support in the fire hydrant equipment cupboard on level 1.

Photograph 1. White wall paint– Penthouse mechanical room – Lead-based paint: 0.59 % wt.

Paints that are similar to the identified lead-base paints must be assumed to be similar and managed as such (e.g, all door frames on level 9). In order to comply with the Lead In Construction Standard, 29 CFR, 1926.62, the lead paint identified items that will be disturbed as part of the renovation must be handled by personnel who have completed lead awareness training or by a licensed lead abatement contractor. The door frames and duct work must be removed with minimal disturbance to the painted surface to avoid creating airborne lead based dust above the OSHA action level. These items must be disposed as construction and demolition (C&D) debris in accordance with the Philadelphia VA Solid Waste program.

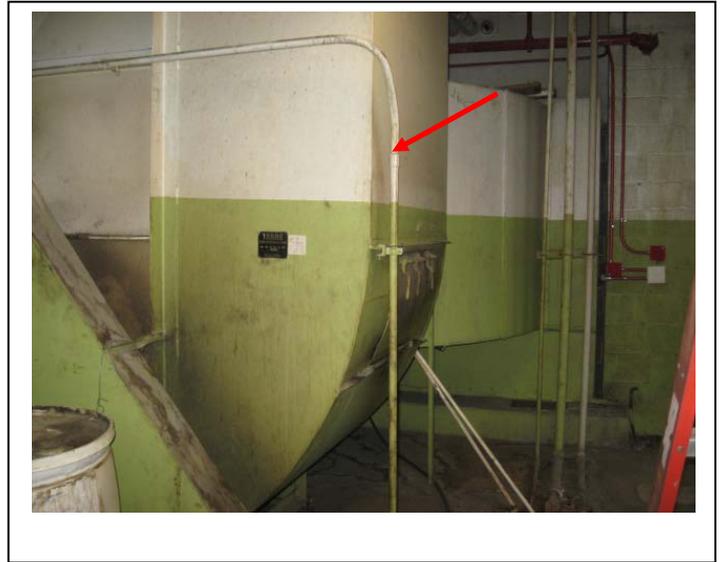
Photograph 2. White paint on duct– Penthouse mechanical room – Lead-based paint: 0.52 % wt.

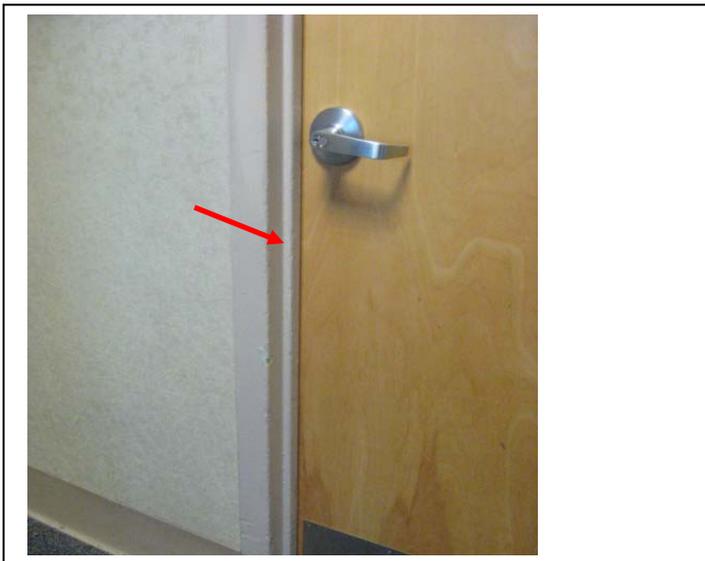
Photograph 3. Beige paint – Level 9, Door metal frame – Lead-based paint: 0.55 % wt.

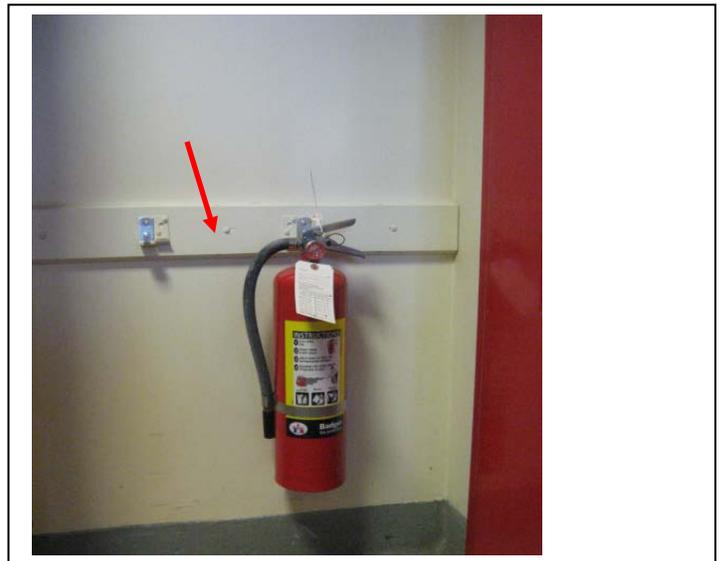
Photograph 4. Beige paint – Level 1, wood support in fire cupboard - Lead-based paint: 0.56 % wt.

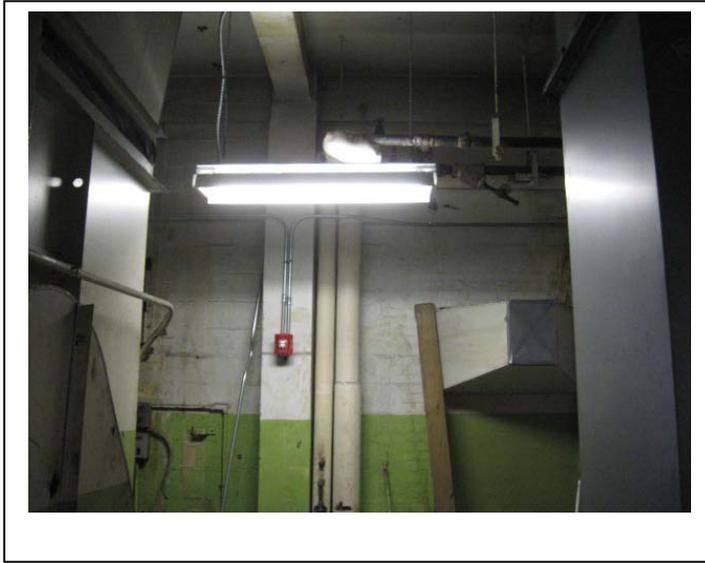
Photograph 5. Florescent bulbs and ballasts – Penthouse mechanical room – HBM: Potential Mercury and PCB.

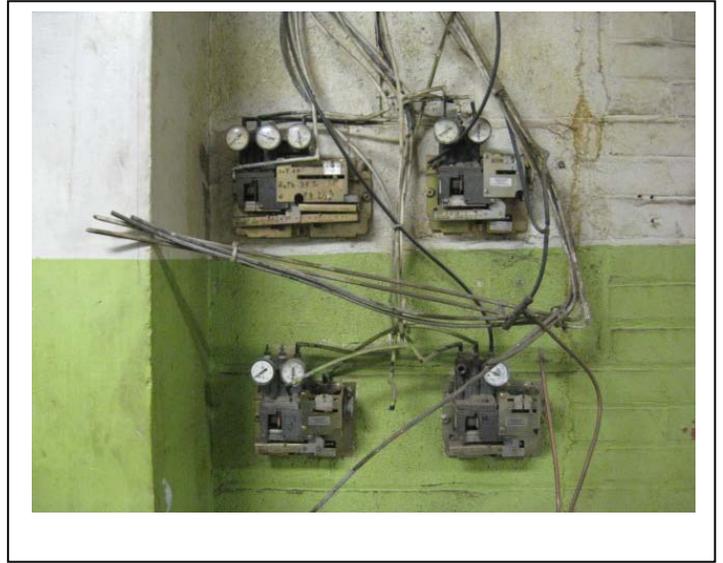
Photograph 6. Pressure gauges– Penthouse mechanical room – HBM: Potential Mercury.

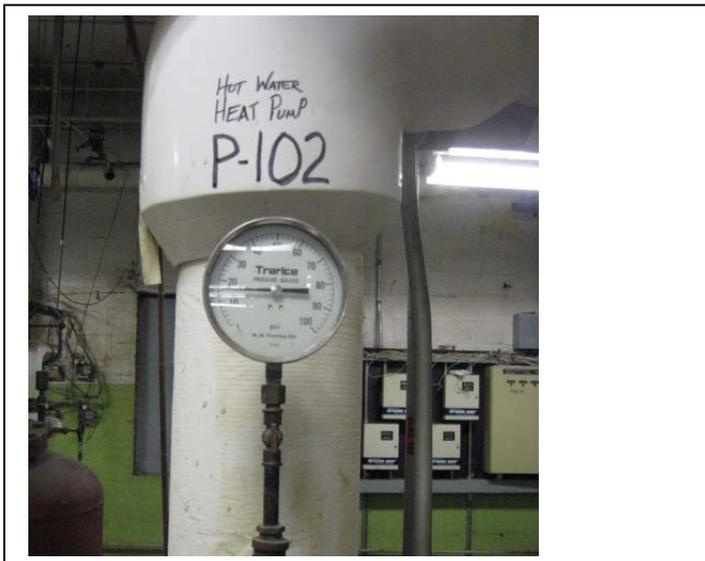
Photograph 7. Pressure gauge– Penthouse mechanical room – HBM: Potential Mercury.

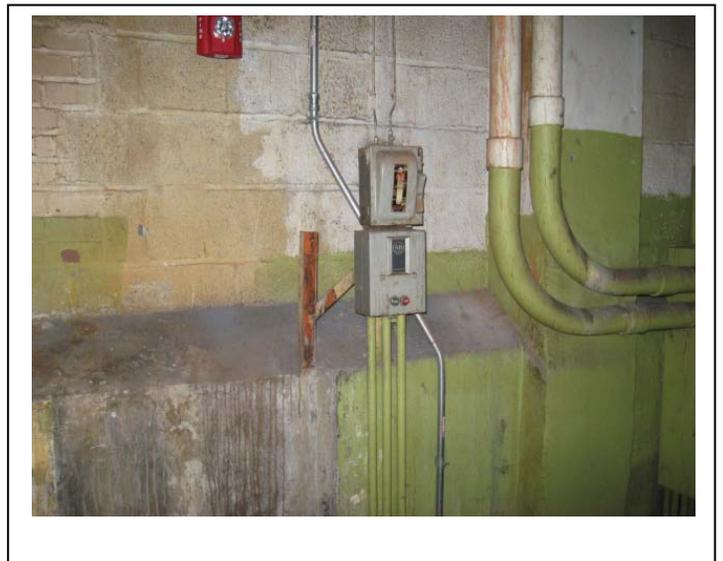
Photograph 8. Electrical Switches– Penthouse mechanical room – HBM: Potential Mercury.

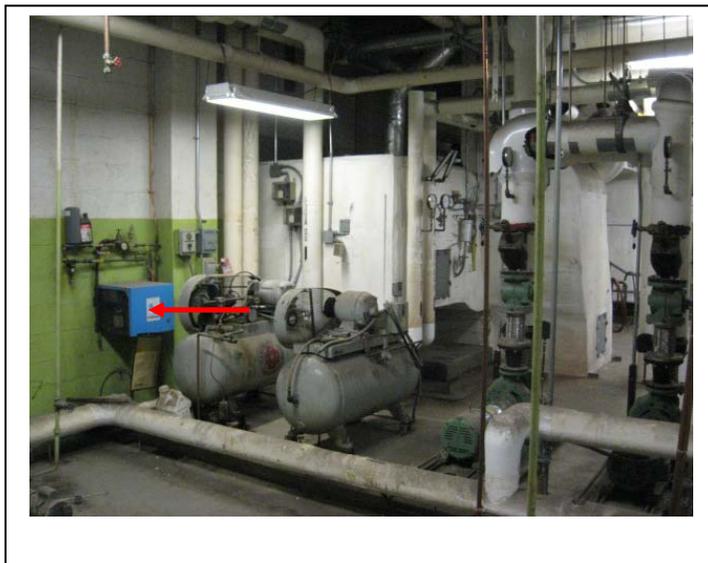
Photograph 9. Compressed air drier – Penthouse mechanical room – HBM: Refrigerant R134A or R22

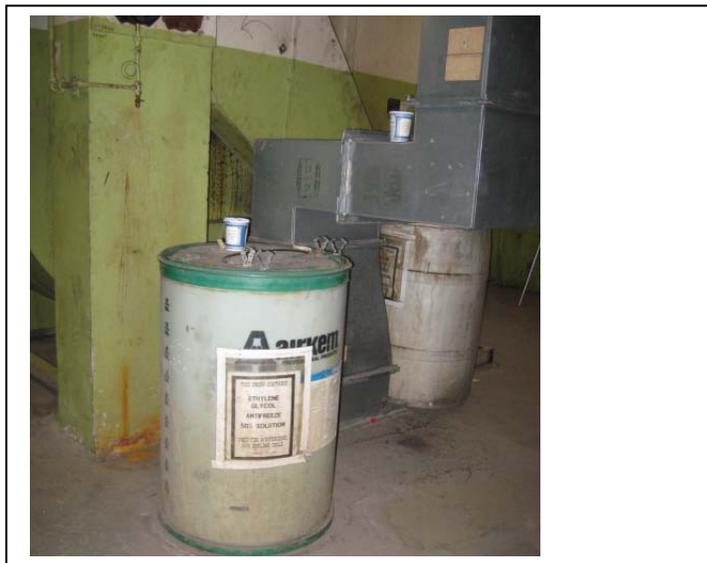
Photograph 10. 50 gallon drum of Ethylene Glycol (anti-freeze) – Penthouse mechanical room – HBM: Miscellaneous Chemicals.

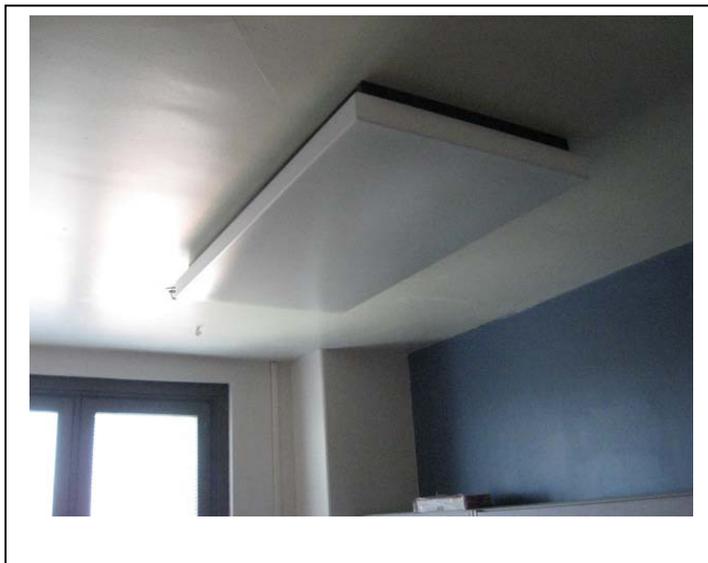
Photograph 11. Florescent bulbs and ballasts – Level 9 – HBM: Potential Mercury and PCB.

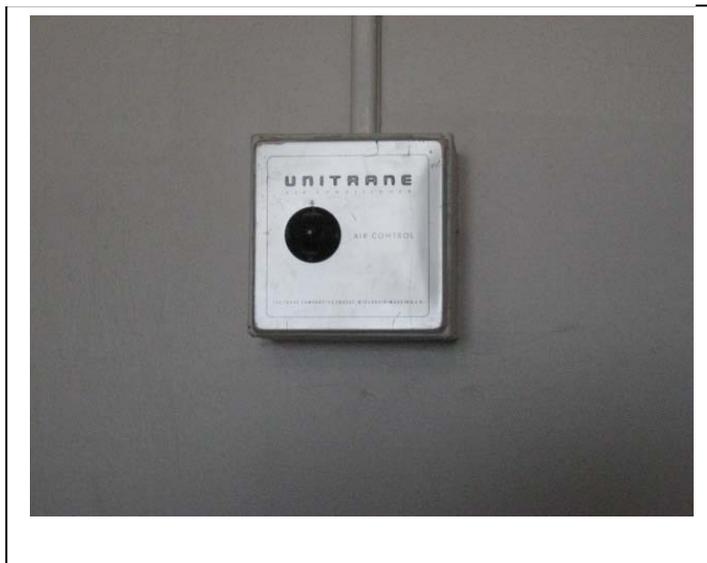
Photograph 12. Air controller – Level 9 – HBM: Potential Mercury.

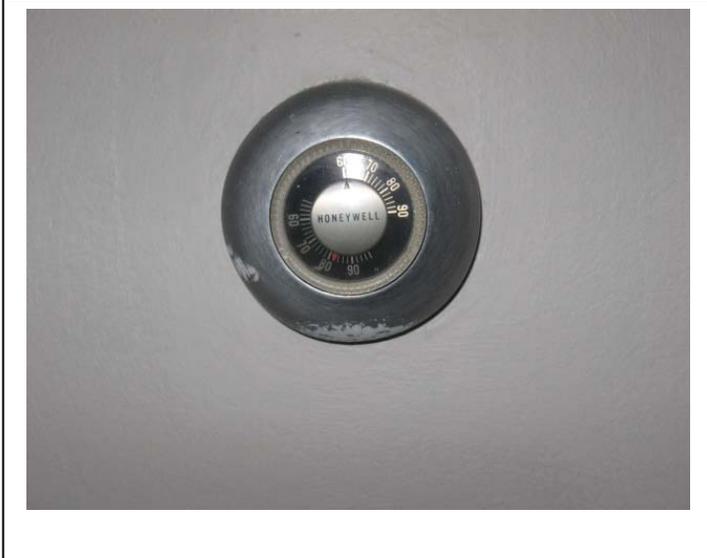
Photograph 13. Thermostat – Level 9 – HBM: Potential Mercury.

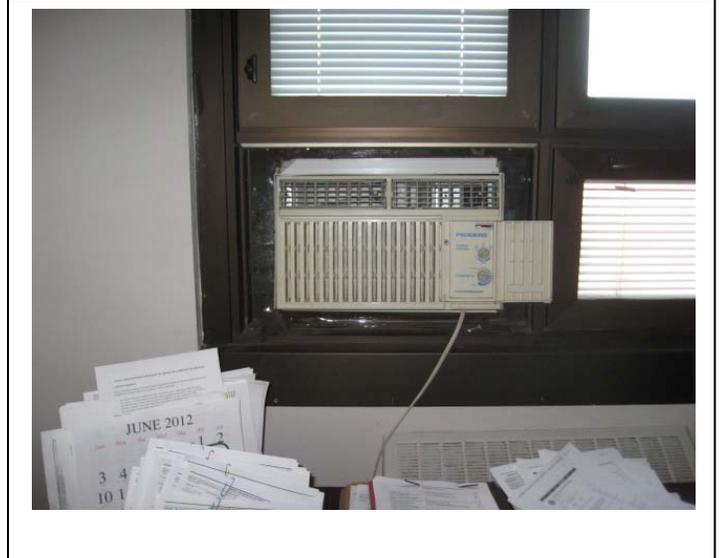
Photograph 14. Air-conditioner – Level 9 – HBM: CFCs related to refrigerant.

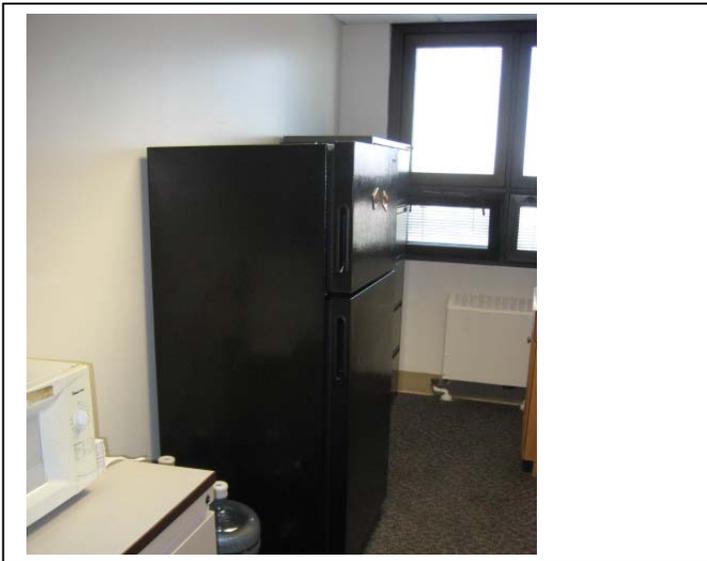
Photograph 15. Fridge – Level 9 – HBM: CFCs related to refrigerant.

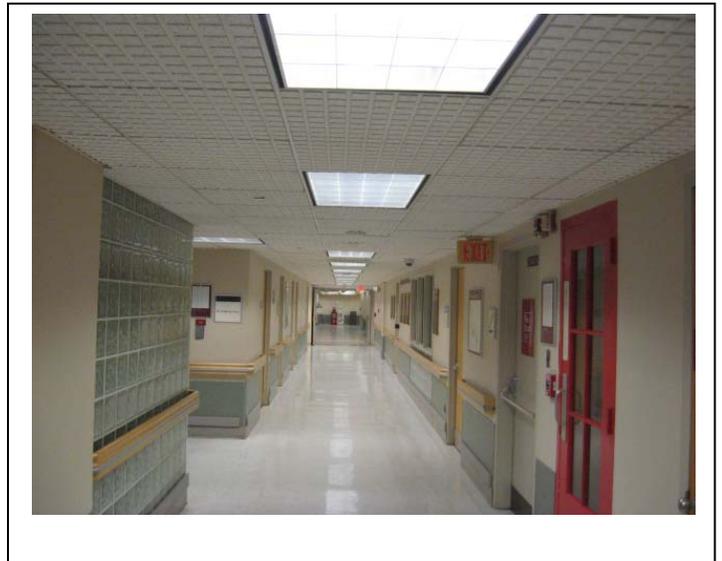
Photograph 16. Florescent bulbs and ballasts – Level 1 – HBM: Mercury and PCBs.
