December 2, 2010

Mr. William Romzick  
Jacobs  
180 Promenade Circle, Suite 300  
Sacramento, CA 95834

Re: Geotechnical Investigation  
Columbarium Wall 2, Santa Fe national Cemetery, Santa Fe, New Mexico  
*SFB Project No.: 361-10*

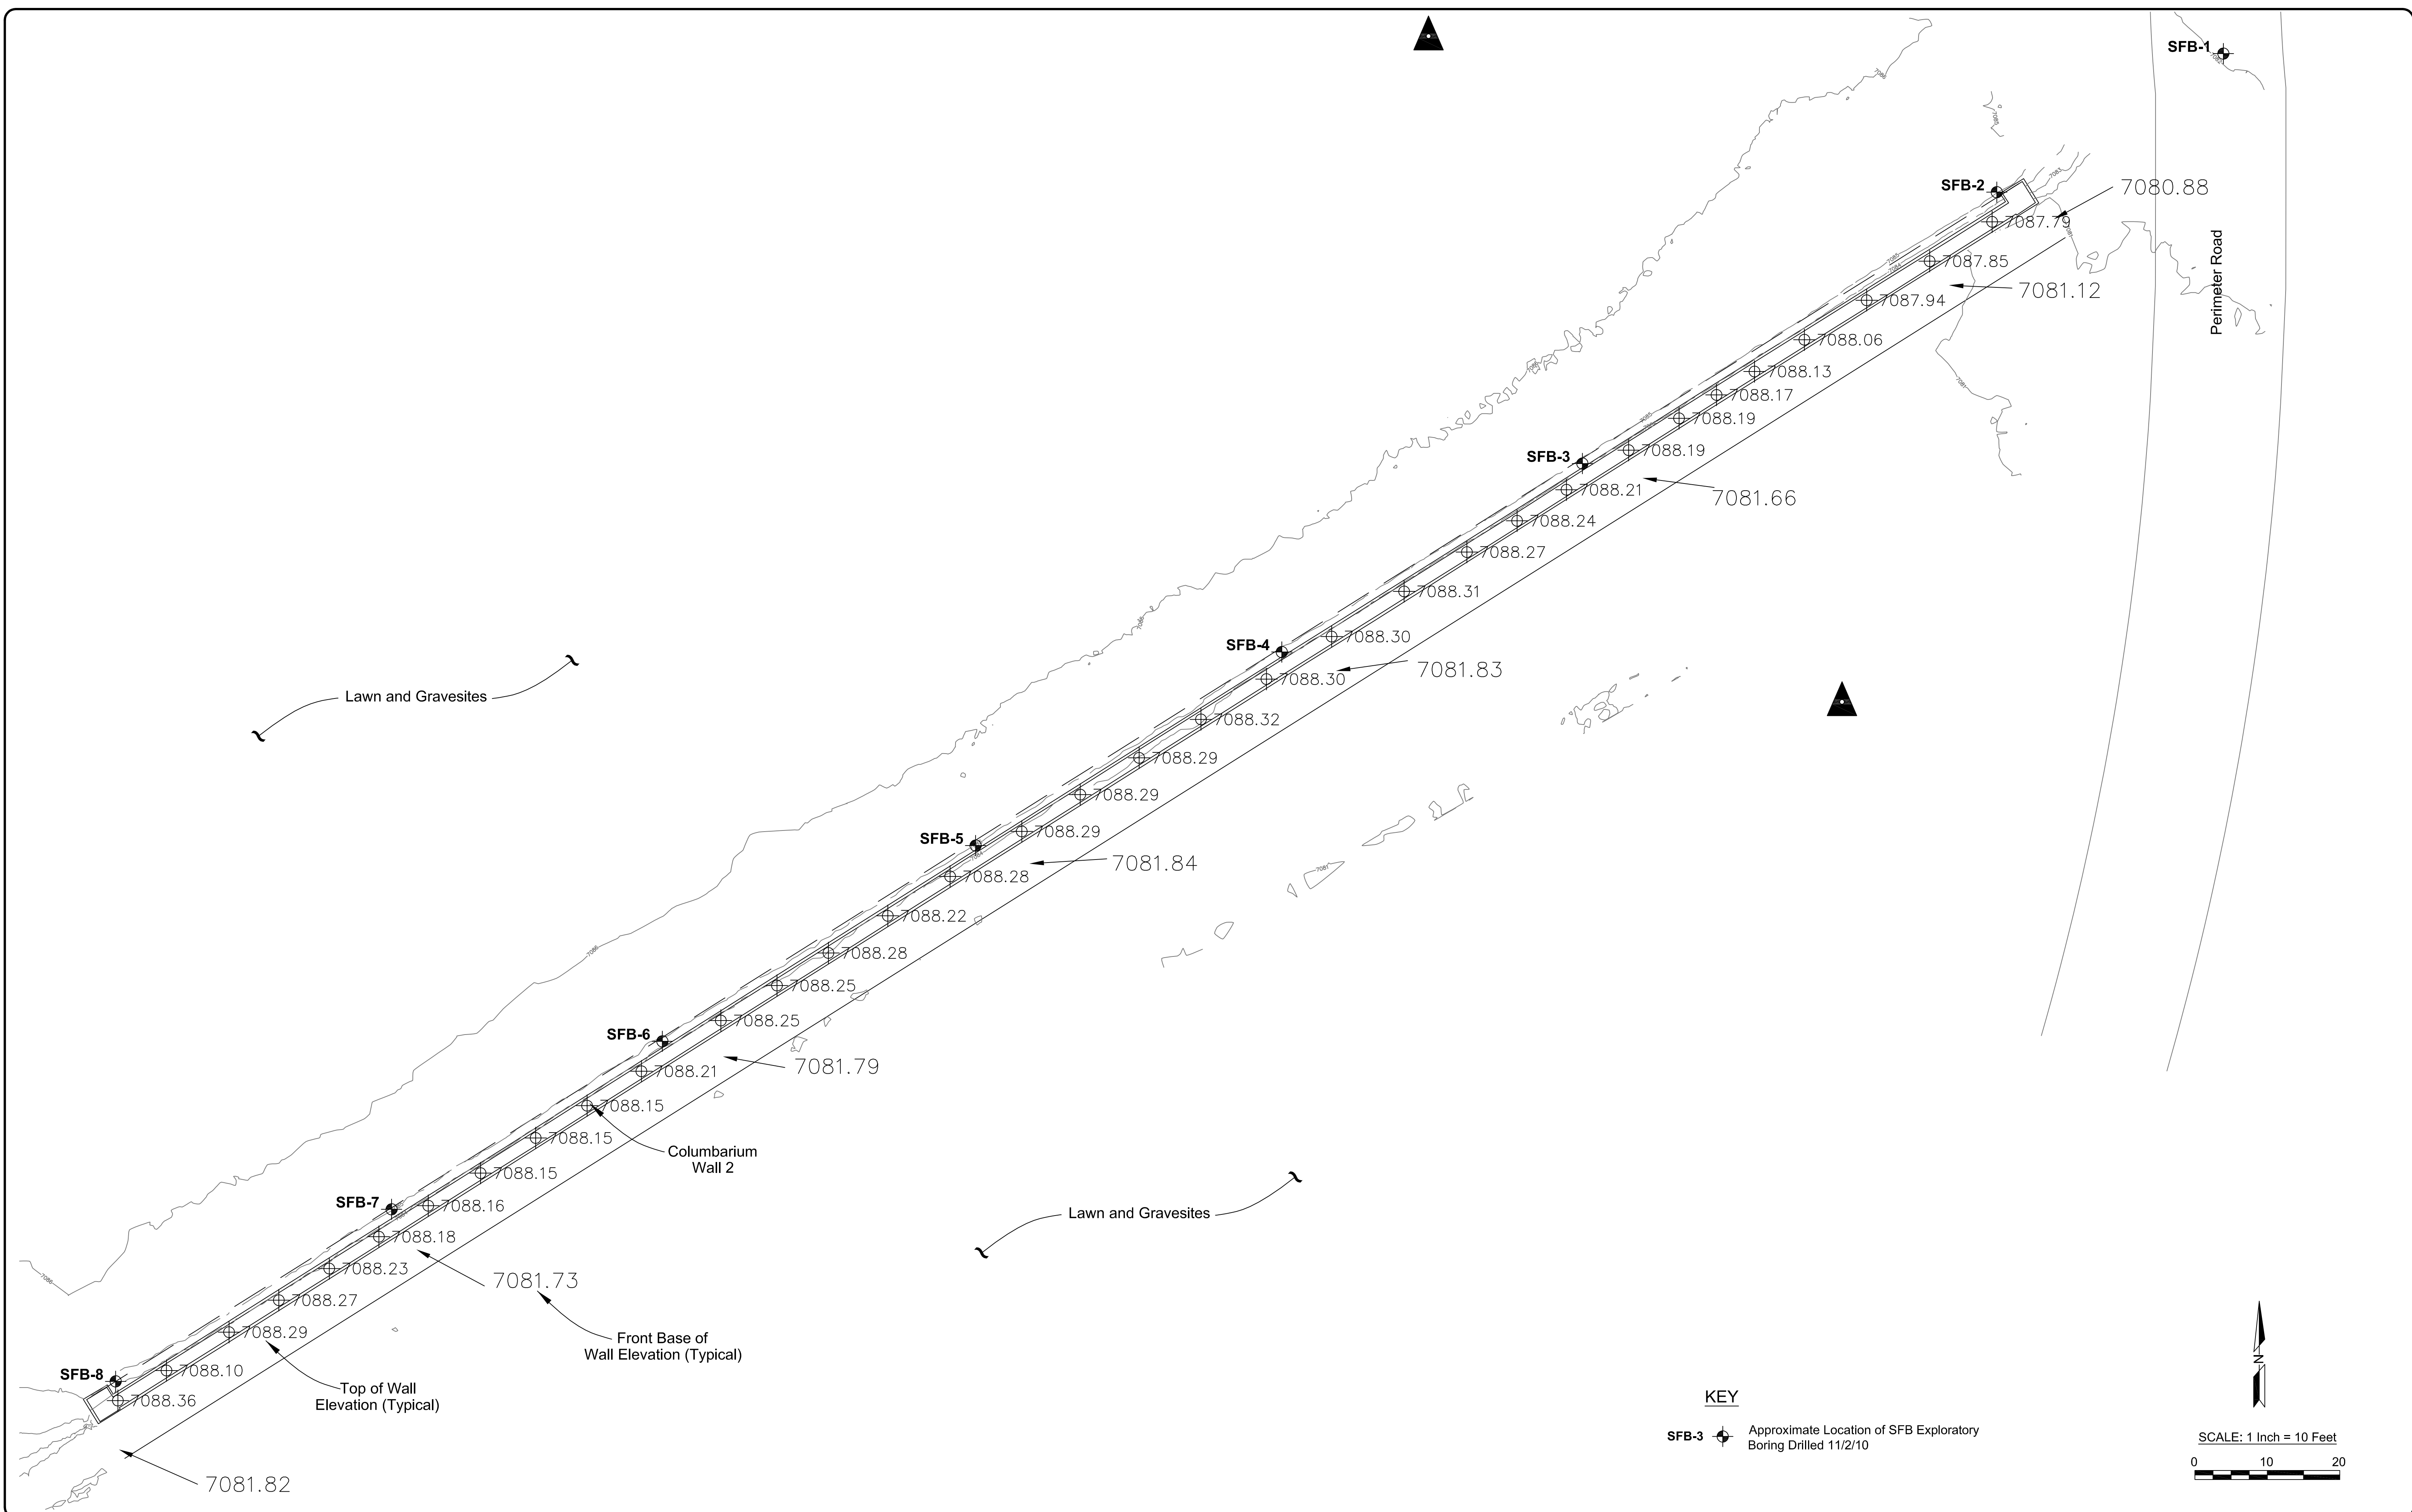
The Columbarium Wall 2 has undergone differential settlement that has resulted in cracking of concrete and masonry, and has also resulted in tension cracks and “pulling apart” of joints. As shown on Figure 1, the wall is approximately 350 feet in length, 6-1/2 feet in height, and retains 4 to 4-1/2 feet of fill. It is assumed that the wall is founded on a simple, shallow concrete pad. A concrete walkway exists at the front of the wall, and lawn and gravesites are located adjacent to the front and back of the wall. The lawn areas are irrigated. The results of our investigation indicate that a drainage system exists adjacent to the back of the wall, between the backfill and the wall.

On November 2, 2010, we performed a reconnaissance of the wall and surrounding area. At the time of our reconnaissance and as shown on Figure 1, the wall was bounded by lawn and gravesites to the north, a concrete walkway and lawn/gravesites to the south, and landscaping on

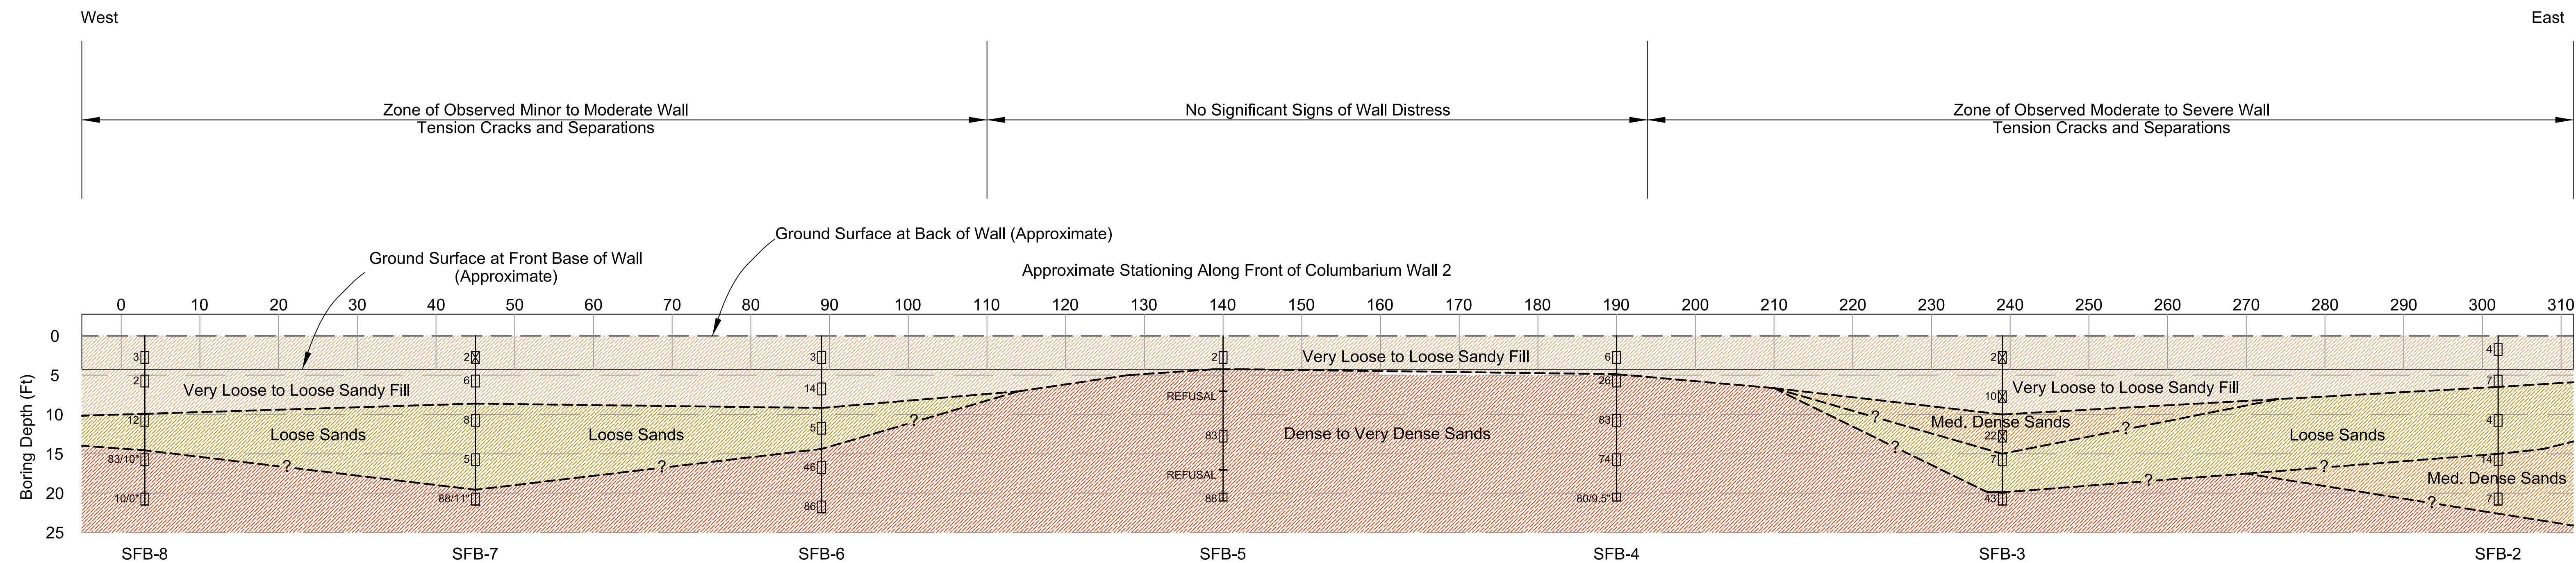
CROSS-SECTION  
COLUMBARIUM WALL 2

Figure 2 provides a cross-section along the length of Columbarium Wall 2 showing the relationship of the wall with the fill materials and native soils encountered in our borings. Figure 2 also shows the general locations where we observed distress in the wall. As shown in Figure 2,

the observed distress correlates well with the location of the loose fills and soils, approximately located below the eastern and western third of the wall. The middle third of the wall is underlain by dense to very dense soils and shows little distress.

Based on the results of our site reconnaissance, subsurface exploration, laboratory testing, and geotechnical engineering analyses, it is our opinion that Columbarium Wall 2 is experiencing distress where the wall is underlain by loose fill materials and loose native soils. The roadway and retaining wall to the east of Columbarium Wall 2 appear to be functioning properly and do not appear to have a negative impact on Columbarium Wall 2. Distress is observed in Columbarium Wall 2 where loose fills or soils exist below the wall (below the approximate eastern and western third of the wall), and relatively no distress is observed in Columbarium Wall 2 where the wall is underlain by dense native soils (below the approximate middle third of the wall). The loose fills and soils below the wall will continue to consolidate over time resulting in additional settlement and distress to Columbarium Wall 2.

In order to adequately support Columbarium Wall 2, we recommend compaction grouting be performed within the loose fills and soils below the wall. Figure 2 shows the approximate locations of these loose fills and soils. Compaction grouting consists of pushing grout tubes below the ground surface until moderate resistance is encountered (resistance is typically encountered at the interface between the loose fills/soils and medium dense to dense soils). At that point, cement based grout is injected into the ground at high pressures creating a grout bulb that radiates outward, densifying (compacting) the surrounding granular soils. After the initial grout bulb is created, the grout tube is raised a few feet and another grout bulb is created. This process should be continued until a sufficient number of grout bulbs are created below the wall and the underling, supporting soils are adequately densified. Once the grouting is completed, the shear strength and density of the underlying fills and soils are significantly improved, resulting in adequate support for the wall. Granular soils, such as those underlying the wall, are best suited for compaction grouting techniques. Benefits of compaction grouting include minimal disturbance to existing improvements and no need for demolition and reconstruction of the wall. In some cases, compaction grouting is able to re-level overlying improvements (such as walls).

the grouting process. The vertical extent of the compaction grouting should include all of the loose soils and fills below the wall shown on Figure 2. Laterally, the grouted zone below the wall should include the area between 1:1 (horizontal to vertical) projected planes extending downward from the outer edges of the base of the wall.

Upon completion of the grouting, we recommend a Standard Penetration Resistance value (SPT) of at least 25 be achieved in the granular soils within the grouted zone. The SPT values should be determined after grouting by drilling at least four exploratory borings (two within each grouted zone) to a depth of approximately 20 feet. SPT tests should be taken at least every 3 feet in depth. We also recommend that we review the grouting plans and specifications prior to construction to confirm that the intent of our recommendations contained in this report have been satisfied.
