FEDERAL TRANSIT BUS TEST

**Manufacturer: ARBOC SPECIALTY VEHICLES, LLC
Model: SPIRIT OF EQUSS**

**Tested in Service-Life Category
10 Year / 350,000 Miles**

Report Number: LTI-BT-R1803

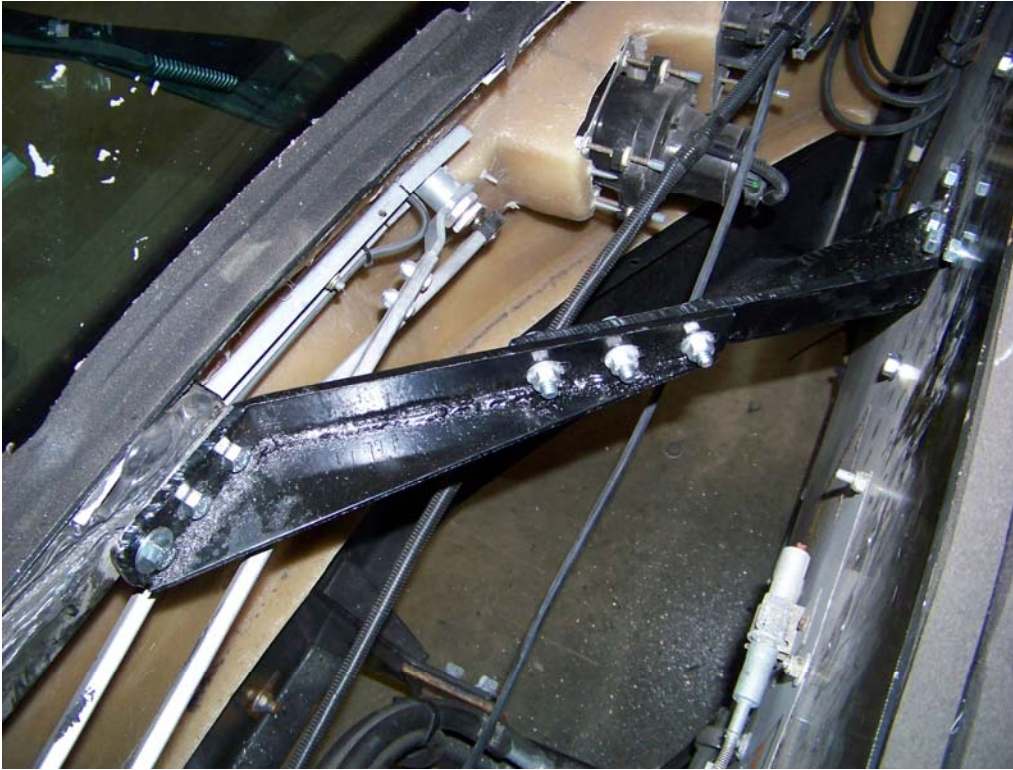
**LOWER WINDSHIELD SUPPORT ADDED AND REPAIRED
(1,254 TEST MILES)**

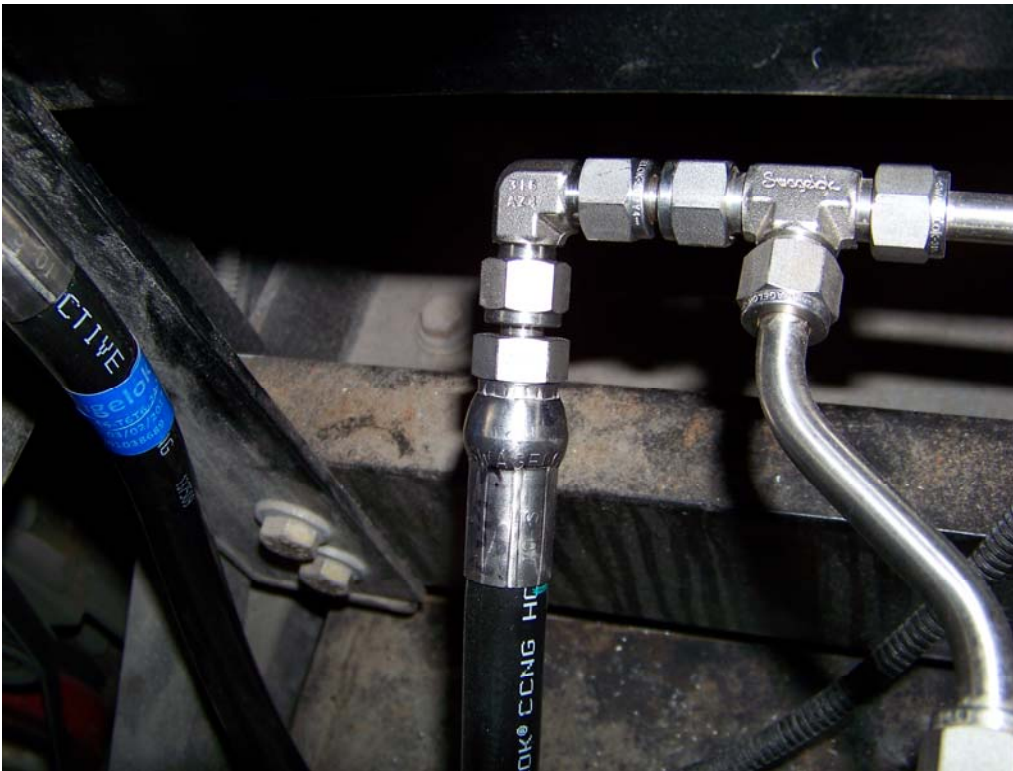
**FLEX CNG LINE INSTALLED BETWEEN TANKS AND
SUPPLY (1,487 TEST MILES)**

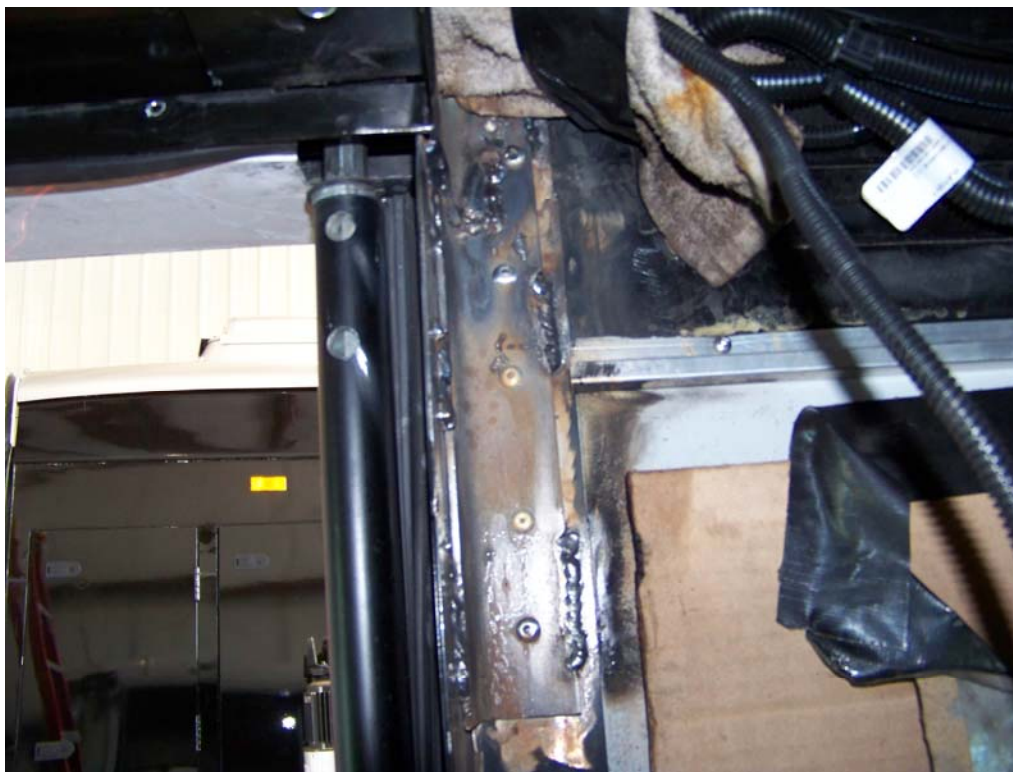
The FTA required the test bus to run an additional 1,813 miles at GVW at the end of the test to validate the correction of the Class 2 door failure which occurred on June 6, 2018. The additional miles were completed without any further failures relating to the door.

**DOOR FRAMEWORK REPAIRS
(5,724 TEST MILES)**

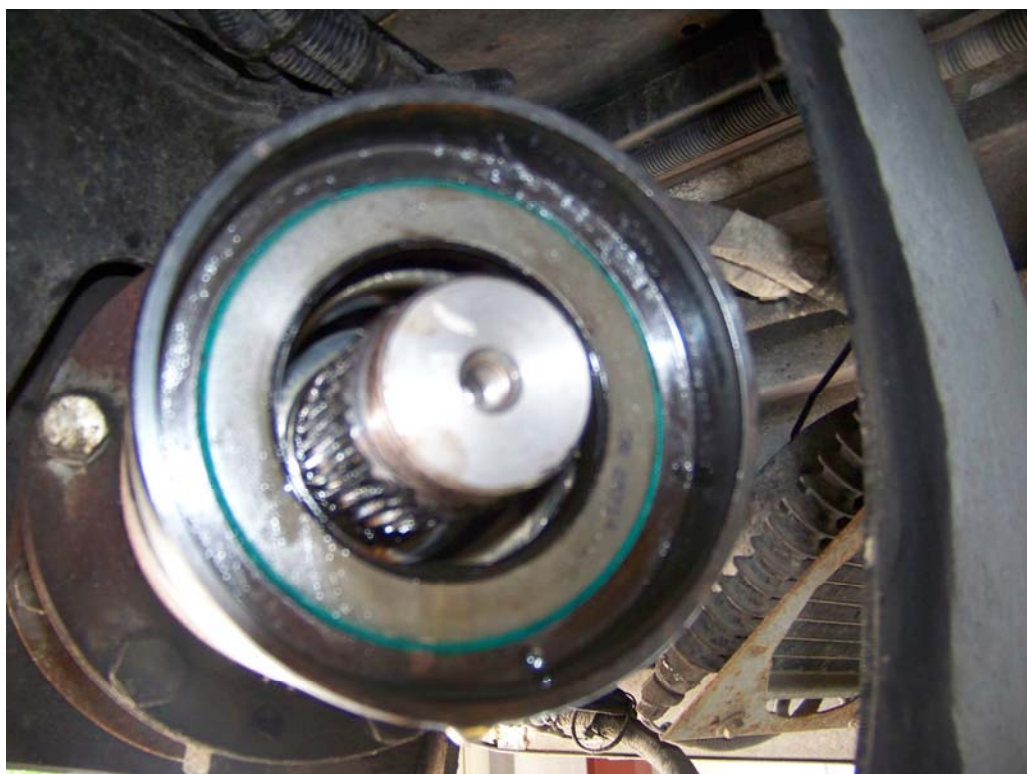
**OIL SEAL REPLACED ON GEARBOX
(5,787 TEST MILES)**

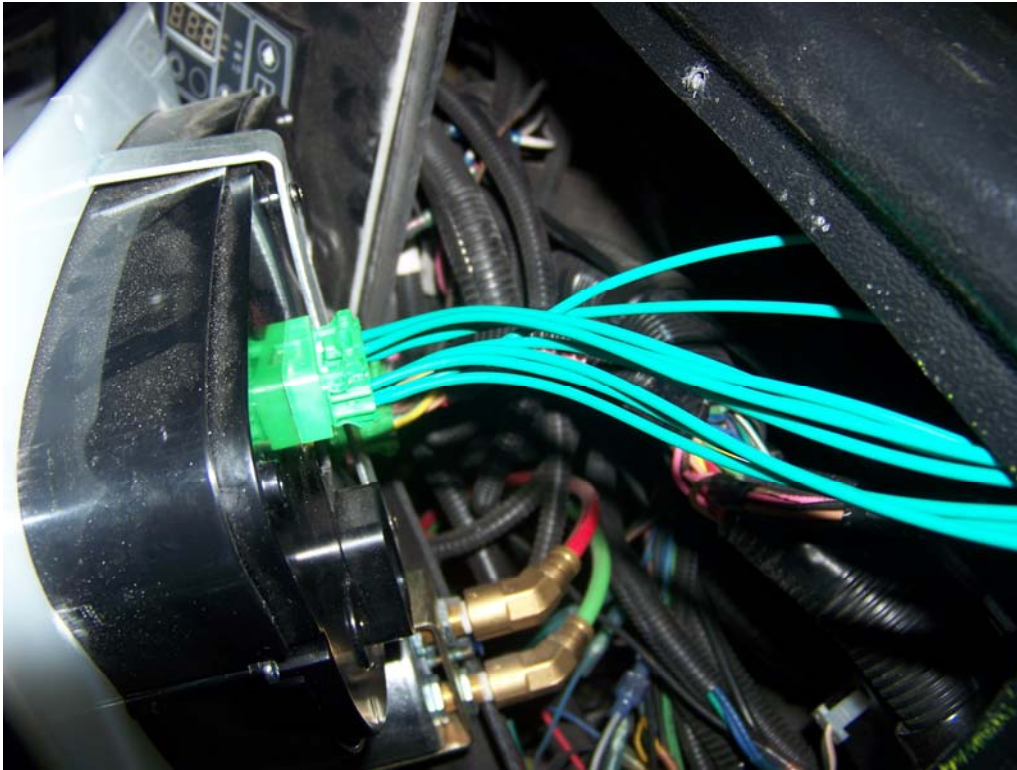
**DASH CLUSTER PLUG REPLACED
(7,129 TEST MILES)**

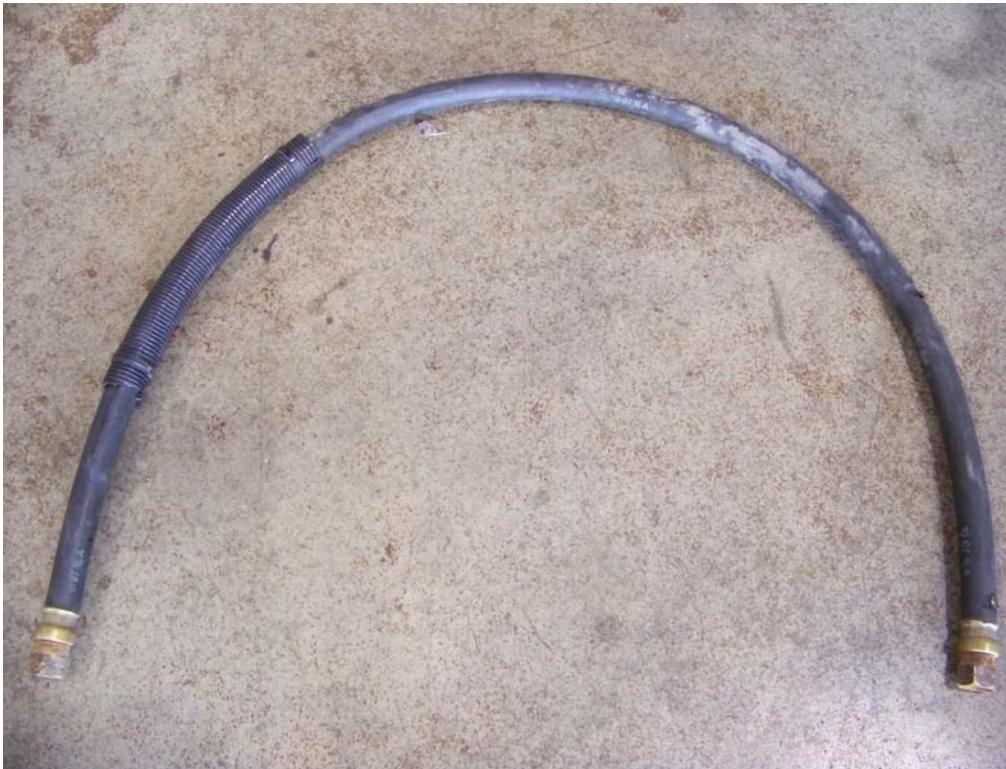
**FRONT BRAKE AIR HOSE LEAK DUE TO WHEEL
CONTACT (7,931 TEST MILES)**
