**ASBESTOS SURVEY AND ASSESSMENT
OF THE
VETERANS ADMINISTRATION MEDICAL CENTER
660-18-232 DEMOLISH BUILDING 1, G ZONE
LOCATED AT**

**550 FOOTHILL DRIVE
SALT LAKE CITY, UTAH**

VETERANS ADMINISTRATION
DATE OF SURVEY: DECEMBER 19, 2017
NESHAP - REGULATED
ASBESTOS-CONTAINING MATERIALS (R-ACM)

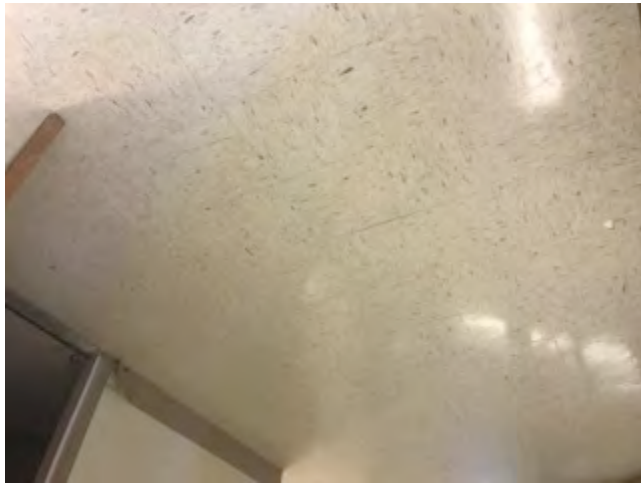
PHOTO 1: 12" Vinyl Floor Tile

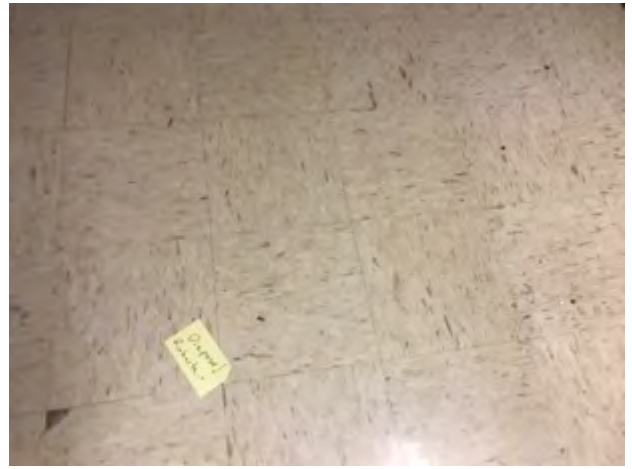
PHOTO 2: 12" Vinyl Floor Tile

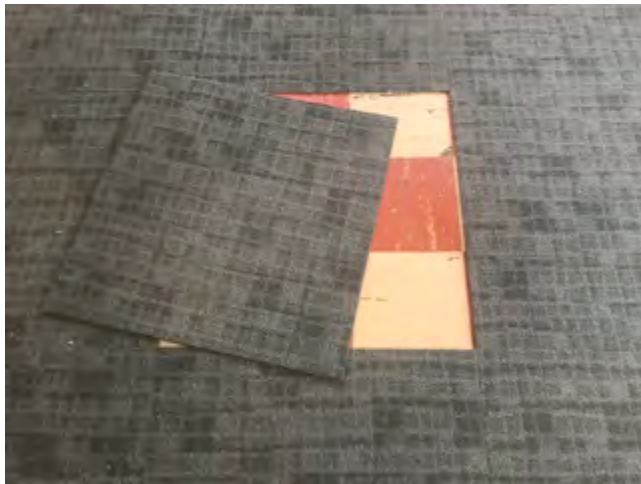
PHOTO 3: 9" Floor Tile

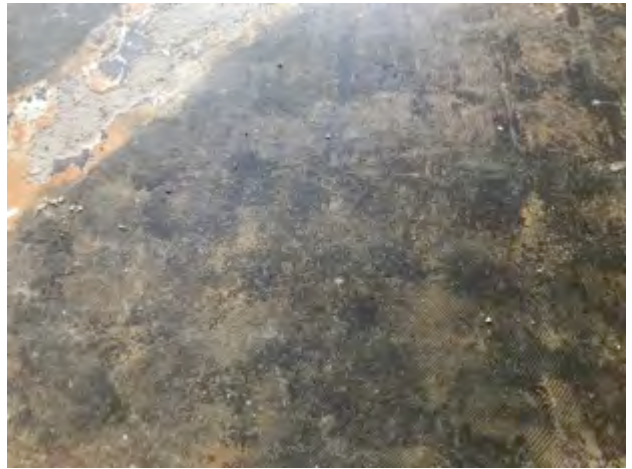
PHOTO 4: Tile Adhesive Black Mastic

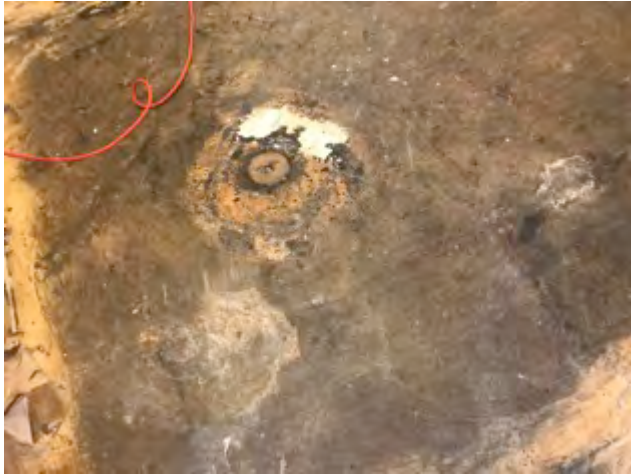
PHOTO 5: Carpet Adhesive & Black Mastic

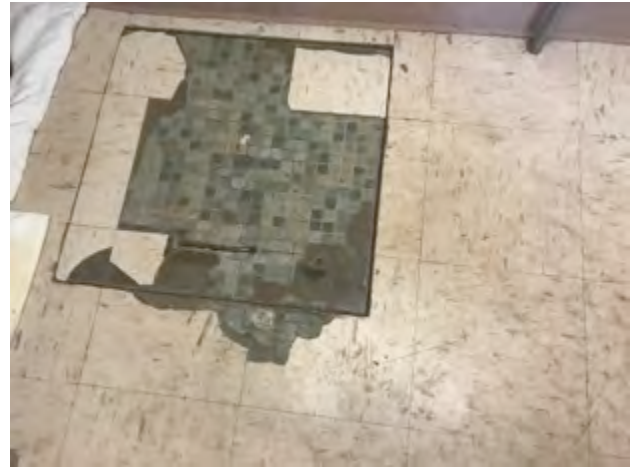
PHOTO 6: Ceramic Tile & Grout/Tan Green Resinous Material

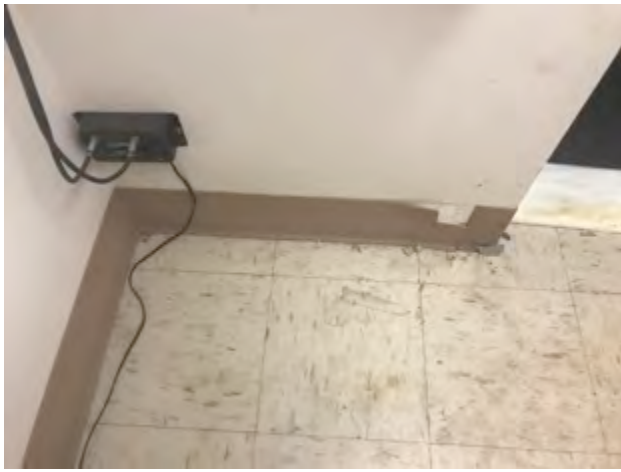
PHOTO 7: Vinyl Cove Base Tile

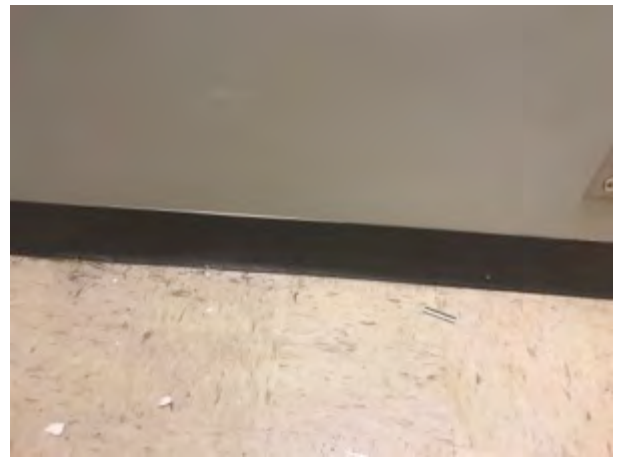
PHOTO 8: Vinyl Cove Base Black

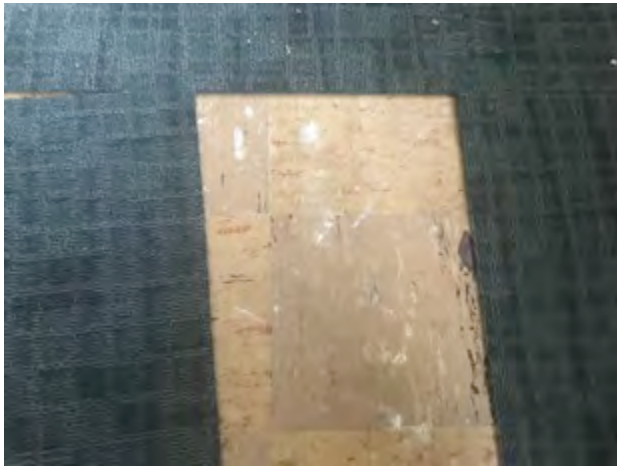
PHOTO 9: 12" Vinyl Floor Tile

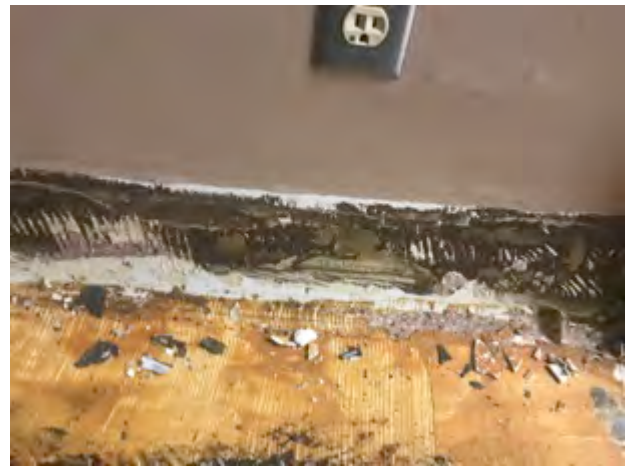
PHOTO 10: Cove Base Adhesive

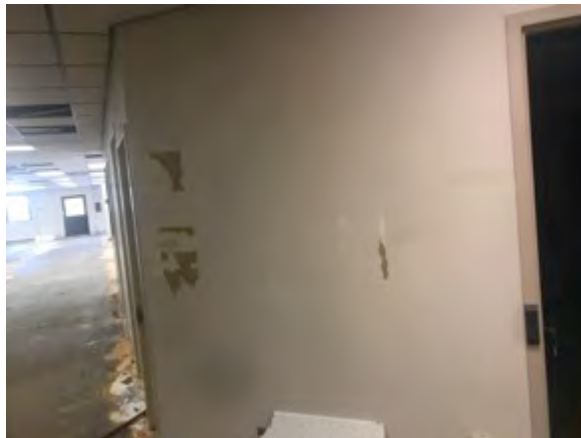
PHOTO 11: Wall System

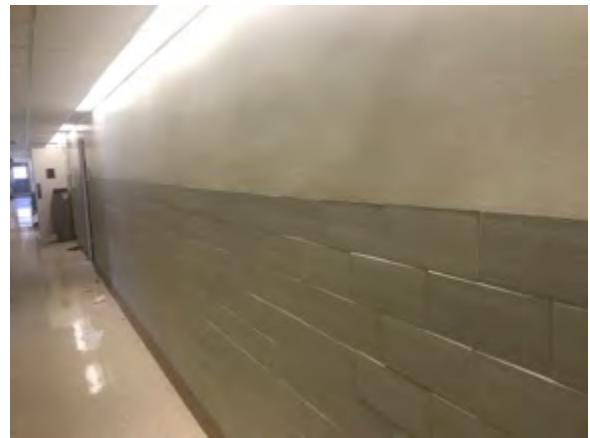
PHOTO 12: Plaster Surfacing

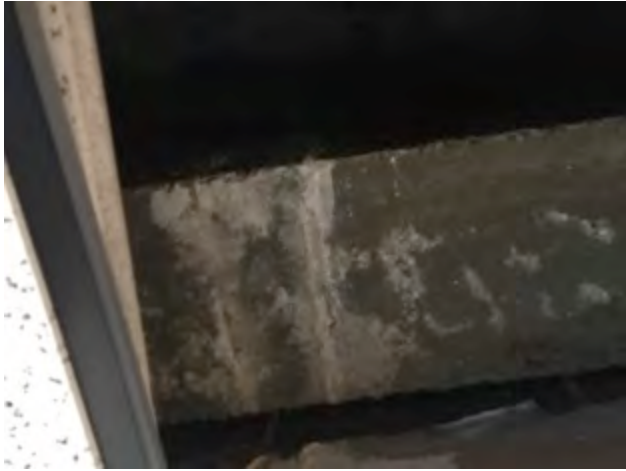
PHOTO 13: Concrete Deck Patch/Filler Material

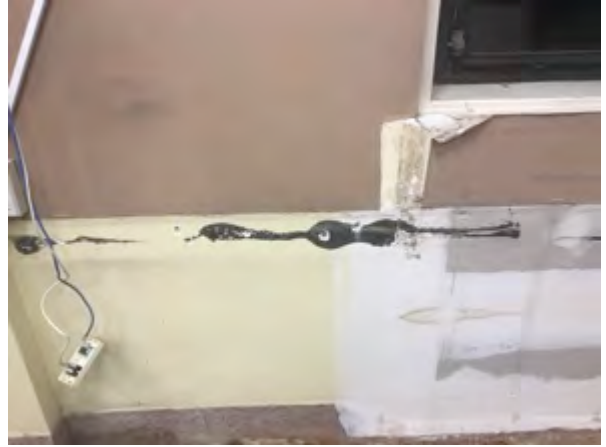
PHOTO 14: Black Construction Adhesive

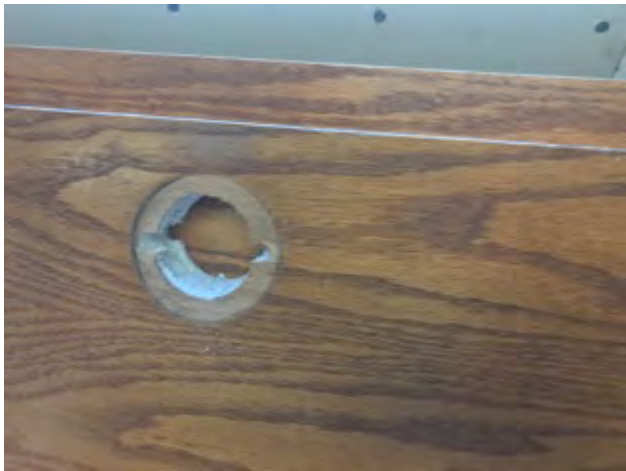
PHOTO 15: Fire Door Insulation

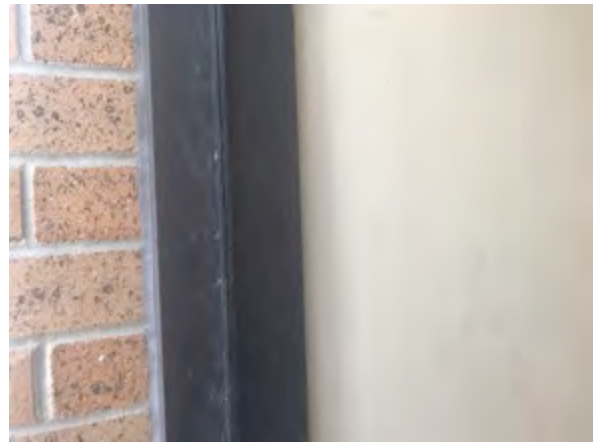
PHOTO 16: Fire Door Frame Material

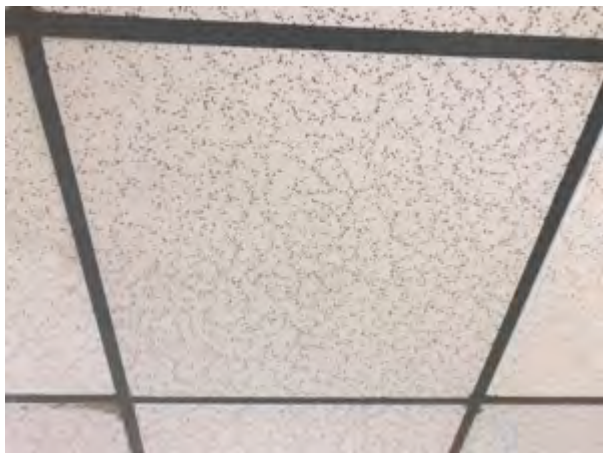
PHOTO 17: Ceiling Panel #1

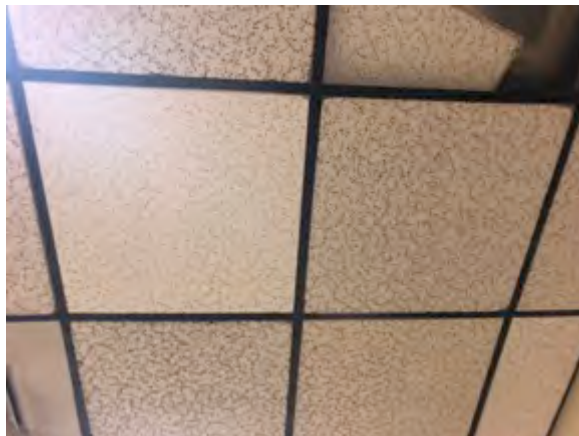
PHOTO 18: Ceiling Panel #2

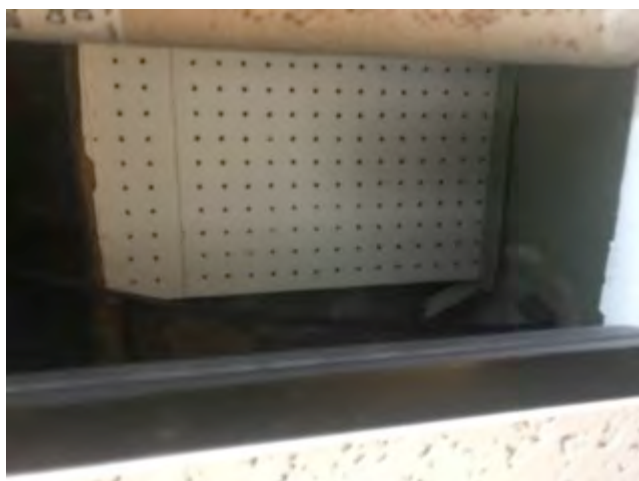
PHOTO 19: 12" Ceiling Tile (Above Drop Down Ceiling)

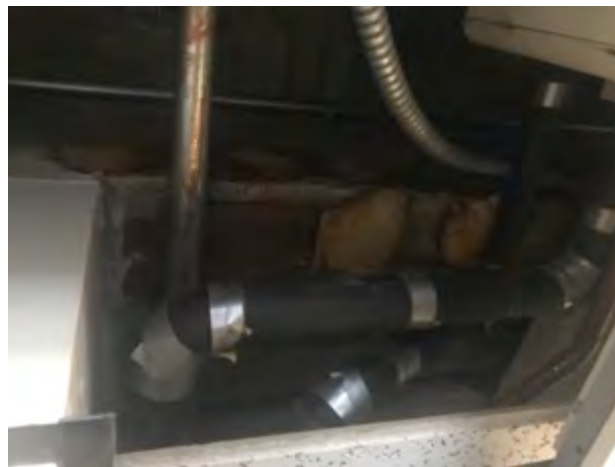
12" Ceiling Tile Adhesive- (Above drop down ceiling)	Above Ceilings in Offices, and Library	270 LF	6-8% Chrysotile	20	Good
Drinking Fountain Putty	Hallway	1 Unit	8% Chrysotile	22	Good
HVAC Duct Sealant #1	Throughout	875 LF	7-12% Chrysotile	28	Good
TSI- Pipe Lagging (Air Cell)	1G17G	35 LF	70-80% Chrysotile	32	Good
TSI – Plaster Fittings	1G11, 1G09, 1G05, 1G03A, 1G03, 1G01, 1G01A, 1G02A, 1G02, 1G02B, 1G04, 1G08, 1G12, Bathrooms	85 Each	4-10% Chrysotile	33	Good
Roofing Material- Yellow Foam, Black Tar Mastic	Roof	9,250 ft ²	None Detected 3% Chrysotile	42	Good
9'X9' Vinyl tile- Green	1B47	150 ft ²	12-15 % Chrysotile	39	Good
Exterior Wall Black Tar	All Exterior Wall Cavities	7,250 ft ²	Assumed	42	Good

PHOTO 20: 12" Ceiling Tile Adhesive

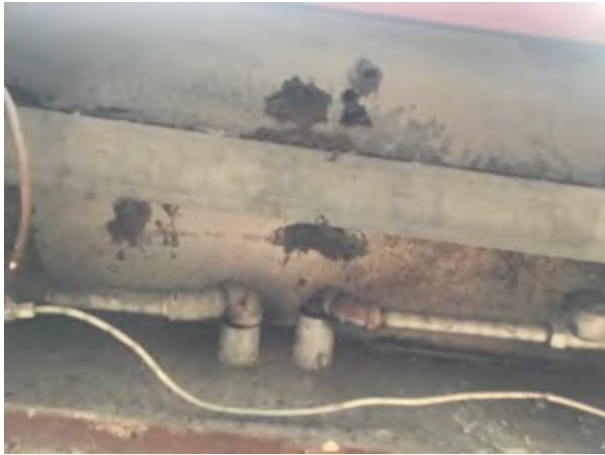
PHOTO 21: Radiator Shield Board

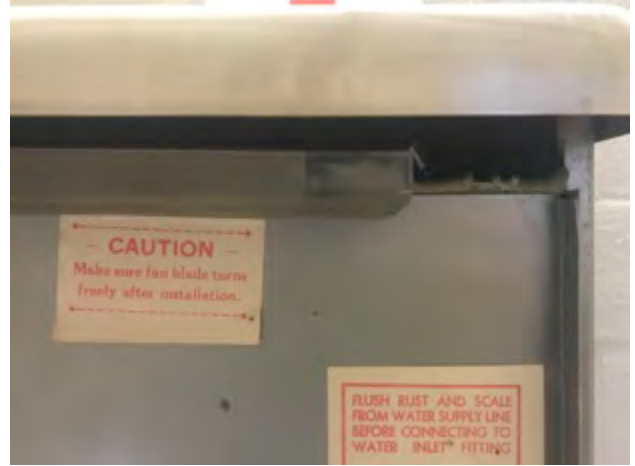
PHOTO 22: Drinking Fountain Putty

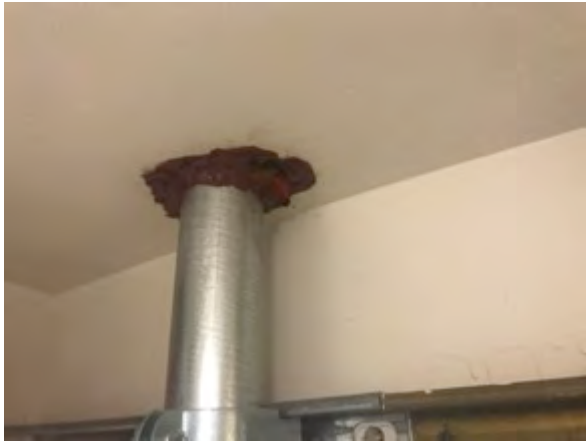
PHOTO 23: Dark Red Fire Putty

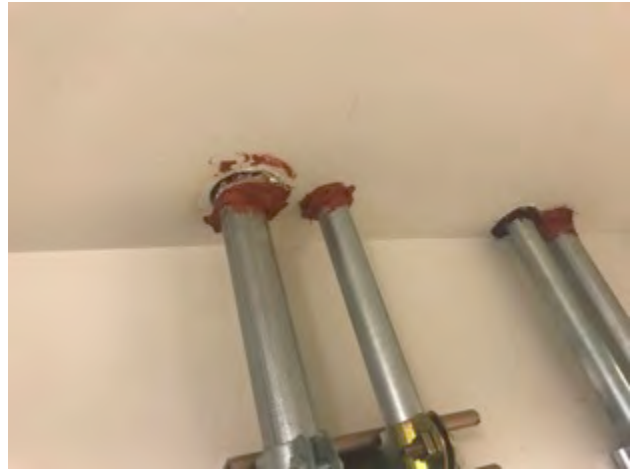
PHOTO 24: Light Red Fire Putty

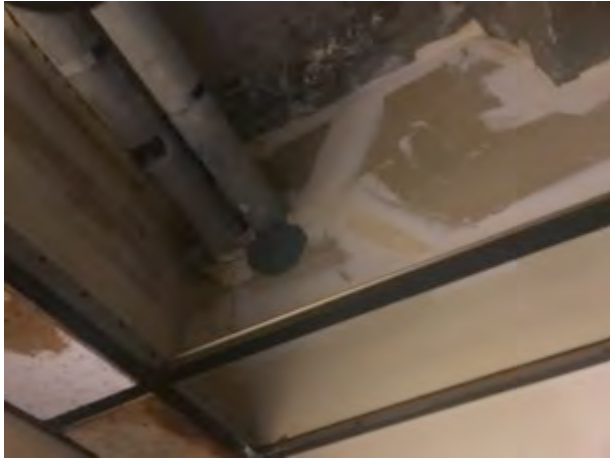
PHOTO 25: Green Fire Putty

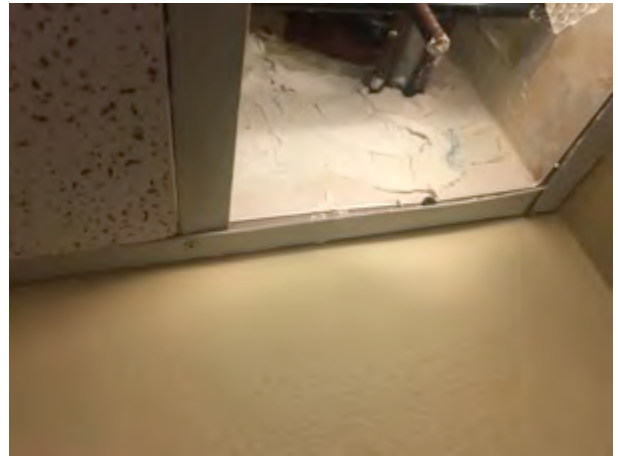
PHOTO 26: White Fire Putty

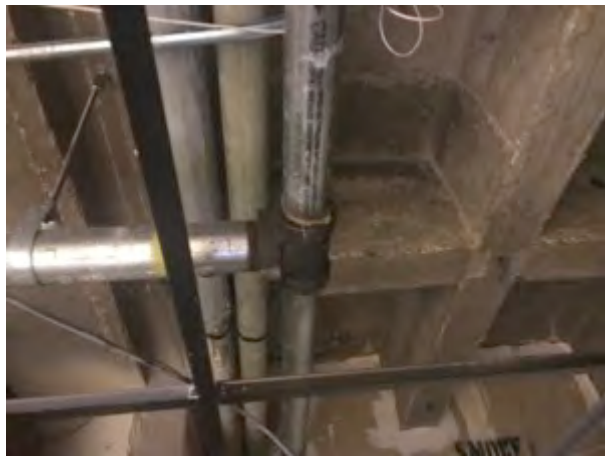
PHOTO 27: Plumber's Putty

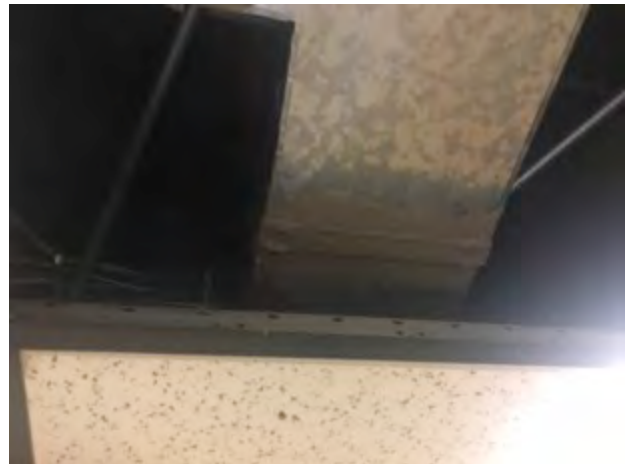
PHOTO 28: HVAC Duct Sealant #1

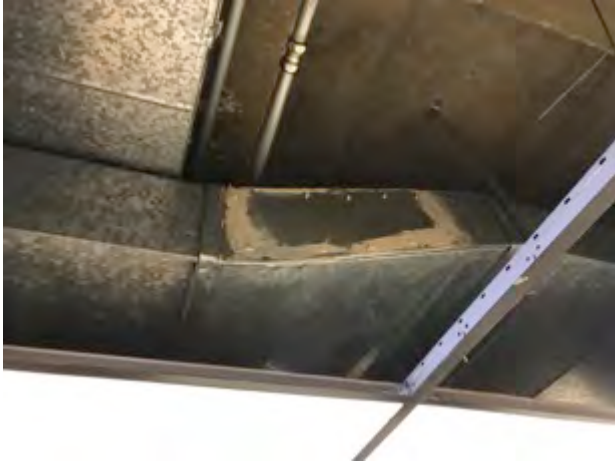
PHOTO 29: HVAC Duct Sealant #2

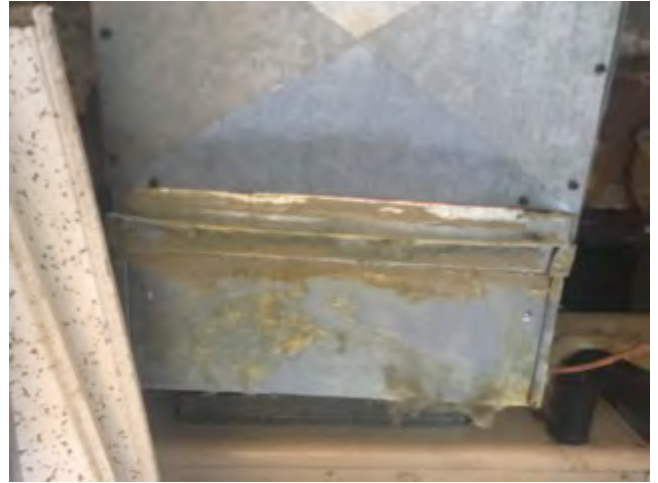
PHOTO 30: Duct Insulation Adhesive Yellow

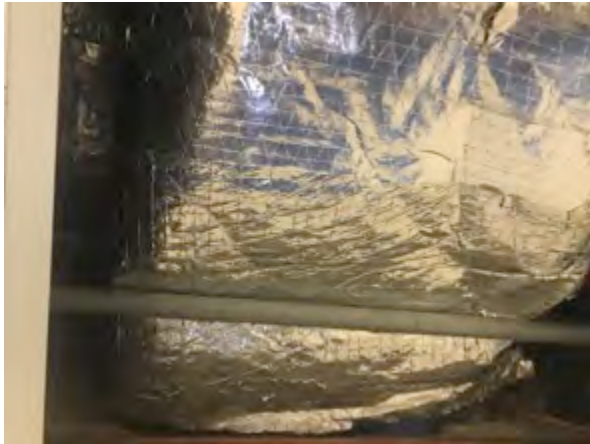
PHOTO 31: Duct Insulation

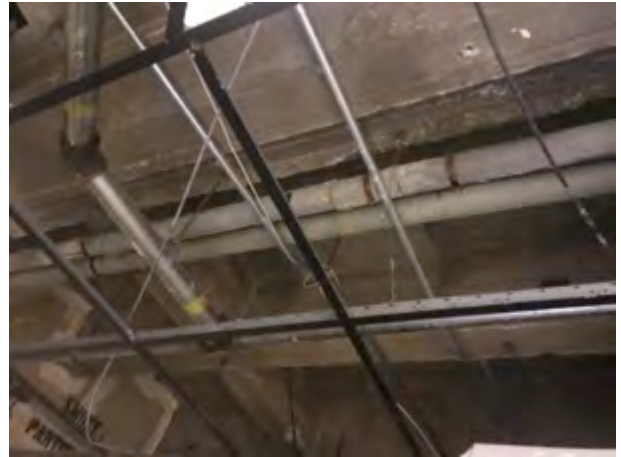
PHOTO 32:n TSI Pipe Ligging

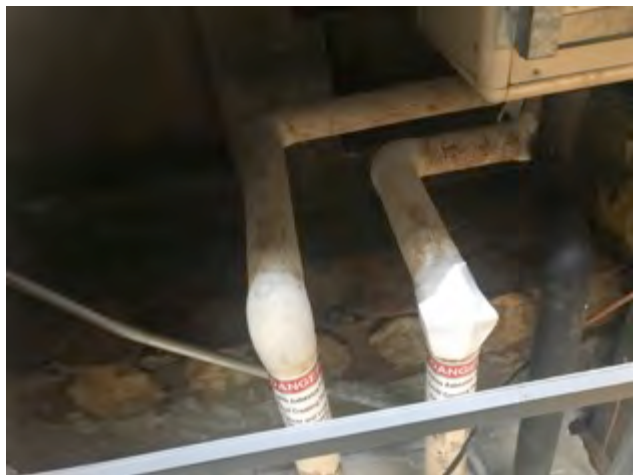
PHOTO 33: Plaster Fittings

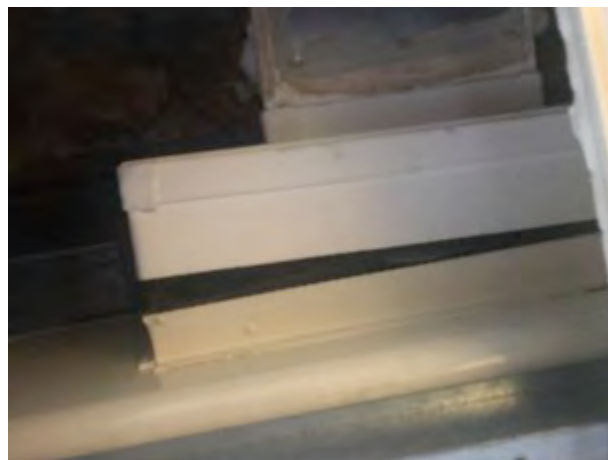
PHOTO 34: HVAC Vibrator Isolator

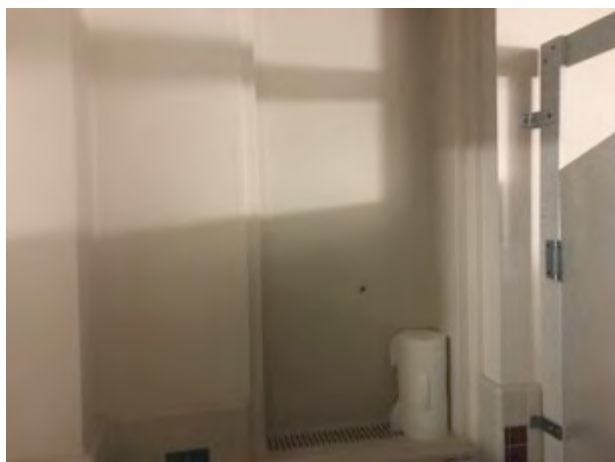
PHOTO 35: Bathroom Panel

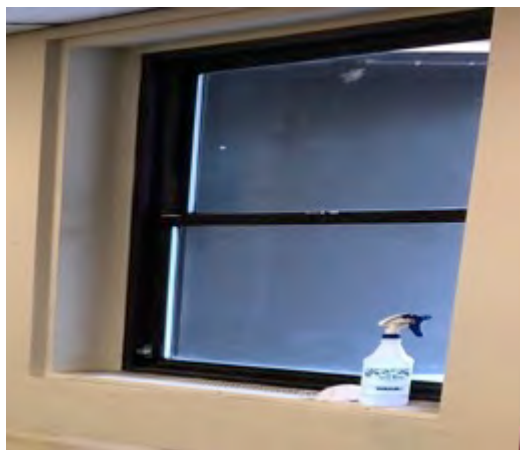
PHOTO 36: Window Caulking

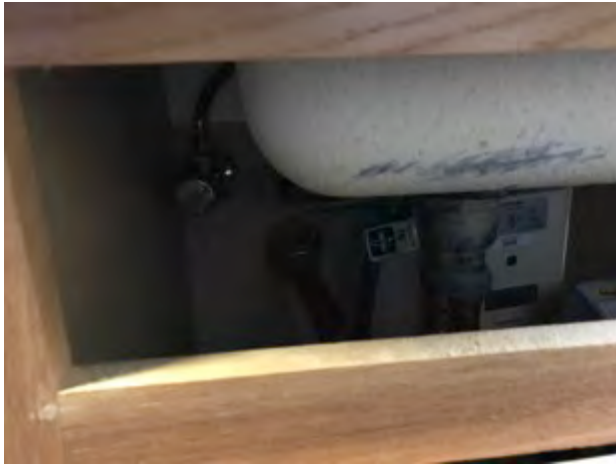
PHOTO 37: Sink Undercoating #1

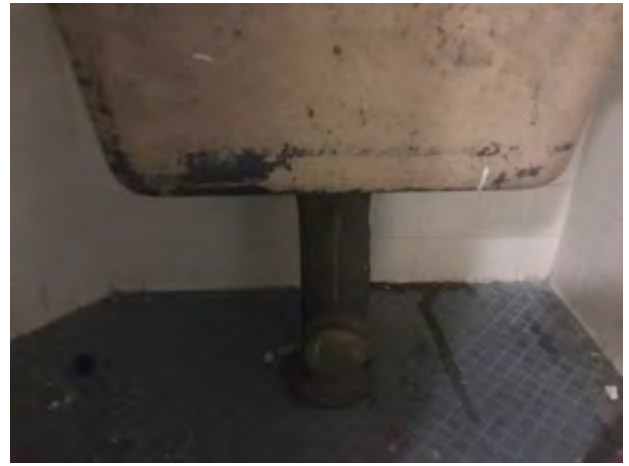
PHOTO 38: Sink Undercoating #2

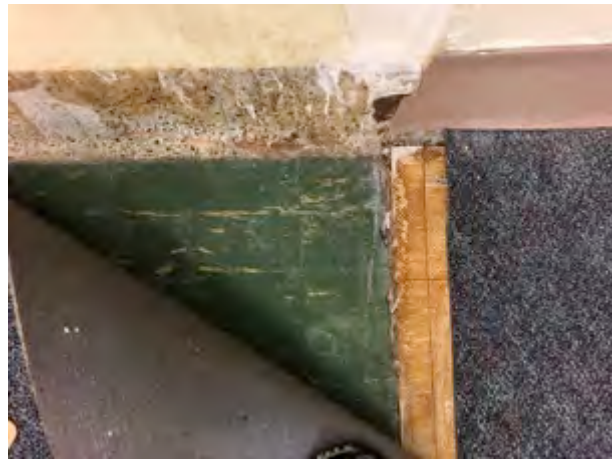
PHOTO 39: 9"X9" Green Tile

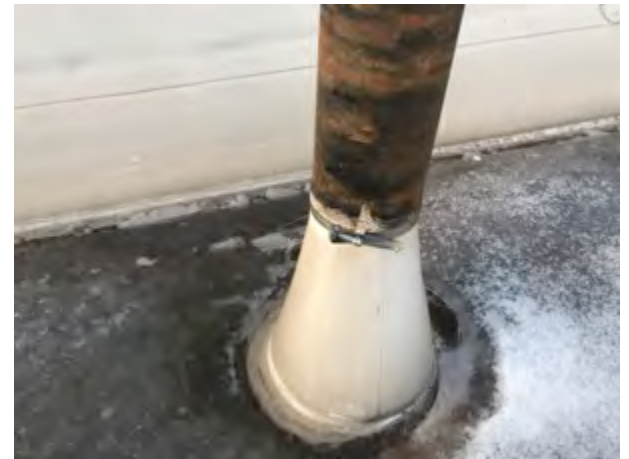
PHOTO 40: Roof Penetration Sealant

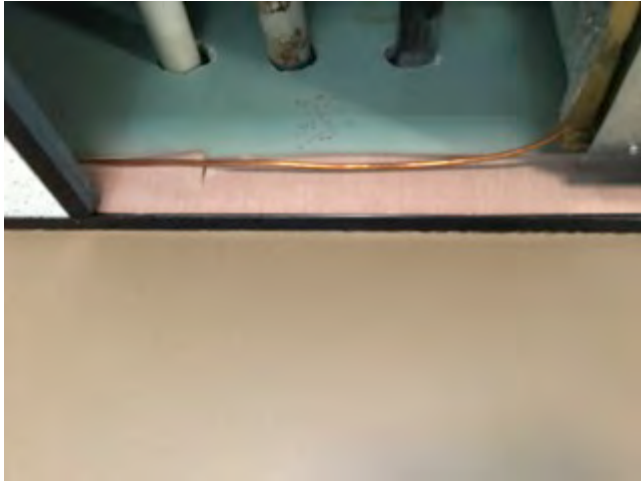
PHOTO 41: Wall Coverings

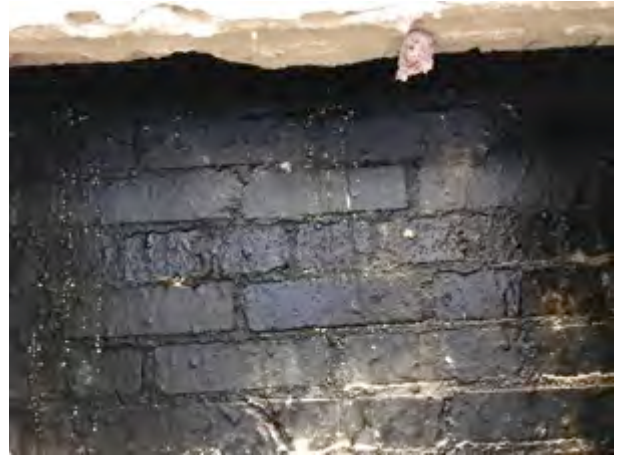
PHOTO 42: Exterior Wall Tar

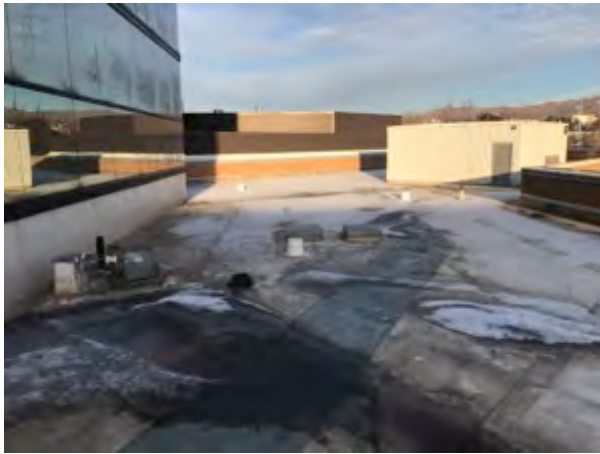
PHOTO 43: Roof

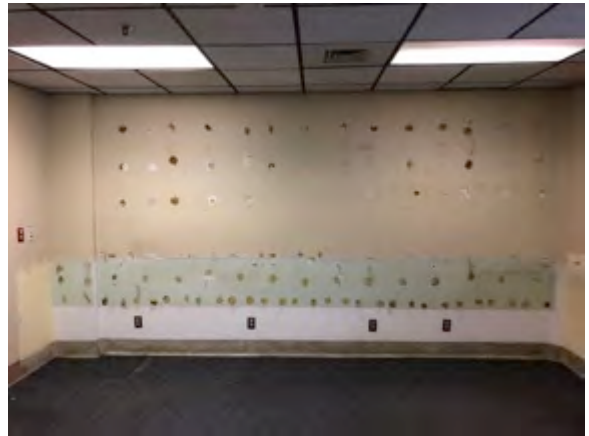
PHOTO 40: Adhesive On Wall
