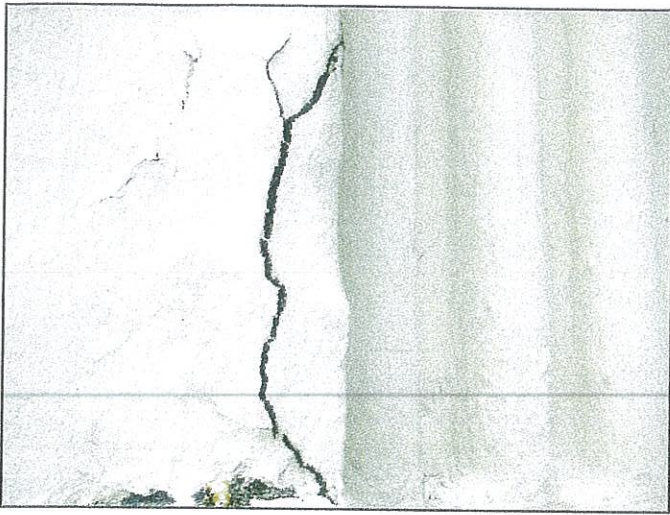
Photograph 32: Close Up View of Spalled Concrete

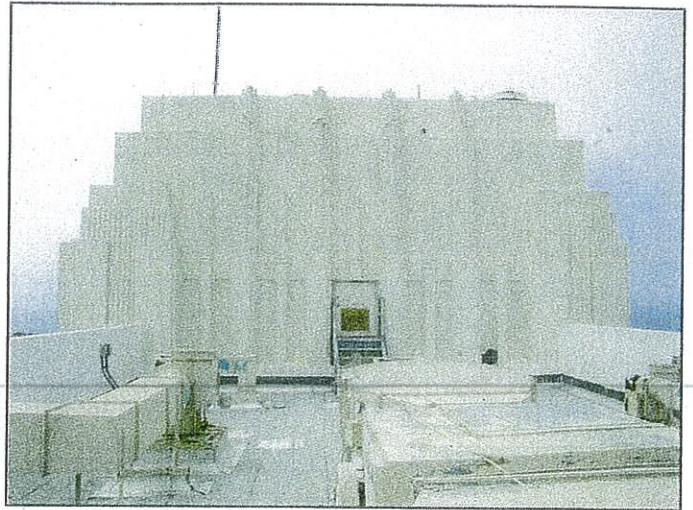
Photograph 33: Overall View of Spalled Concrete

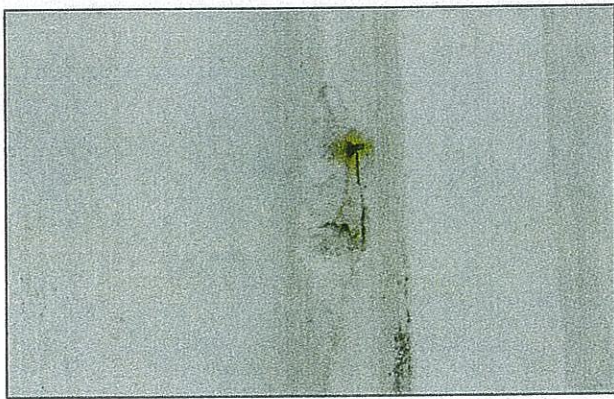
Photograph 42: Typical Concrete Spall with Corroded Reinforcing

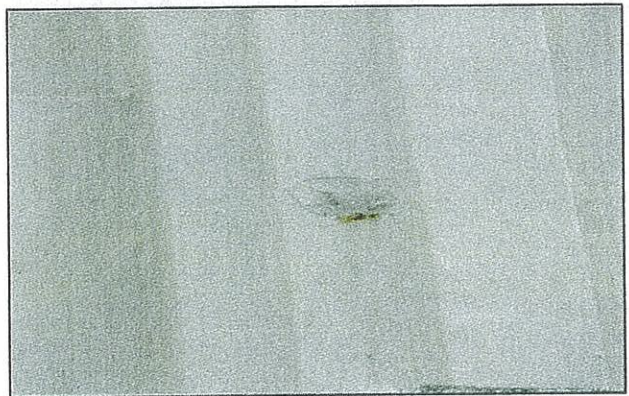
Photograph 43: Typical Concrete Spall with Corroded Reinforcing

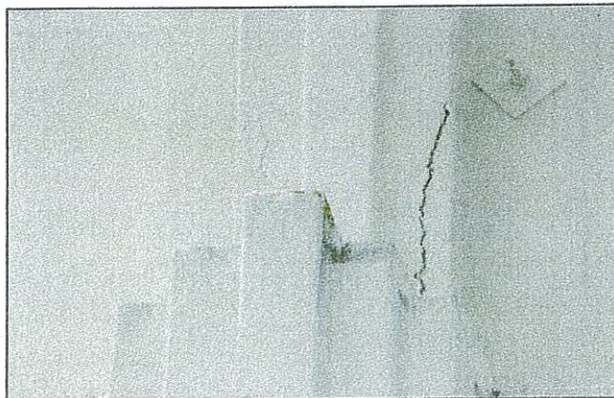
Photograph 44: Concrete Spall

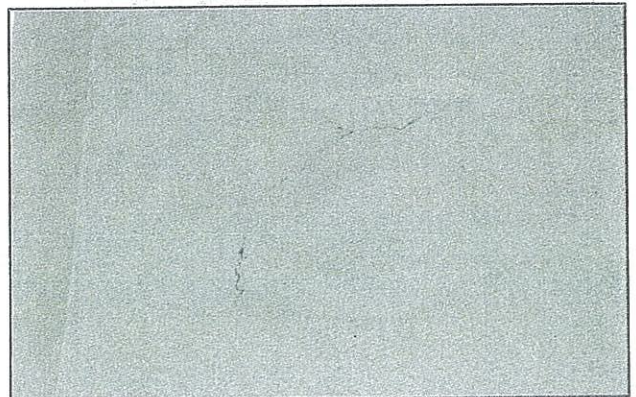
Photograph 45: Developing Concrete Spall Being Held in Place by the Exterior Coating

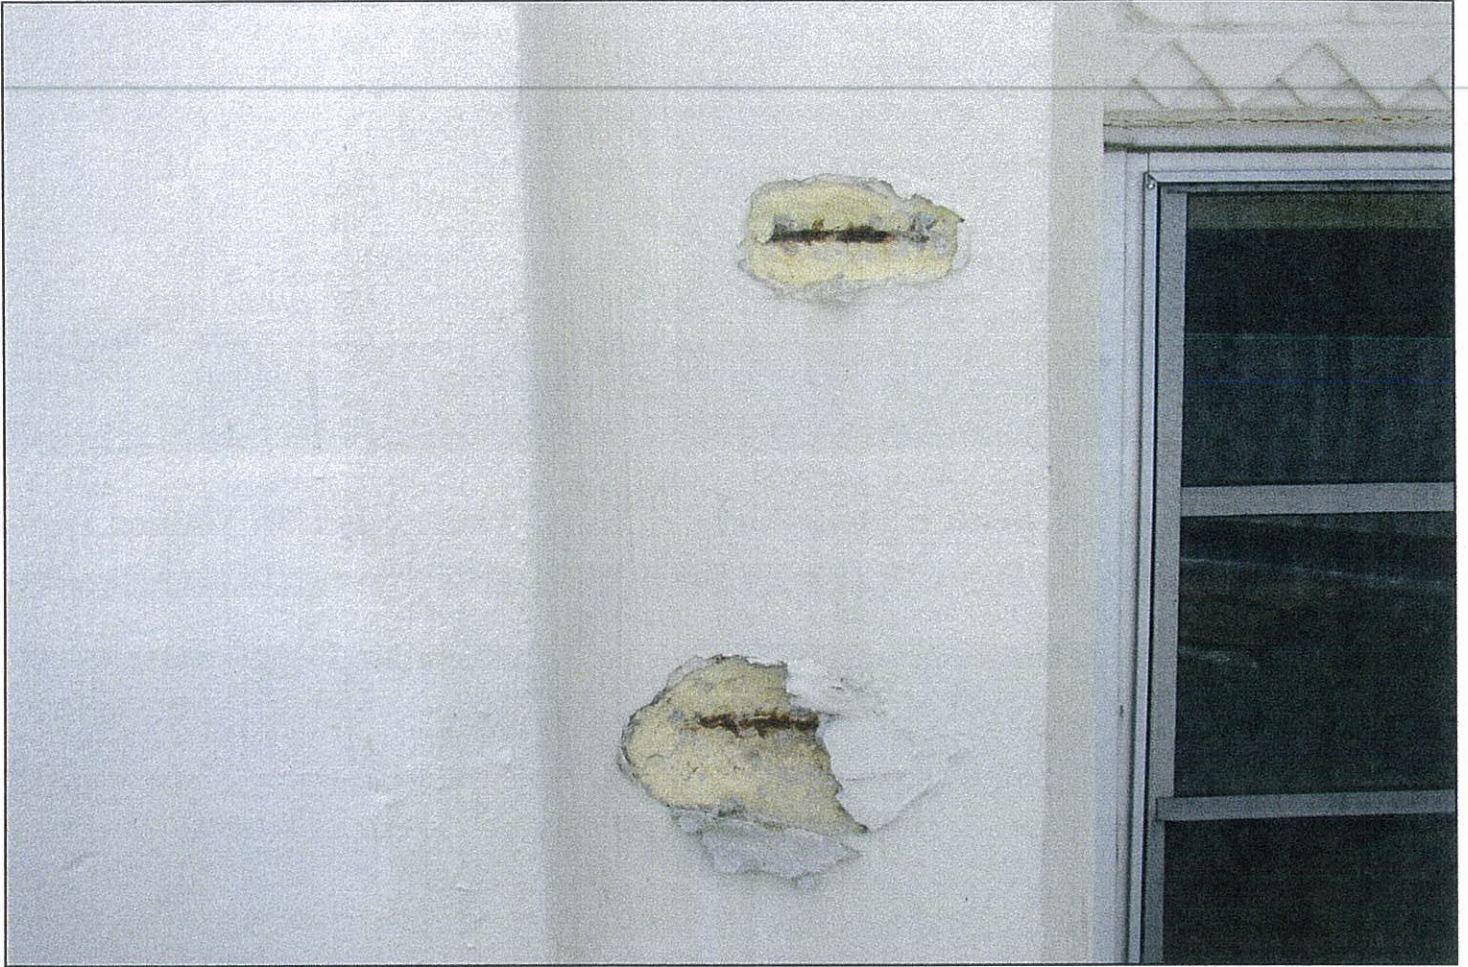
Photograph 47: Failed Spall Repairs

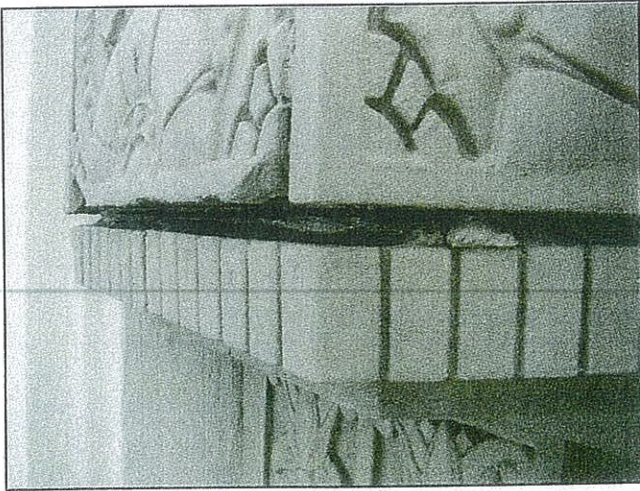
**Photograph 34: Missing and Loose
Terra Cotta Mortar Joint**

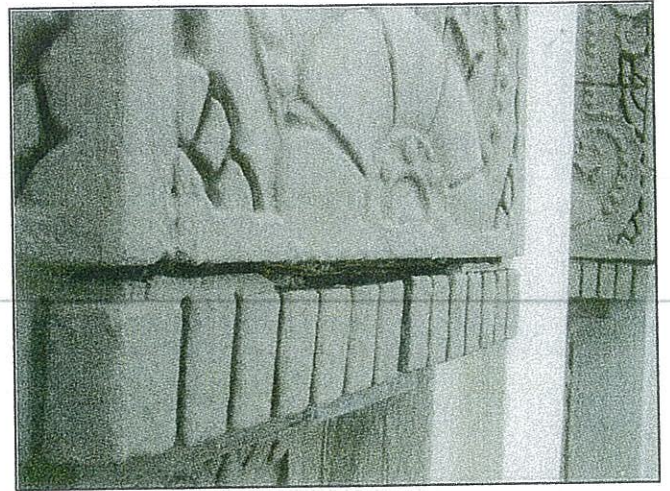
**Photograph 35: Missing and Loose
Terra Cotta Mortar Joint**

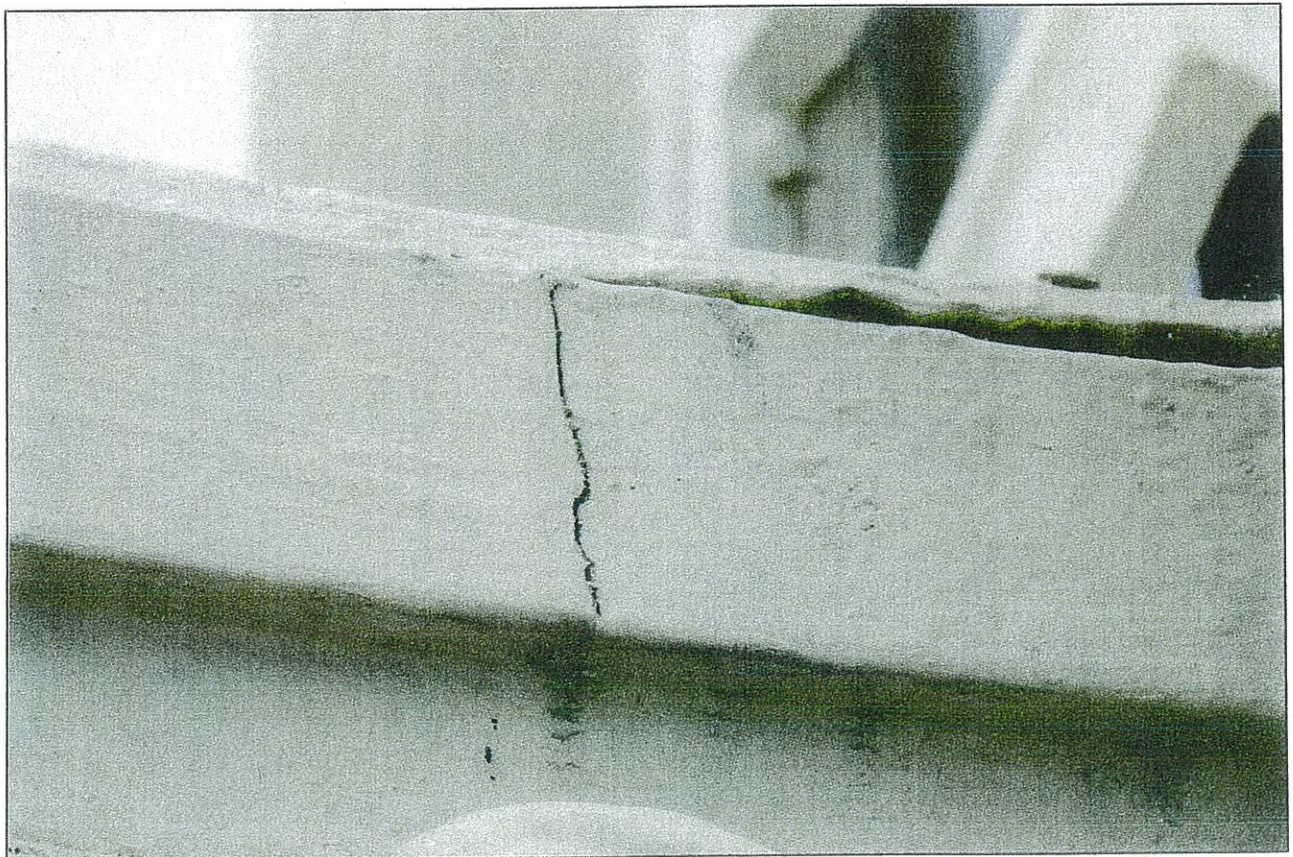
Photograph 36: Cracked Terra Cotta

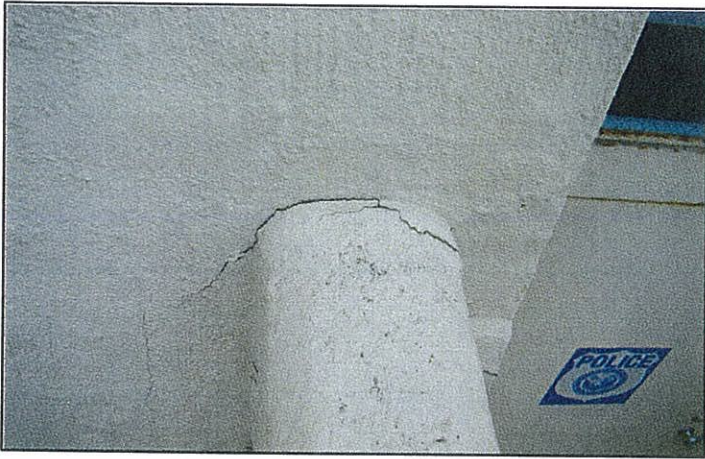
**Photograph 37: Concrete Crack
At Exterior Retaining Wall and
North Building Face**

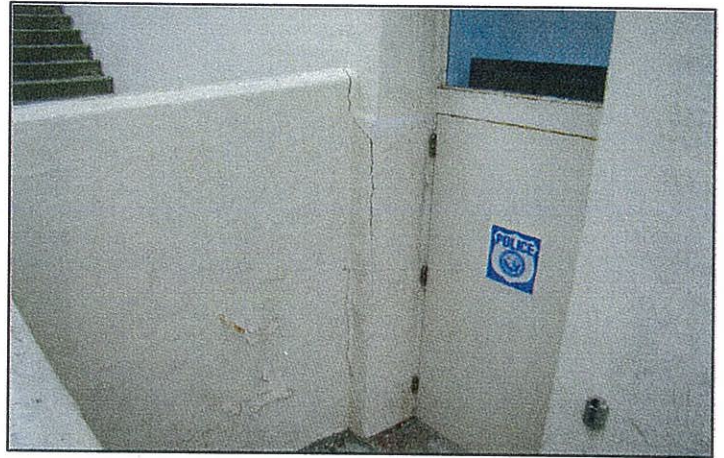
**Photograph 38: Concrete Crack
At Exterior Retaining Wall and
North Building Face**

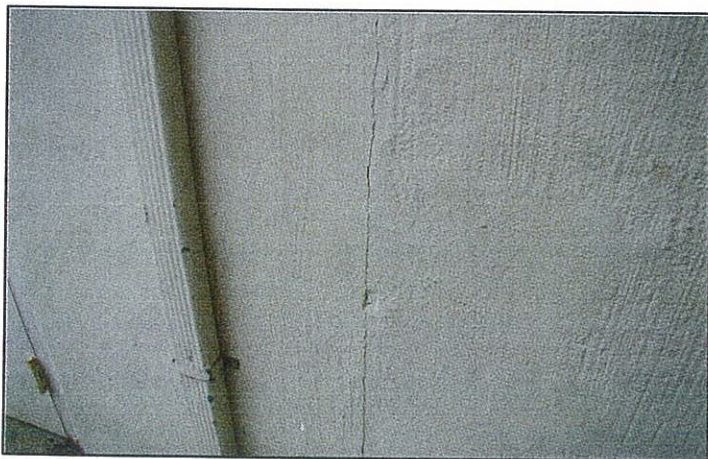
**Photograph 39: Concrete Crack
At North Face Exterior Wall**

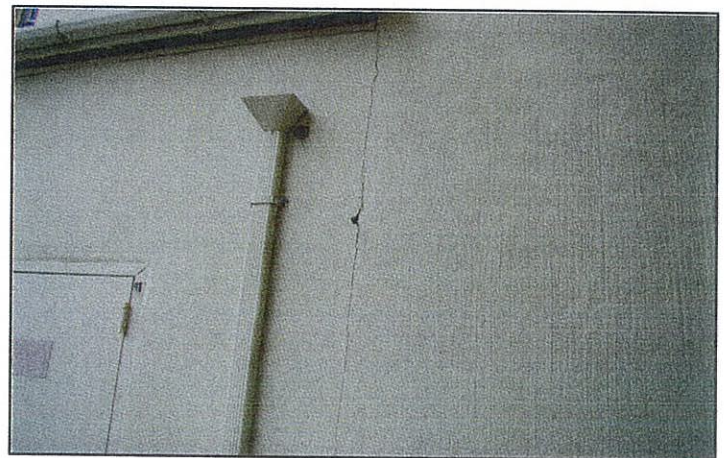
**Photograph 40: Concrete Crack
At North Face Exterior Wall**
