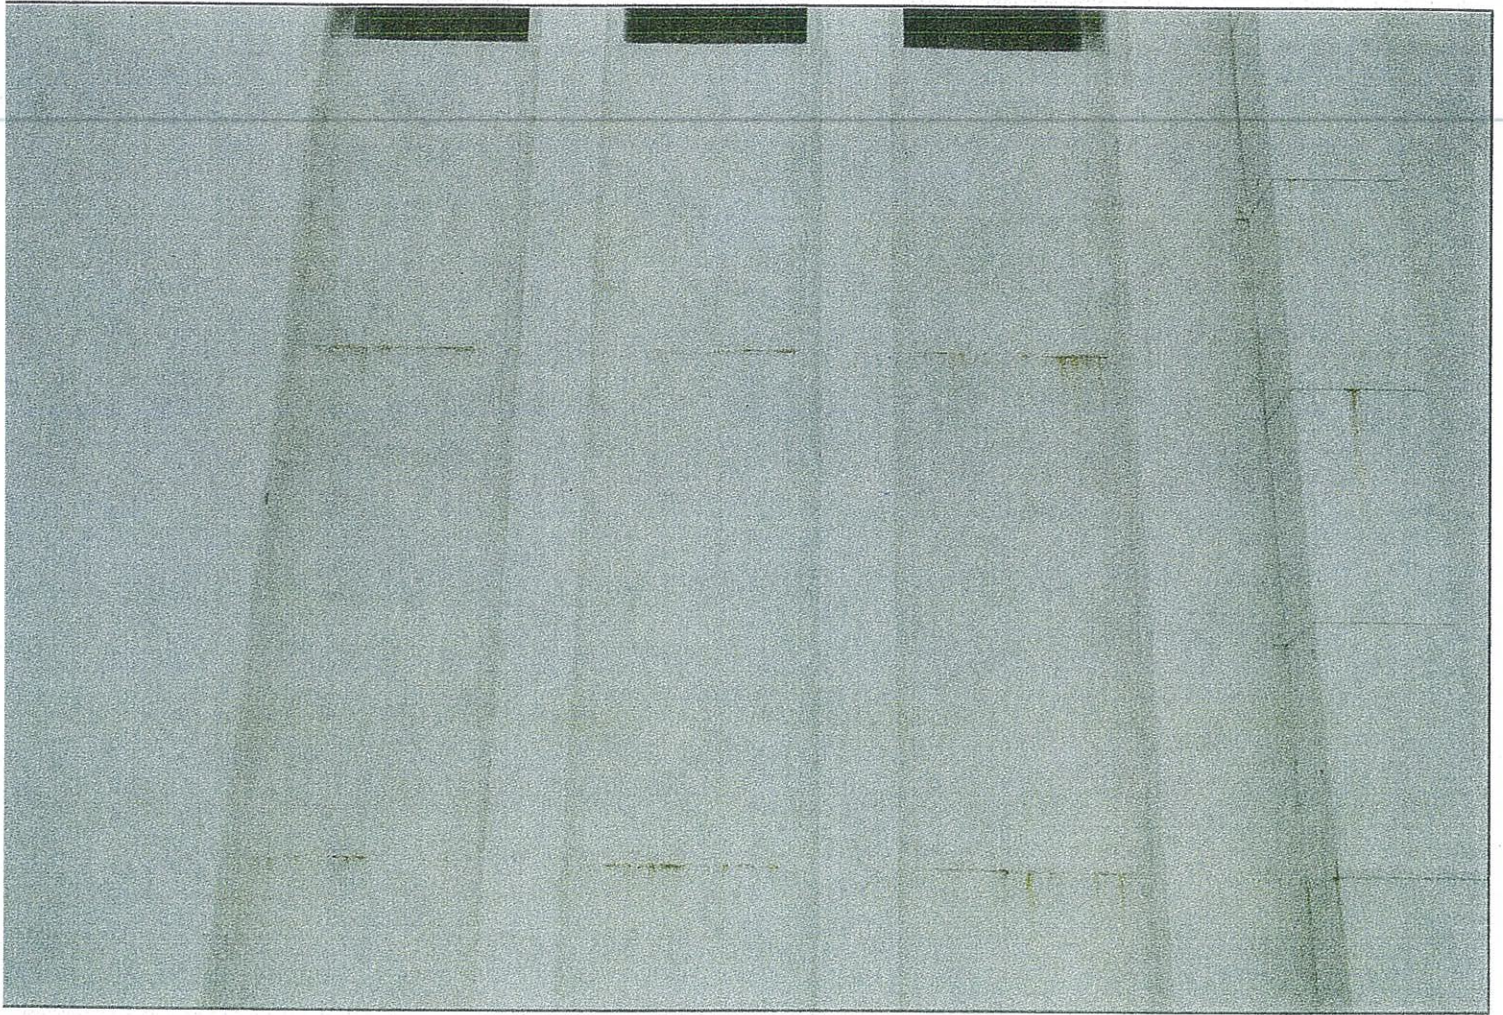
Photograph 41: Rusted Shelf Angles

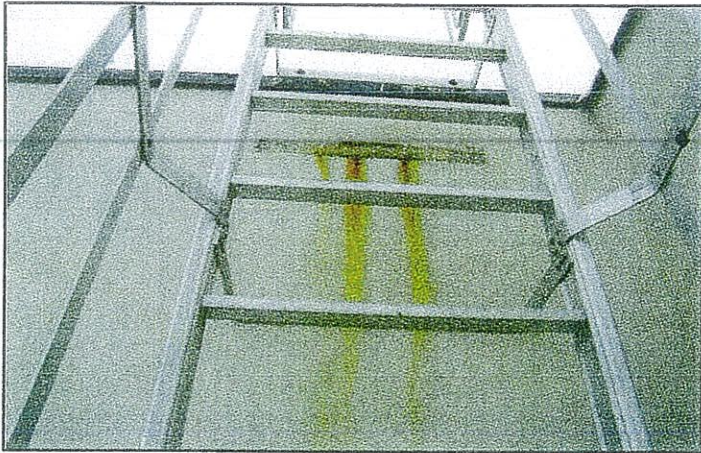
Photograph 48: Stain from Ladder

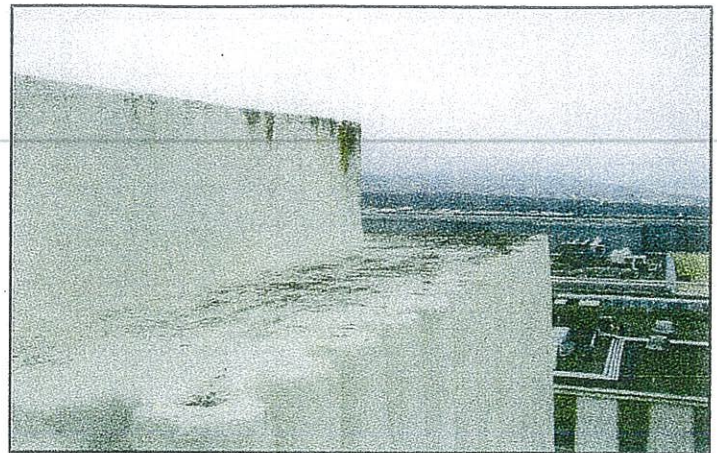
Photograph 49: Stained Parapet

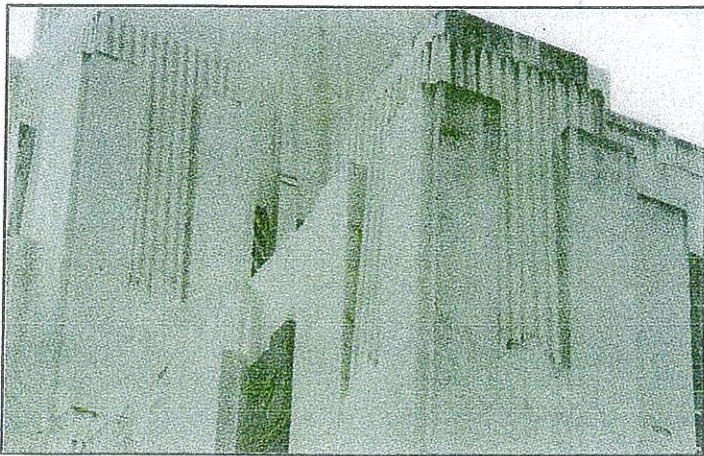
Photograph 50: Typical Façade Staining

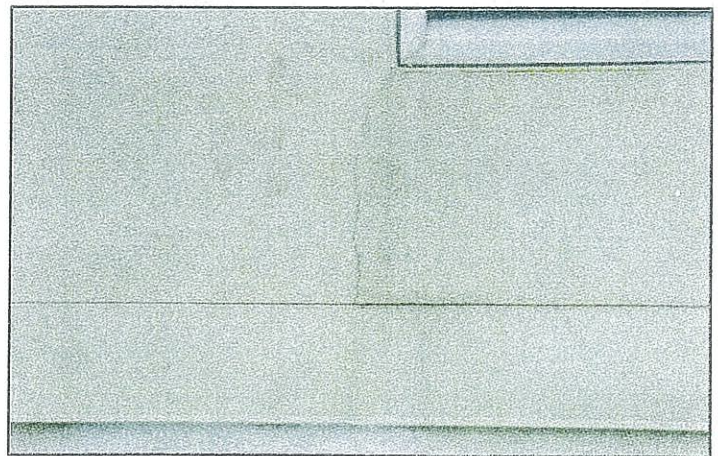
Photograph 51: Stain at Louver

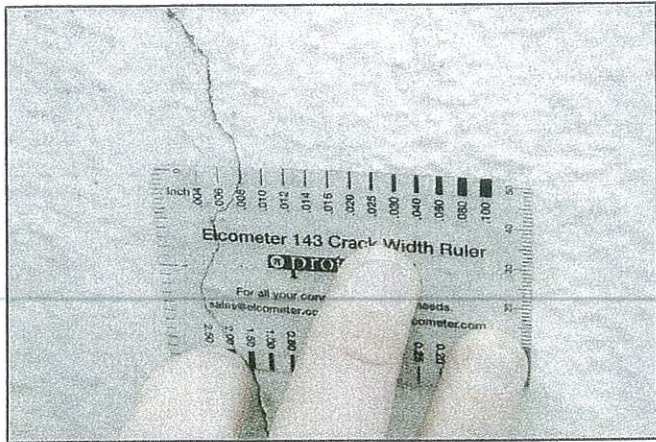
Photograph 52: Typical Plaster Crack

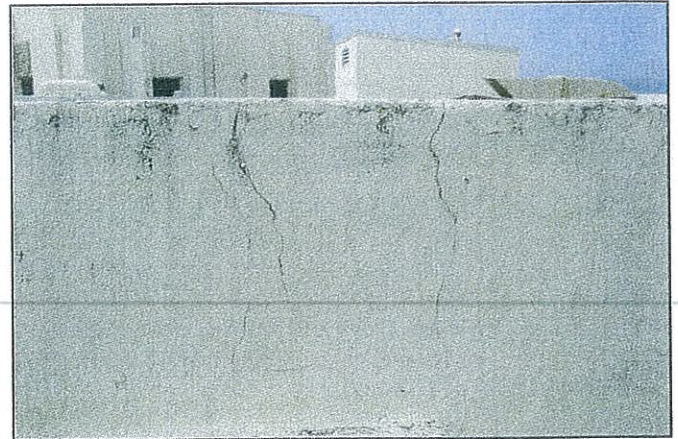
Photograph 53: Plaster Cracking at Parapet

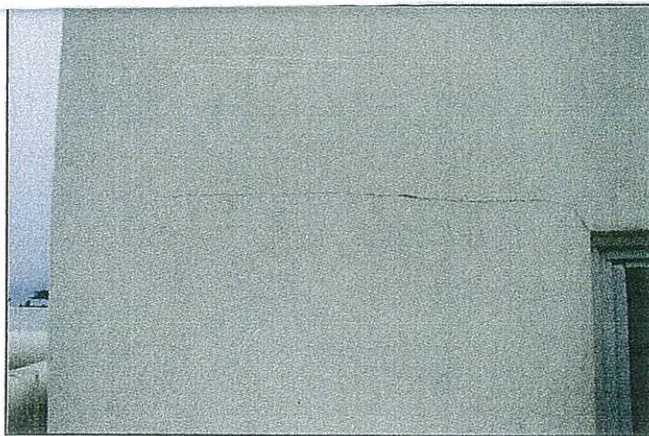
Photograph 54: Typical Stucco Crack

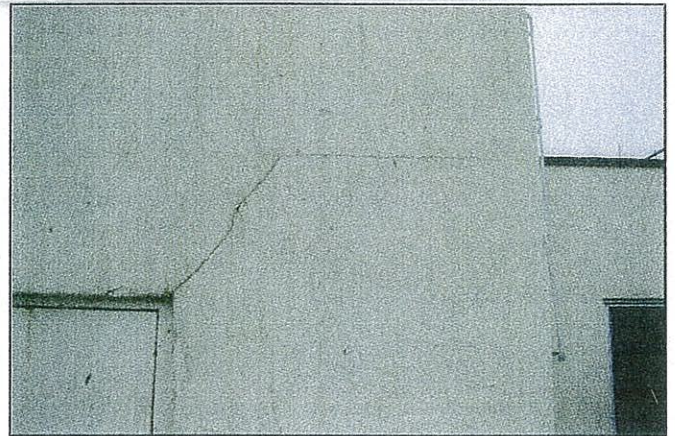
Photograph 55: Typical Stucco Crack

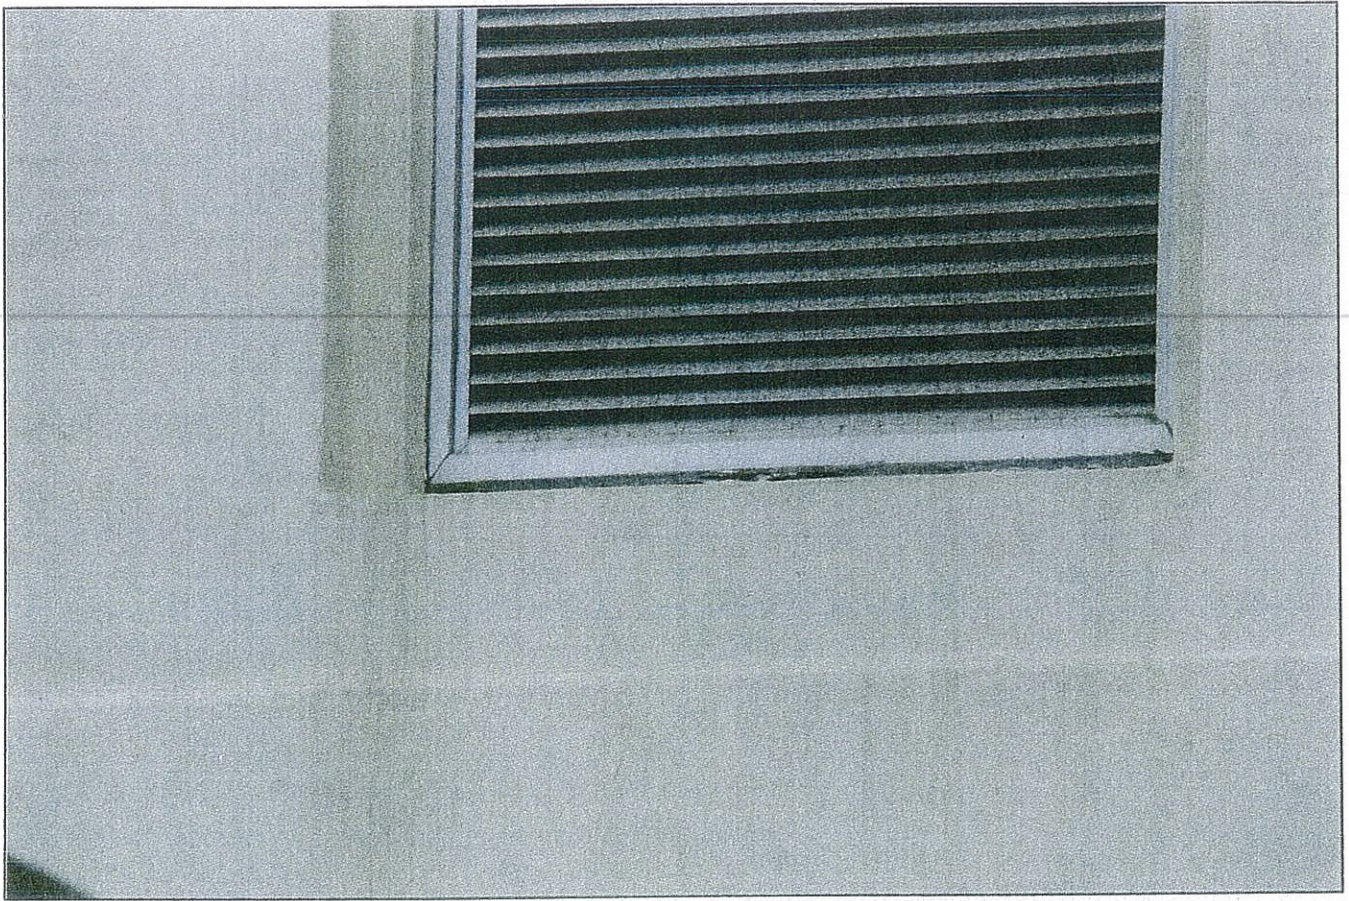
Photograph 56: Cracked Sealant at Louver

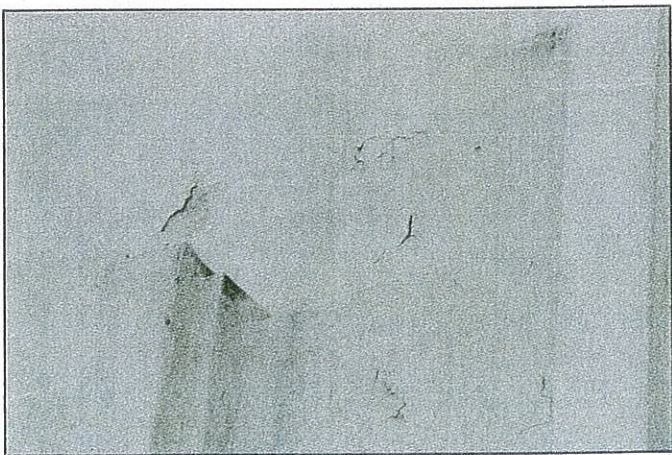
Photograph 57: Typical Peeling Coating

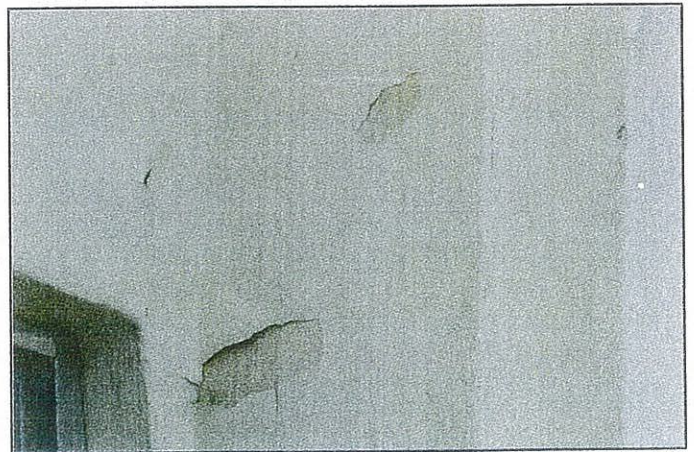
Photograph 58: Typical Peeling Coating

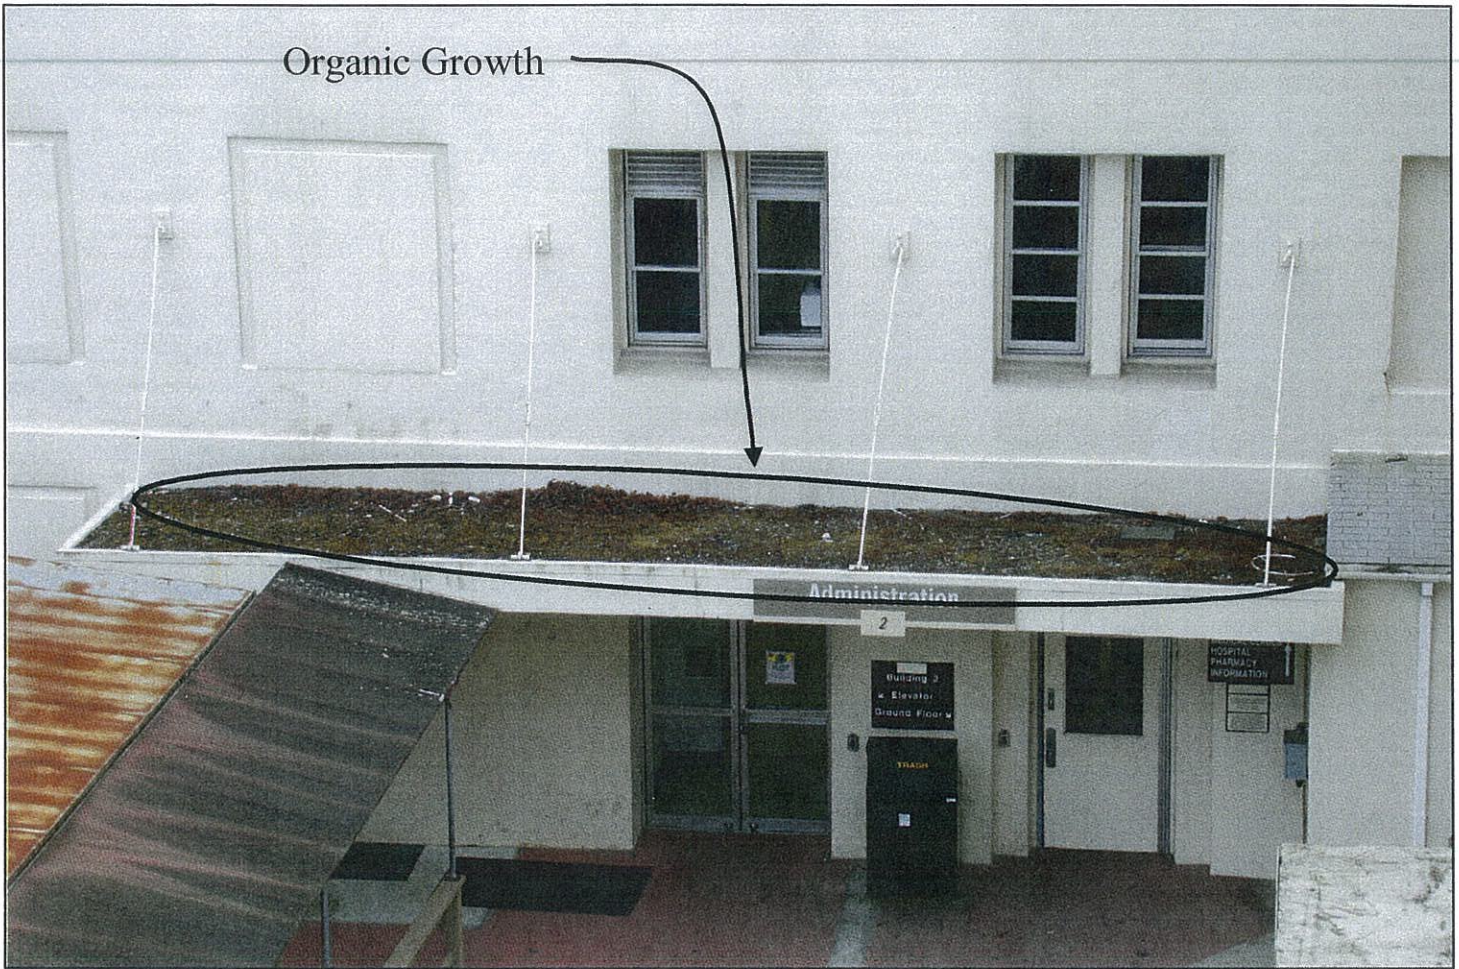
Photograph 59: Organic Growth on Canopy Roof
