Date: June 18, 2012

From: Bud Griffith
President
Construction Resources, Inc.

Re: Louis Stokes Cleveland VA Medical Center
Roof Infrared Study for Possible Green Roof Design

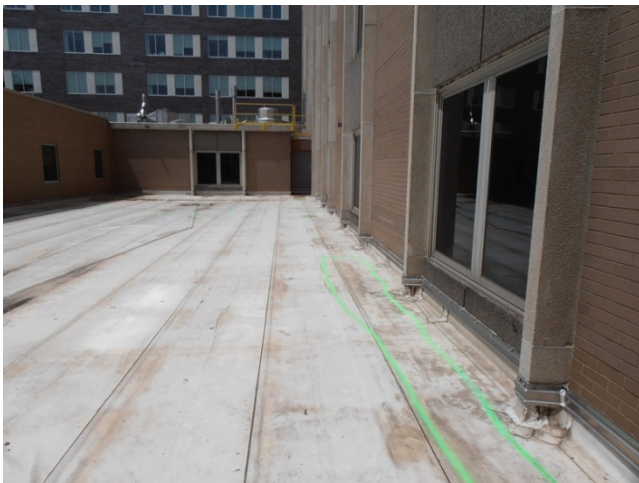
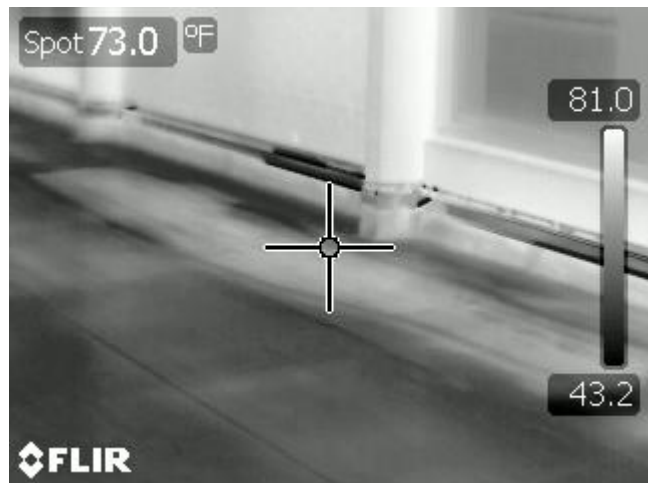
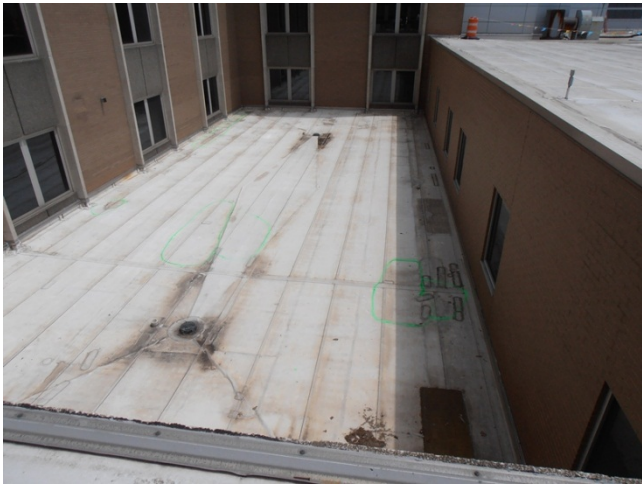
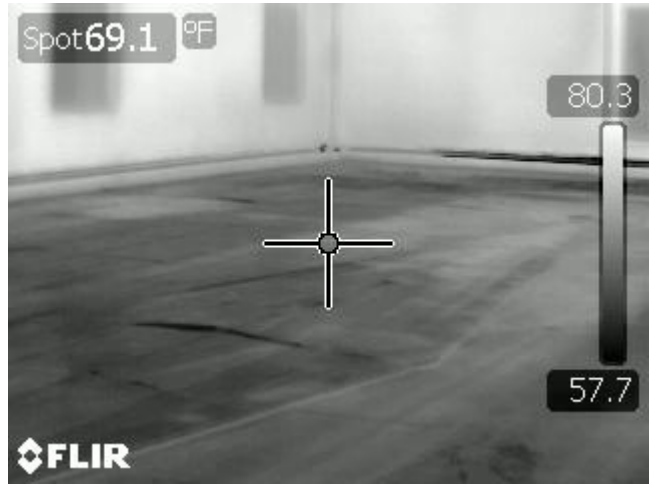
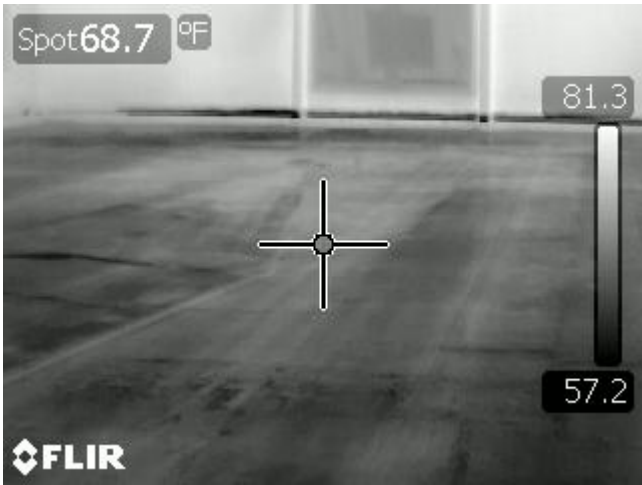
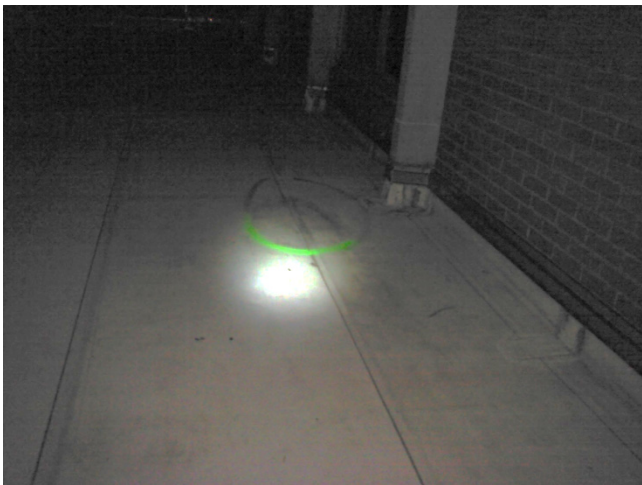
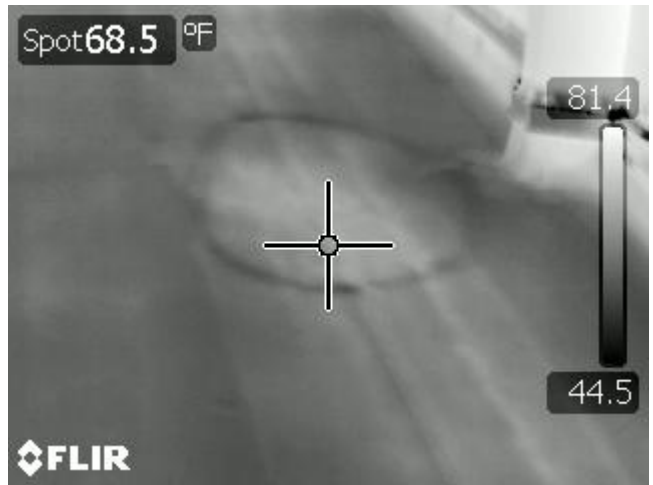
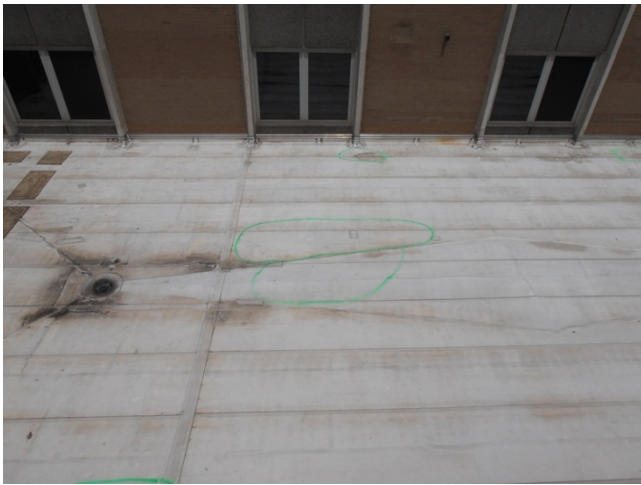
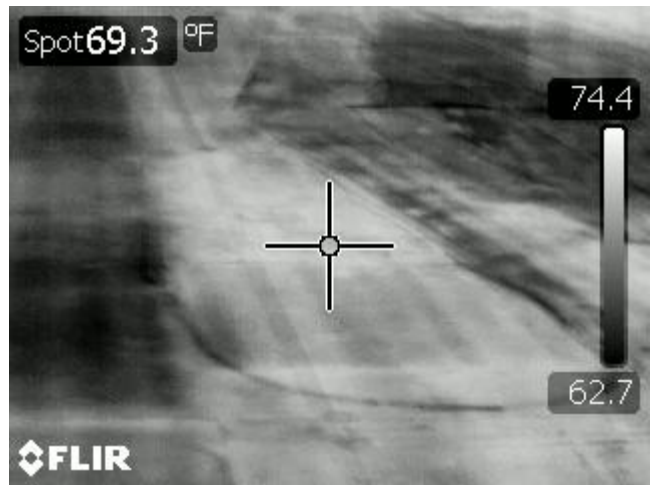
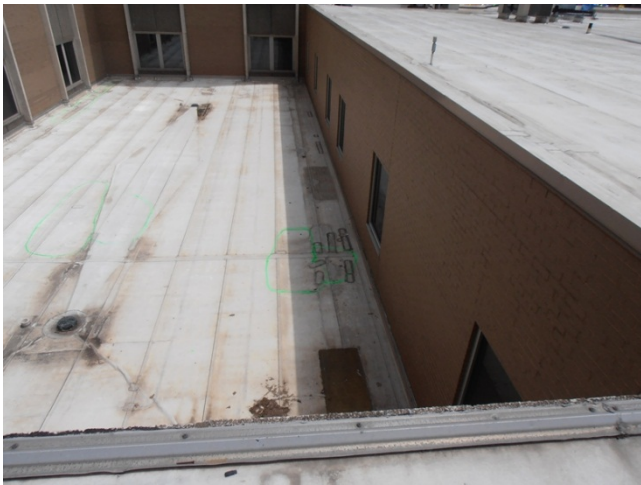
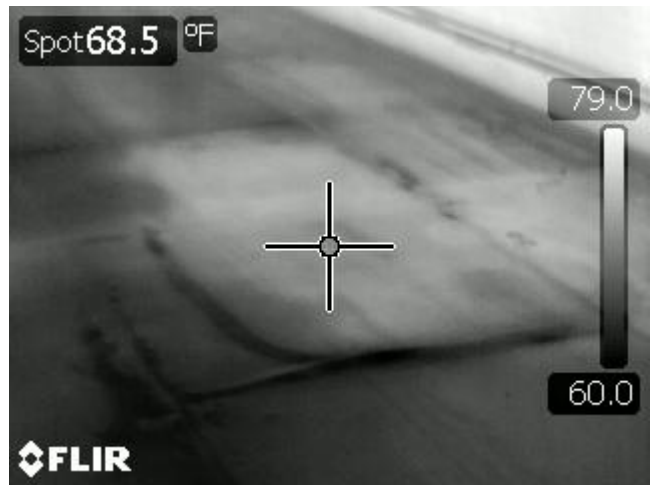
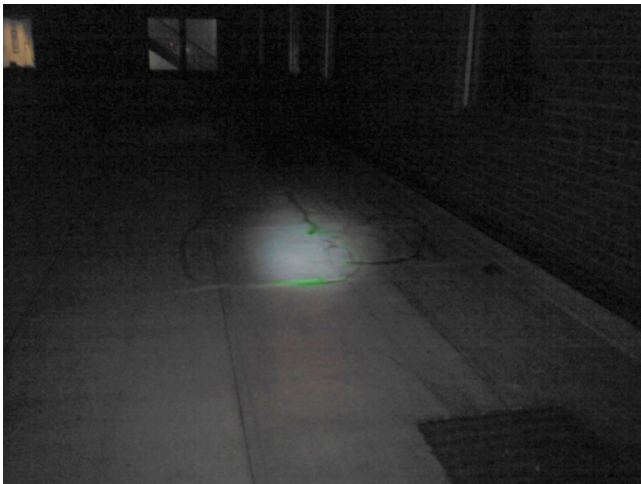
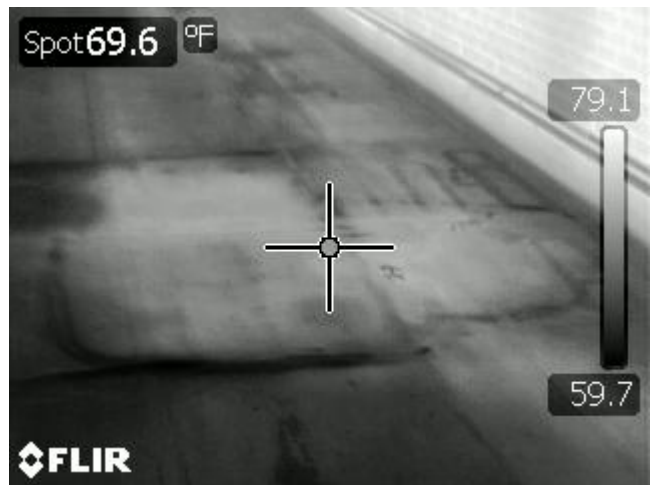
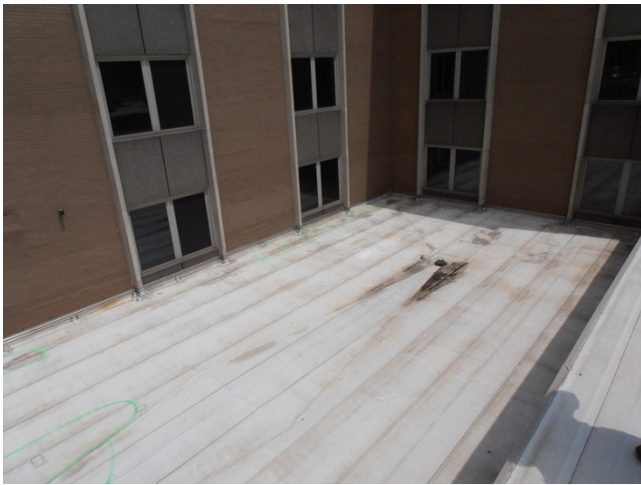
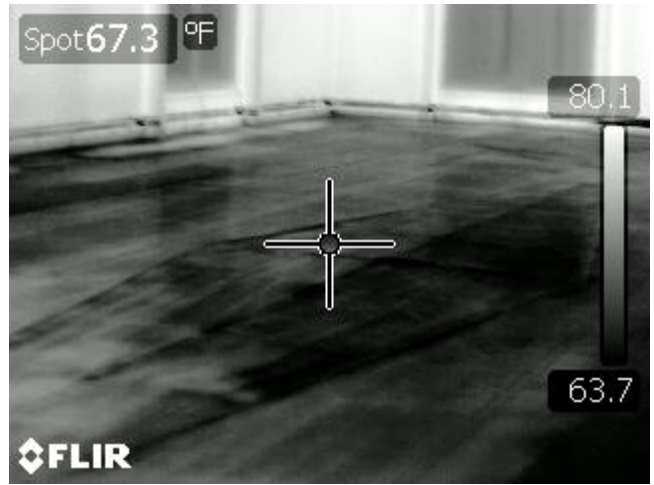
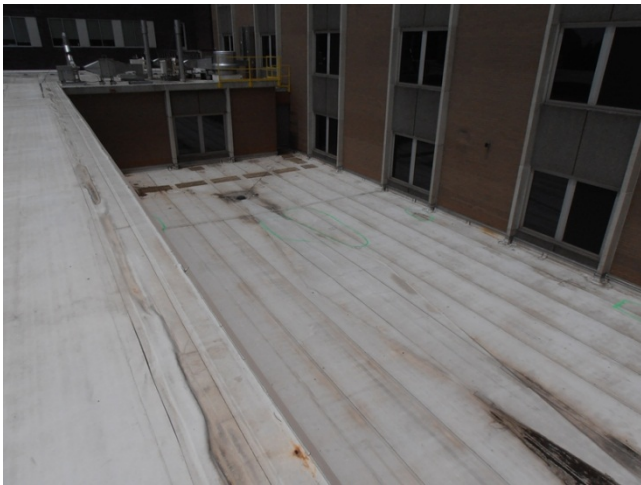
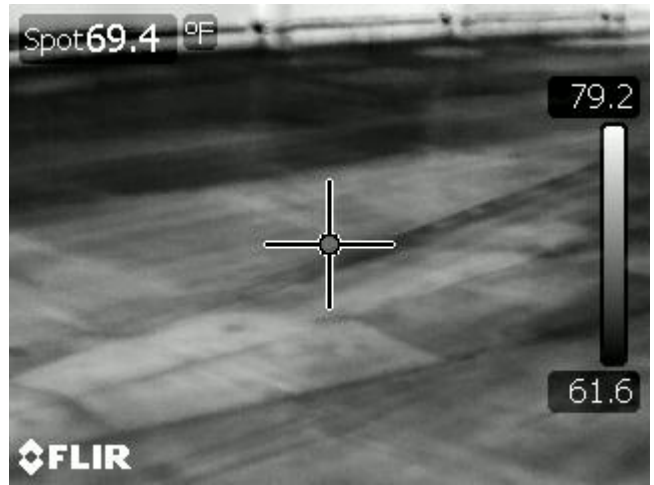
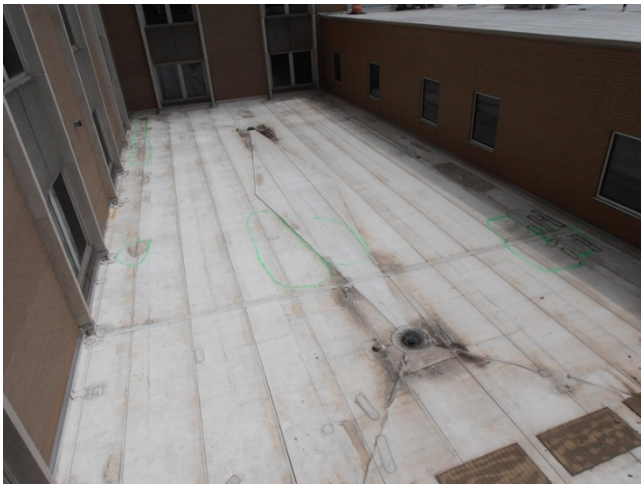
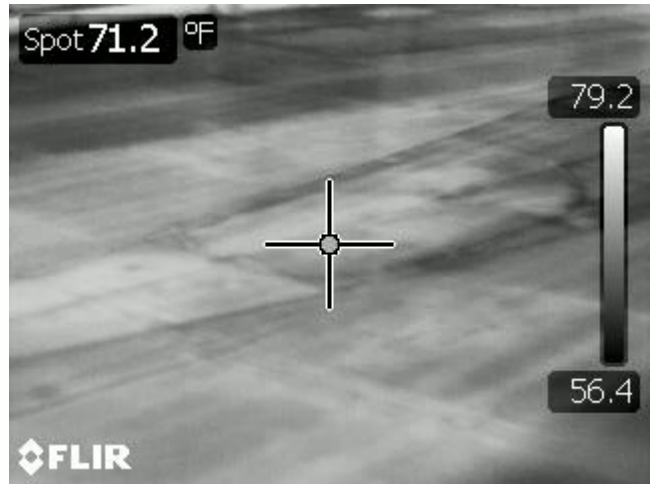
The infrared camera was utilized on this roof area. Numerous areas were located and marked on the roof with green spray paint. The following photographs denoted the areas of suspected moisture. Note that the Tramex meter supplied readings that moisture was prevalent throughout the roof. It was assumed that this was anomaly. Note that the second study confirmed this condition.

Based on the findings of the infrared study performed on June 7, 2012 it was assumed that areas of moisture were present throughout the field of Area 1 and a potential minor area of moisture may exist near the drains on Area 2. Note that the results of this investigation must be confirmed with destructive testing as large scale moisture within roof components or other sources of heat from within the building can cause false conclusions to be reached.

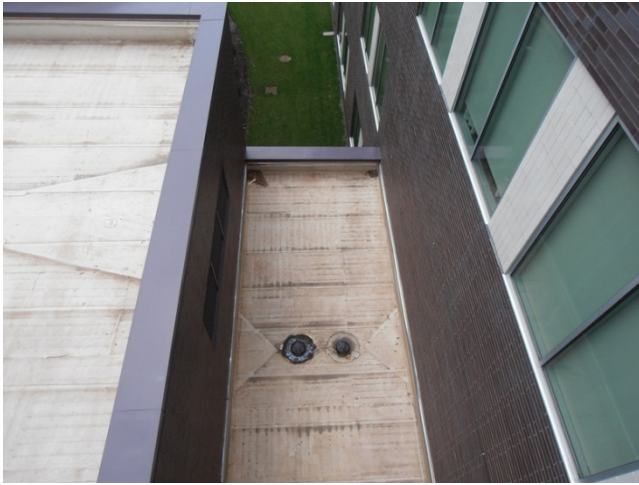
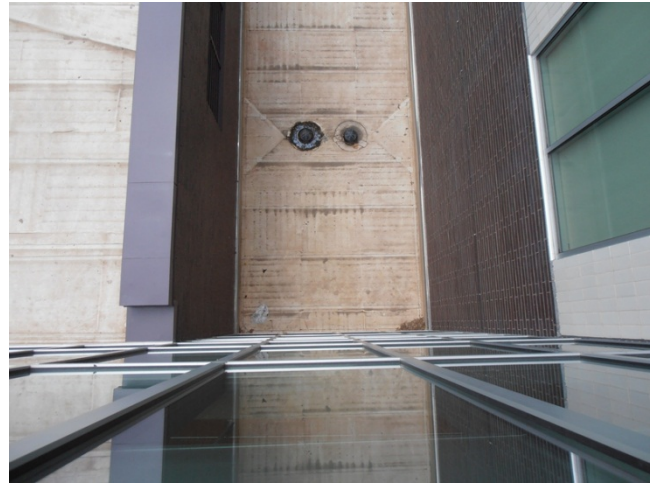
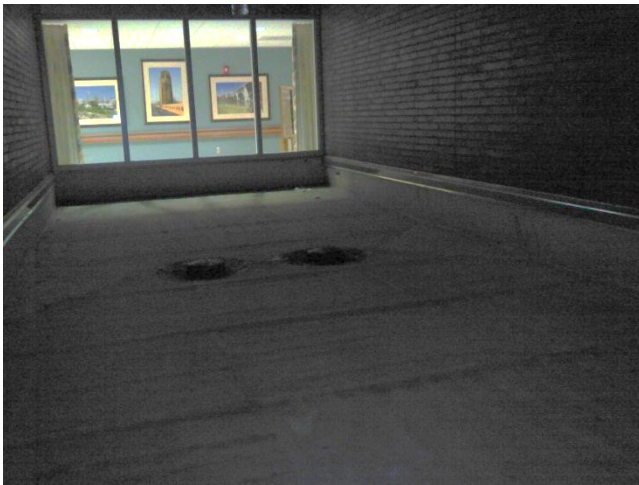
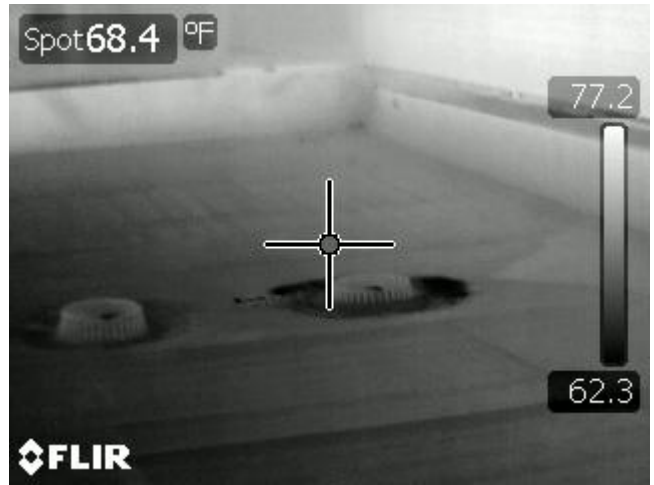
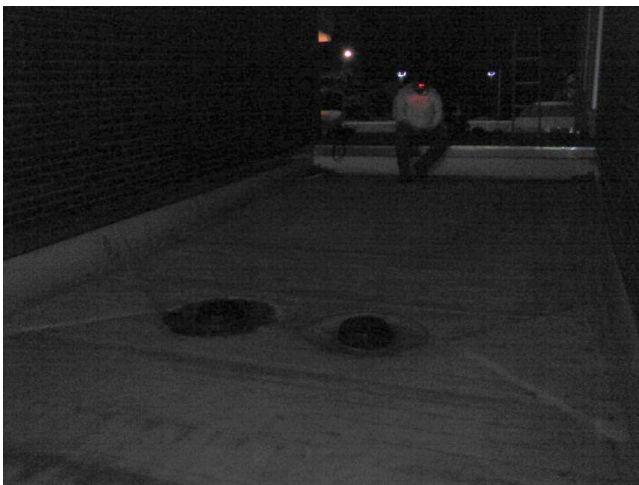
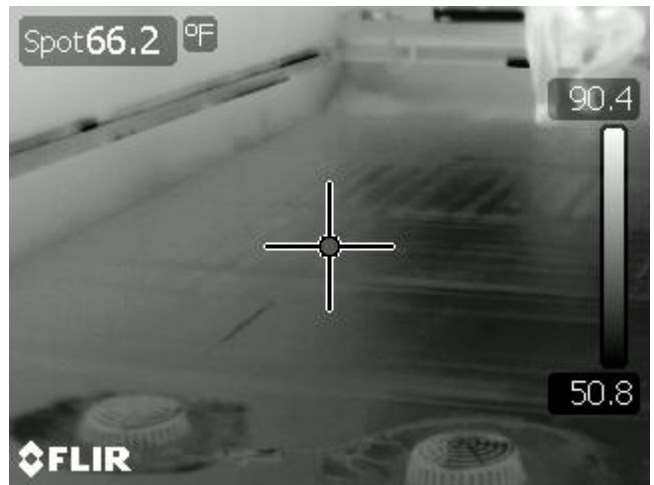
Area 2

The infrared camera showed no signs of moisture within the roof system during the site visit. The Tramex did register a small area of moisture to the southwest of the western drain.
