Building 2 Deficiencies

VA Project No. 600-12-163

VA Long Beach Healthcare System
Long Beach Medical Center, Long Beach, CA

CONSTRUCTION DOCUMENTS (100%) SUBMITTAL NARRATIVE

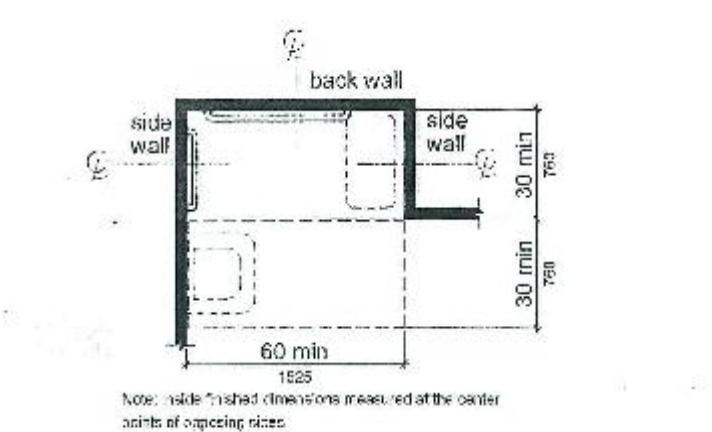
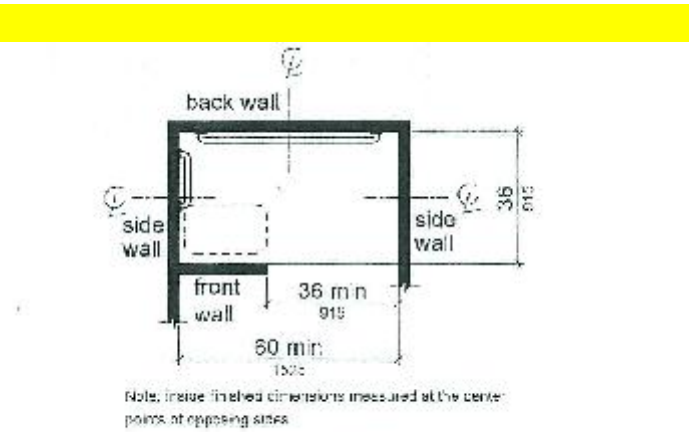
1. Typical Accessible Shower Stall Options

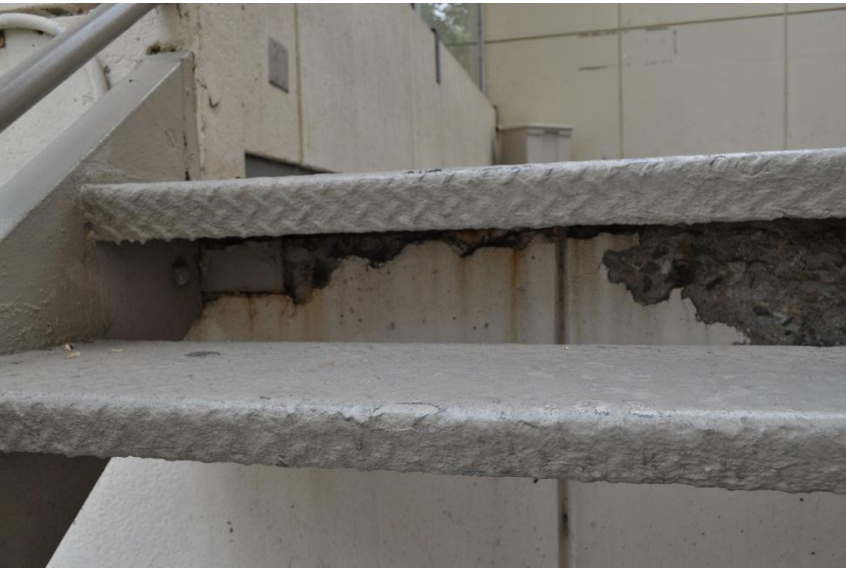
2. Spalling at Exterior Stair

- 3.2.10 FCA #157089: Numerous spalled areas along the West façade and at the other building faces across the façade perimeter are identified for repair. Embedded handrails that are corroded and / or severed will be replaced with a galvanized option designed to meet current VA requirements. As noted previously, the use of galvanized metal will prevent spalling in those areas from reoccurring. (existing condition ref. photos 2, 3 & 9).

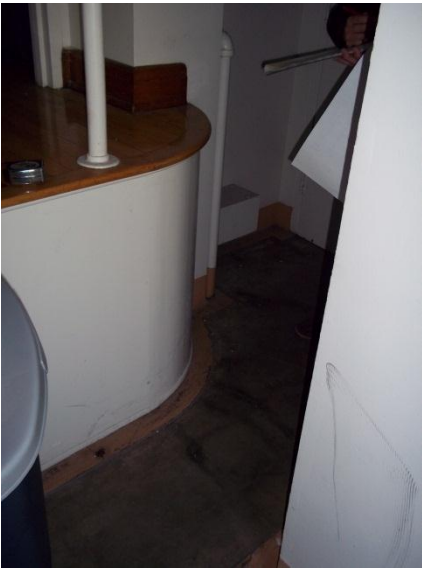
3. Limited Clearance Restroom Behind Stage

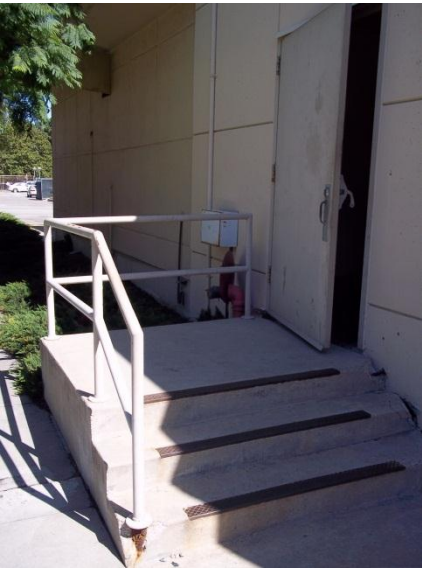
3. Corroded Hand-rail

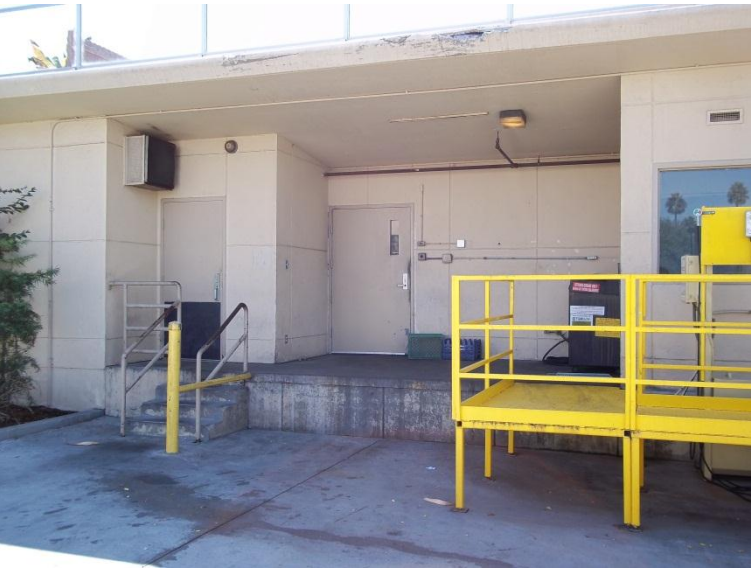
4. Non-Compliant Handrail

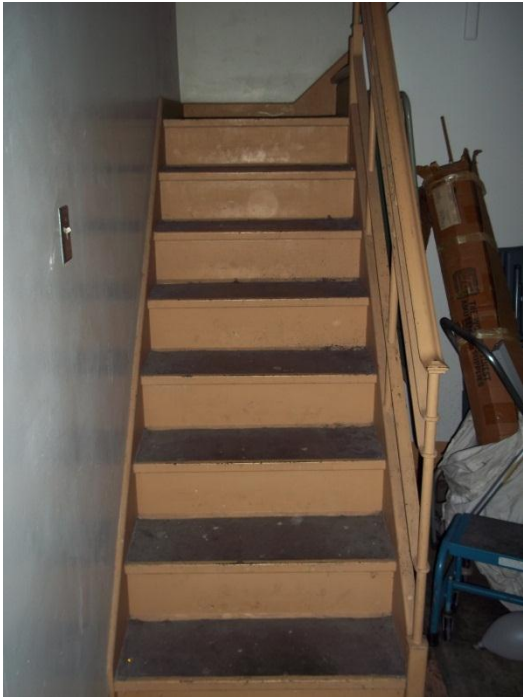
5. Non-compliant Mezzanine Stair

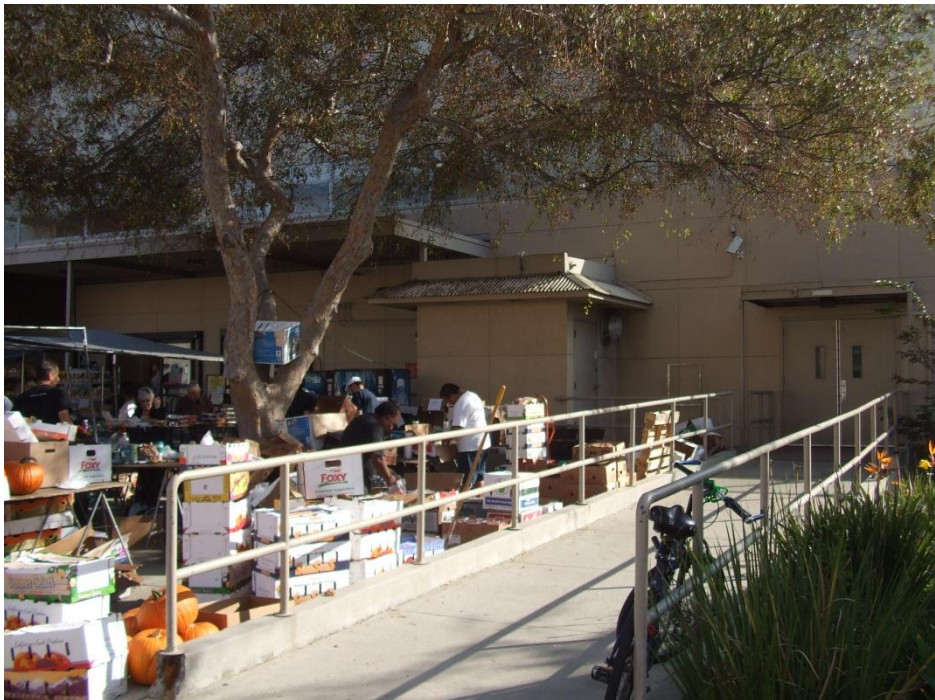
6. Non-compliant Handrail at Ramp near main entrance

The basement mechanical and electrical rooms are accessible from grade via the loading dock located in the northeast corner of the central loading courtyard. The main public entry is accessed from a concrete ramp. Although the ramp appears to meet the VA standards, the handrails are not code compliant and are scheduled to be re-placed. Handrail replacement will result in the replacement of three sets of cast-in-place concrete stairs (loading areas and main entrance) and the two cast-in-place concrete ramps at the main entrance. These stairs and ramps will be replaced and upgraded to meet ADA / VA accessibility requirements.

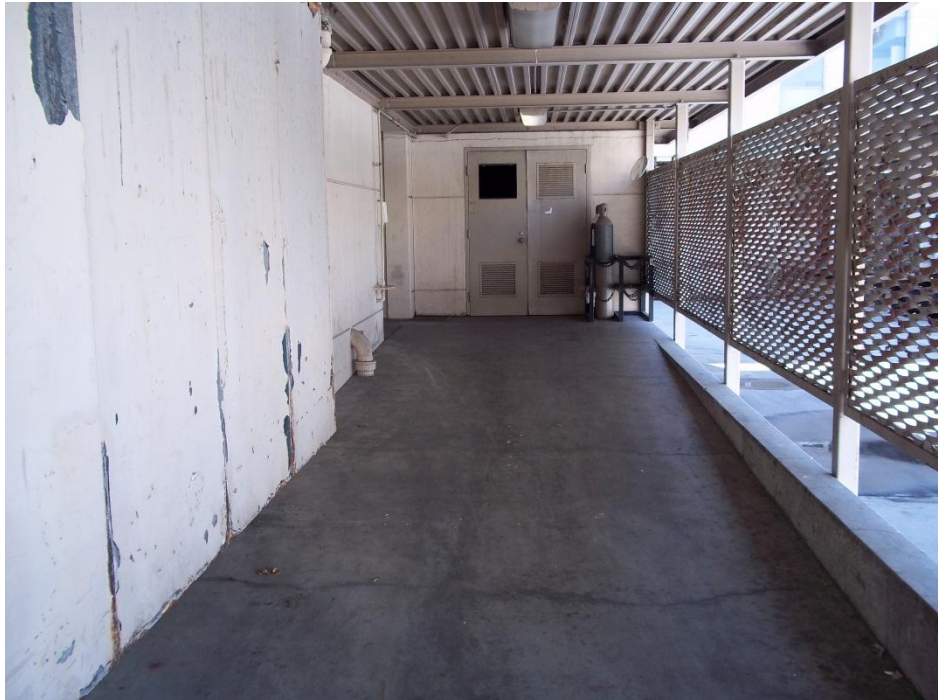
7. Objects protruding are not compliant

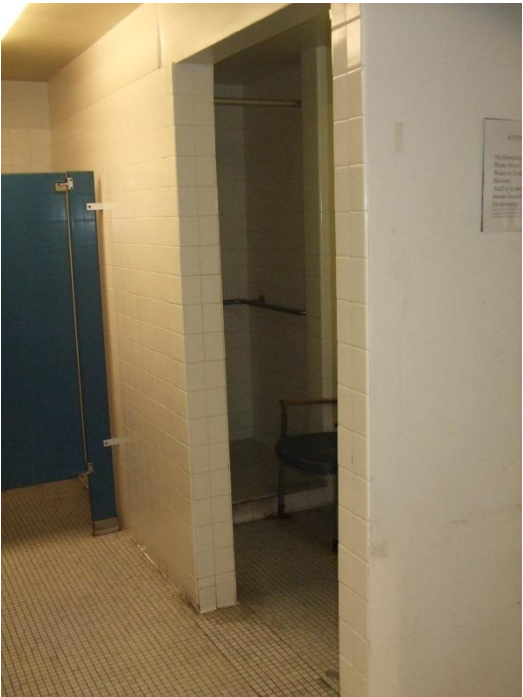
8. Non- accessible shower @ Locker Area

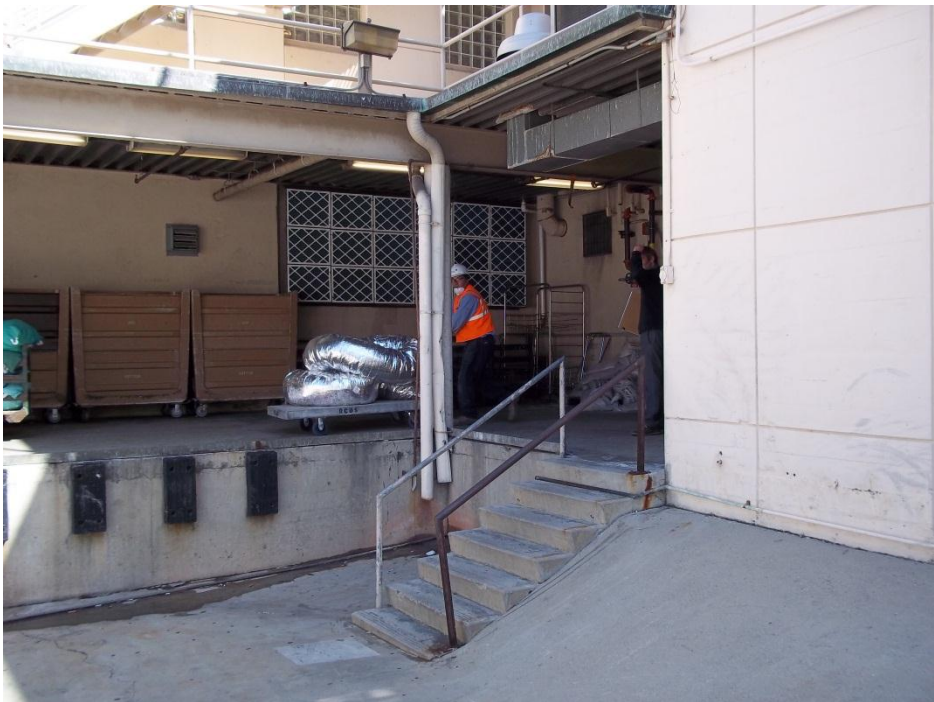
9. Damaged, non-compliant handrail @ Loading Dock Stair

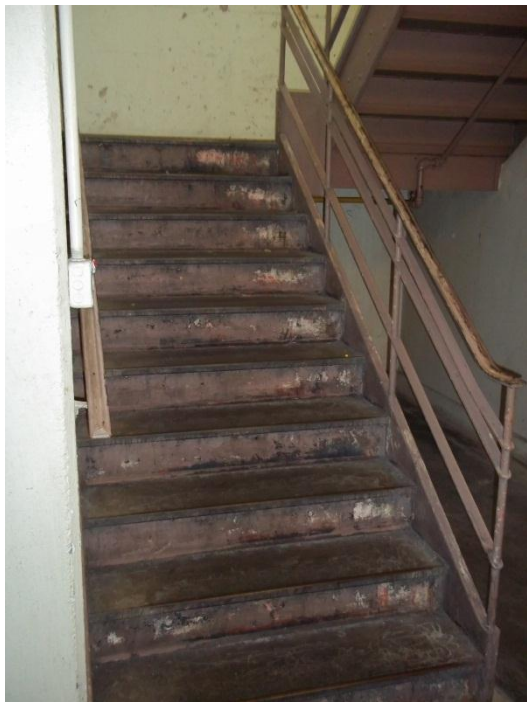
10. Damaged, non-compliant handrail @ basement stair to Canteen

The additional major code concern remaining is the exterior steel exit stairs (ref. photos 2, 11, & 12). There are four sets of exterior steel stairs- two located along the North east face and two located along the west face just above the central loading dock. These stairs currently serve as a means of egress from assembly areas located on levels two and three. The open tread risers and both the guard and handrails are not code compliant. It is recommended that these issues be addressed at a later date, although they are not listed in the FCA and currently not part of the project scope. In addition all existing stairs require contrasting strips in order to meet accessibility and VA standards (ref. photo 10).

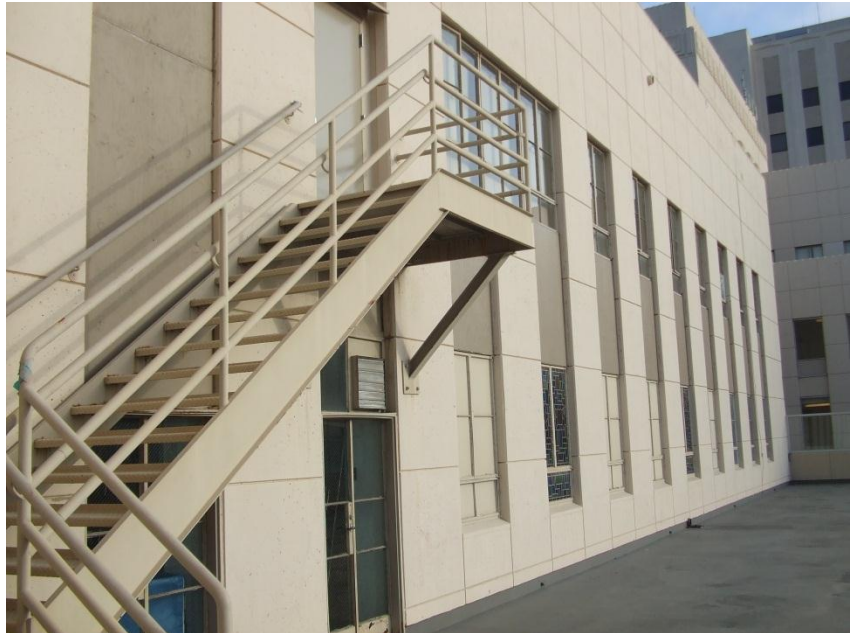
11. Non- compliant exterior stairs at Library

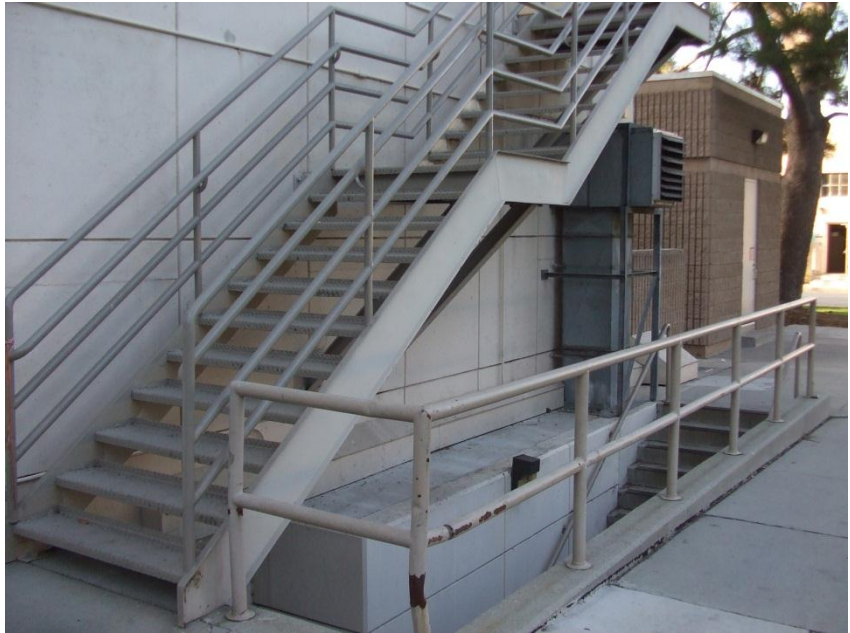
12. Non- compliant exterior stairs at Auditorium

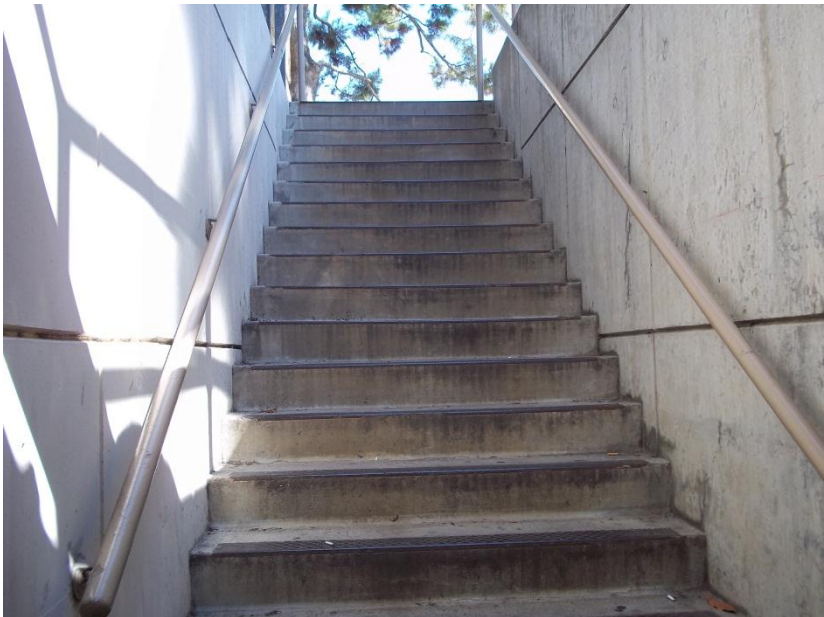
13. Non- compliant handrail at basement stairs

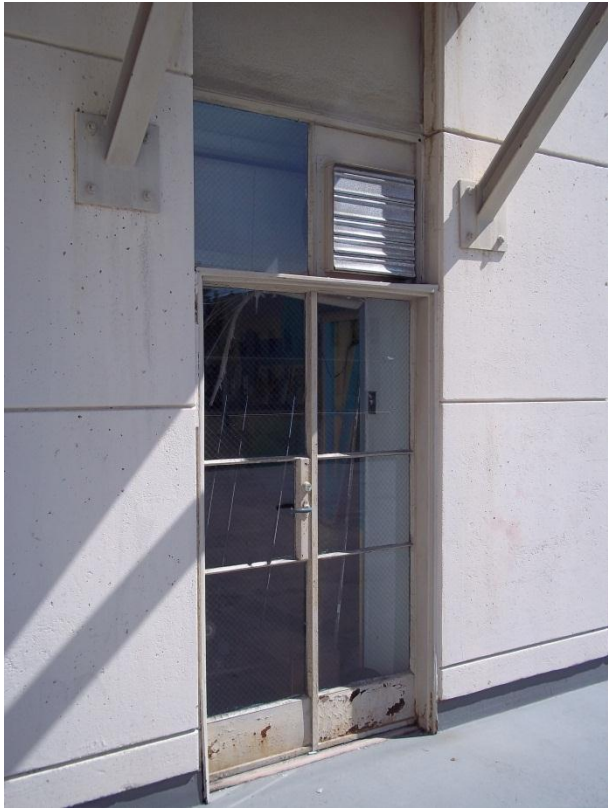
14. Corroded Steel Patio Doors near Chapel

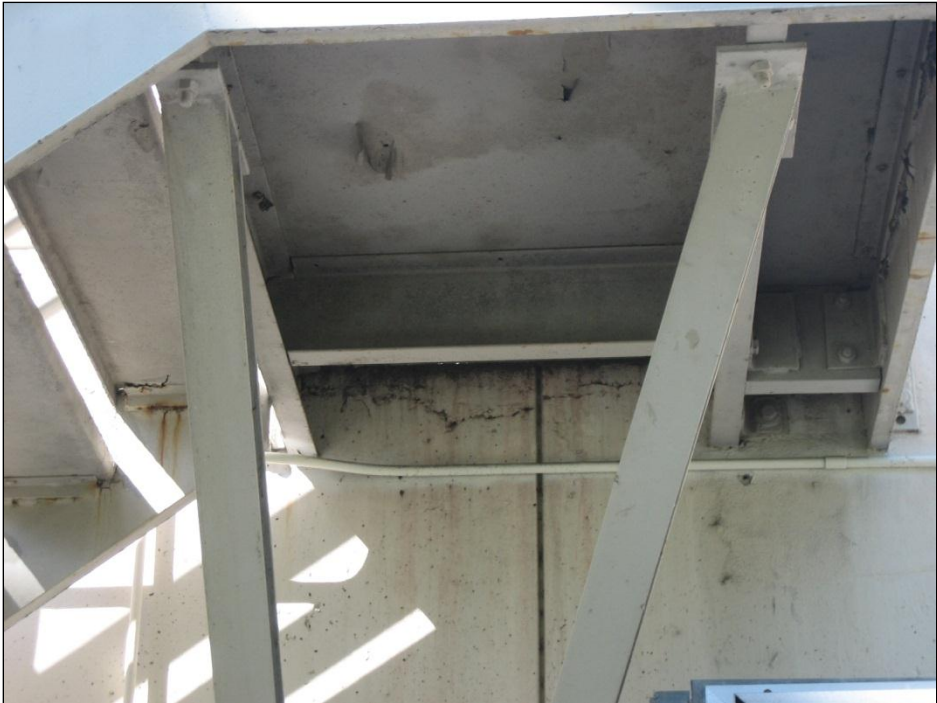
Photo 1 - Location 1 – 2nd Floor Stair Landing

Location #	Floor	Decription
1	2nd	Concrete spalling at the 2nd floor stair landing connection.
2	2nd	Concrete spalling at the 2nd floor stair landing connection.
3	Ground	Concrete spalling at the exterior ramp handrails. Rusting and shearing off of exterior ramp handrails.
4	Ground	Concrete spalling at the exterior ramp handrails. Rusting and shearing off of exterior ramp handrails.
5	Ground	Concrete spalling at canopy over loading dock.
6	Ground	Concrete spalling at the exterior ramp handrails.
7	Ground	Concrete spalling at exterior stairs
8	2nd	Concrete spalling at the 2nd floor stair landing connection.
9	3rd	Deterioration at 3rd floor stair landing connection.
10	Basement	Canopy over loading dock. Bent steel beam and concrete spalling of supporting columns.

- 1.1 Proposed Repair / Upgrade - Locations 1, 2, 5, 7, 8, 9 (Photos 1, 2, 7, 8, 10, 11, 12, 13)
- For the localized areas of spalled concrete, we recommended the following procedure (preliminary):
- Demolish spalled and/or cracked concrete until sound concrete is reached.
 - Roughen existing surface to minimum 1/4" amplitude.

- At the stair landing connections, note any further corrosion and deterioration of the existing structural steel framing to the engineer of record for further action.
- Drill & epoxy #3 rebar into existing concrete to tie into new concrete.
- Apply bonding agent to existing surface and pour back with non-shrink epoxy grout, minimum 7,000psi strength.
