LIMITED ASBESTOS INSPECTION

Audie L. Murphy VA Hospital

*Room LO11
7400 Merton Minter
San Antonio, Texas 78229*

**for
Ms. Kelly Garcia**

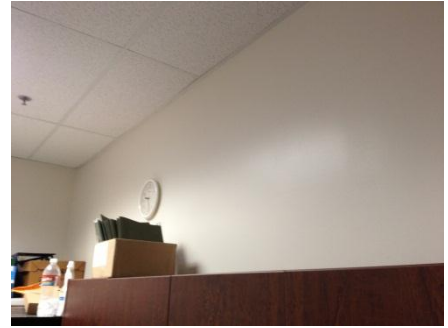
3. Wallboard – NAD
Float Mud – NAD

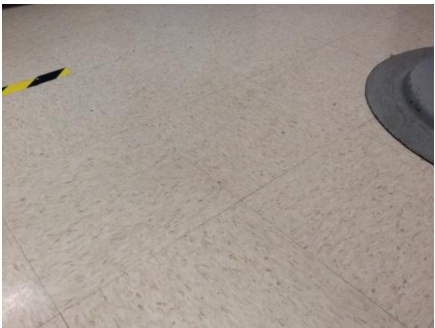
4. 12" White Floor Tile with
Brown Specks – NAD

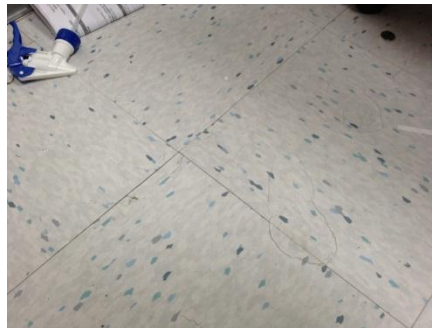
5. 12" Gray Floor Tile with
Blue Specks – NAD

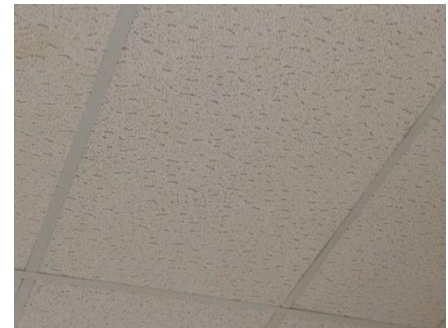
6. Ceiling Tile – NAD

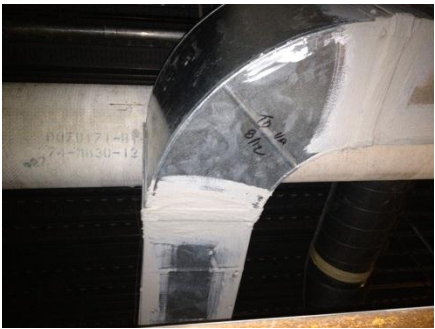
7. Duct Mastic – NAD

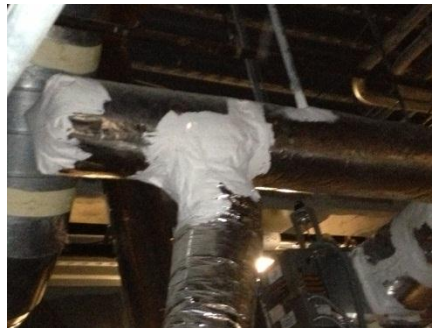
8. Duct Mastic – NAD

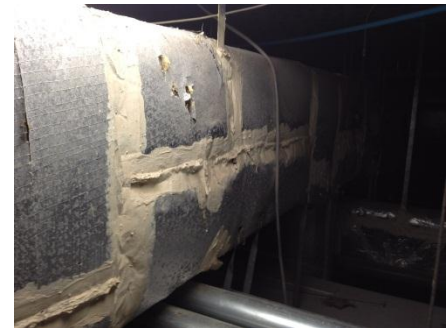
9. Duct Mastic – NAD

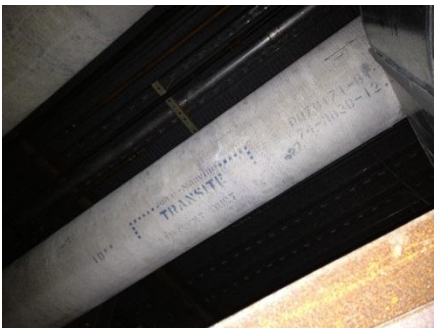
5.1.3. The other materials observed but were not sampled included Transite® pipes and the debris above the drop down ceiling. Both the pipe and the debris are assumed to be asbestos containing and must be handled as such.

7.2. Non-Friable Materials. Transite® pipe

10. Transite Pipes

8.3. Do not disturb the Transite®.

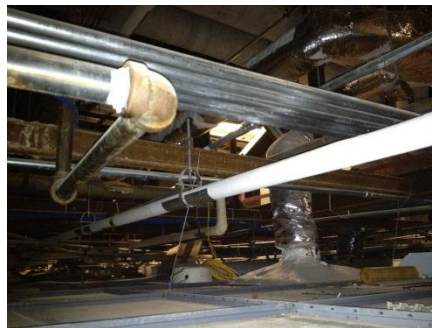
11. Above Drop Down Ceiling

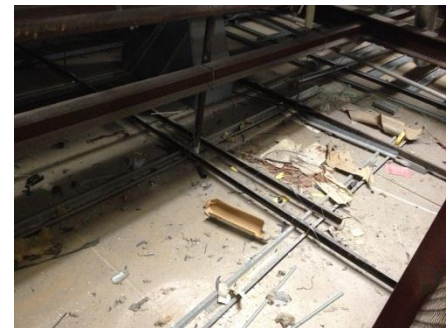
7.1. Friable Asbestos Material. Debris on top of the dropped ceiling.

12. Debris Above Ceiling

8.2. HEPA vacuum the top of the dropped ceiling prior to renovation.

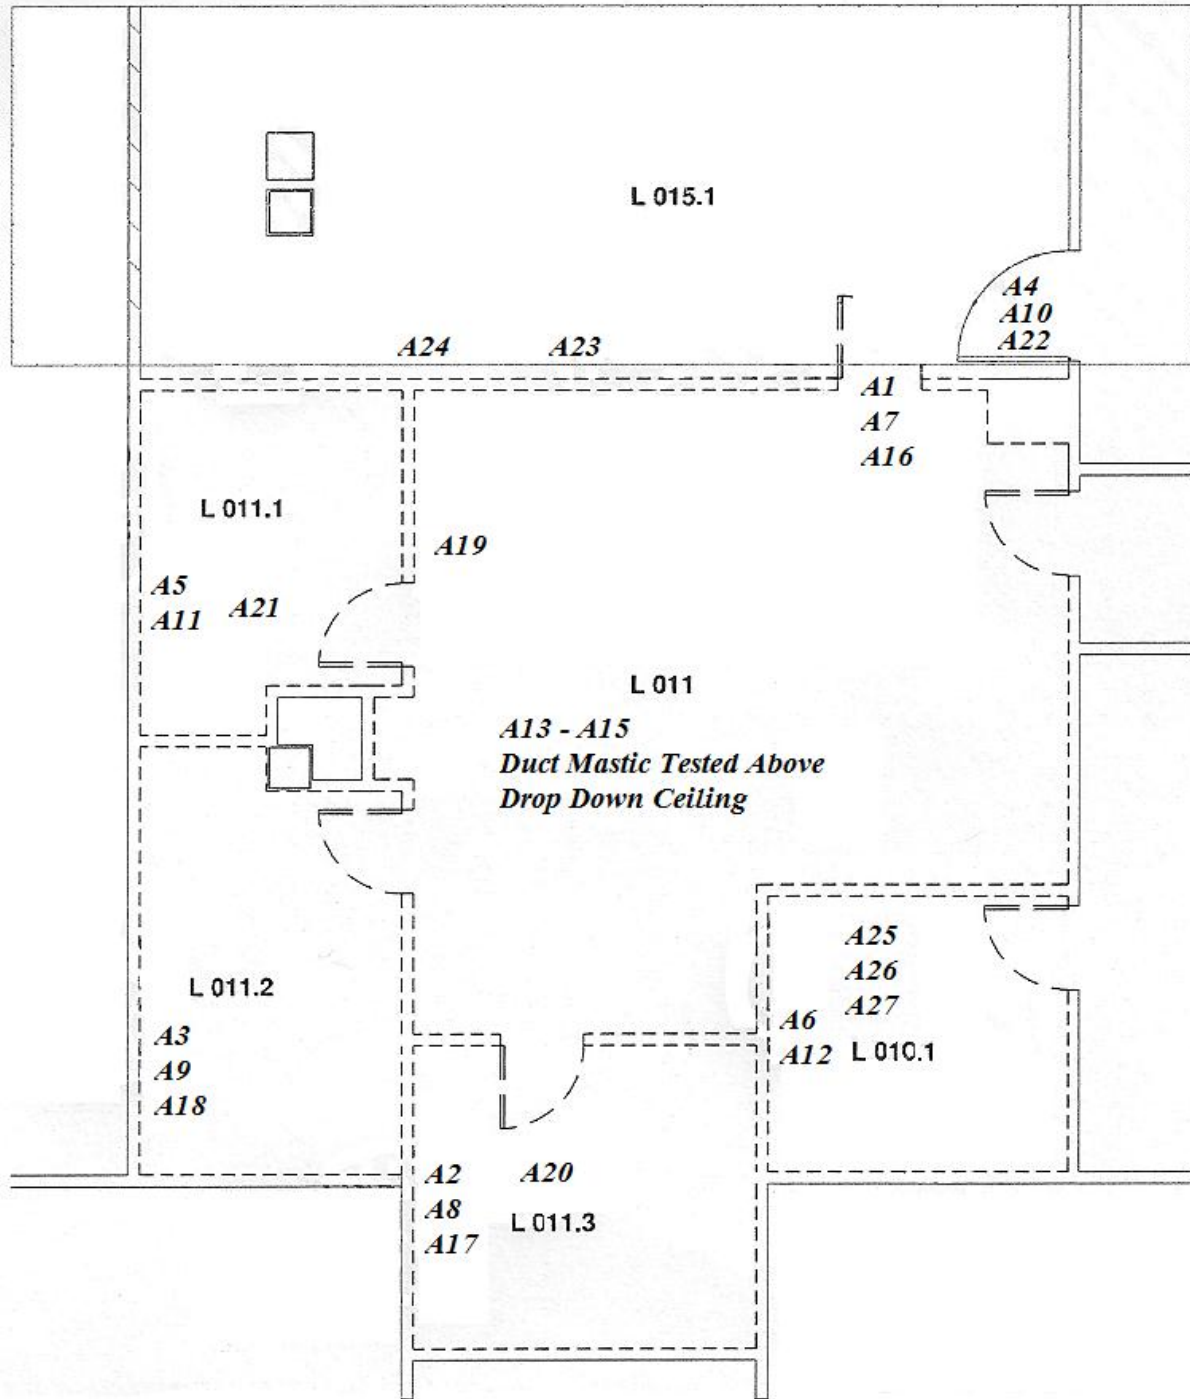
Audie L. Murphy VA Hospital Room L011 Site Diagram

- A1 – A6: Wallboard
- A7 – A12: Float Mud
- A13 – A15: Duct Mastic
- A16 – A18: Ceiling Tile
- A19 – A21: Underlayment
- A22 – A24: 12" White Floor Tile
- A25 – A27: 12" Gray Floor Tile
