LIMITED ASBESTOS INSPECTION

Audie L. Murphy VA Hospital

*Room GB013
7400 Merton Minter
San Antonio, Texas 78229*

**for
Ms. Kelly Garcia**

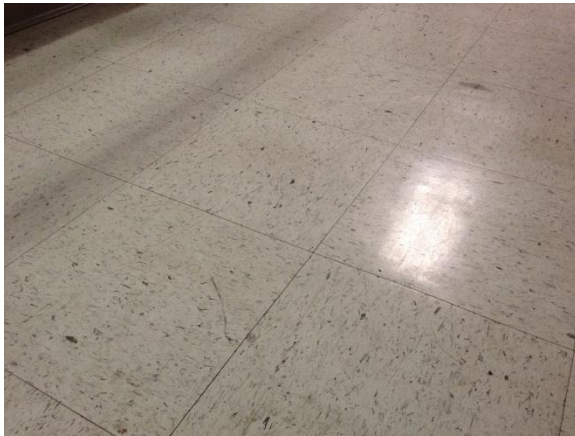
6.2. Summary Positive Asbestos Containing Building Materials. None. The laboratory results indicated “NAD – No Asbestos Detected” in all samples.

3. 12" x 12" White Floor Tile with Black Specks – NAD

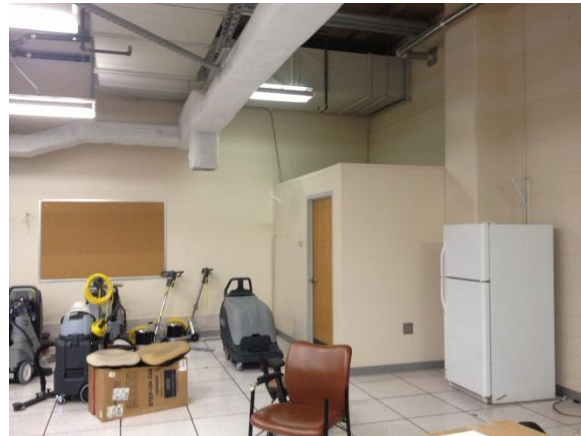
4. Wallboard & Float Mud – NAD

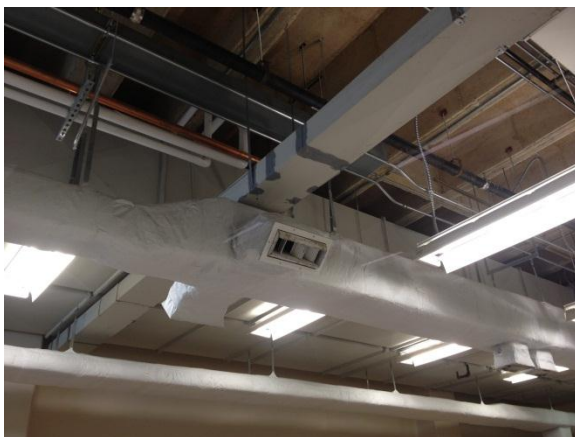
5.1.3. The escort (Mr. Robert Martinez), indicated that the duct mastic located in Room GB013 was not sampled because the material was recently installed.

5. Ducts

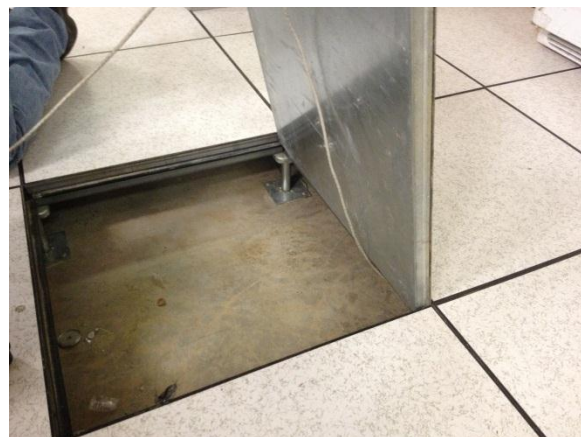
6. Raised Flooring

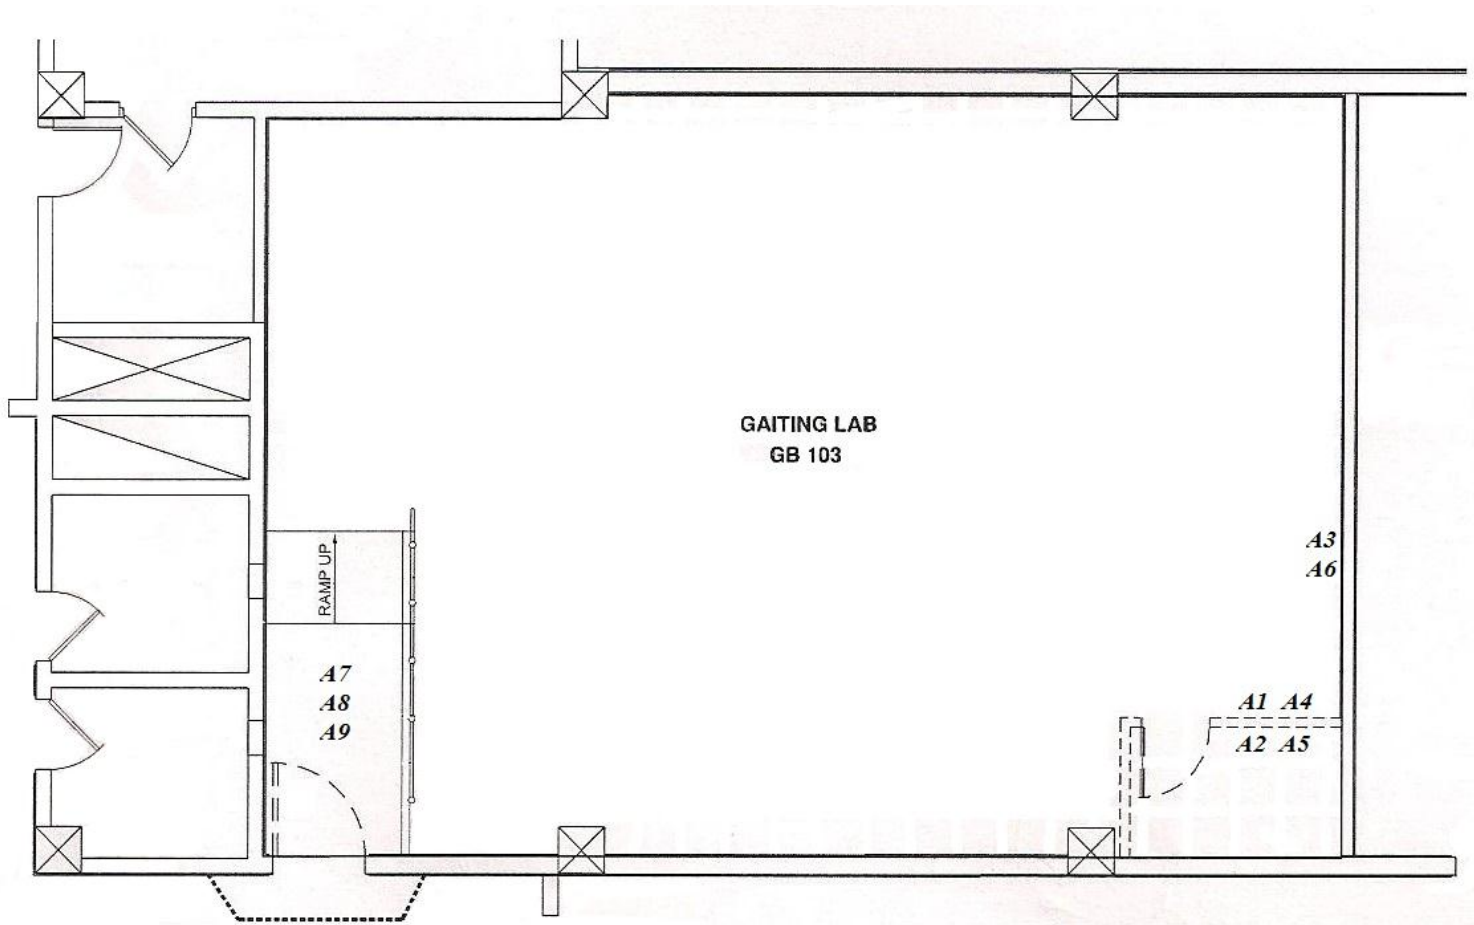
**Audie L. Murphy VA Hospital
Room GB013 Site Diagram**

A1 – A3: Wallboard

A4 – A6: Float Mud

A7 – A9: 12" Gray Floor Tile
