May 6, 2013

This letter is in response to limited sampling in Mechanical Room M003 on 30 April 2013. The results were emailed on 1 May 2013 along with photographs.

**Audie L. Murphy VA Hospital
7400 Merton Minter
San Antonio, Texas 78229
30 April 2013**

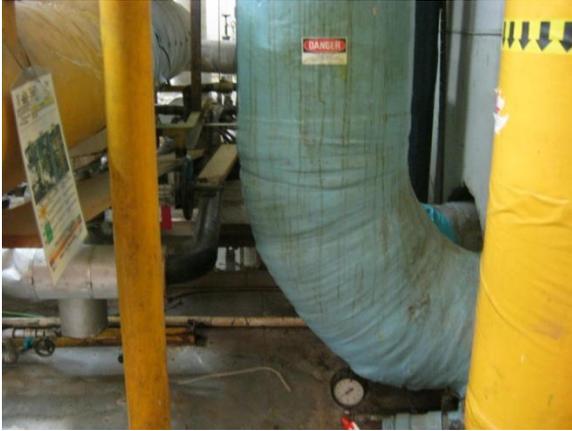
The laboratory results indicated that Sample Areas 1, 5, and 6 contained Chrysotile Asbestos. See Enclosure 3.

1. Sample Area #1 Pipe Mastic – 5% Chrysotile

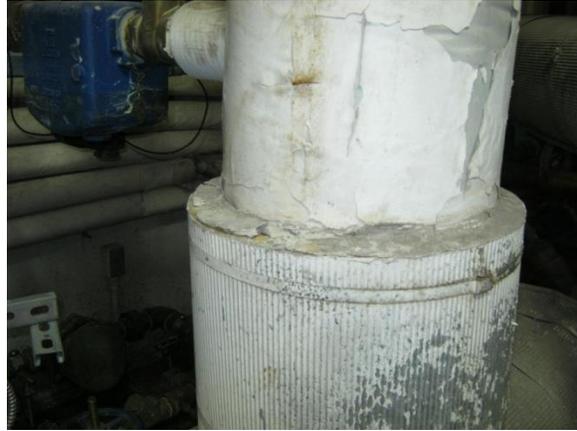
2. Sample Area #2 Pipe Insulation – No Asbestos Detected (NAD)

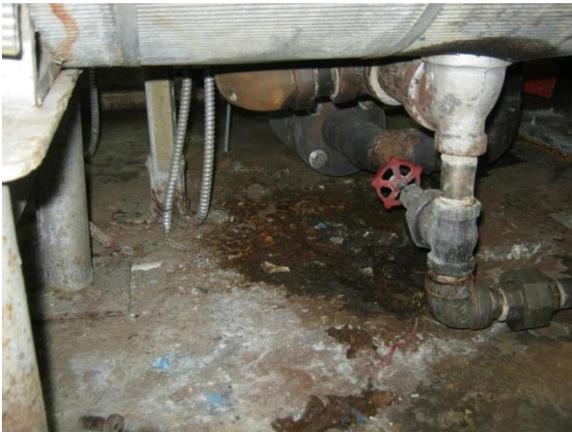
3. Sample Area #3 Debris – No Asbestos Detected (NAD)

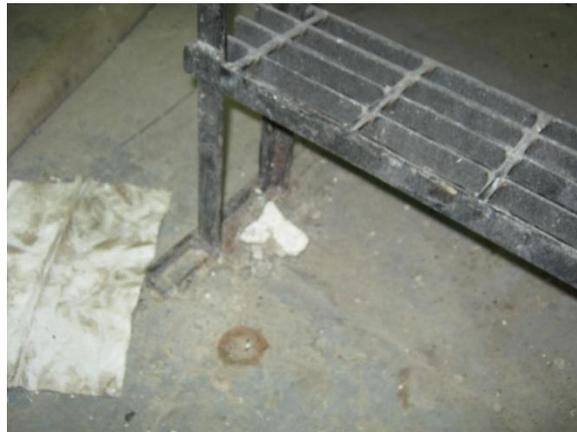
4. Sample Area #4 Debris – No Asbestos Detected (NAD)

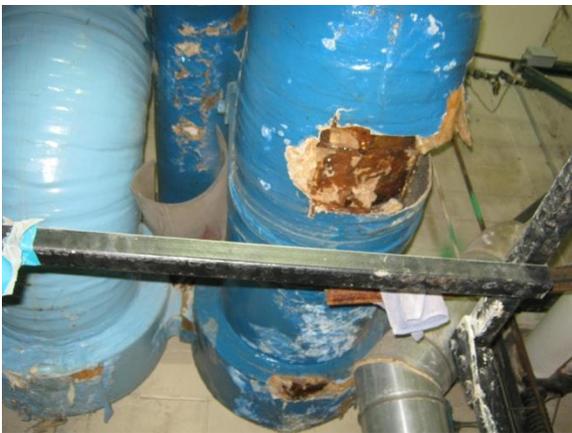
5. Sample Area #5 Pipe Mastic – 5% Chrysotile

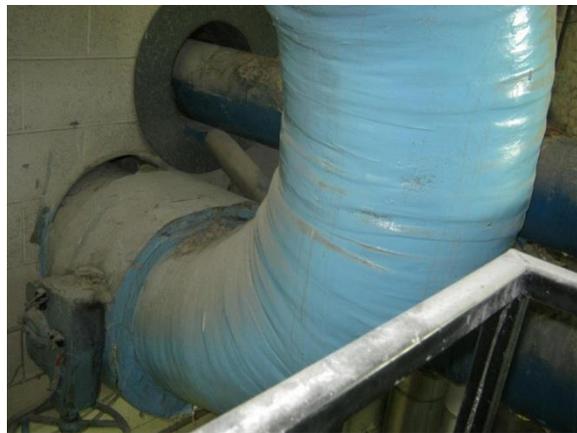
6. Sample Area #6 Pipe Mastic – 5% Chrysotile
