# **ASBESTOS CONTAINING BUILDING MATERIAL REPORT BUILDING 23**

**Bay Pines VA Medical Center  
10000 Bay Pines Boulevard  
Bay Pines, Florida**

Project No. 2009011.001

July 31, 2009

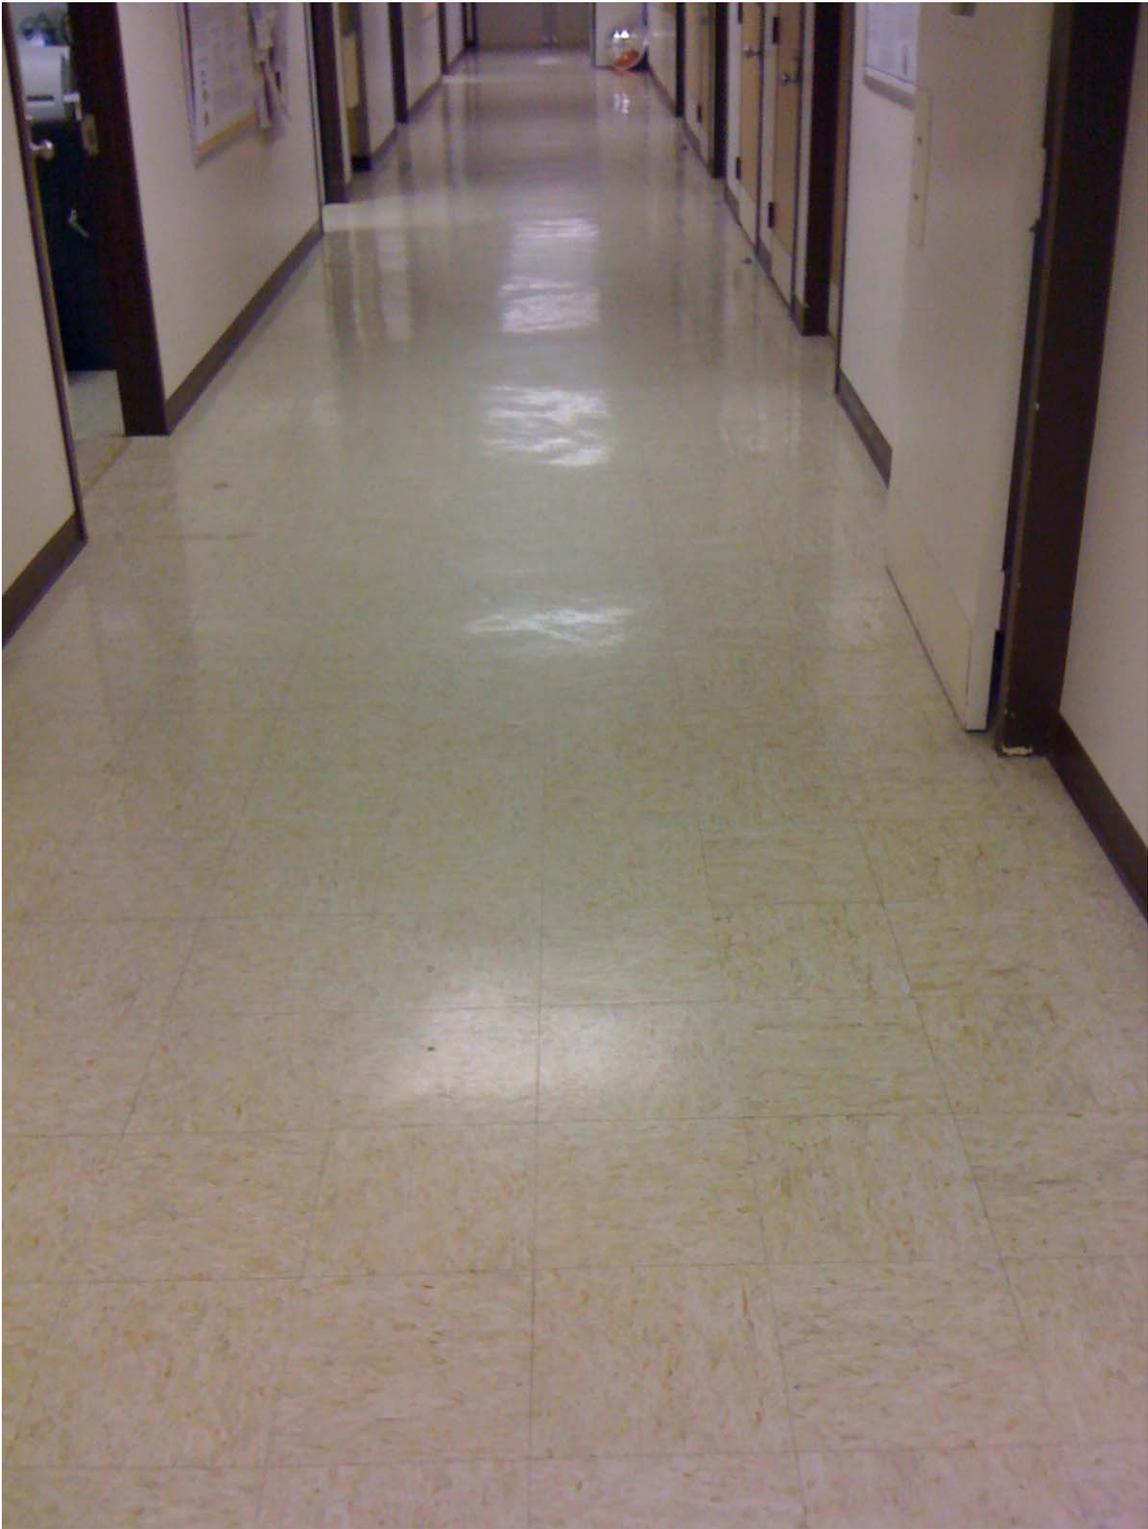
Sample#	Sample Location	ACM Location	Description of Material	Percent and Type of Asbestos	Condition	Estimated Quantity	NESHAP Category
1 Tile	Hallway	Hallways, Offices 2 <sup>nd</sup> Floor	12" x 12" White Tan Floor Tile	8% Chrysotile	Good	14,600 SF	I
1 Mastic	Hallway	Hallways, Offices 2 <sup>nd</sup> Floor	Black Mastic	2% Chrysotile	Good	14,600 SF	I
37 Tile	Room 218	Room 218	12" x 12" Grey Floor Tile	10% Chrysotile	Good	30 SF	I
37 Mastic	Room 218	Room 218	Black Mastic	3% Chrysotile	Good	30 SF	I
62 Tile	1 <sup>st</sup> Floor Lobby	1 <sup>st</sup> Floor Hallway	2' x 2' White/Grey Floor Tile	10% Chrysotile	Good	2,600 SF	I
62 Mastic	1 <sup>st</sup> Floor Lobby	1 <sup>st</sup> Floor Hallway	Black Mastic	2% Chrysotile	Good	2,600 SF	I
89 Tile	Room 117/115F	Room 117/115F	12" x 12" White Black Floor Tile/Black Mastic	7% Chrysotile	Good	200 SF	I
89 Mastic	Room 117/115F	Room 117/115F	Black Mastic	2% Chrysotile	Good	200 SF	I

**Building 23**  
**Sample 1 Tile – 12" x 12" White Tan Floor Tile and Mastic**

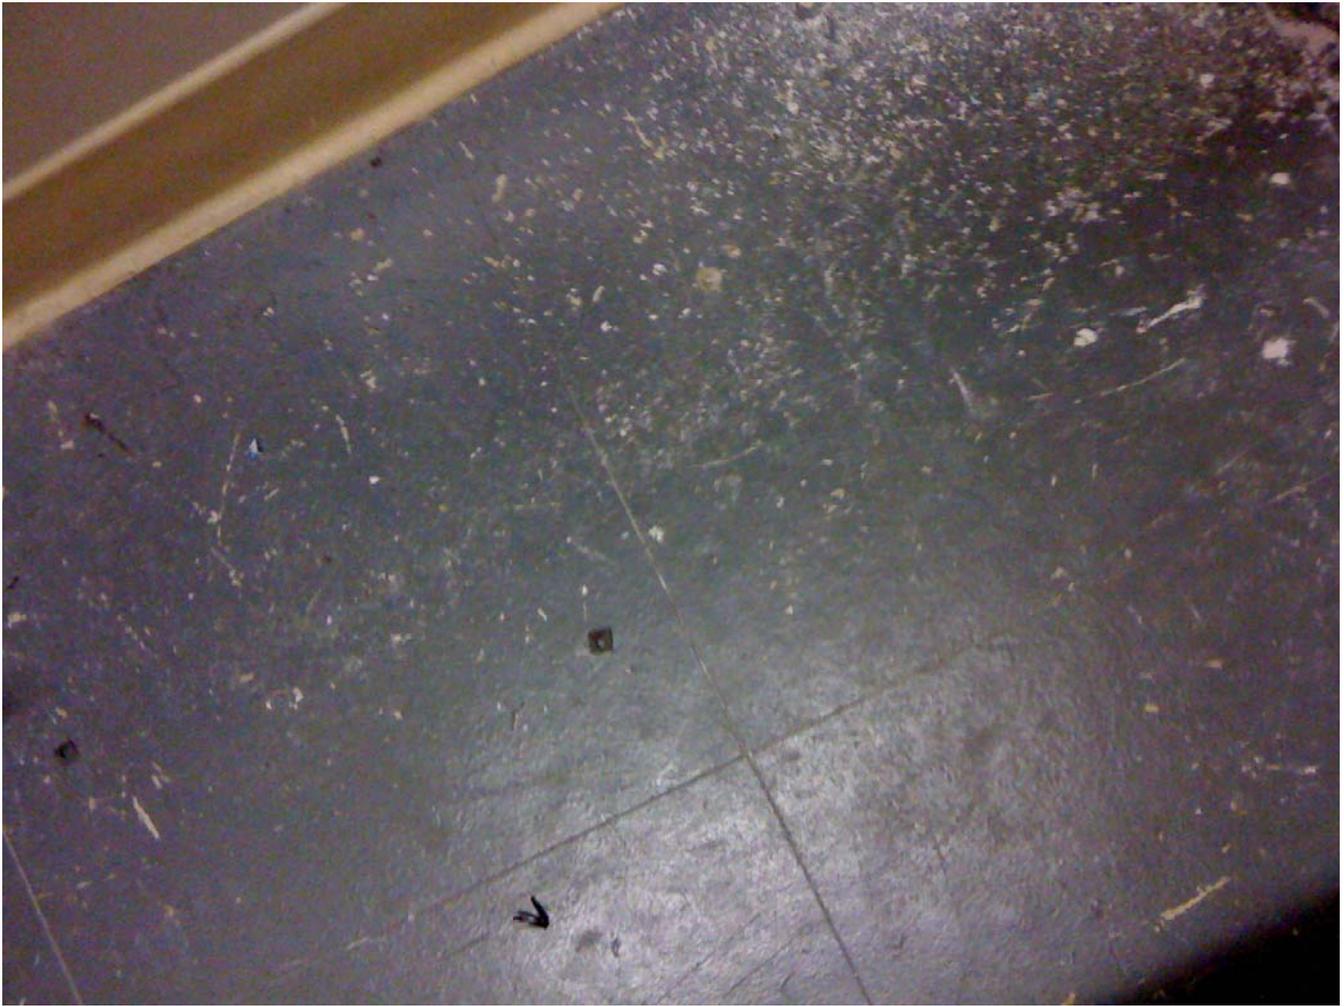
**Building 23**  
**Sample 37 Tile - 12" x 12" Grey Floor Tile and Mastic**

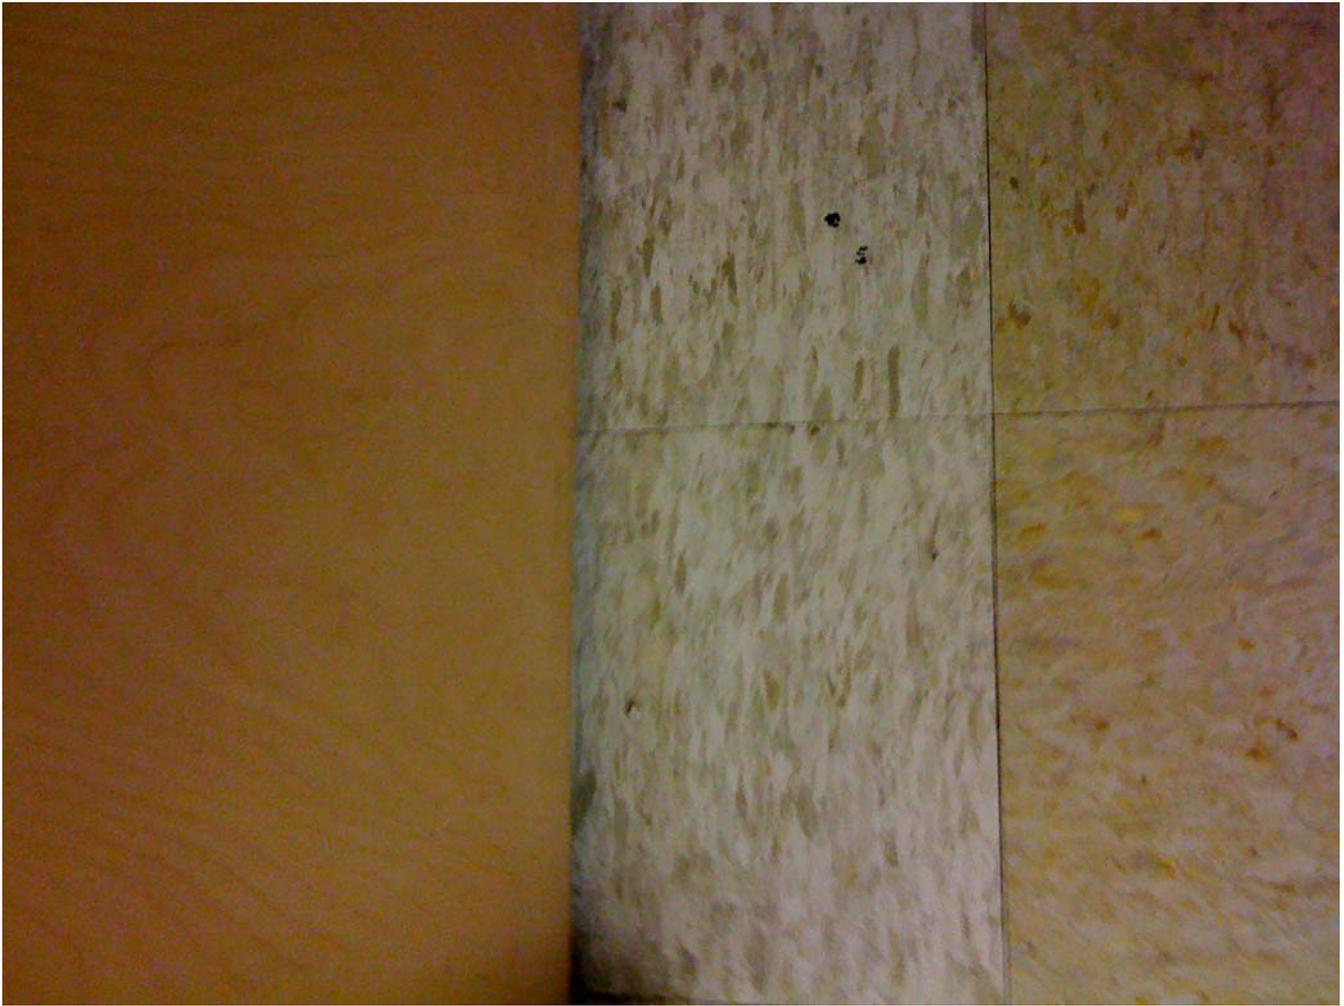
**Building 23**  
**Sample 62 Tile - 2' x 2' White/Grey Floor Tile and Mastic**

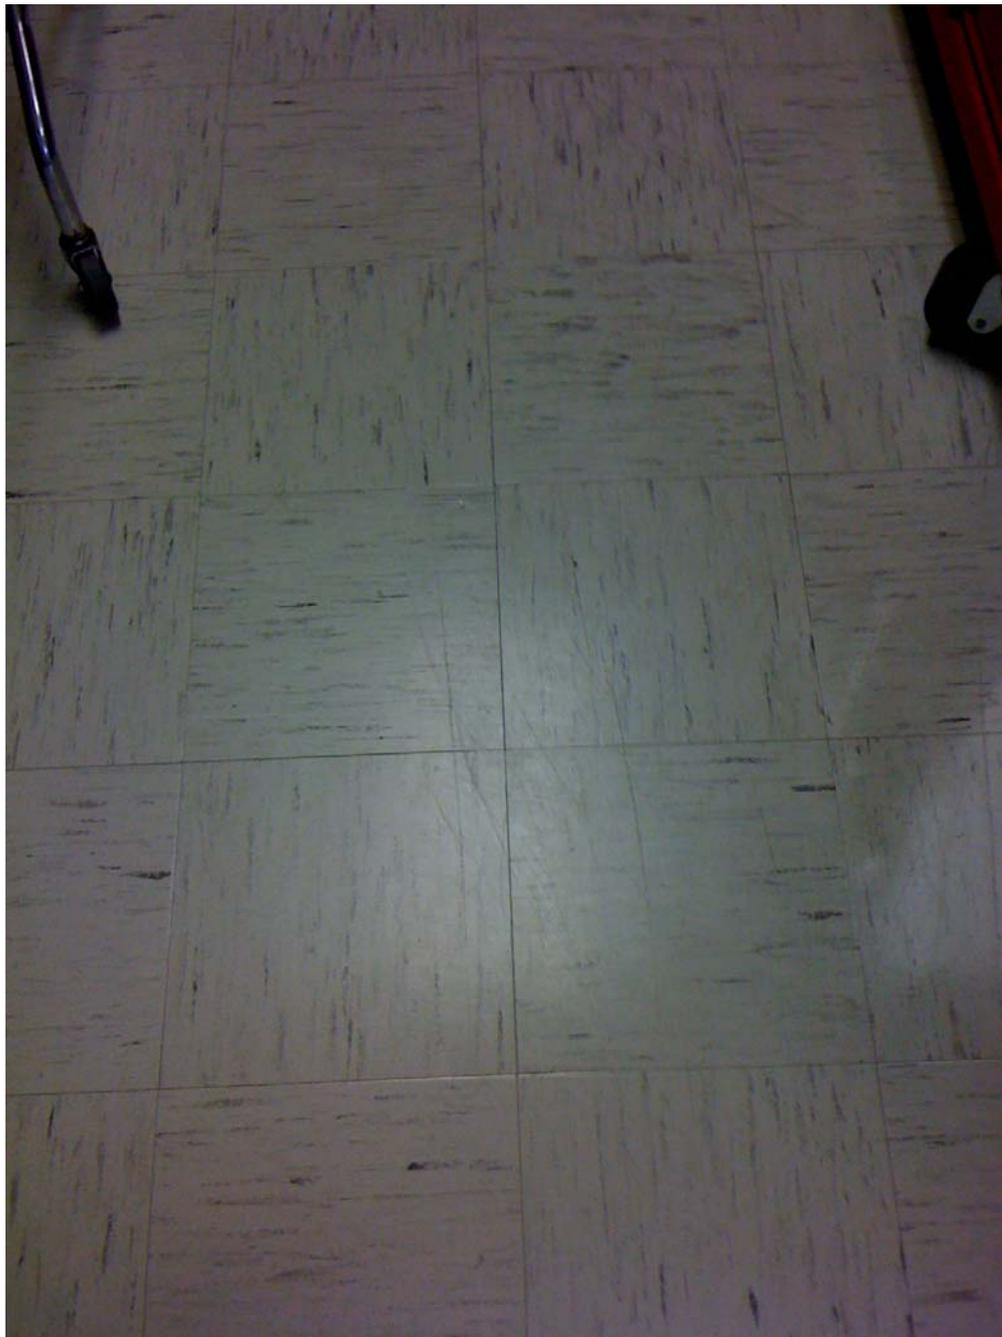
**Building 23**  
**Sample 89 Tile - 12" x 12" White Black Floor Tile/Black Mastic**

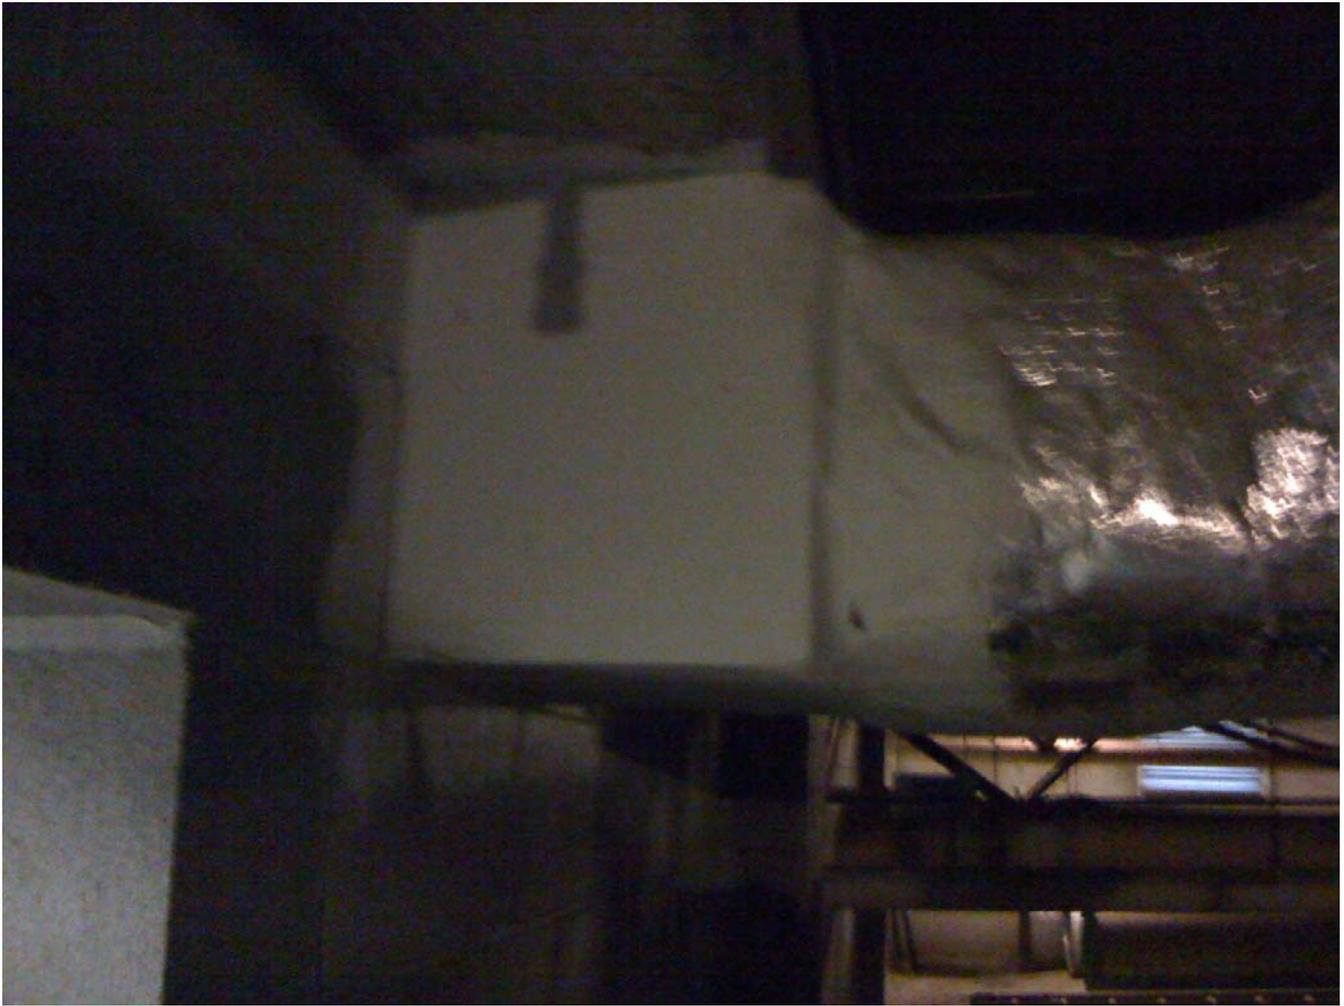
92	Basement	Basement	Brown Duct Mastic	6% Chrysotile	Good	150 SF	I

**Building 23**  
**Sample 92 – Brown Duct Mastic**

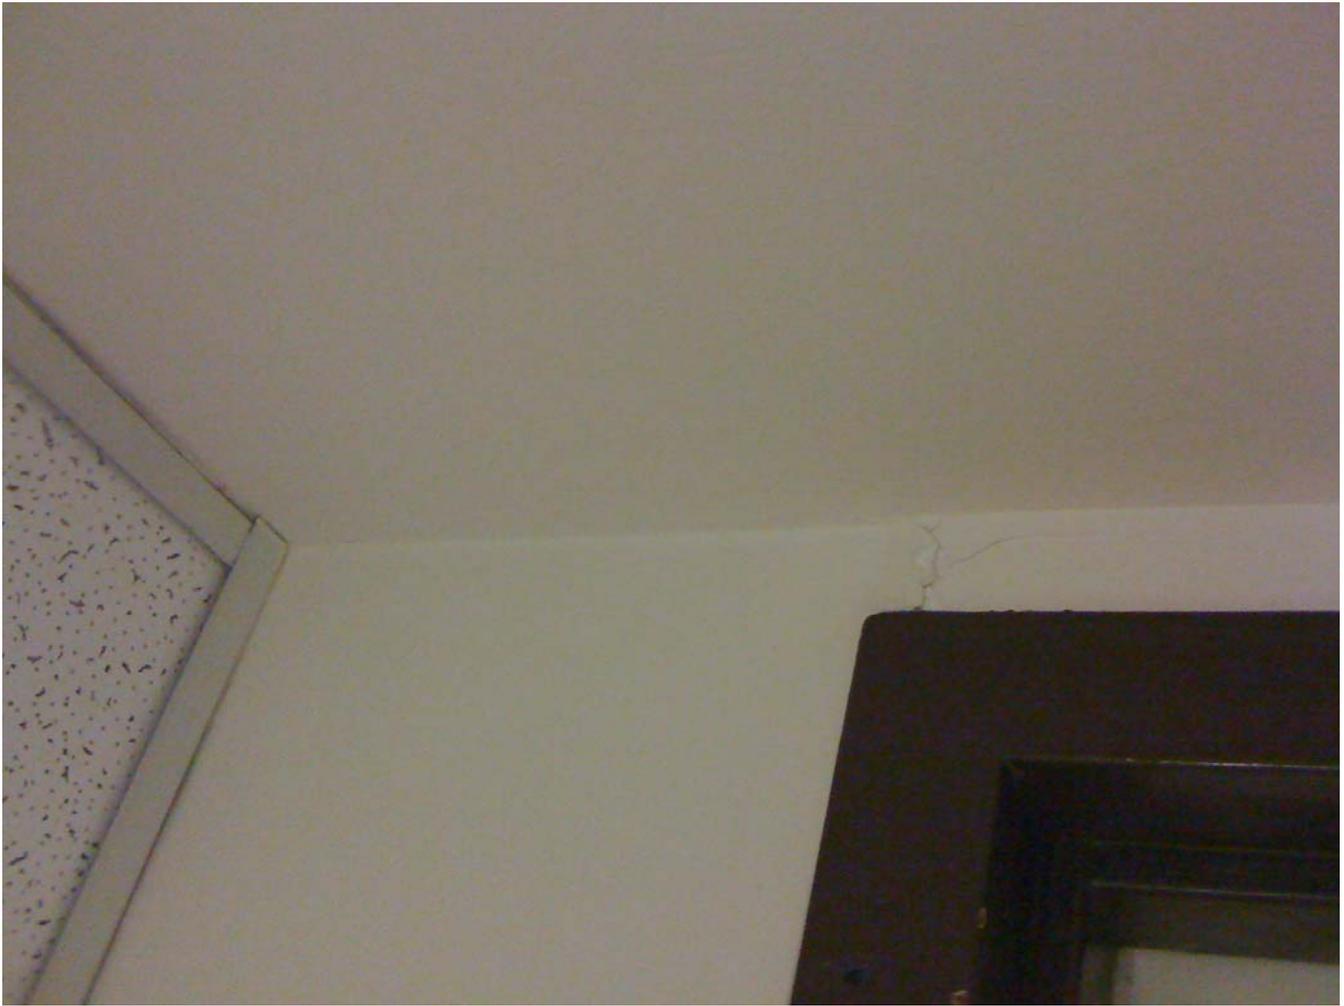
**Building 23**  
**Sample 25 - Joint Compound**
