**LIMITED PRE-RENOVATION
ASBESTOS INSPECTION REPORT
IMPROVE CHILLER PLAN EFFICIENCY
BUILDINGS 131, 133, 133CA AND 188
VA PROJECT #556-14-006**

**SITE:
CAPTAIN JAMES A. LOVELL FHCC
3001 GREEN BAY ROAD
NORTH CHICAGO, ILLINOIS**

PROJECT REFERENCE #14786

AUGUST 2014

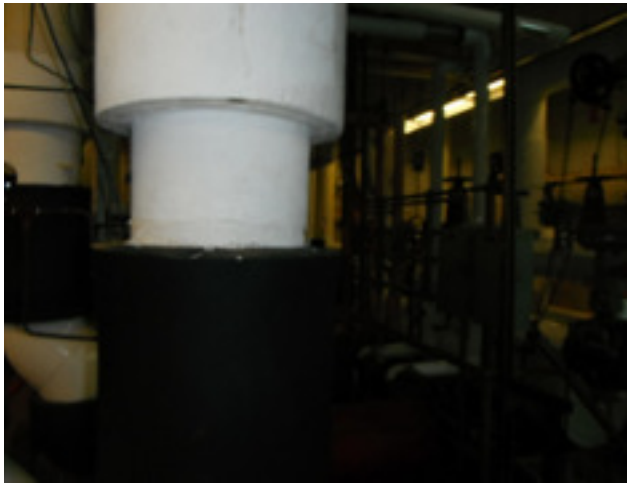
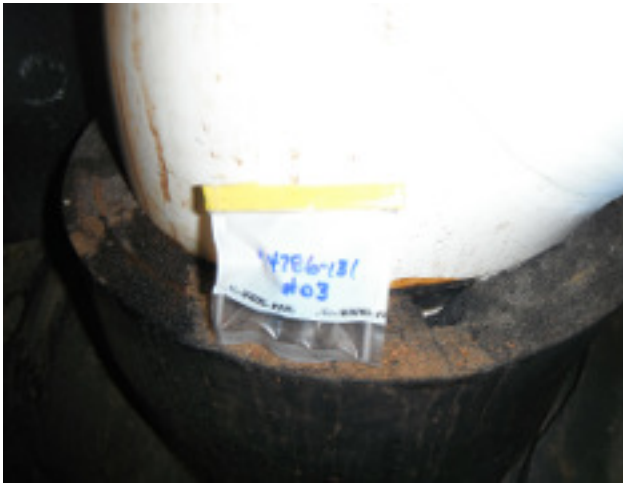
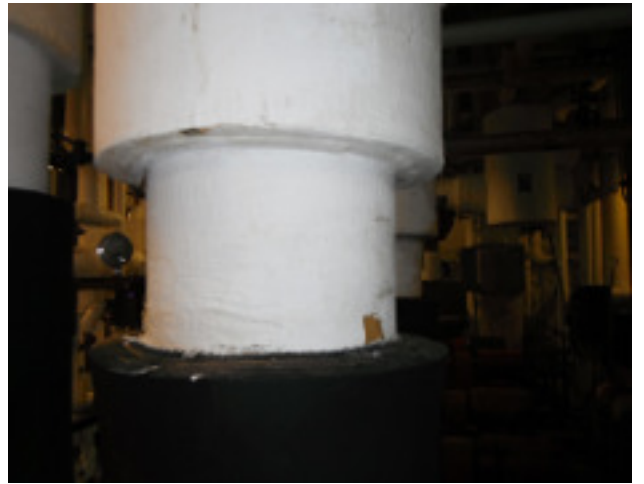
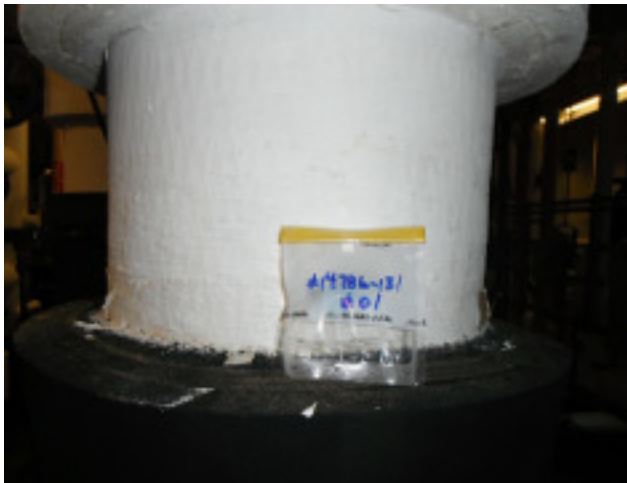
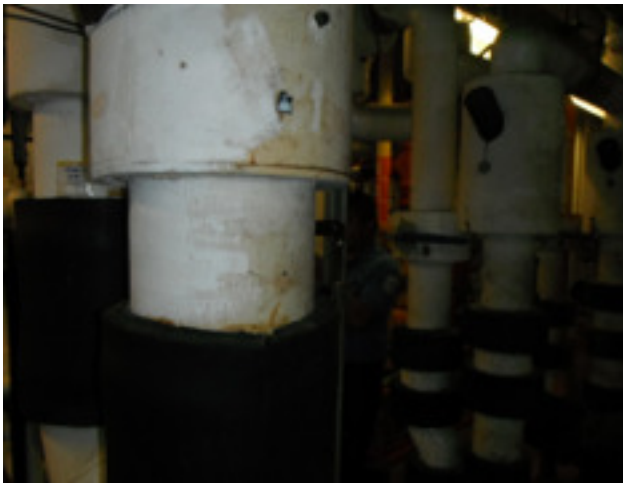
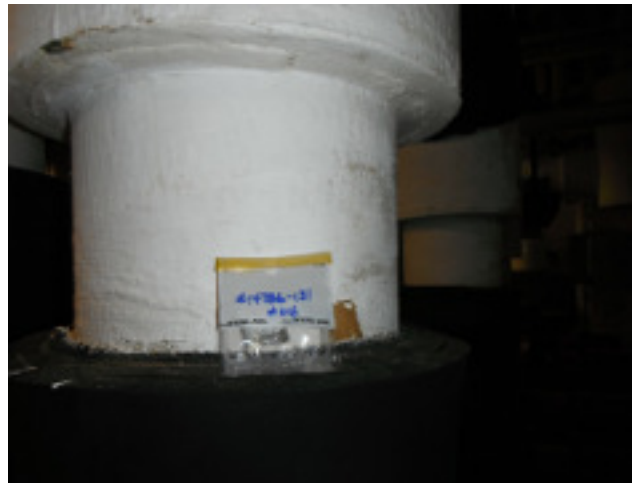
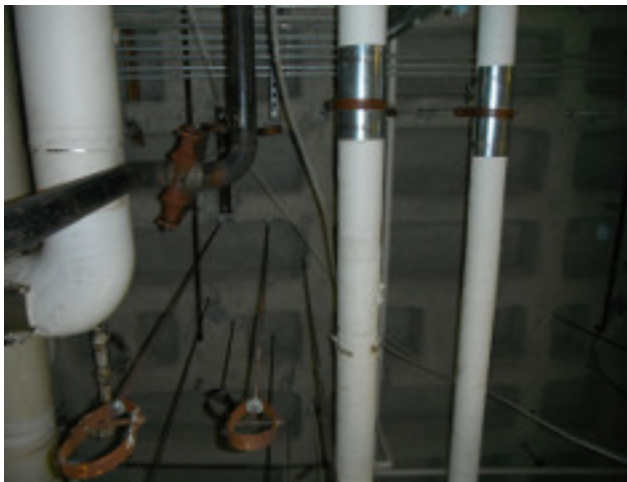
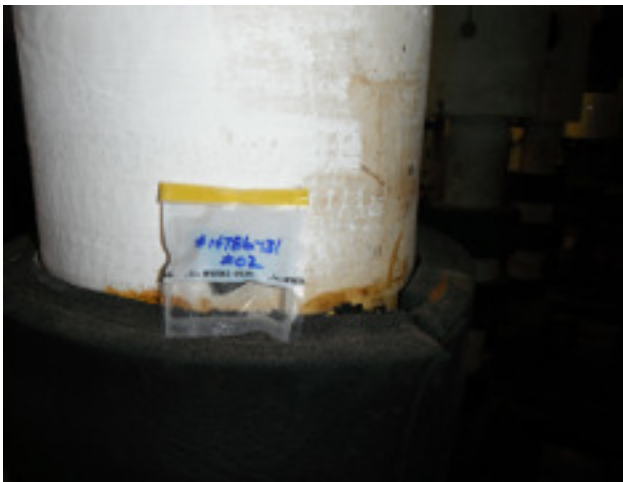
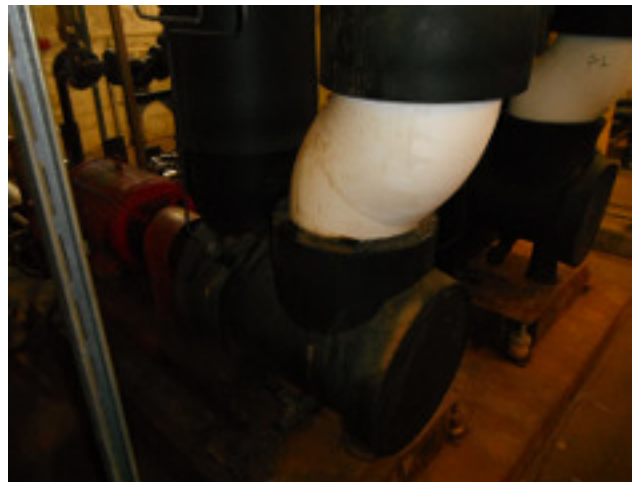
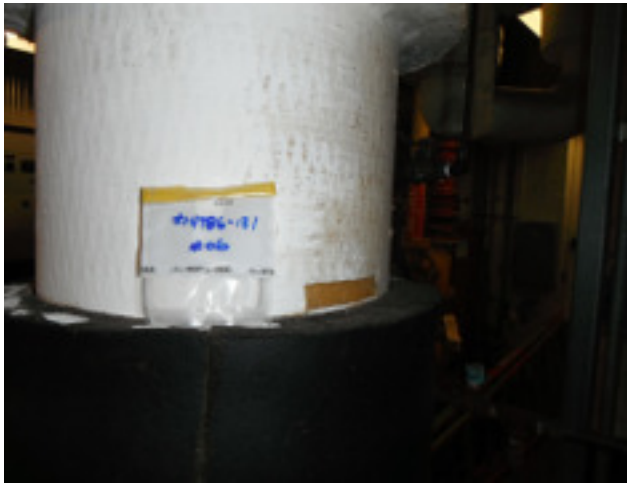
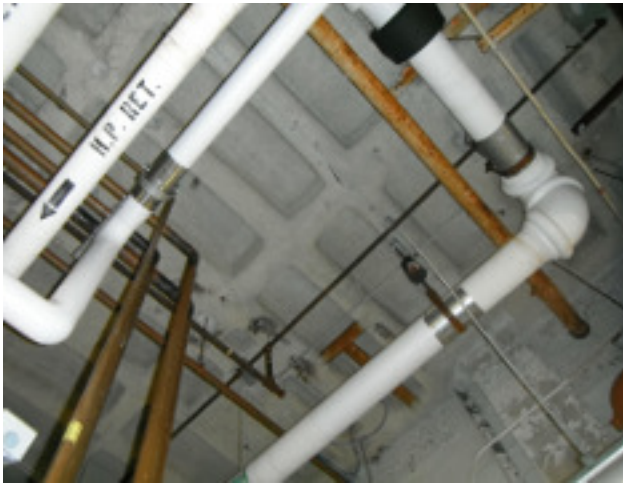
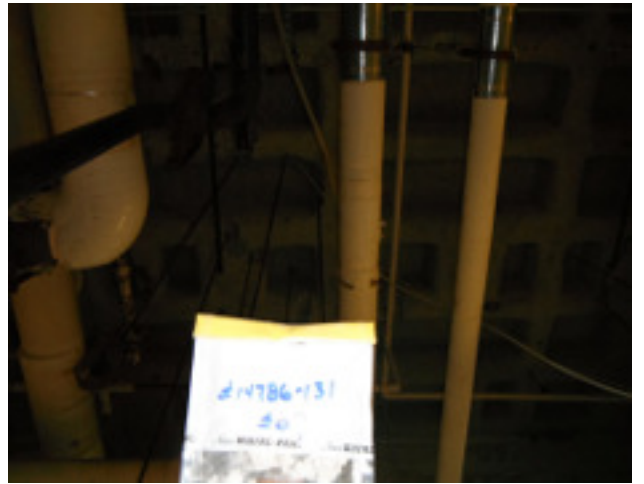
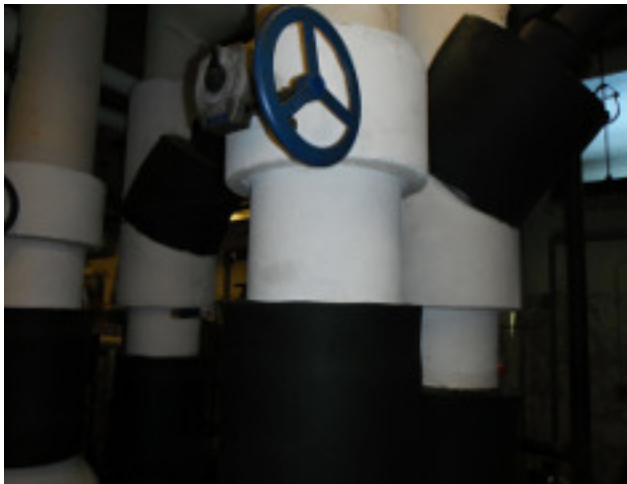
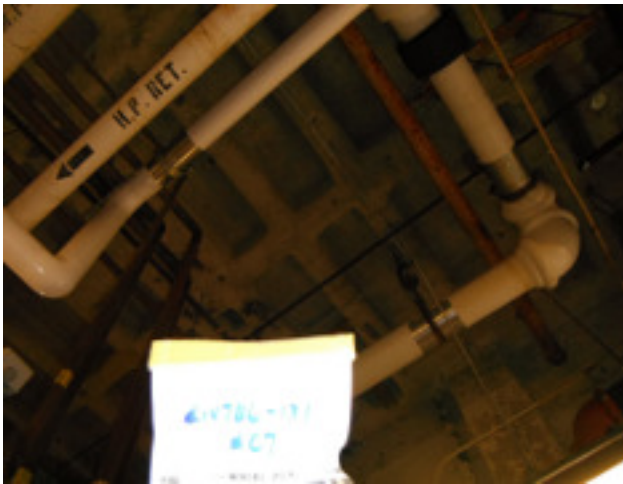
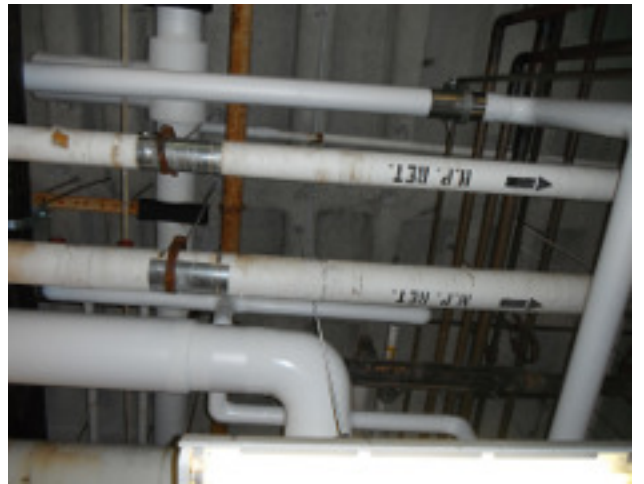
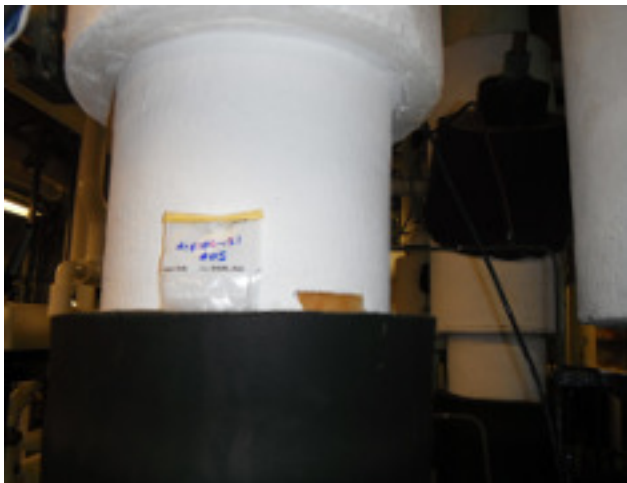
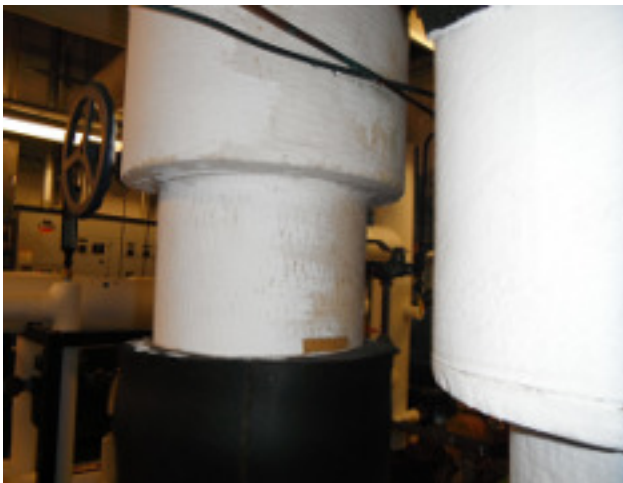
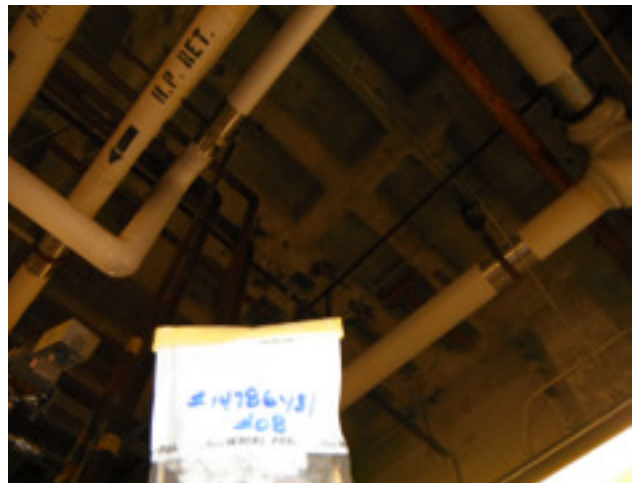
Building 131
Material Sample Photos

Building 131 –

- Rubber insulation mastic
- Fiberglass insulation paper wrap
- Spray-on insulation, gray

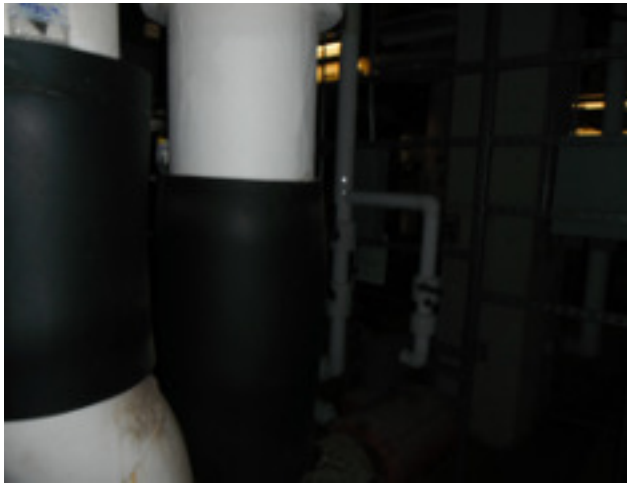
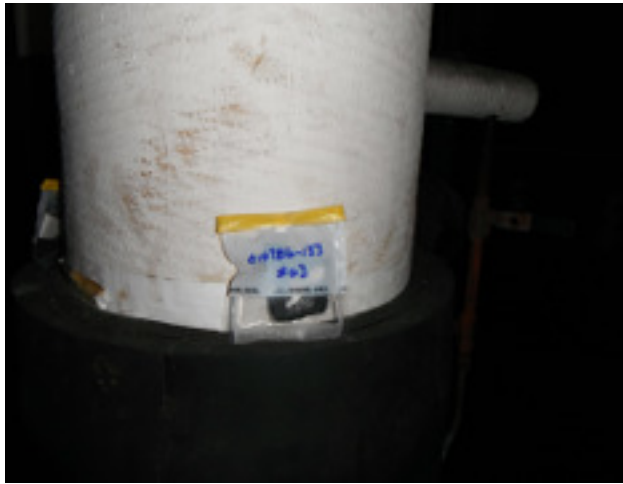
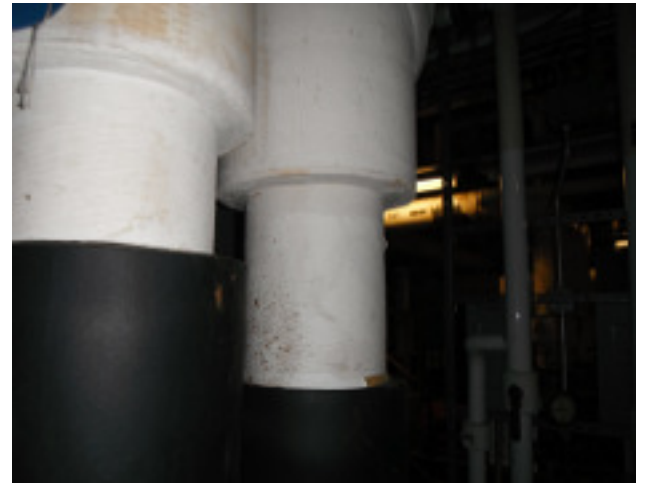
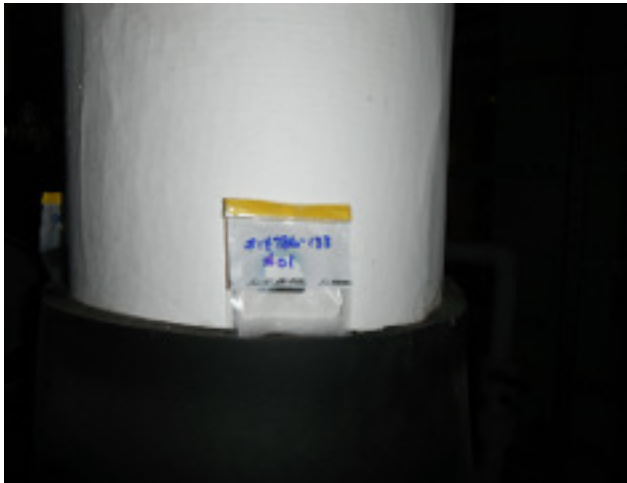
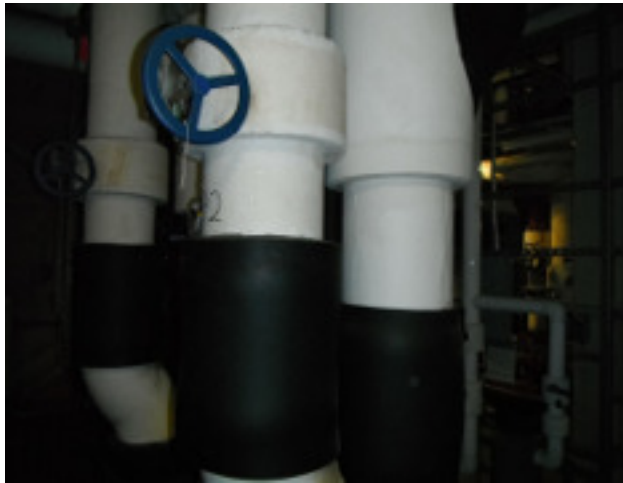
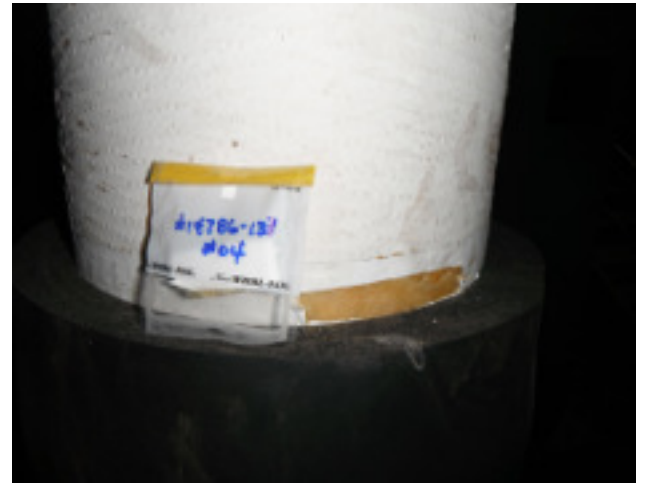
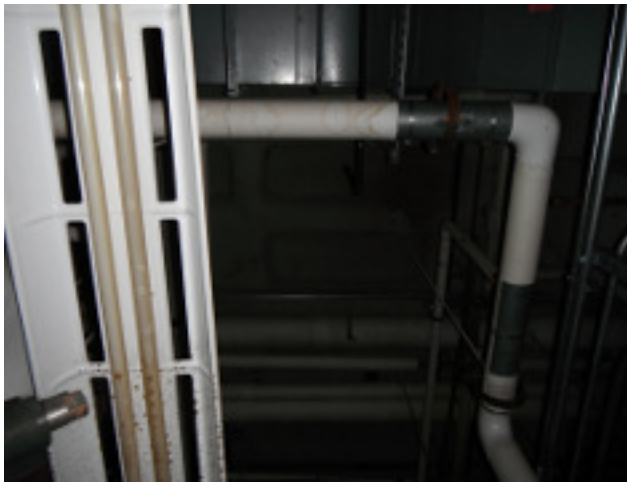
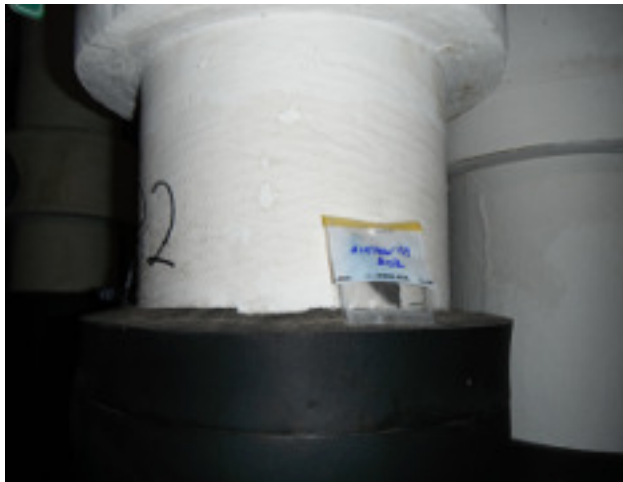
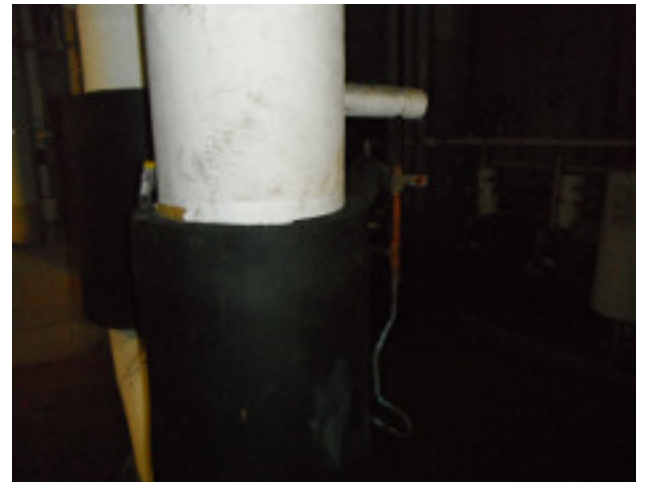
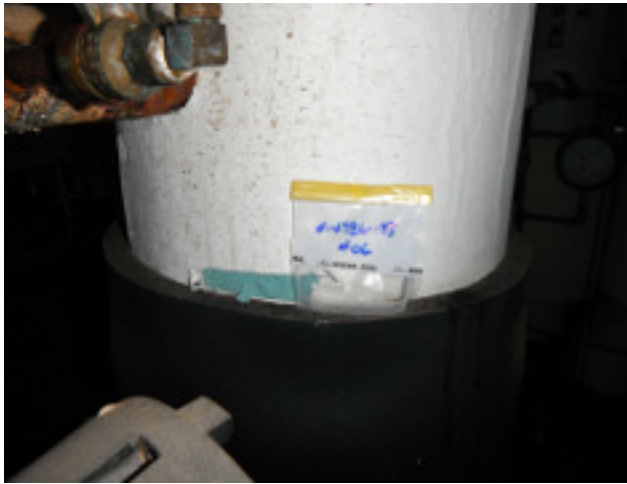
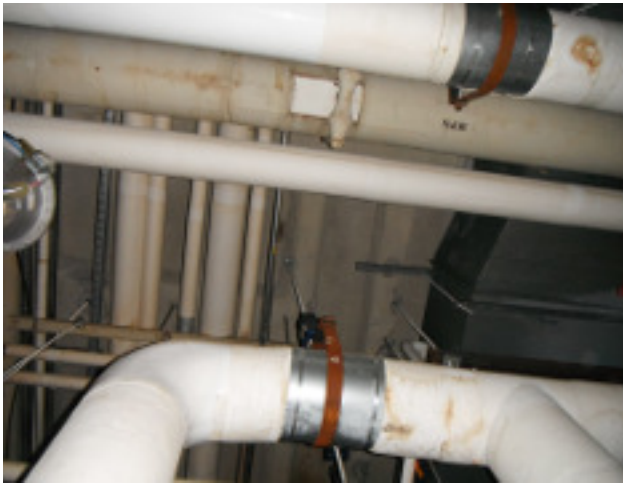
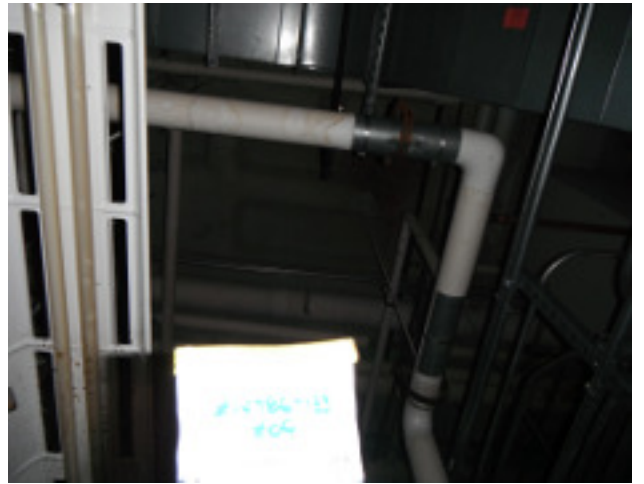
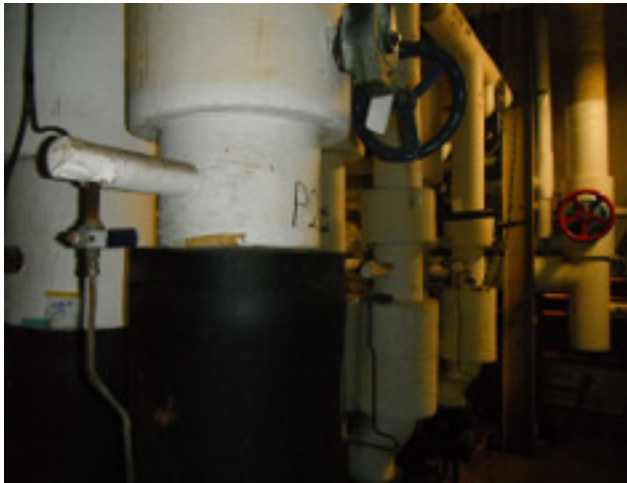
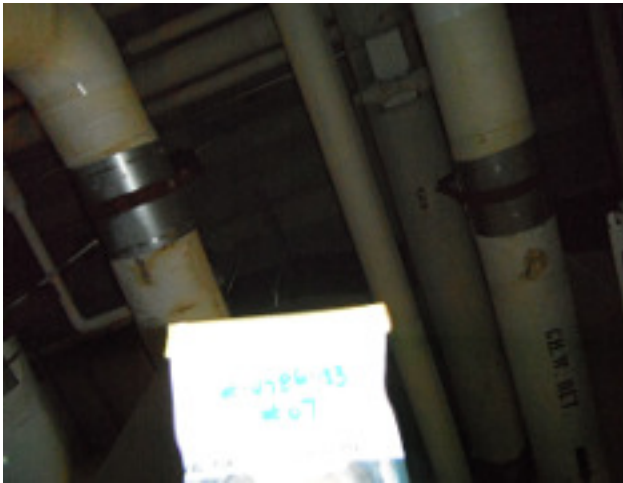
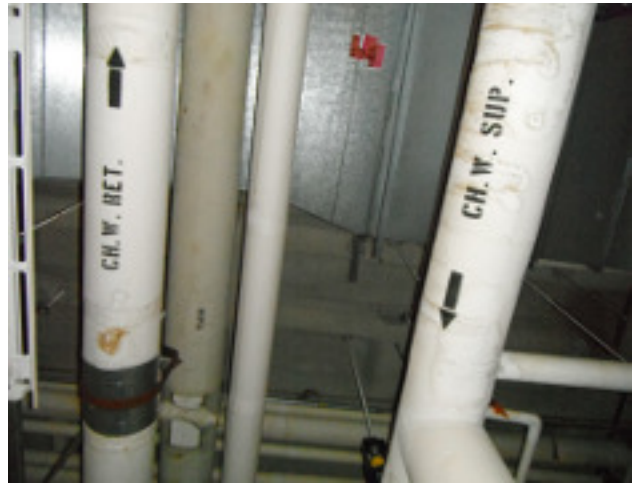
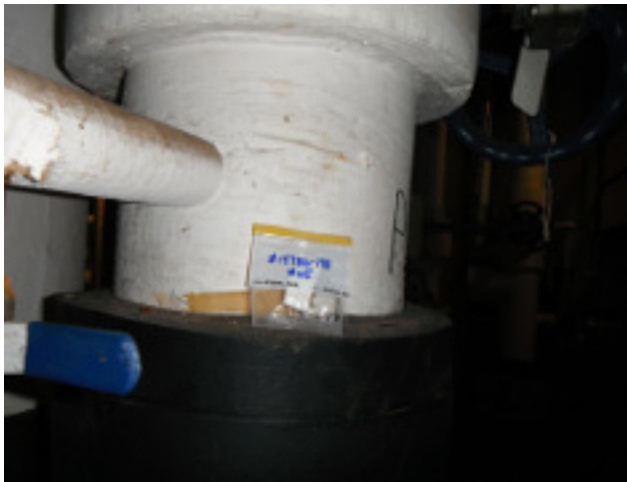
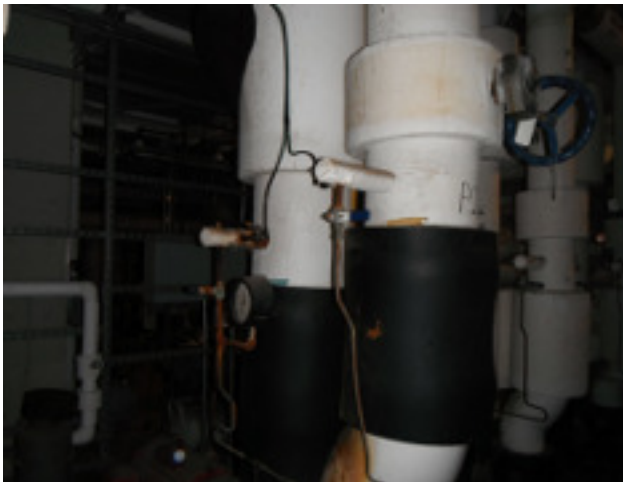
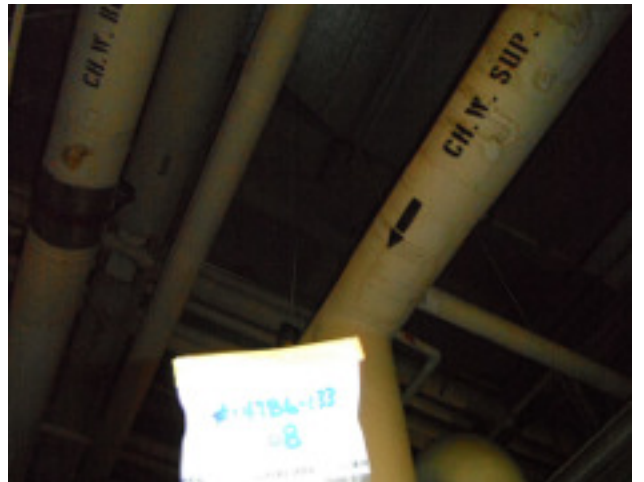
Building 133
Material Sample Photos

Building 133 –

- Rubber insulation mastic, black
- Fiberglass insulation paper wrap
- Spray-on insulation, gray

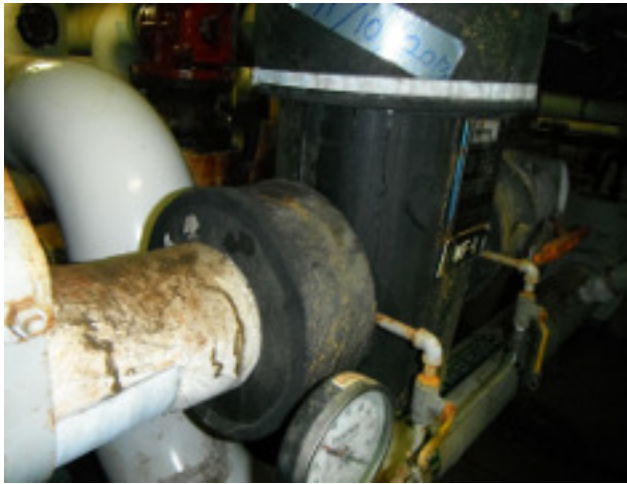
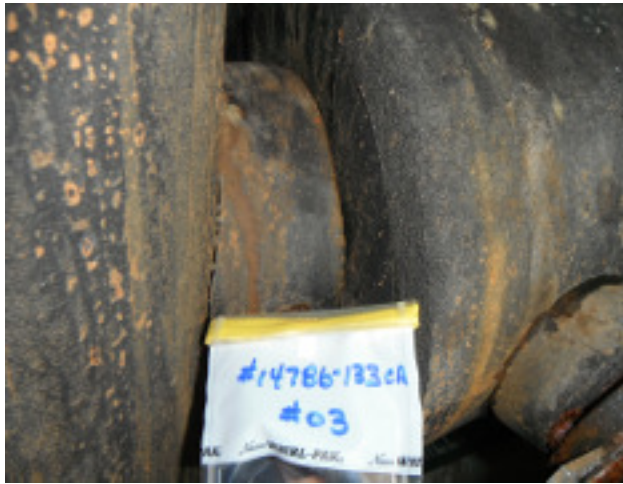
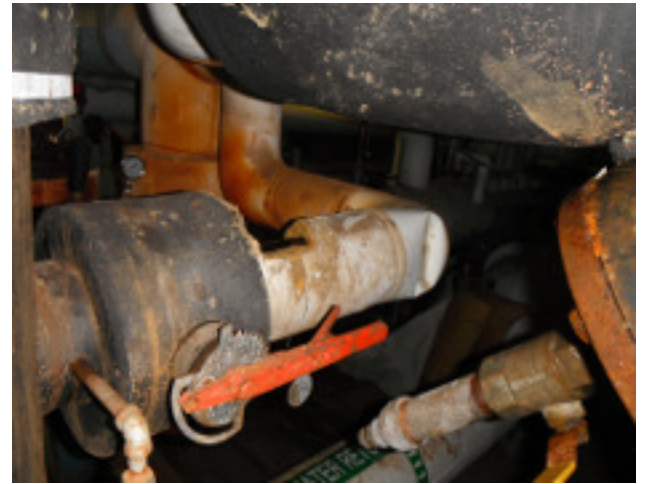
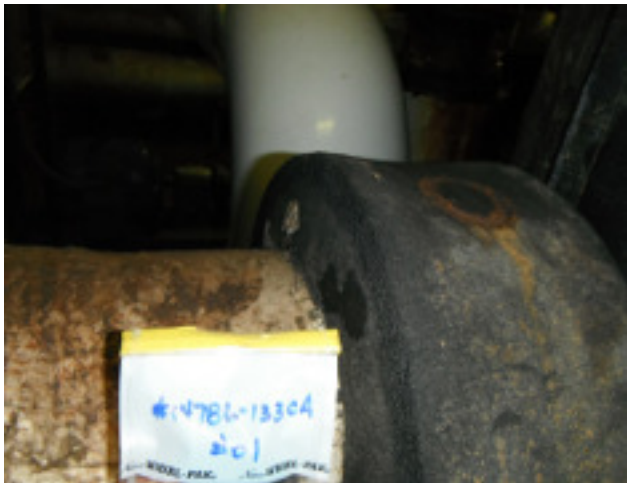
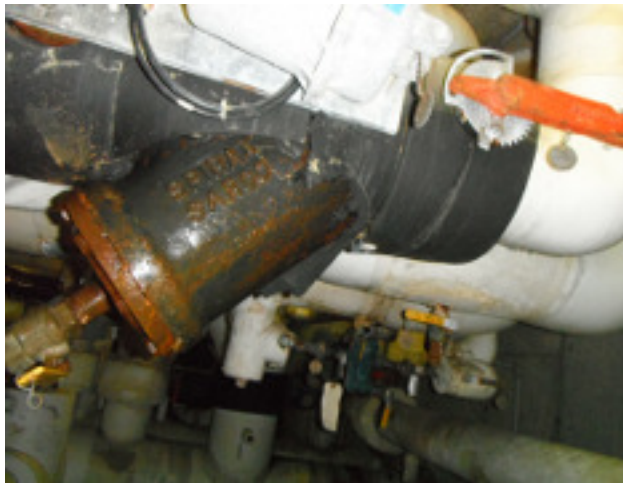
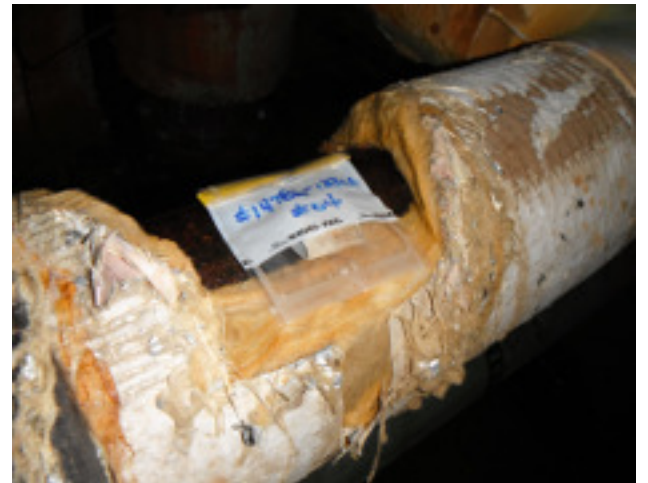
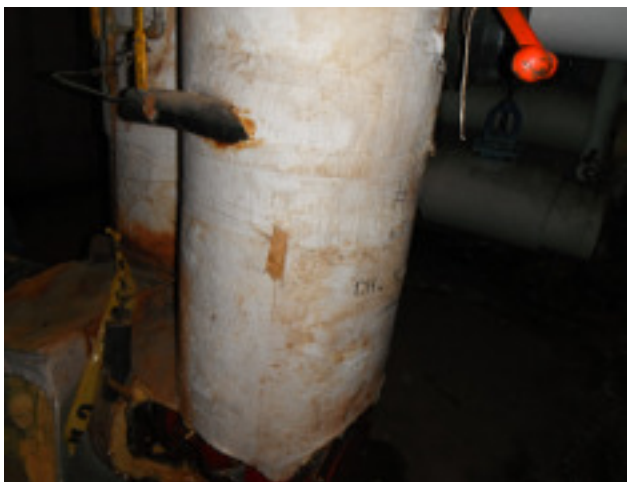
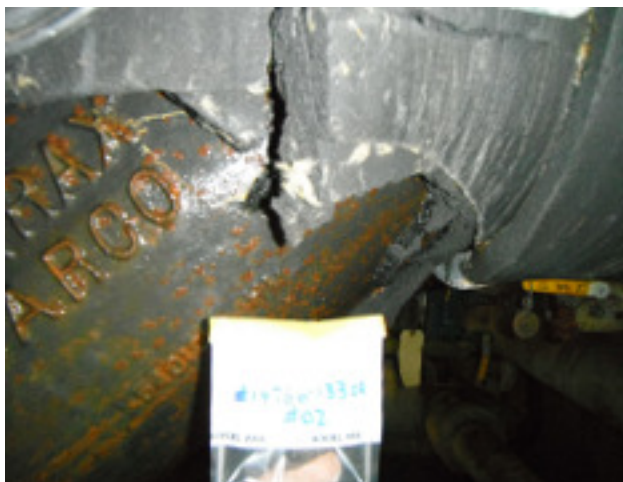
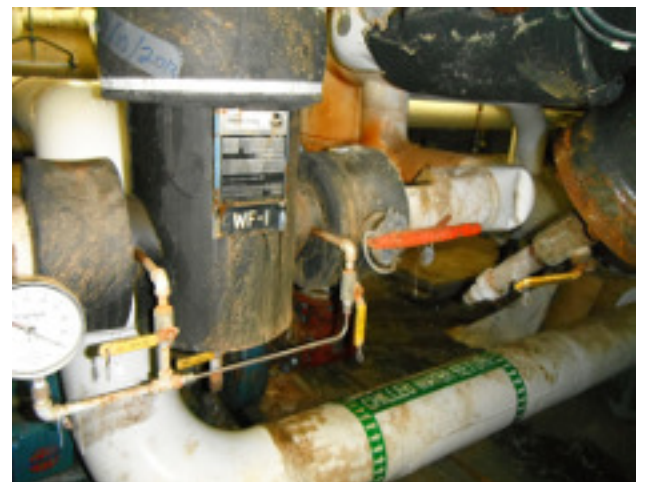
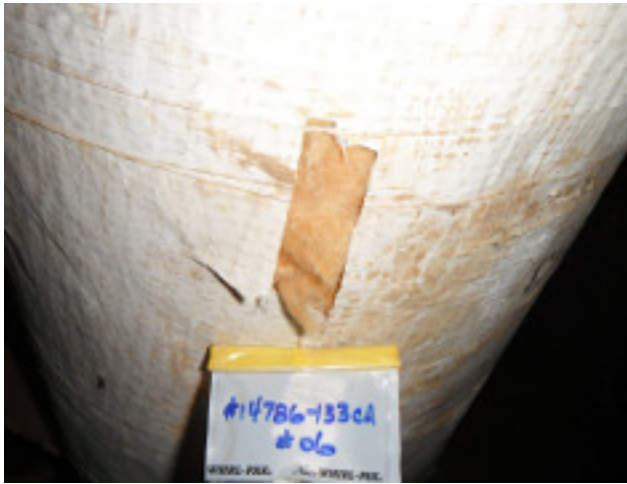
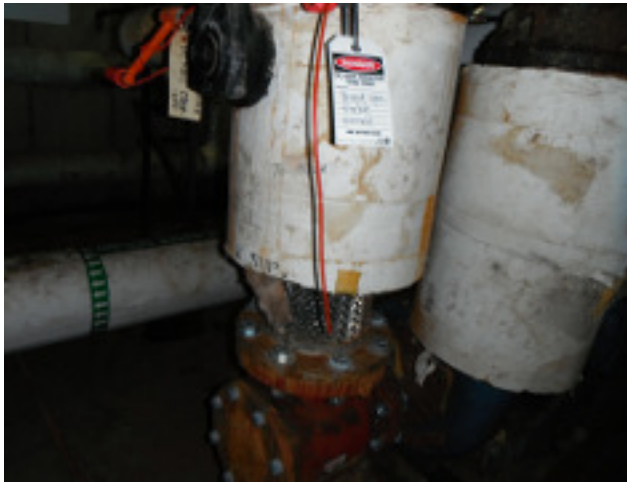
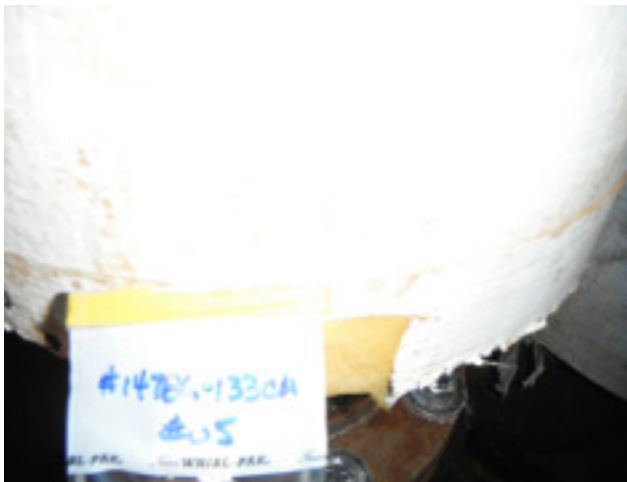
Building 133CA
Material Sample Photos

Building 133CA –

- Rubber insulation mastic, black
- Fiberglass insulation paper wrap

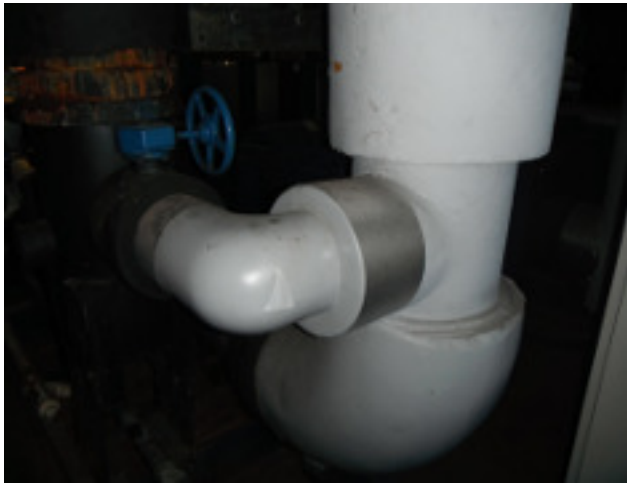
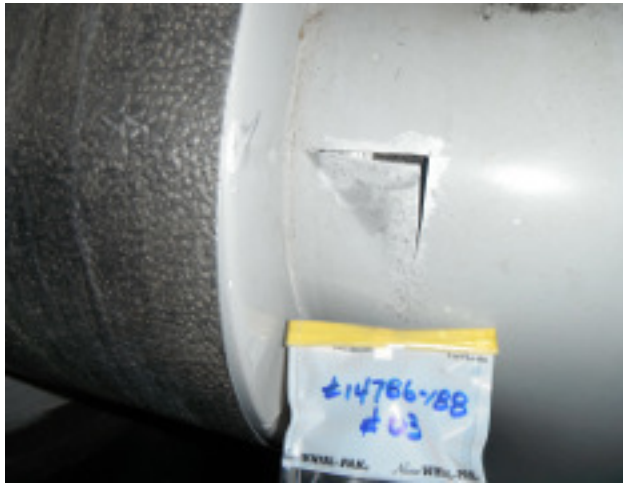
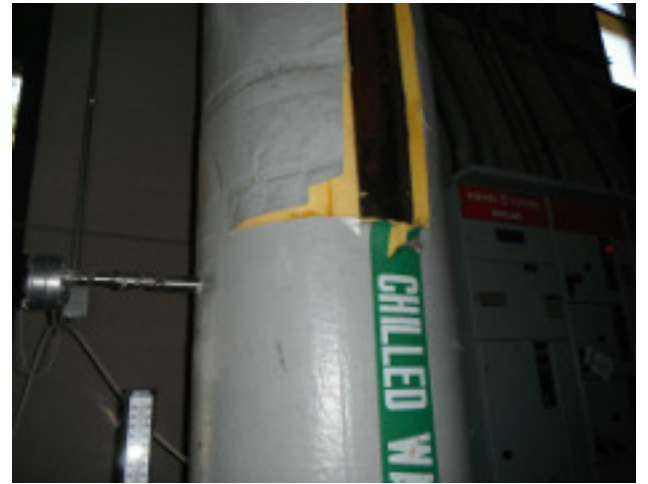
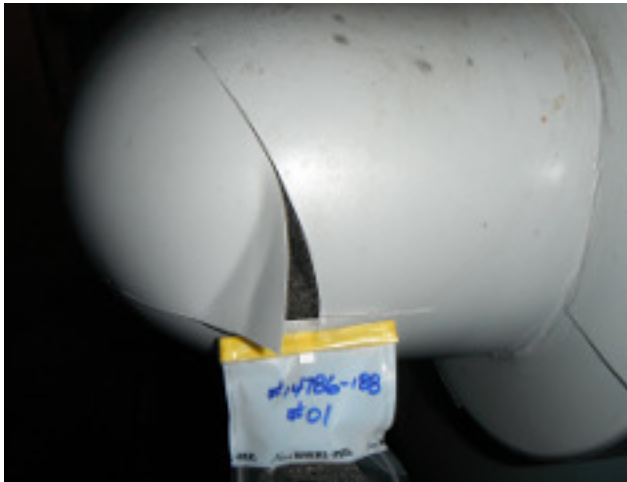
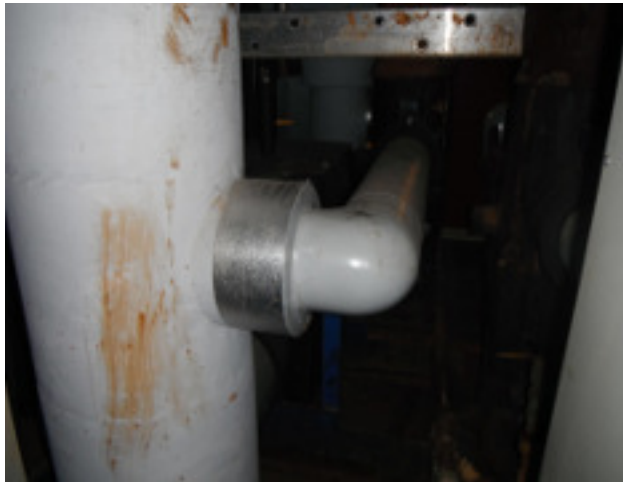
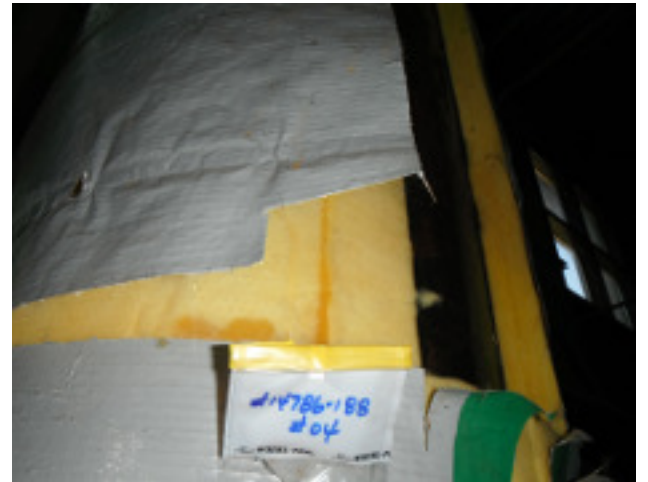
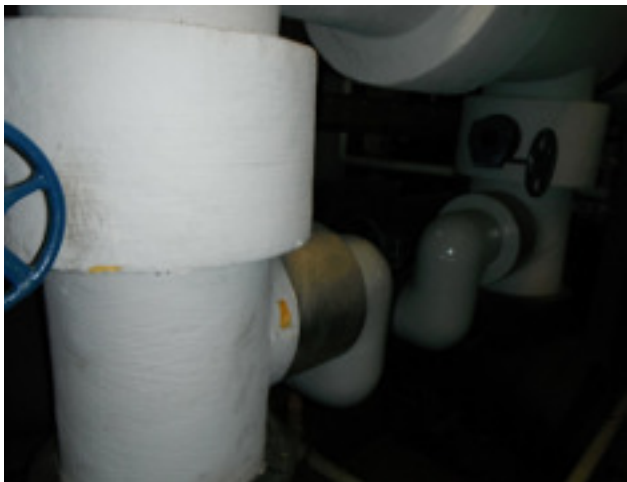
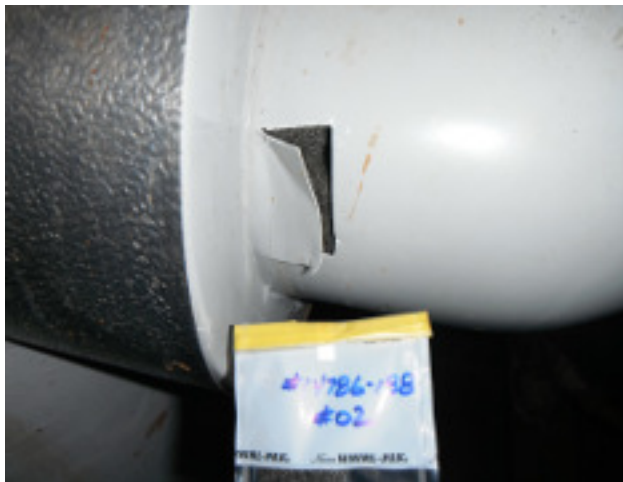
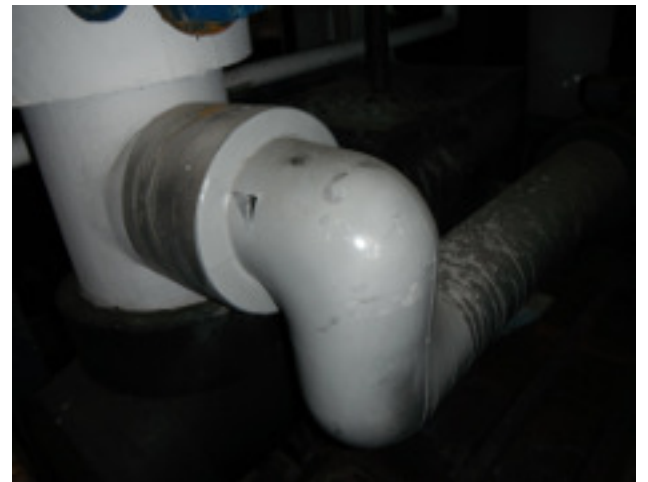
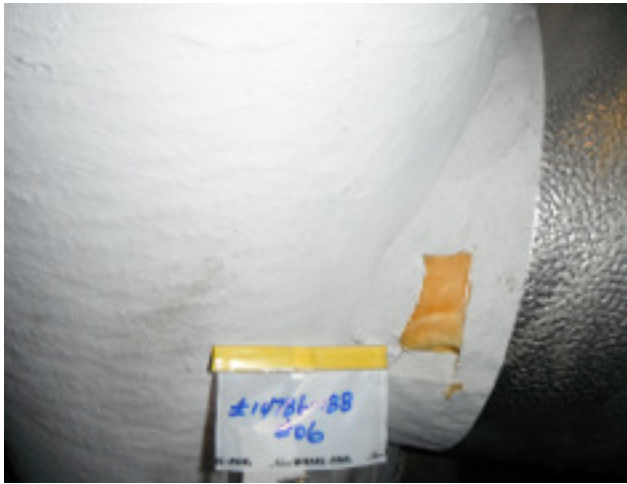
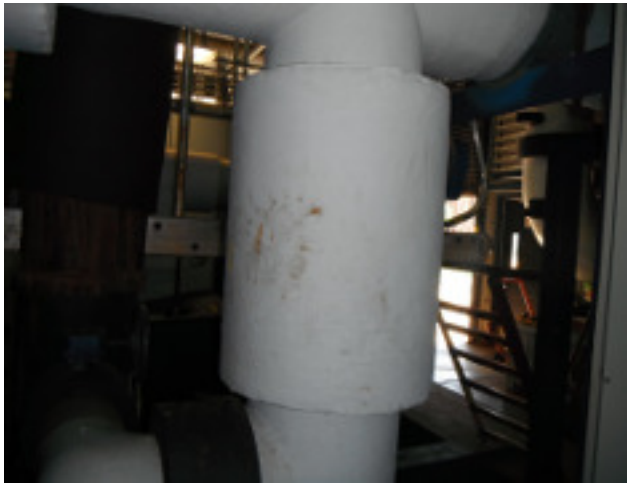
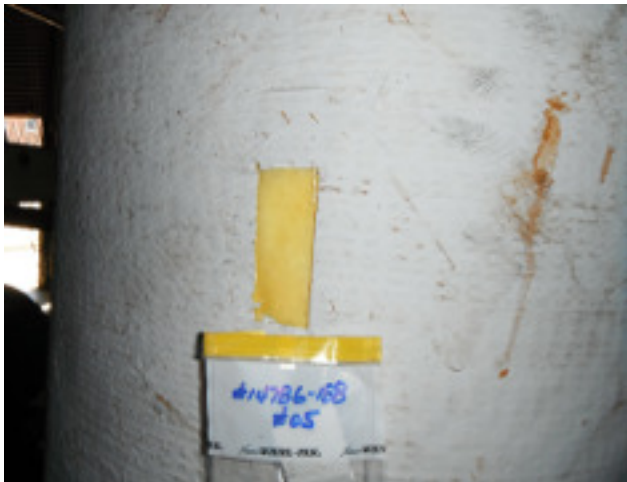
Building 188
Material Sample Photos

Building 188 –

- Fiberglass insulation paper wrap
- Stink block fittings on pipe
