Project No. 01.GSAVA15.15

Subject: Confirmation Asbestos Sampling Report
San Francisco Veterans Affairs Medical Center
Building 1 – Rooms 117, 118 & 119
4150 Clement Street
San Francisco, CA 94116

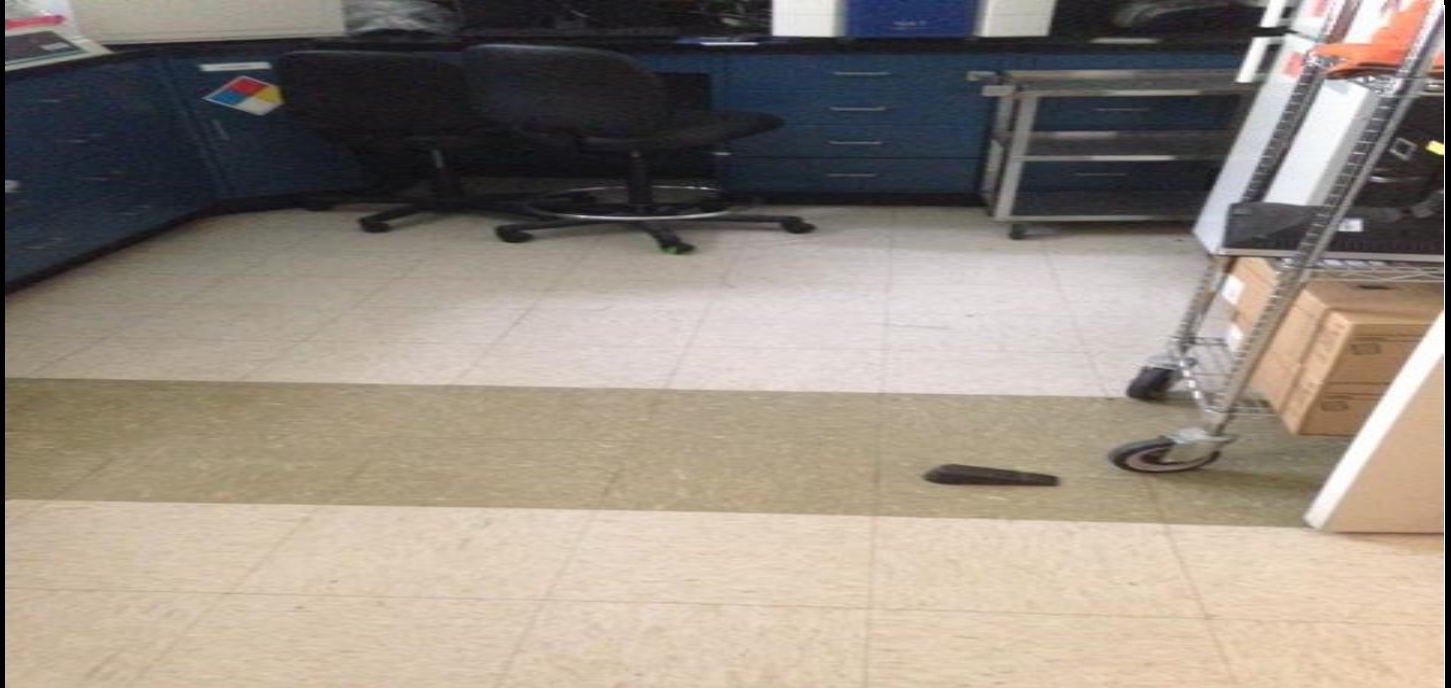
Photograph No. 1

Room 118/119

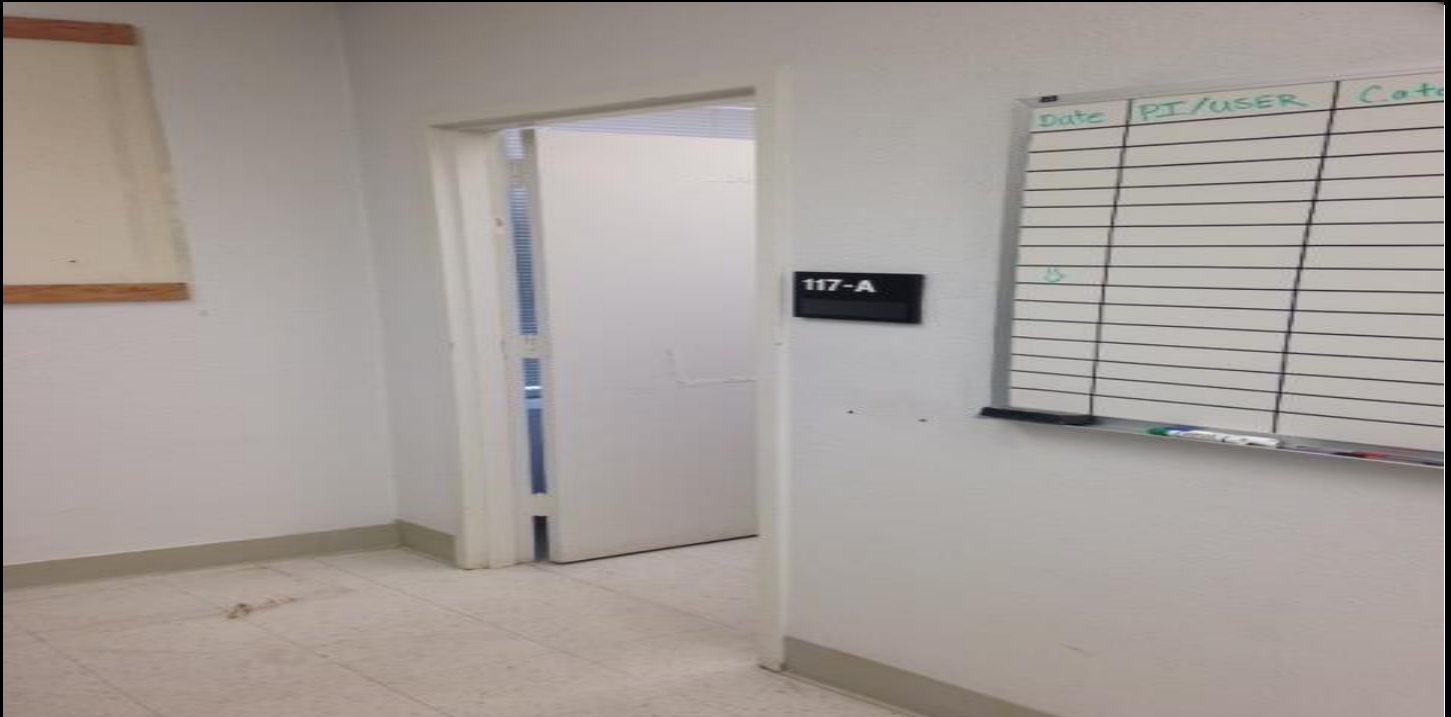
Photograph No. 2

Room 117/117A

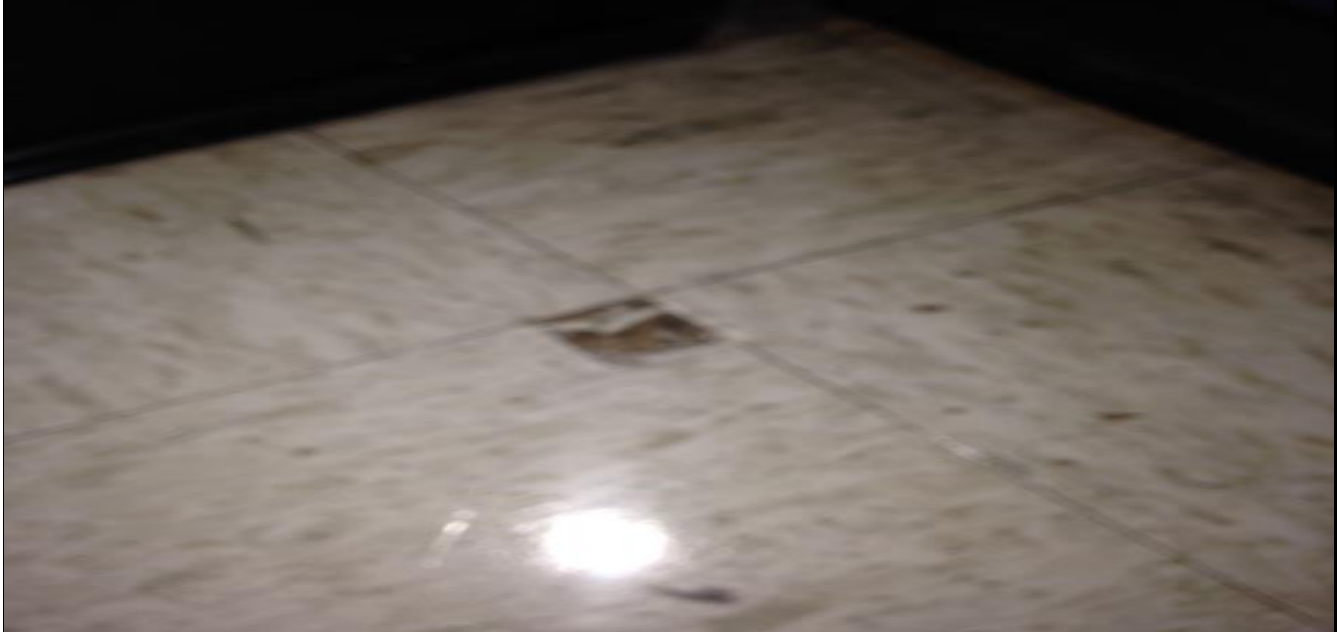
Photograph No. 3

Sample 1A

Client #: 1A		
Micro #: 216345-01A Analyst: RL HM #1 - 12" OFF WHITE TILE AND OLIVE STREAKS WITH BLACK MASTIC OVER BROWN SHEET FLOORING WITH BURLAP BACKING ROOM 118 / 119 - SOUTH UNDER COUNTER	FLOOR TILE (WHITE): 2% CHRYSOTILE ASBESTOS MASTIC (BLACK): 10% CHRYSOTILE ASBESTOS	NFM: SYNTHETIC MATERIAL, CARBONATE, ADHESIVE.
Client #: 1A		
Micro #: 216345-01B Analyst: RL HM #1 - 12" OFF WHITE TILE AND OLIVE STREAKS WITH BLACK MASTIC OVER BROWN SHEET FLOORING WITH BURLAP BACKING ROOM 118 / 119 - SOUTH UNDER COUNTER <i>LAB NOTE: BROWN SHEET FLOORING</i>	FLOORING (BROWN): NONE DETECTED BACKING: NONE DETECTED	5 % CELLULOSE NFM: BINDER, OTHER, MISCELLANEOUS.
Client #: 1B		
Micro #: 216345-02A Analyst: RL HM #1 - 12" OFF WHITE TILE AND OLIVE STREAKS WITH BLACK MASTIC OVER BROWN SHEET FLOORING WITH BURLAP BACKING ROOM 118 / 119 - NORTHEAST CORNER <i>LAB NOTE: OFF WHITE FLOOR TILE</i>	FLOOR TILE (WHITE): 2% CHRYSOTILE ASBESTOS MASTIC (BLACK): 10% CHRYSOTILE ASBESTOS LEVELING COMPOUND (TAN): NONE DETECTED	NFM: SYNTHETIC MATERIAL, CARBONATE, ADHESIVE.

EAI recommends that identified ACMs be removed by a state-licensed abatement contractor prior to any activities that may disturb the material. Should suspect materials be found that have not been previously sampled, it is recommended that a sample be collected and the material(s) remain undisturbed until the sample analytical results are obtained. Additionally, *EAI* recommends that during activities that could cause disturbance creating airborne dust, respiratory protection be used. In general, work should be conducted in accordance with federal, state and local regulations, including, but not limited to, the EPA National Emission Standard for Hazardous Air Pollutants (NESHAP), the California Occupational Safety and Health Administration (Cal-OSHA) and the Bay Area Air Quality Management District (BAAQMD). A summary of asbestos regulations is attached herein.

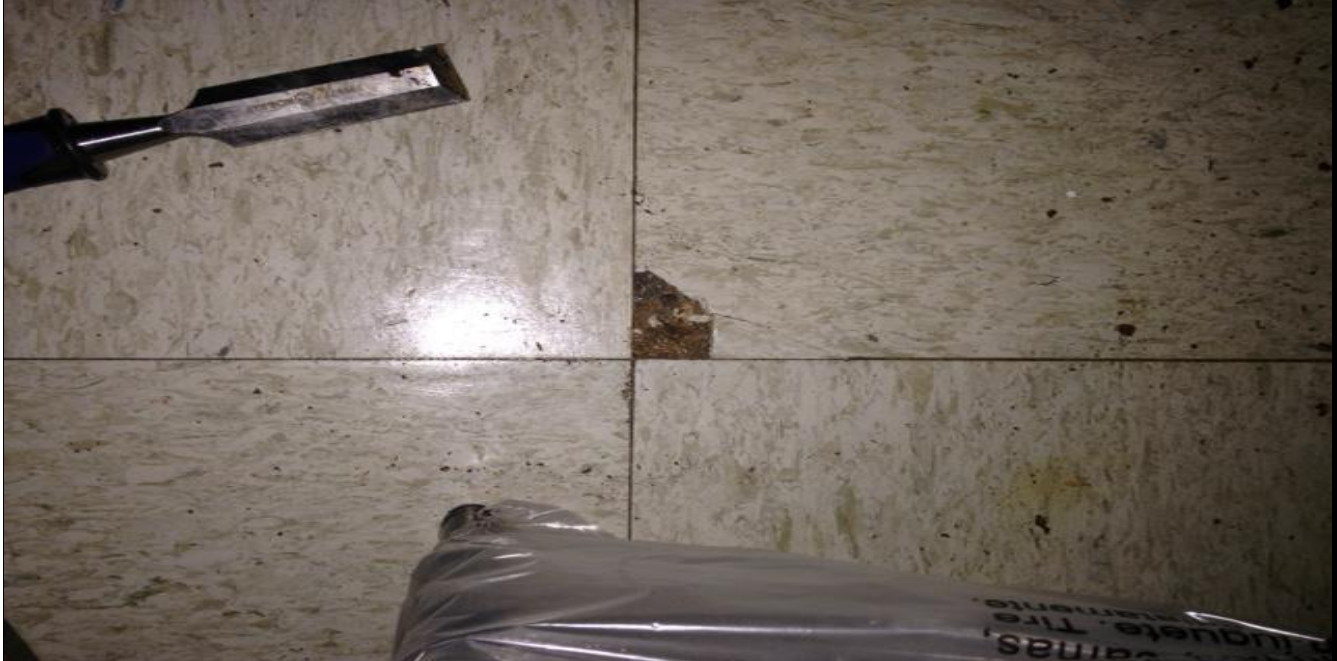
Photograph No. 4

Sample 1B

Client #: 1B		
Micro #: 216345-02B Analyst: RL HM #1 - 12" OFF WHITE TILE AND OLIVE STREAKS WITH BLACK MASTIC OVER BROWN SHEET FLOORING WITH BURLAP BACKING ROOM 118 / 119 - NORTHEAST CORNER <i>LAB NOTE: BROWN SHEET FLOORING</i>	FLOORING (BROWN): NONE DETECTED BACKING: NONE DETECTED	5 % CELLULOSE NFM: BINDER, OTHER, MISCELLANEOUS.
Client #: 2A		
Micro #: 216345-03 Analyst: RL HM #2 - 12" OLIVE TILE WITH BLACK AND YELLOW MASTIC, OVER BROWN SHEET FLOORING AND BURLAP BACKING ROOM 118 / 119 - WEST BUILDING WALL	FLOOR TILE: 2% CHRYSOTILE ASBESTOS MASTIC (BLACK / YELLOW): 10% CHRYSOTILE ASBESTOS LEVELING COMPOUND (TAN): NONE DETECTED	NFM: SYNTHETIC MATERIAL, CARBONATE, ADHESIVE.

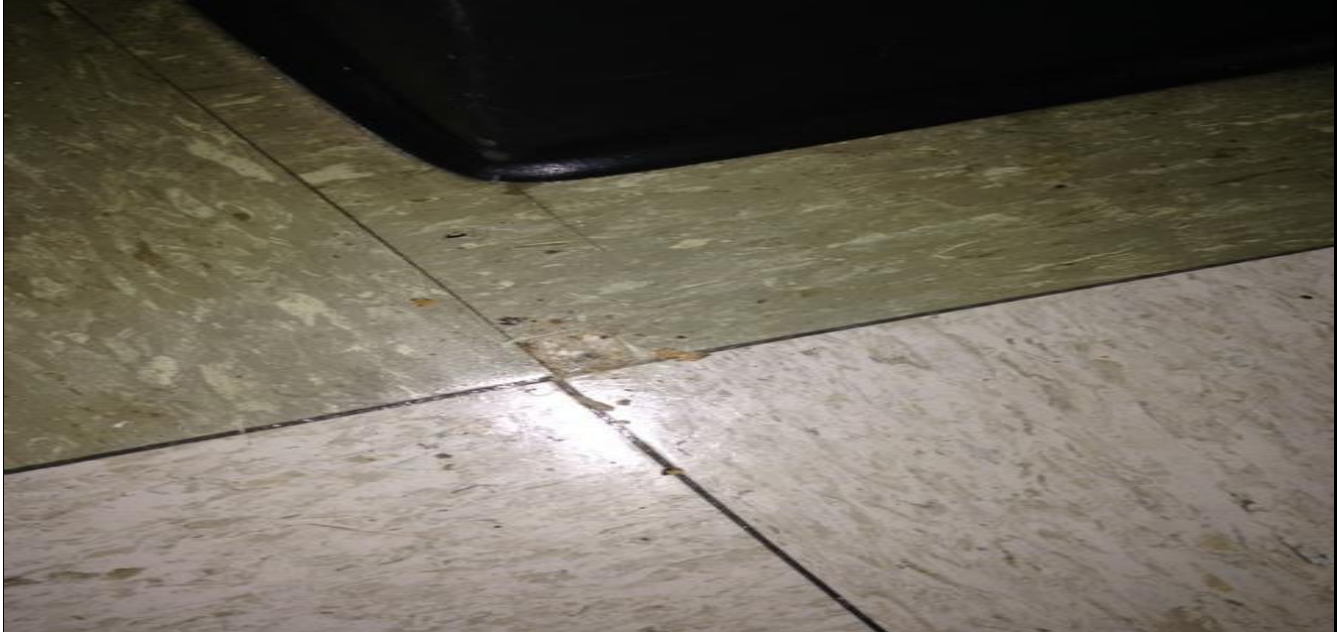
Photograph No. 5

Sample 2A

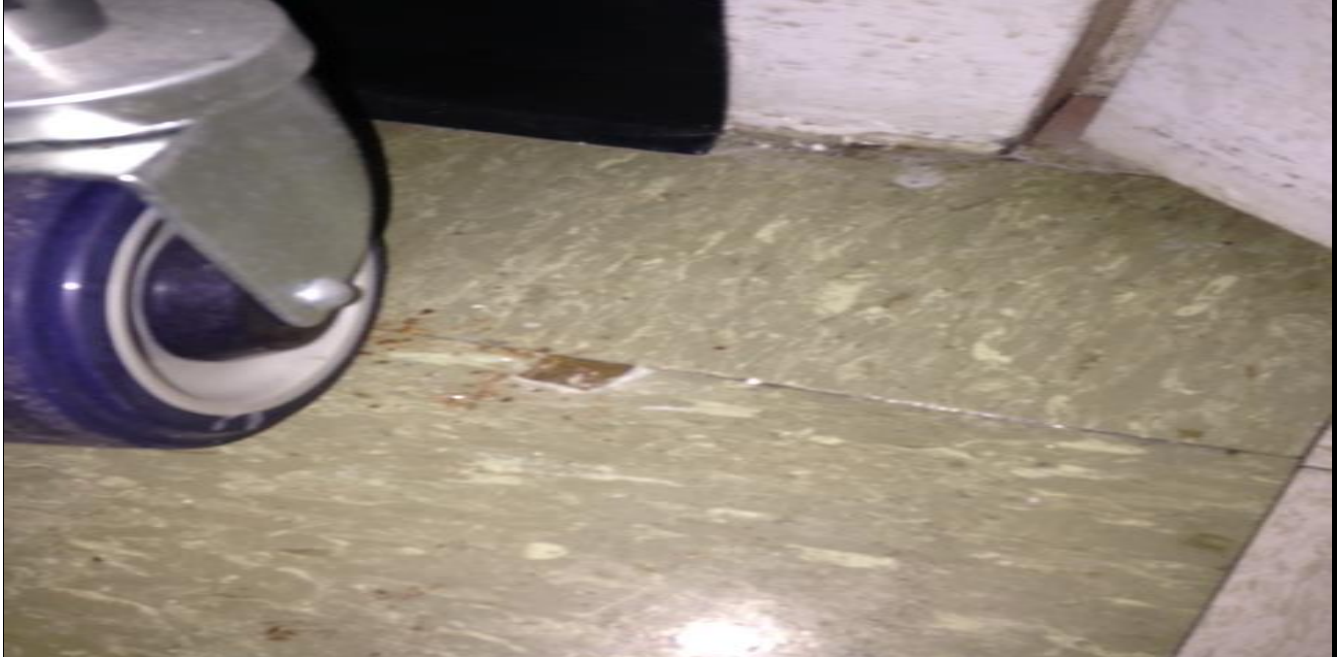
Photograph No. 6

Sample 2B

Client #: 2B		
Micro #: 216345-04A Analyst: RL AF HM #2 - 12" OLIVE TILE WITH BLACK AND YELLOW MASTIC, OVER BROWN SHEET FLOORING AND BURLAP BACKING ROOM 118 / 119 - BEHIND DOOR LAB NOTE: FLOOR TILE	FLOOR TILE: 2% CHRYSOTILE ASBESTOS MASTIC (BROWN / YELLOW): NONE DETECTED	NFM: SYNTHETIC MATERIAL, CARBONATE, ADHESIVE.
Client #: 2B		
Micro #: 216345-04B Analyst: RL AF HM #2 - 12" OLIVE TILE WITH BLACK AND YELLOW MASTIC, OVER BROWN SHEET FLOORING AND BURLAP BACKING ROOM 118 / 119 - BEHIND DOOR LAB NOTE: BROWN SHEET FLOORING	FLOORING (BROWN): NONE DETECTED BACKING: NONE DETECTED	5 % CELLULOSE NFM: BINDER, OTHER, MISCELLANEOUS.
Client #: 3A		
Micro #: 216345-05A Analyst: RL HM #3 - 12" WHITE TILE AND GREY FLECKS WIT BLACK MASTIC OVER TAN TILE AND BLACK MASTIC OVER BROWN RSF AND BURLAP BACKING ROOM 117 - SOUTHWEST AREA LAB NOTE: TOP FLOOR TILE	FLOOR TILE: NONE DETECTED MASTIC (BLACK): NONE DETECTED	NFM: SYNTHETIC MATERIAL, CARBONATE, ADHESIVE.

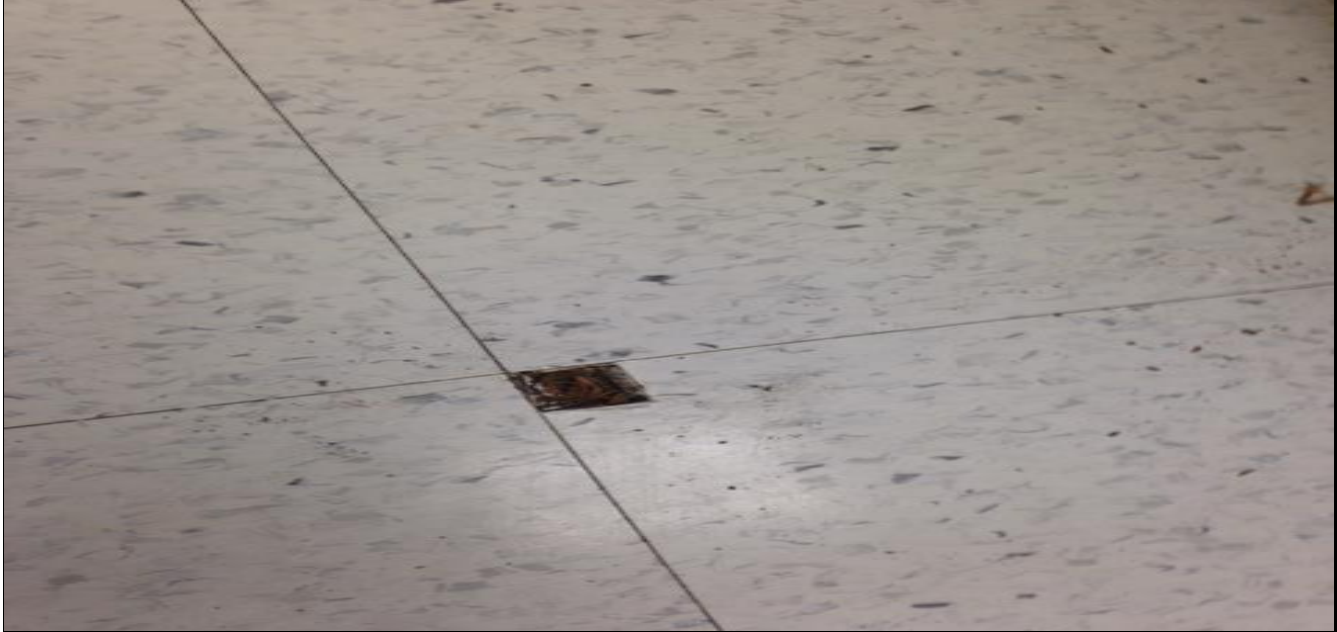
Photograph No. 7

Sample 3A

Client #: 3A		
Micro #: 216345-05B Analyst: RL HM #3 - 12" WHITE TILE AND GREY FLECKS WIT BLACK MASTIC OVER TAN TILE AND BLACK MASTIC OVER BROWN RSF AND BURLAP BACKING ROOM 117 - SOUTHWEST AREA LAB NOTE: MIDDLE FLOOR TILE	FLOOR TILE: 3% CHRYSOTILE ASBESTOS MASTIC (BLACK): 5% CHRYSOTILE ASBESTOS	NFM: SYNTHETIC MATERIAL, CARBONATE, ADHESIVE.
Client #: 3A		
Micro #: 216345-05C Analyst: RL HM #3 - 12" WHITE TILE AND GREY FLECKS WIT BLACK MASTIC OVER TAN TILE AND BLACK MASTIC OVER BROWN RSF AND BURLAP BACKING ROOM 117 - SOUTHWEST AREA LAB NOTE: BOTTOM FLOOR TILE	FLOORING: NONE DETECTED BACKING: NONE DETECTED	5 % CELLULOSE NFM: BINDER, OTHER, MISCELLANEOUS.

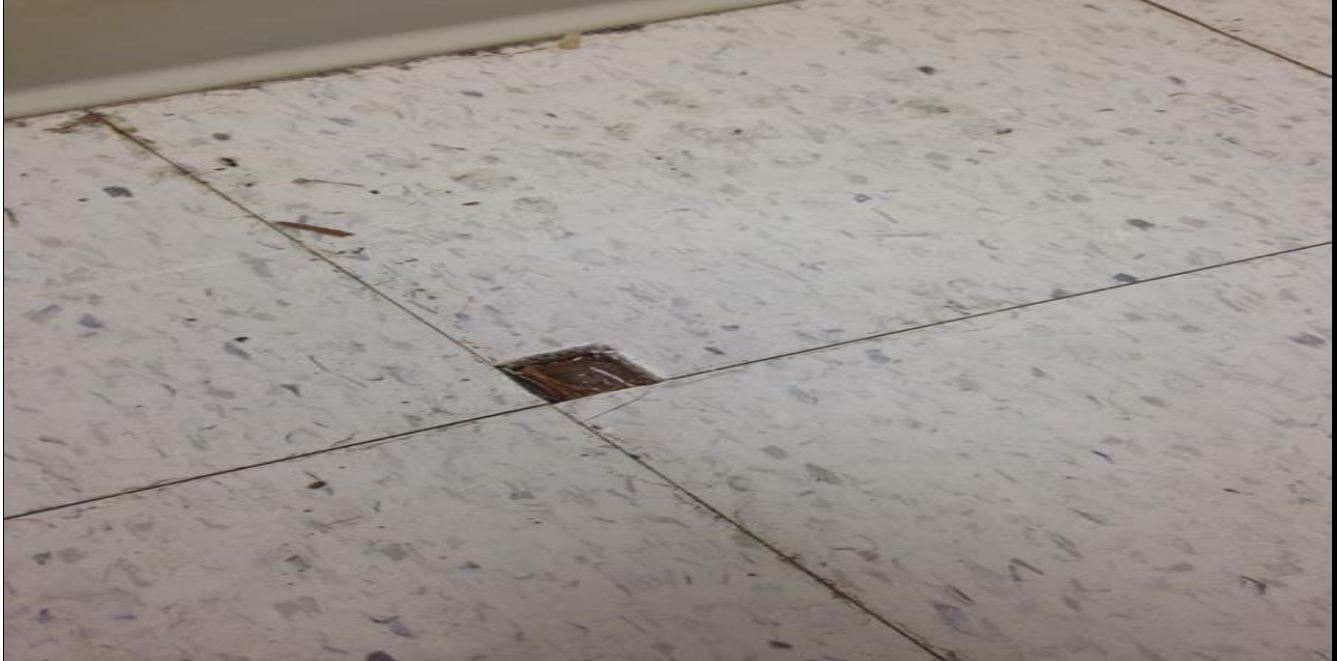
Photograph No. 8

Sample 3B

Client #: 3B		
Micro #: 216345-06A Analyst: RL HM #3 - 12" WHITE TILE AND GREY FLECKS WIT BLACK MASTIC OVER TAN TILE AND BLACK MASTIC OVER BROWN RSF AND BURLAP BACKING ROOM 117 - EAST ALCOVE LAB NOTE: TOP FLOOR TILE	FLOOR TILE: NONE DETECTED MASTIC (BLACK): NONE DETECTED	NFM: SYNTHETIC MATERIAL, CARBONATE, ADHESIVE.
Client #: 3B		
Micro #: 216345-06B Analyst: RL HM #3 - 12" WHITE TILE AND GREY FLECKS WIT BLACK MASTIC OVER TAN TILE AND BLACK MASTIC OVER BROWN RSF AND BURLAP BACKING ROOM 117 - EAST ALCOVE LAB NOTE: MIDDLE FLOOR TILE	FLOOR TILE: 3% CHRYSOTILE ASBESTOS MASTIC (BLACK): 5% CHRYSOTILE ASBESTOS	NFM: SYNTHETIC MATERIAL, CARBONATE, ADHESIVE.
Client #: 3B		
Micro #: 216345-06C Analyst: RL HM #3 - 12" WHITE TILE AND GREY FLECKS WIT BLACK MASTIC OVER TAN TILE AND BLACK MASTIC OVER BROWN RSF AND BURLAP BACKING ROOM 117 - EAST ALCOVE LAB NOTE: BOTTOM FLOOR TILE	FLOORING: NONE DETECTED BACKING: NONE DETECTED MASTIC (BROWN): NONE DETECTED	20 % CELLULOSE NFM: BINDER, OTHER, MISCELLANEOUS.

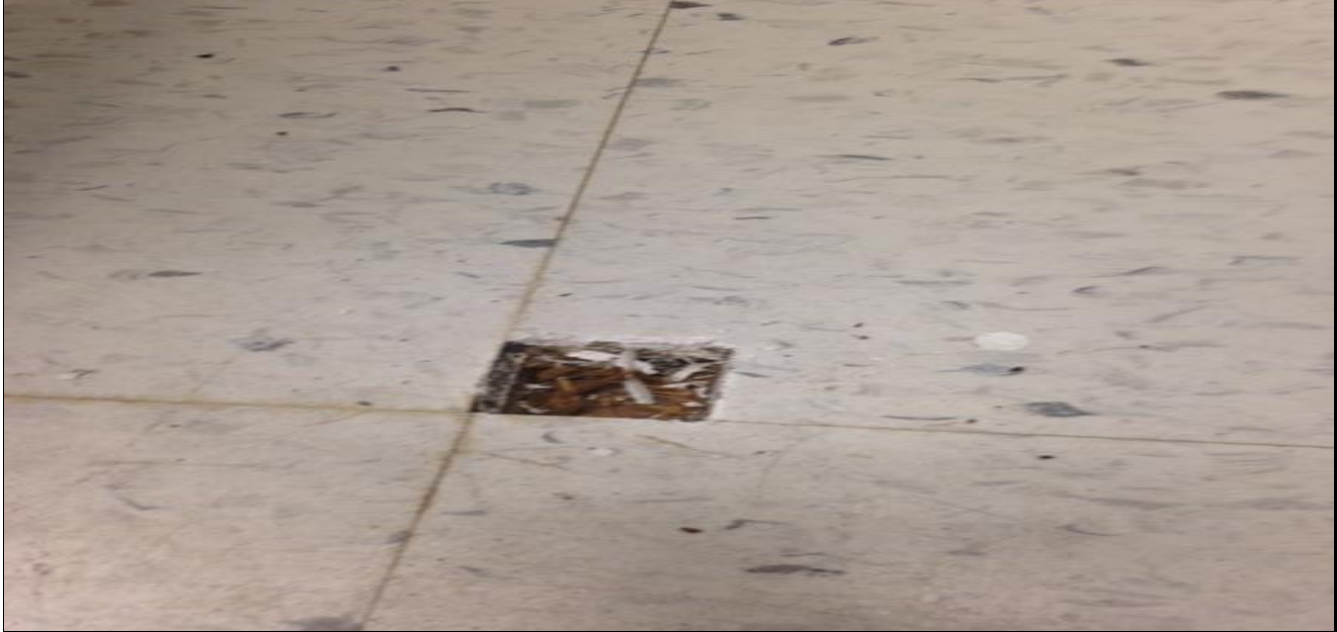
Photograph No. 9

Sample 3C

Client #: 3C		
Micro #: 216345-07A Analyst: RL HM #3 - 12" WHITE TILE AND GREY FLECKS WIT BLACK MASTIC OVER TAN TILE AND BLACK MASTIC OVER BROWN RSF AND BURLAP BACKING ROOM 117A - NORTHWEST CORNER LAB NOTE: TOP FLOOR TILE	FLOOR TILE: NONE DETECTED MASTIC (BLACK): NONE DETECTED	NFM: SYNTHETIC MATERIAL, CARBONATE, ADHESIVE.
Client #: 3C		
Micro #: 216345-07B Analyst: RL HM #3 - 12" WHITE TILE AND GREY FLECKS WIT BLACK MASTIC OVER TAN TILE AND BLACK MASTIC OVER BROWN RSF AND BURLAP BACKING ROOM 117A - NORTHWEST CORNER LAB NOTE: MIDDLE FLOOR TILE	FLOOR TILE: 3% CHRYSOTILE ASBESTOS MASTIC (BLACK): 5% CHRYSOTILE ASBESTOS	NFM: SYNTHETIC MATERIAL, CARBONATE, ADHESIVE.

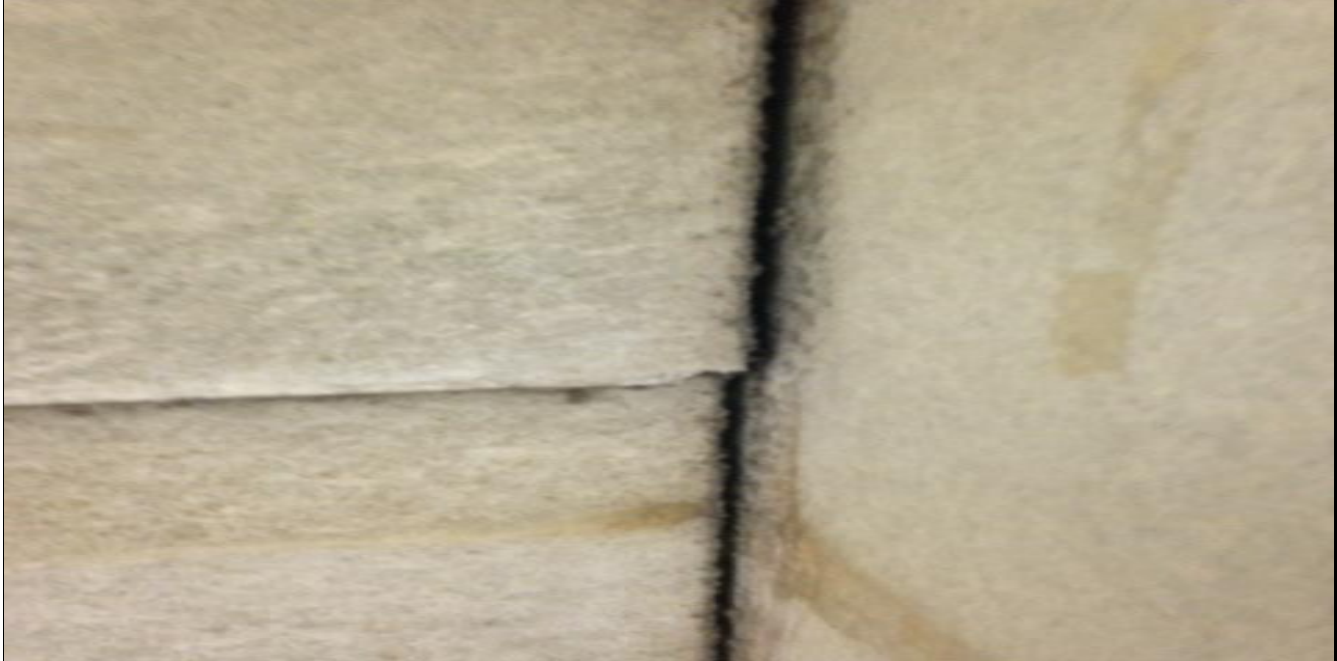
Photograph No. 10

- **Fume Hood Panels located in Room 117 inside the fume hoods (40% Chrysotile Asbestos)**

Sample 4A
