**LIMITED RENOVATION
ASBESTOS SURVEY REPORT**

**Site Preparation for PET/CT Installation
Project 546-CSI-113
Bruce W. Carter VAMC
Miami, Florida**

GLE Project No.: 15950-00326

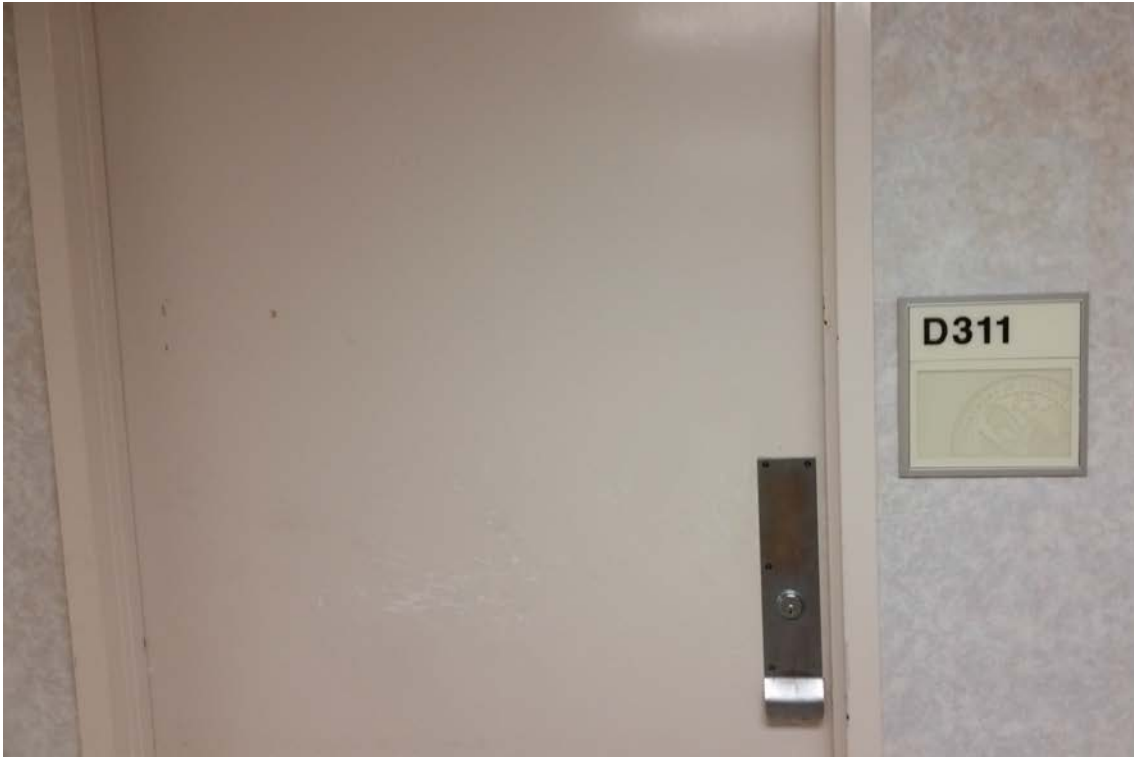
Upper Photo:
Room D311 at Bruce W. Carter VAMC

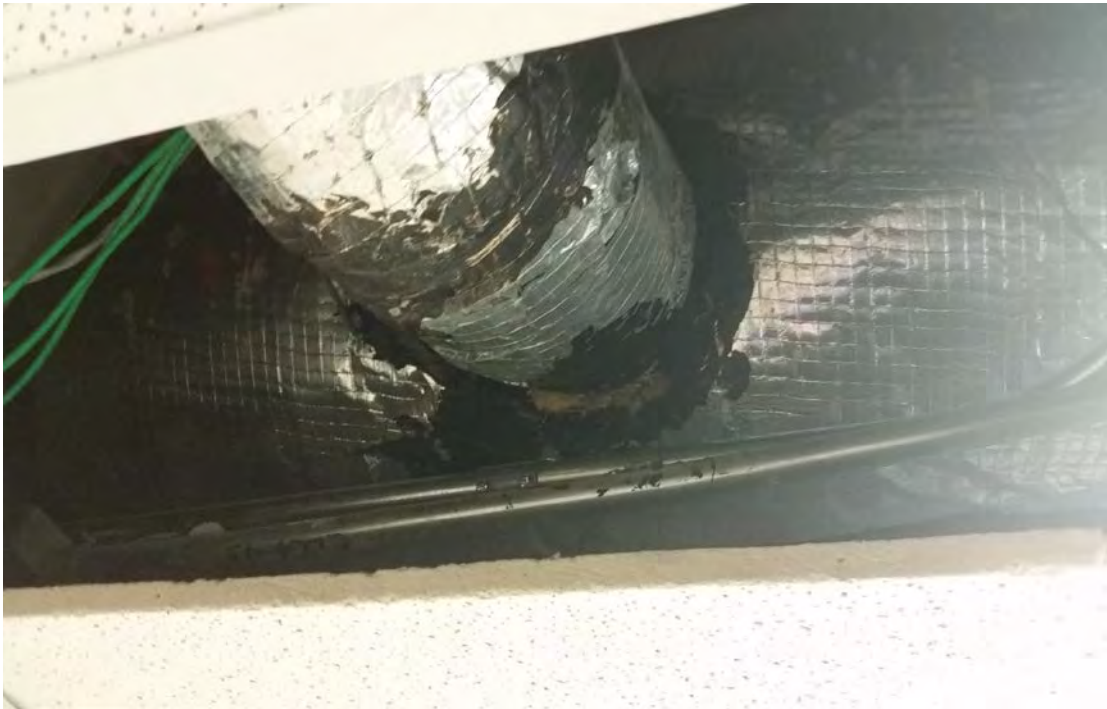
Black HVAC Duct Mastic Black Mastic on Fiberglass Pipe Insulation

These materials are defined by the EPA as a Category I or Category II non-friable materials. These materials do not appear to present a significant issue, as observed, at the time of the survey. We recommend that the identified ACM be maintained as part of an O&M Program and periodically monitored for any changes in condition. Additionally, we recommend that a licensed asbestos abatement contractor properly remove and dispose of the ACM prior to conducting renovation activities that might disturb the ACM. However, Florida regulations do allow a properly trained and licensed roofing contractor to disturb asphalt roofing materials.

Lower Photo:
Black HVAC duct mastic

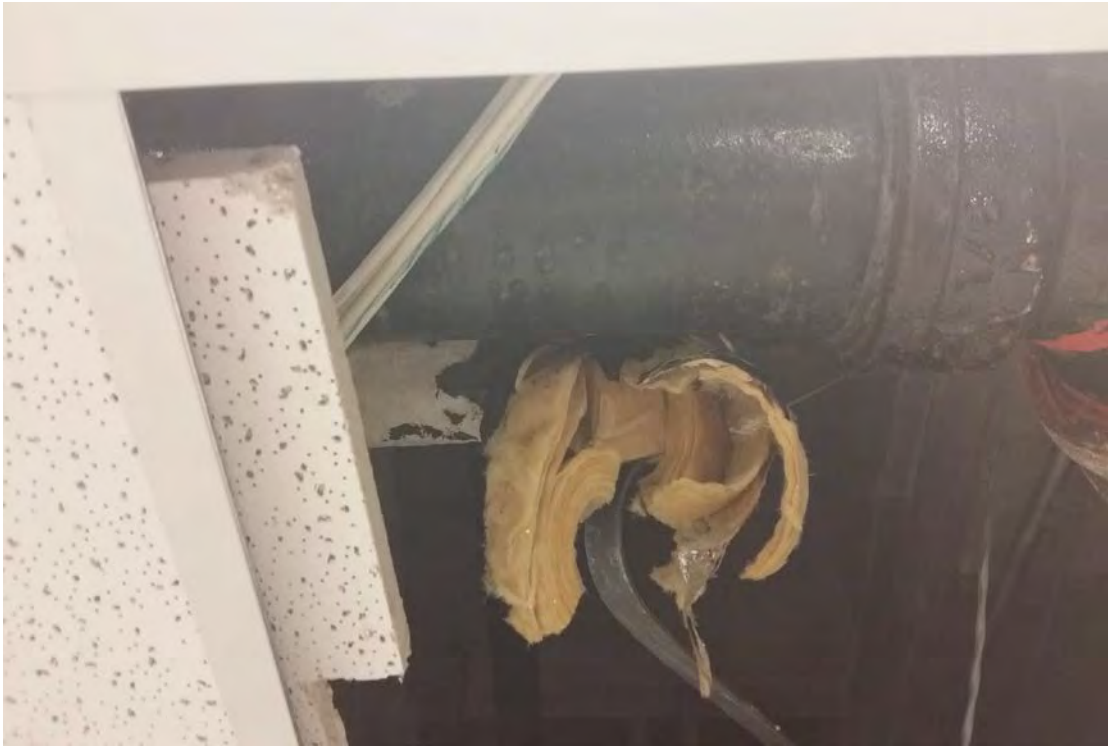
Black HVAC duct mastic with yellow HVAC duct insulation
