**GEOTECHNICAL ENGINEERING REPORT**

VA HOSPITAL – STORAGE BUILDING  
WILKES-BARRE, PA

(Project #13114.1)

OCTOBER 29, 2013

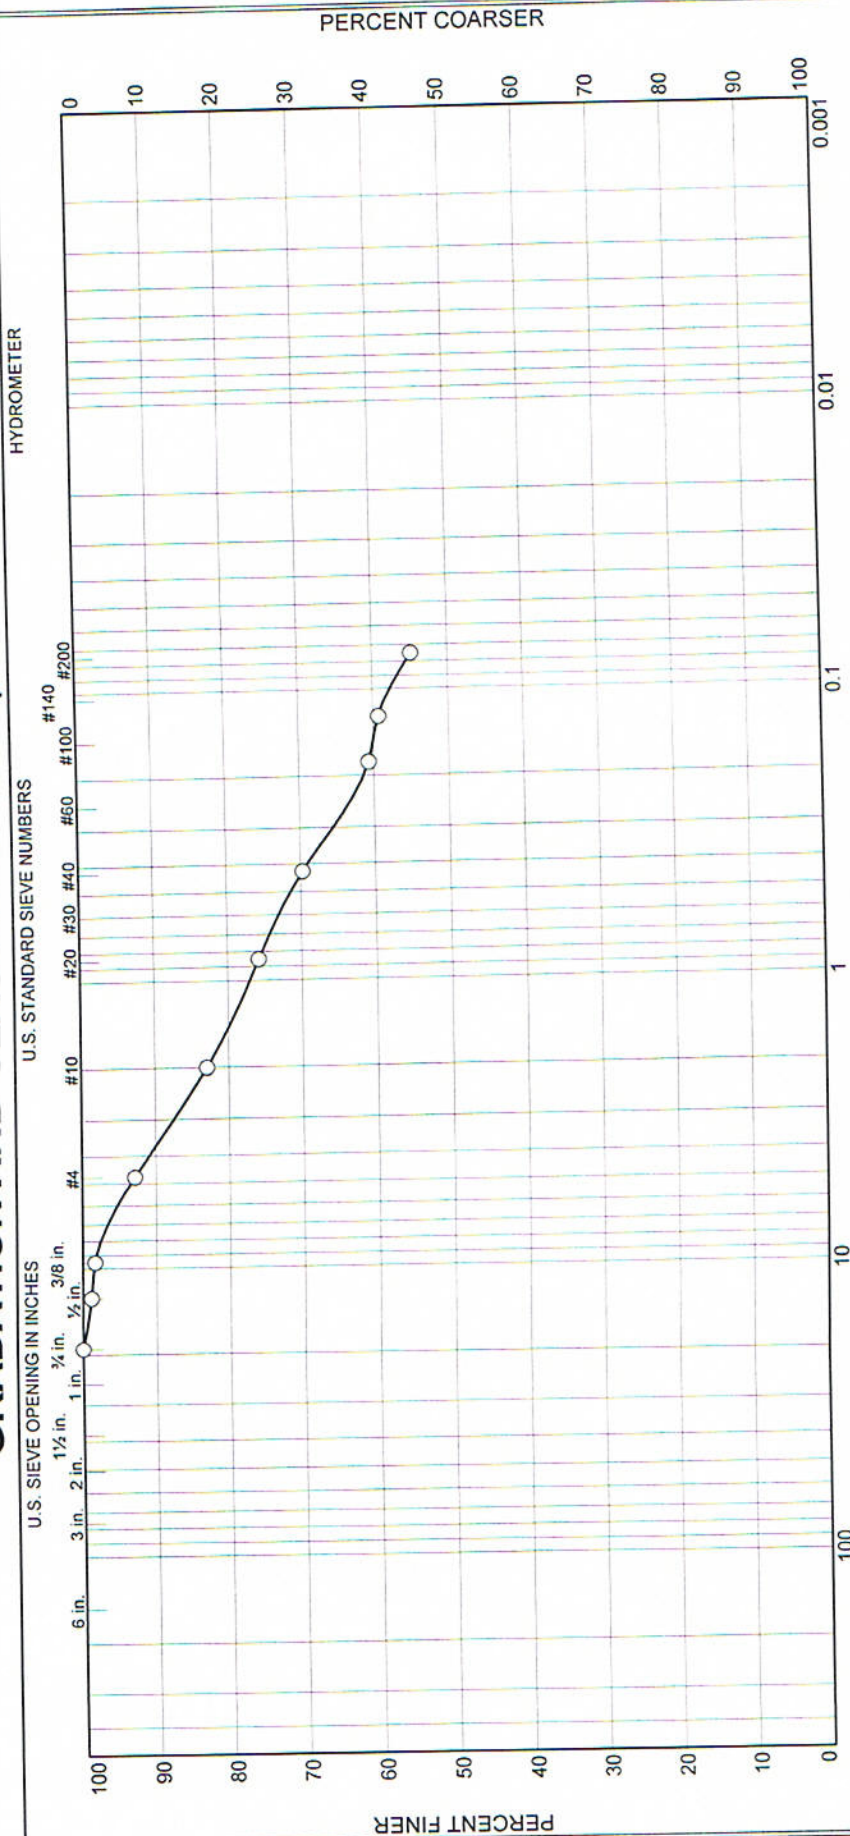
GRAIN SIZE - mm.									
% +3"	% Gravel		% Sand			% Fines		Silt	Clay
	Coarse	Fine	Coarse	Medium	Fine				
0.0	0.0	7.1	10.0	13.2	14.9	54.8

Source	Sample #	Depth/Elev.	Date Sampled	USCS	Material Description	NM %	LL	PL
TP-4	1	4.0'/852	10/23/13	ML	brown sandy SILT Stratum B	22.3	NV	NP

Soil laboratory testing was performed on selected samples from the test pit locations for classification and assessment purposes. Results of testing are included as Enclosure (2) and are summarized below. The natural moisture content was also determined for selected soil samples per ASTM D-2216, as shown on the test pit logs in Enclosure (3).

<u>Test Pit</u>	<u>Depth/ Elevation</u>	<u>Stratum</u>	<u>Classification (D-2487)</u>	<u>% M (D-2216)</u>	<u>% &lt; #200 Sieve Size (D-1140)</u>
TP-4	4.0' El 852.0	B	brown sandy SILT (ML)	22.3%	55%

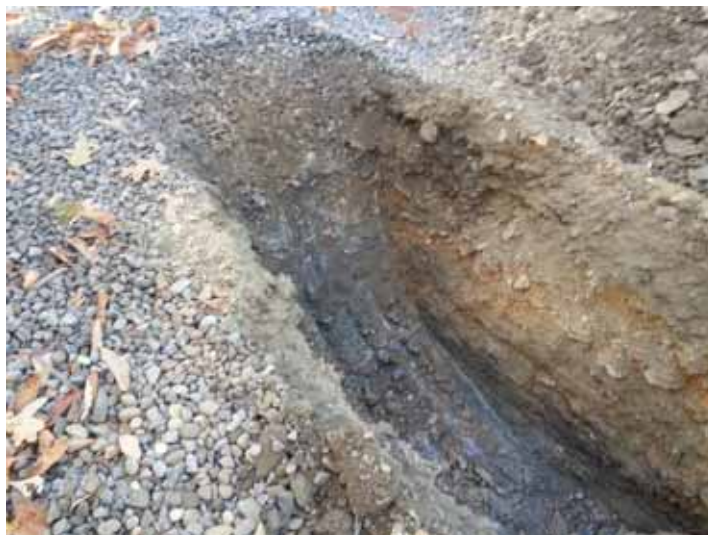
## TEST PIT LOG TP-1

Depth (ft.)	Strata Description	Class.	Str'm	Elev.	InSitu Testing		M (%)	Remarks
					Depth	Geo. Pen.		
	brown silty gravel with sand – FILL		F					
1				853.5	1			
	light brown silty SAND with gravel	SM	B					
2				852.0	2			
	gray DISINTEGRATED ROCK, (shale)		DR					
3				851.0	3			
	Refusal on Rock at 3.5 feet Bottom of Test Pit at 3.5 feet		R					
4					4			
5					5			
6					6			
7					7			
8					8			
9					9			
10					10

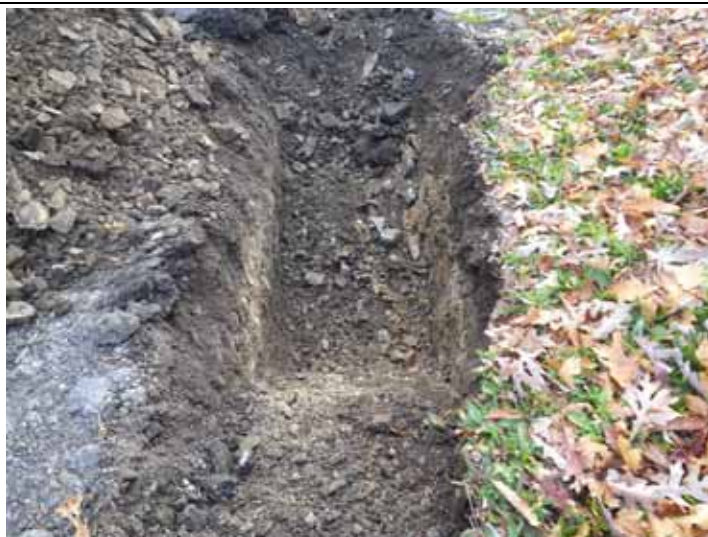
## TEST PIT LOG TP-2

Depth (ft.)	Strata Description	Class.	Str'm	Elev.	InSitu Testing		M (%)	Remarks
					Depth	Geo. Pen.		
	brown silty gravel with sand – FILL		F	852.4				
1	gray, brown DISINTEGRATED ROCK		DR		1			
2	@ 2' – 2.5': gray sandstone			850.5	2			
3	Refusal on Rock at 2.5 feet Bottom of Test Pit at 2.5 feet		R		3			
4					4			
5					5			
6					6			
7					7			
8					8			
9					9			
10					10

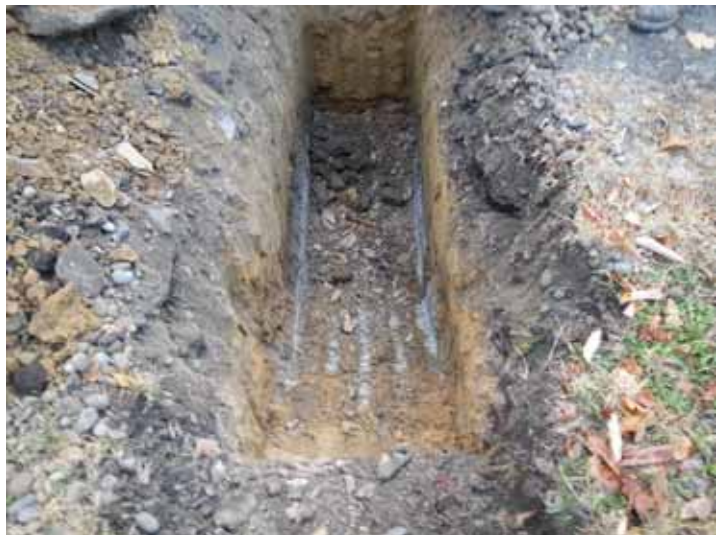
## TEST PIT LOG TP-3

Depth (ft.)	Strata Description	Class.	Str'm	Elev.	InSitu Testing		M (%)	Remarks
					Depth	Geo. Pen.		
	brown silty gravel with sand – FILL		F					
1	light brown sandy SILT with gravel, very compact	ML	B	853.5	1		21.7	
2	trace roots to 2.0'				2			
				852.0				
3	gray DISINTEGRATED ROCK, (shale)		DR		3			
4					4			
				850.0				
5	Bottom of Test Pit at 4.5 feet				5			
6					6			
7					7			
8					8			
9					9			
10					10

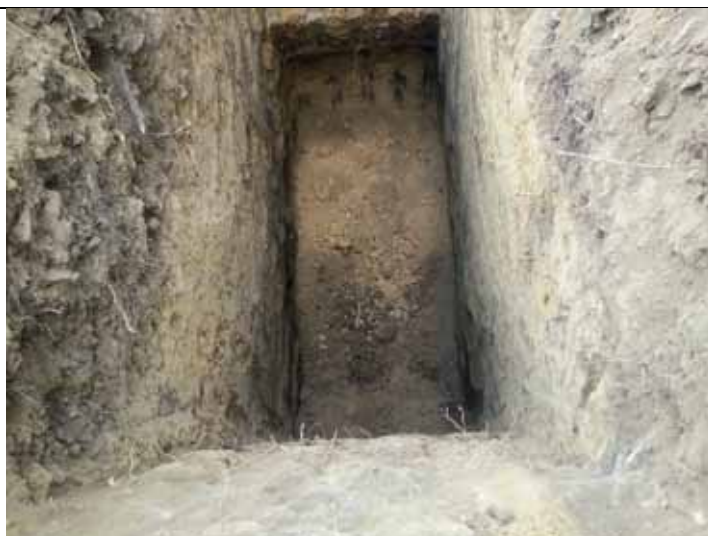
## TEST PIT LOG TP-4

Depth (ft.)	Strata Description	Class.	Str'm	Elev.	InSitu Testing		M (%)	Remarks
					Depth	Geo. Pen.		
— 1 —	brown silty gravel with sand – FILL, with root matter		F		— 1 —			
— 2 — 3 — 4 —	light brown sandy SILT with gravel, very compact  trace roots to 4.0'	ML	B	854.5	— 2 — 3 — 4 —		22.3	
— 5 — 6 —	brown silty SAND with gravel	SM			— 5 — 6 —			
— 7 — 8 — 9 — 10	Bottom of Test Pit at 6.5 feet			849.5	— 7 — 8 — 9 — 10

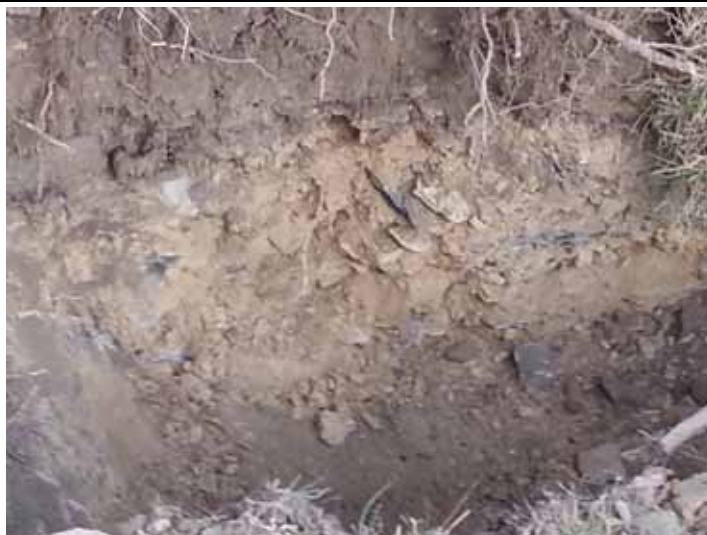
## TEST PIT LOG TP-5

Depth (ft.)	Strata Description	Class.	Str'm	Elev.	InSitu Testing		M (%)	Remarks
					Depth	Geo. Pen.		
—	brown silty gravel with sand – FILL, with root matter		F	855.8	—			
1					1			
—	brown DISINTEGRATED ROCK, with silty sand		DR	853.0	—			
2					2			
—	Refusal on Rock at 3.0 feet Bottom of Test Pit at 3.0 feet		R		—			
3					3			
—					—			
4					4			
—					—			
5					5			
—					—			
6					6			
—					—			
7					7			
—					—			
8					8			
—					—			
9					9			
—					—			
10					10
