BASIS OF GEOTECHNICAL REPORT

VA HOSPITAL
 PARKING GARAGE
 FLOOR ELEVATIONS

VA Ann Arbor Healthcare System
Construct North Parking Structure

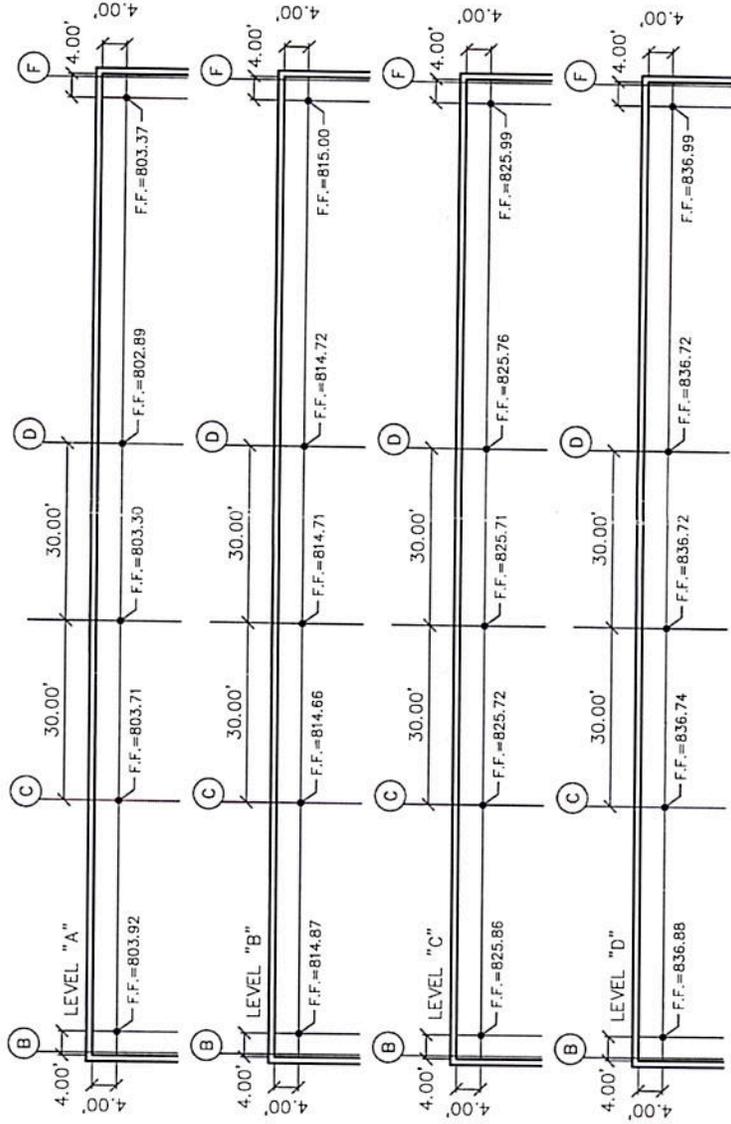
Existing Floor Elevations
