Drawing Title: EXISTING PHOTOS - FIRST FLOOR

Project Title: CORRECT LIFE SAFETY DEFICIENCIES BECKLEY VAMC

FINAL SUBMITTAL

DRAWING NO. A701A

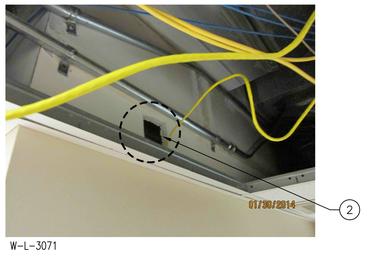
1 A701A NTS FIRST FLOOR – PENETRATION THRU SMOKE & FIRE BARRIERS – 1

W-L-3071
