Drawing Title: EXISTING PHOTOS - SECOND FLOOR

Project Title: CORRECT LIFE SAFETY DEFICIENCIES BECKLEY VAMC

Date: 09-5-2014
Project No. 517-14-106
DRAWING NO. A702C
Dwg. XX Of XX

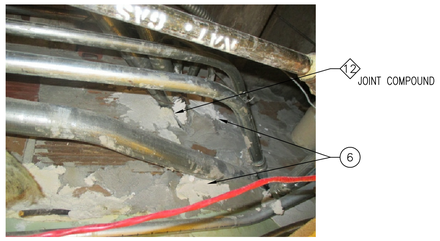
20 A702C NTS SECOND FLOOR – UTILITY SHAFT PENETRATION – SMOKE RESISTANT – 20
