Drawing Title: EXISTING PHOTOS - FOURTH AND FIFTH FLOORS

Project Title: CORRECT LIFE SAFETY DEFICIENCIES BECKLEY VAMC

Date: 09-5-2014
Project No. 517-14-106
DRAWING NO. A704B
Dwg. XX Of XX

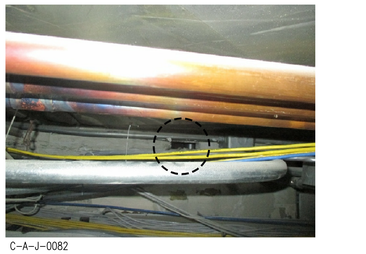
3 A704B NTS FOURTH FLOOR – PENETRATION THRU SMOKE & FIRE BARRIERS – 3

C-A-J-0082
