COMPREHENSIVE SURVEY FOR ASBESTOS CONTAINING MATERIALS

Building 74
Veterans Affairs Medical Center
1970 Roanoke Blvd
Salem, Virginia 24153
Adelaide Project No. VAMC: 10079.00-IN

June 30, 2010

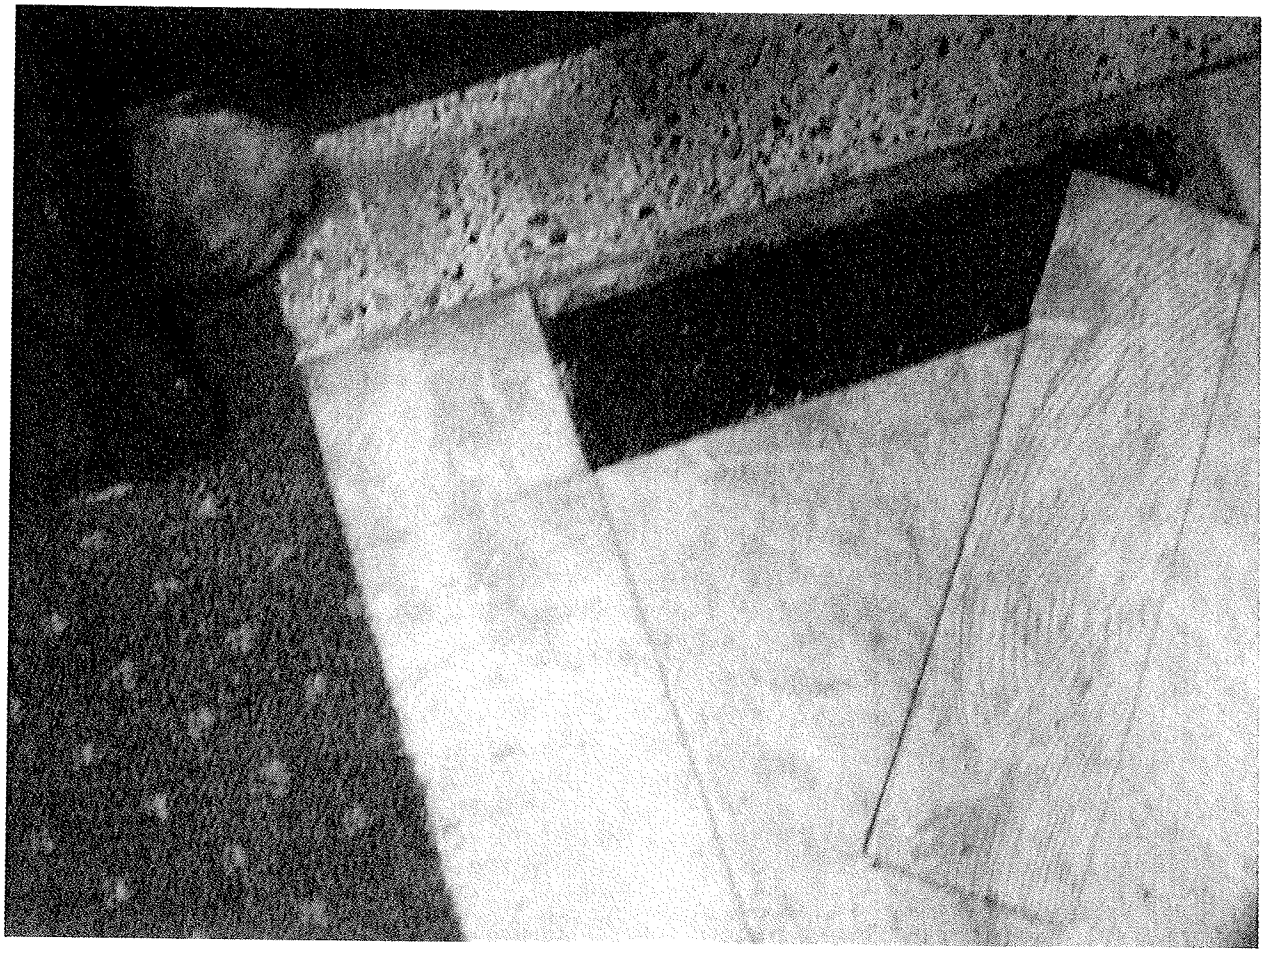
Floor Tile 12x12 Cream W/ Heavy Tan & Brown Streaks

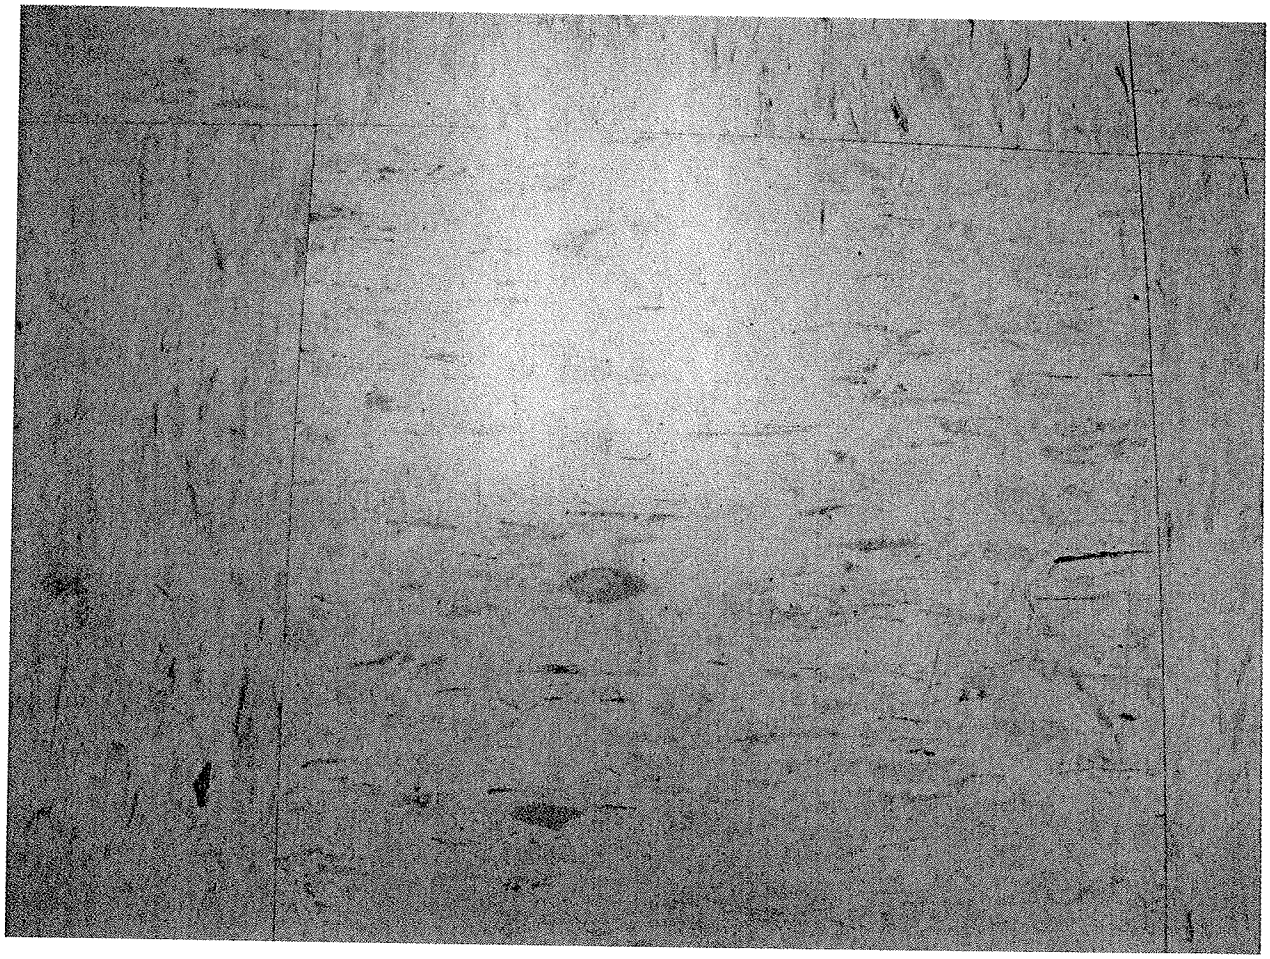
Floor Tile 12x12 White w/ Minimal Brown Streaks

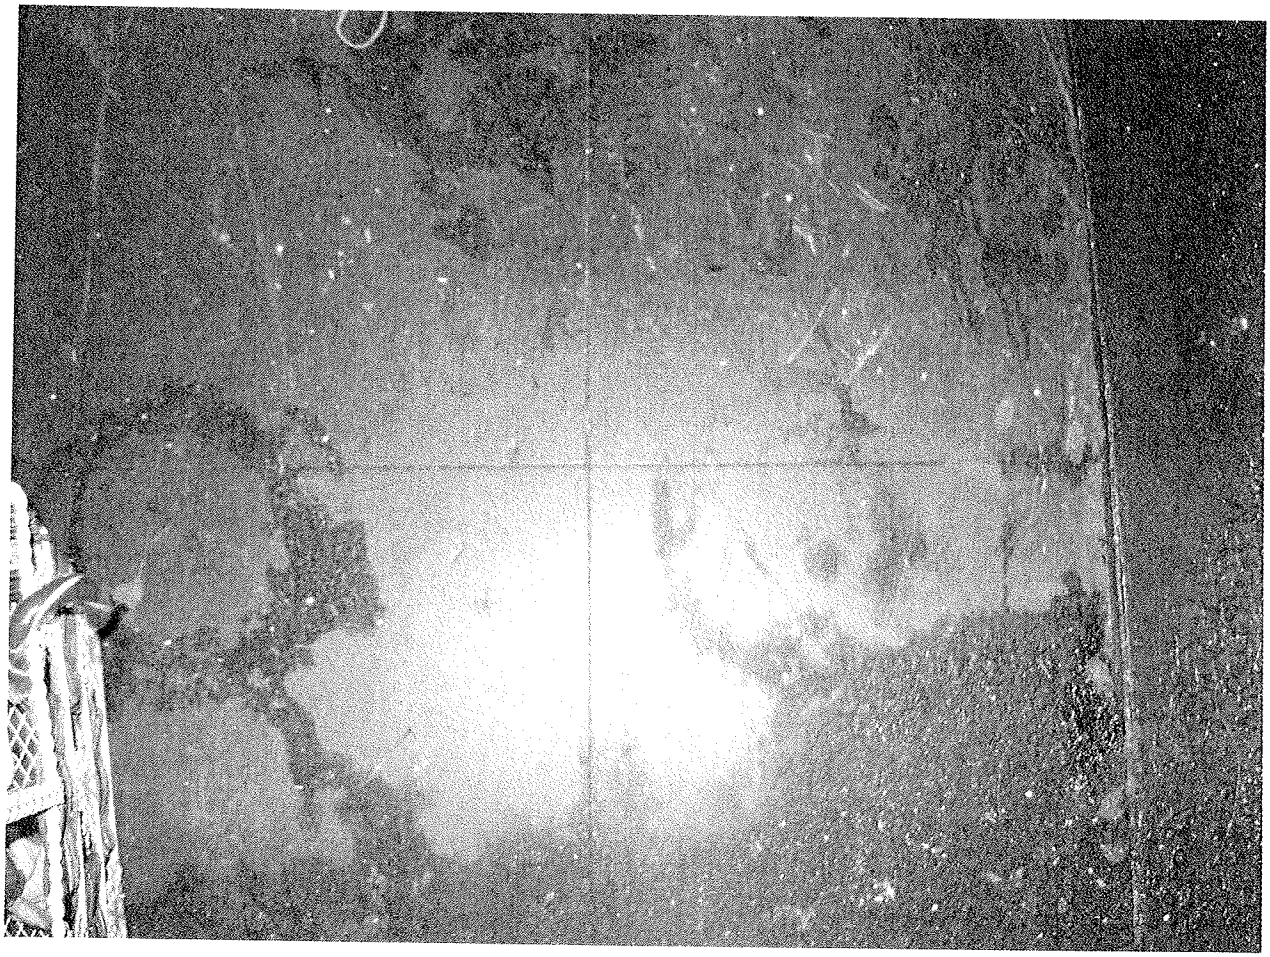
Floor Tile 9” x 9” Orange

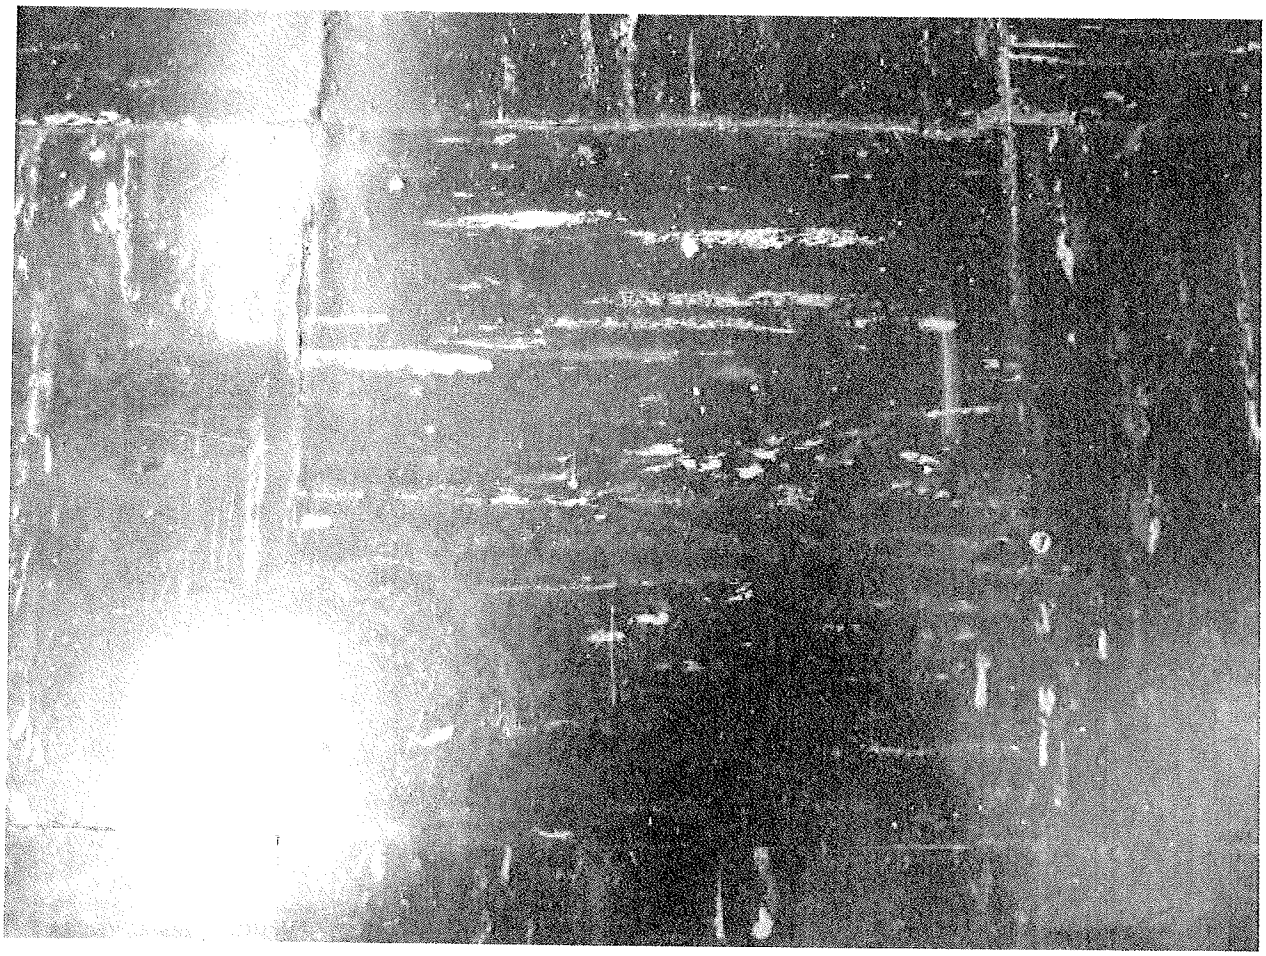
Floor Tile 9” x 9” Brown

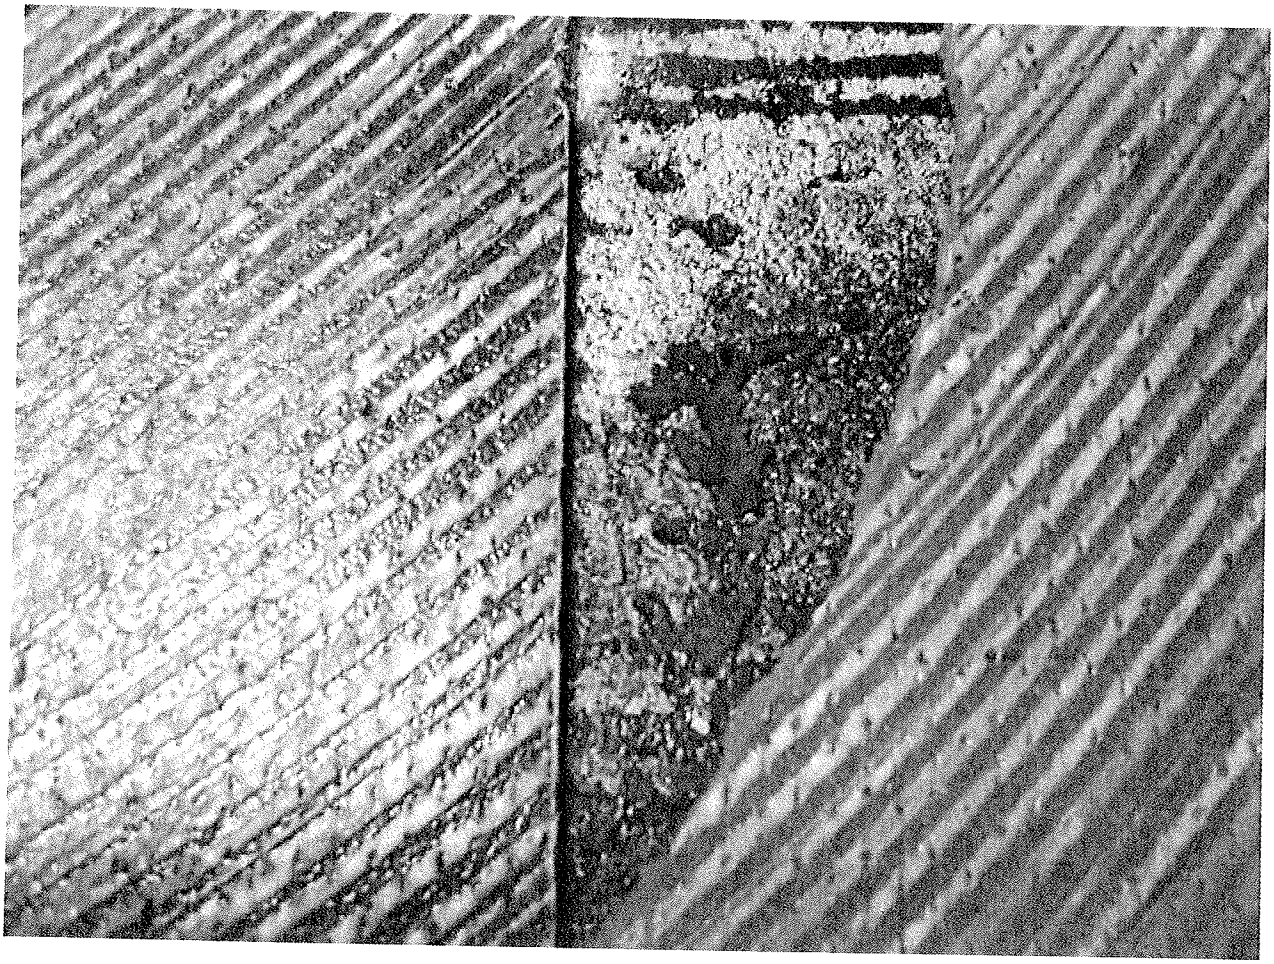
Floor Tile 6” x 12” Red

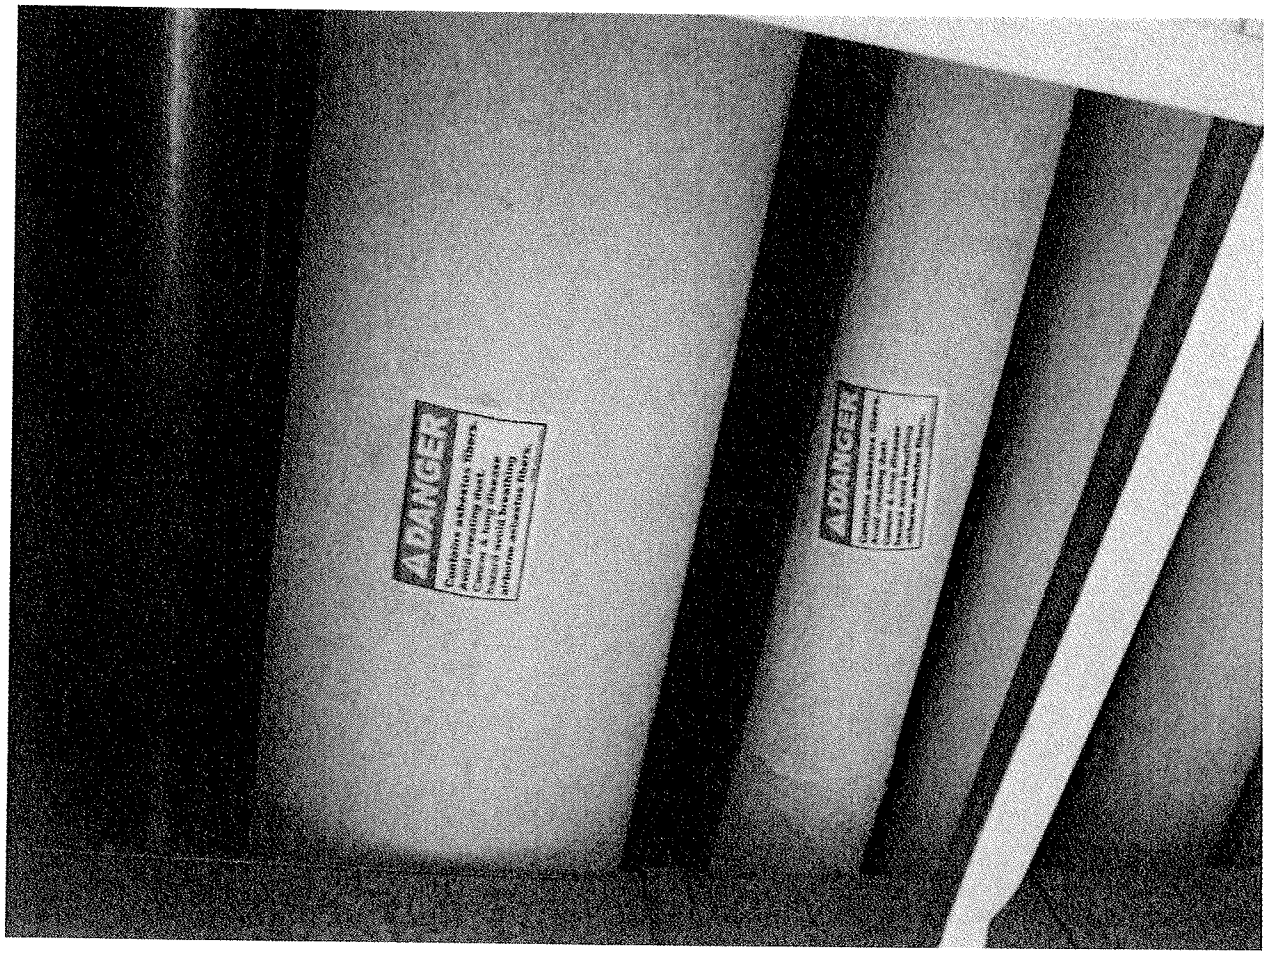
4" TSI Pipe Insulation White
6" TSI Steam Pipe White
