EnviroApplications, Inc.
Engineering & Consulting

Project No. 01.GSAVA22.16

Subject: **Confirmation Asbestos Sampling Report**
San Francisco Veterans Affairs Medical Center
Building 1 – Dispensary and Conference Room
4150 Clement Street
San Francisco, CA 94116

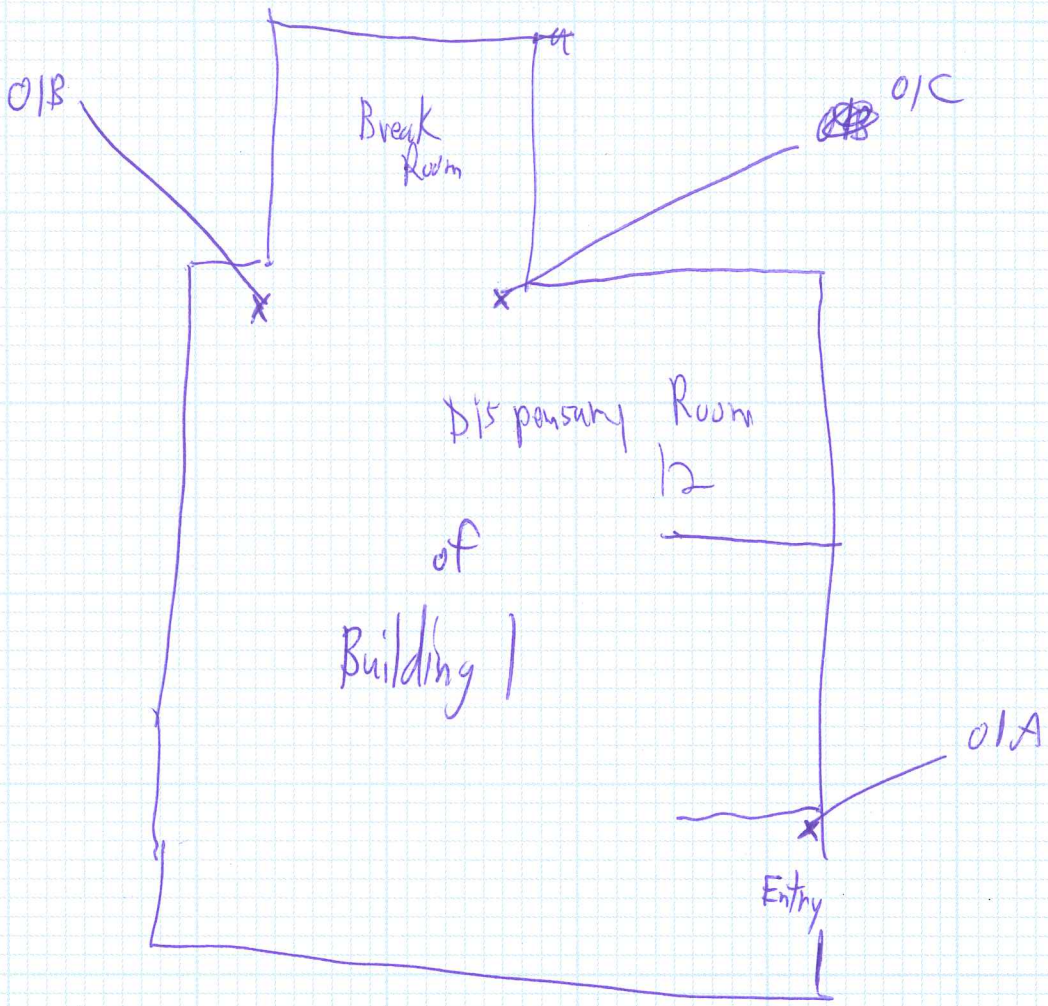
Sample Location Map

PROJECT: Vans 1430 Clement Street / S.F. 94941 Page 1 of 1
Building 1

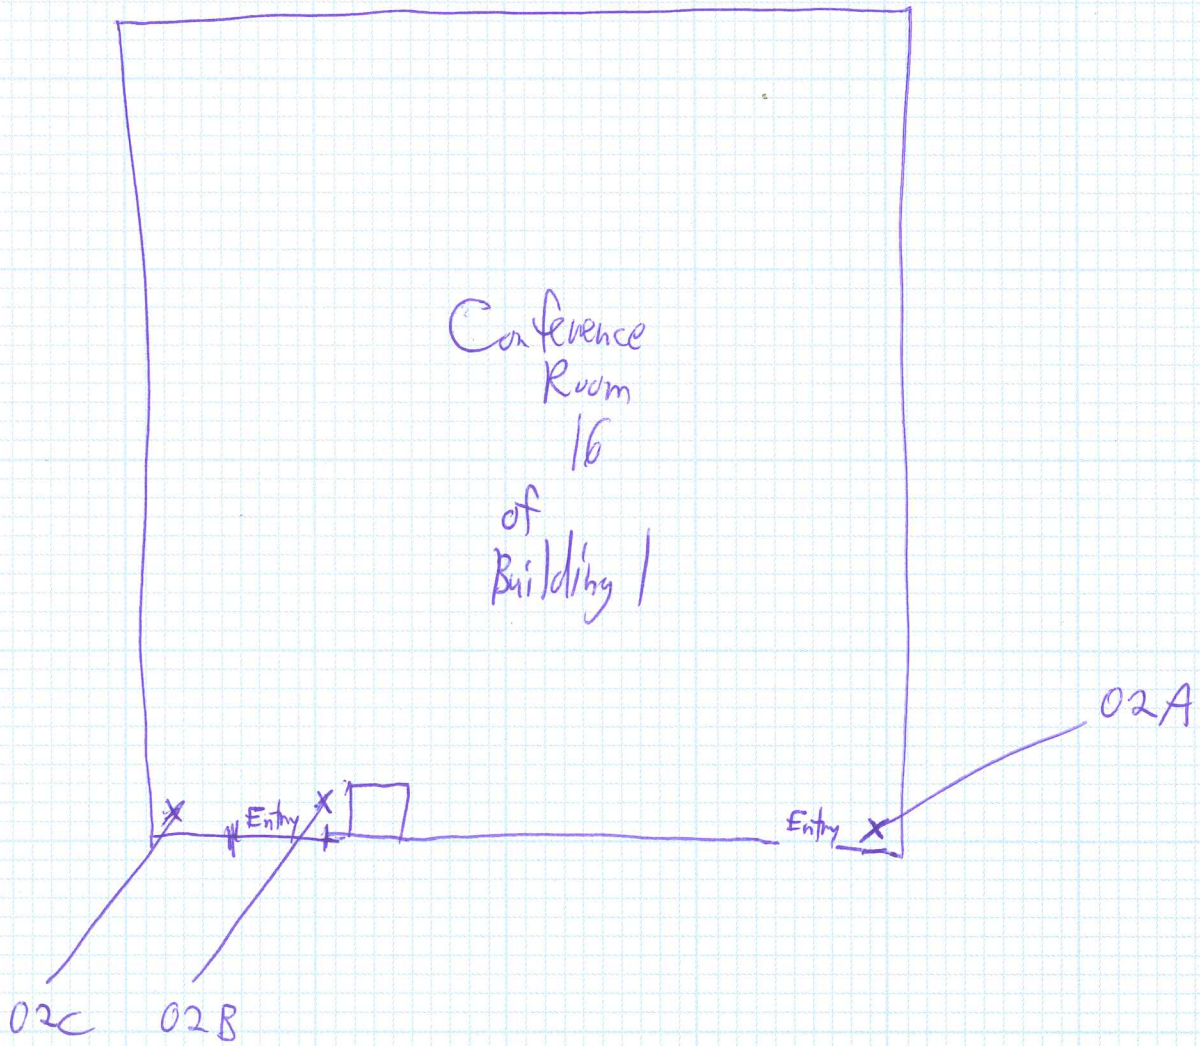
Sample Location Map

PROJECT: Vame/4130 Clement Street/S.F. 94941 Building 1 Page 1 of 1
