**CONSOLIDATED LABS RENOVATION
ASBESTOS INSPECTION REPORT**
STRATTON VETERANS AFFAIRS MEDICAL CENTER
THIRD FLOOR, B-WING AND CORE
ALBANY, NY

June 2013

Drawing Title	
ASBESTOS LOCATION PLAN	
Approved: Project Director	
-	
-	
-

Drawing Number
AB-01

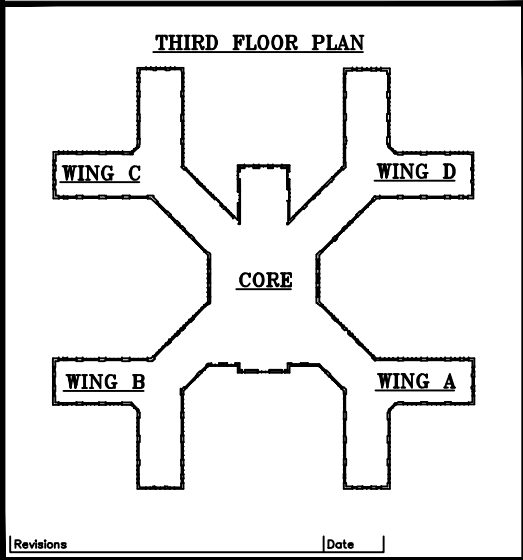
ASBESTOS SURVEY SUMMARY PLAN

HATCHED AREAS INDICATE POSITIVE DETECTION OR PRESUMED PRESENCE OF ASBESTOS CONTAINING BUILDING COMPONENTS
