ASBESTOS CONTAINING BUILDING MATERIAL REPORT BUILDING 22

**Bay Pines VA Medical Center
10000 Bay Pines Boulevard
Bay Pines, Florida**

Project No. 2009011.001

July 31, 2009

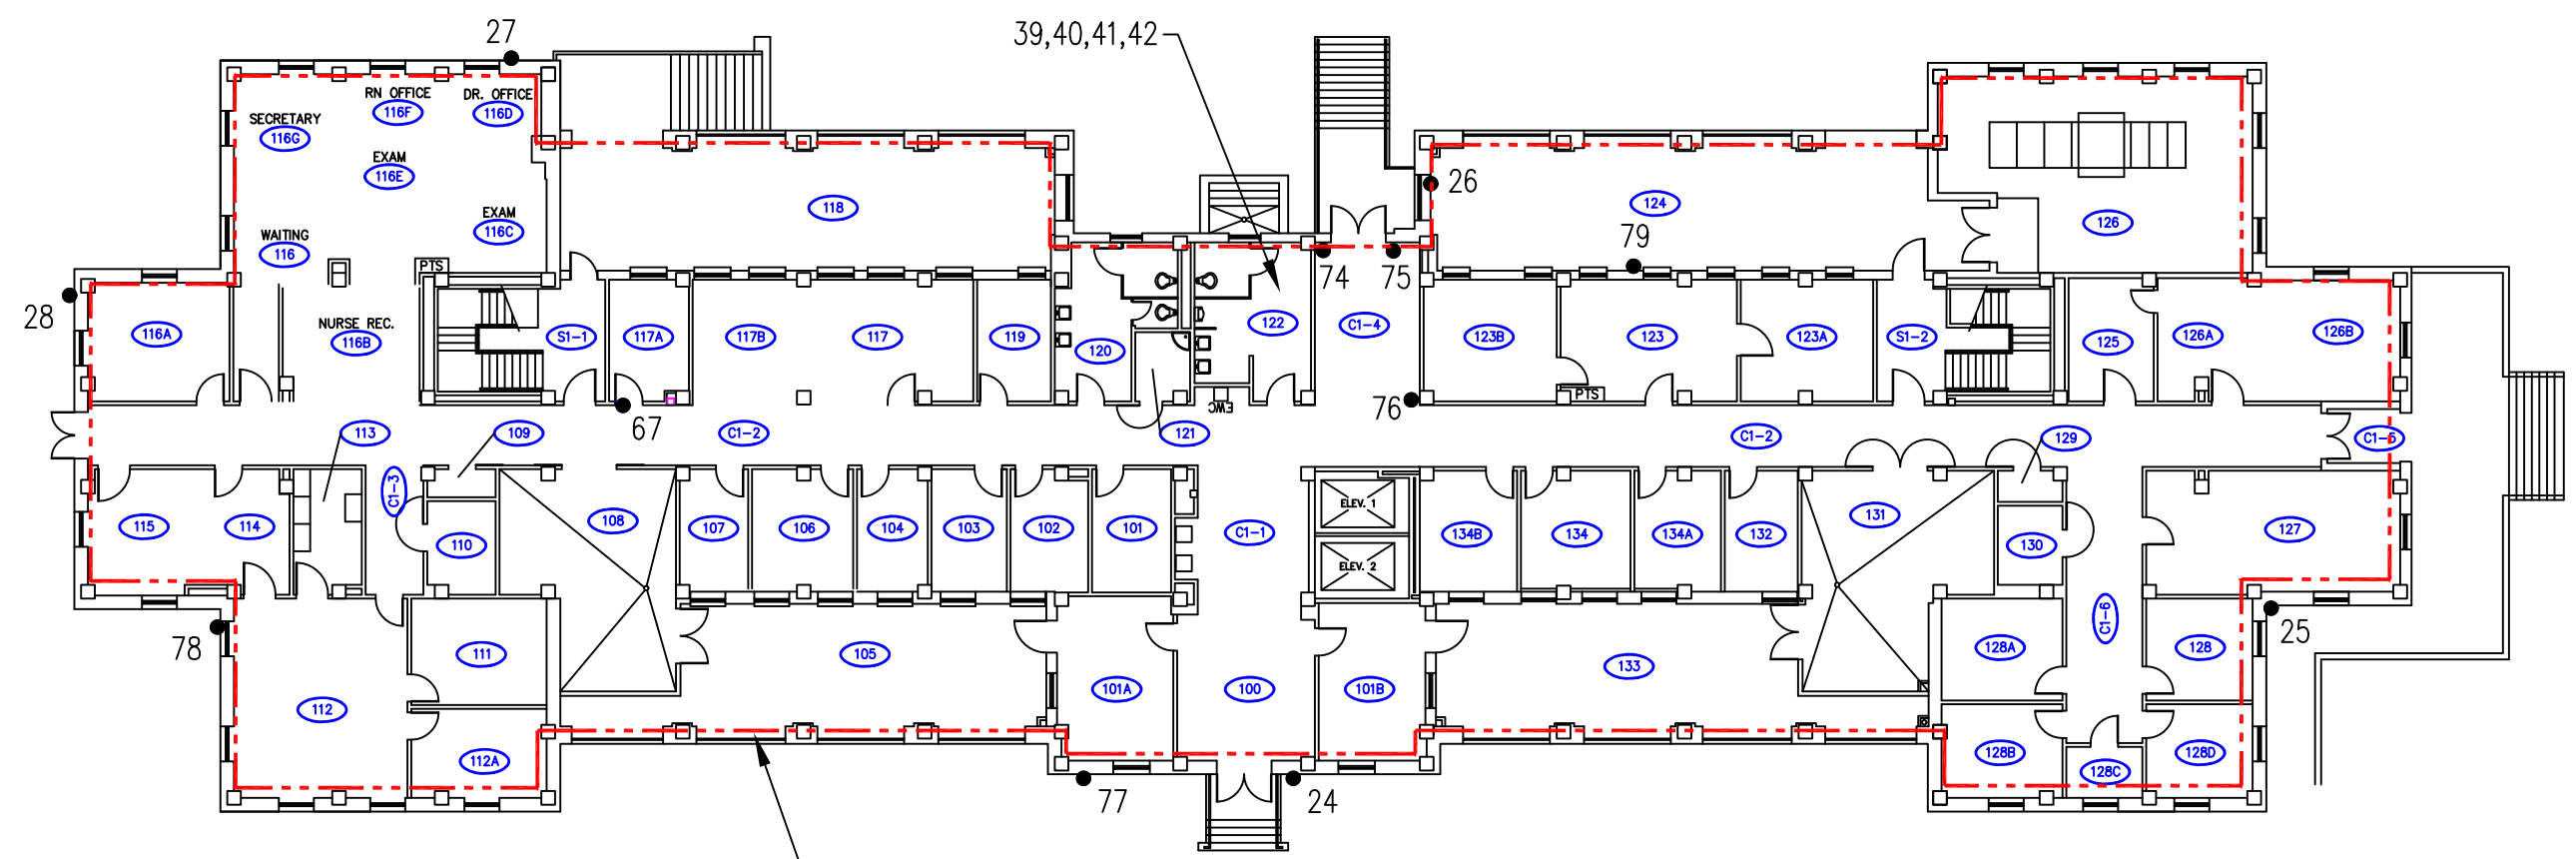
- 1,2 APPROXIMATE SAMPLE LOCATION
- 25 SAMPLE GREATER THAN 1% ASBESTOS
- 25* STOP POSITIVE SAMPLE FOR ASBESTOS
- 25 NO ASBESTOS DETECTED (NAD)
- HATCHED AREAS INDICATE POSITIVE DETECTION OF ASBESTOS CONTAINING BUILDING COMPONENTS
- WATER PROOFING ON EXTERIOR BRICK

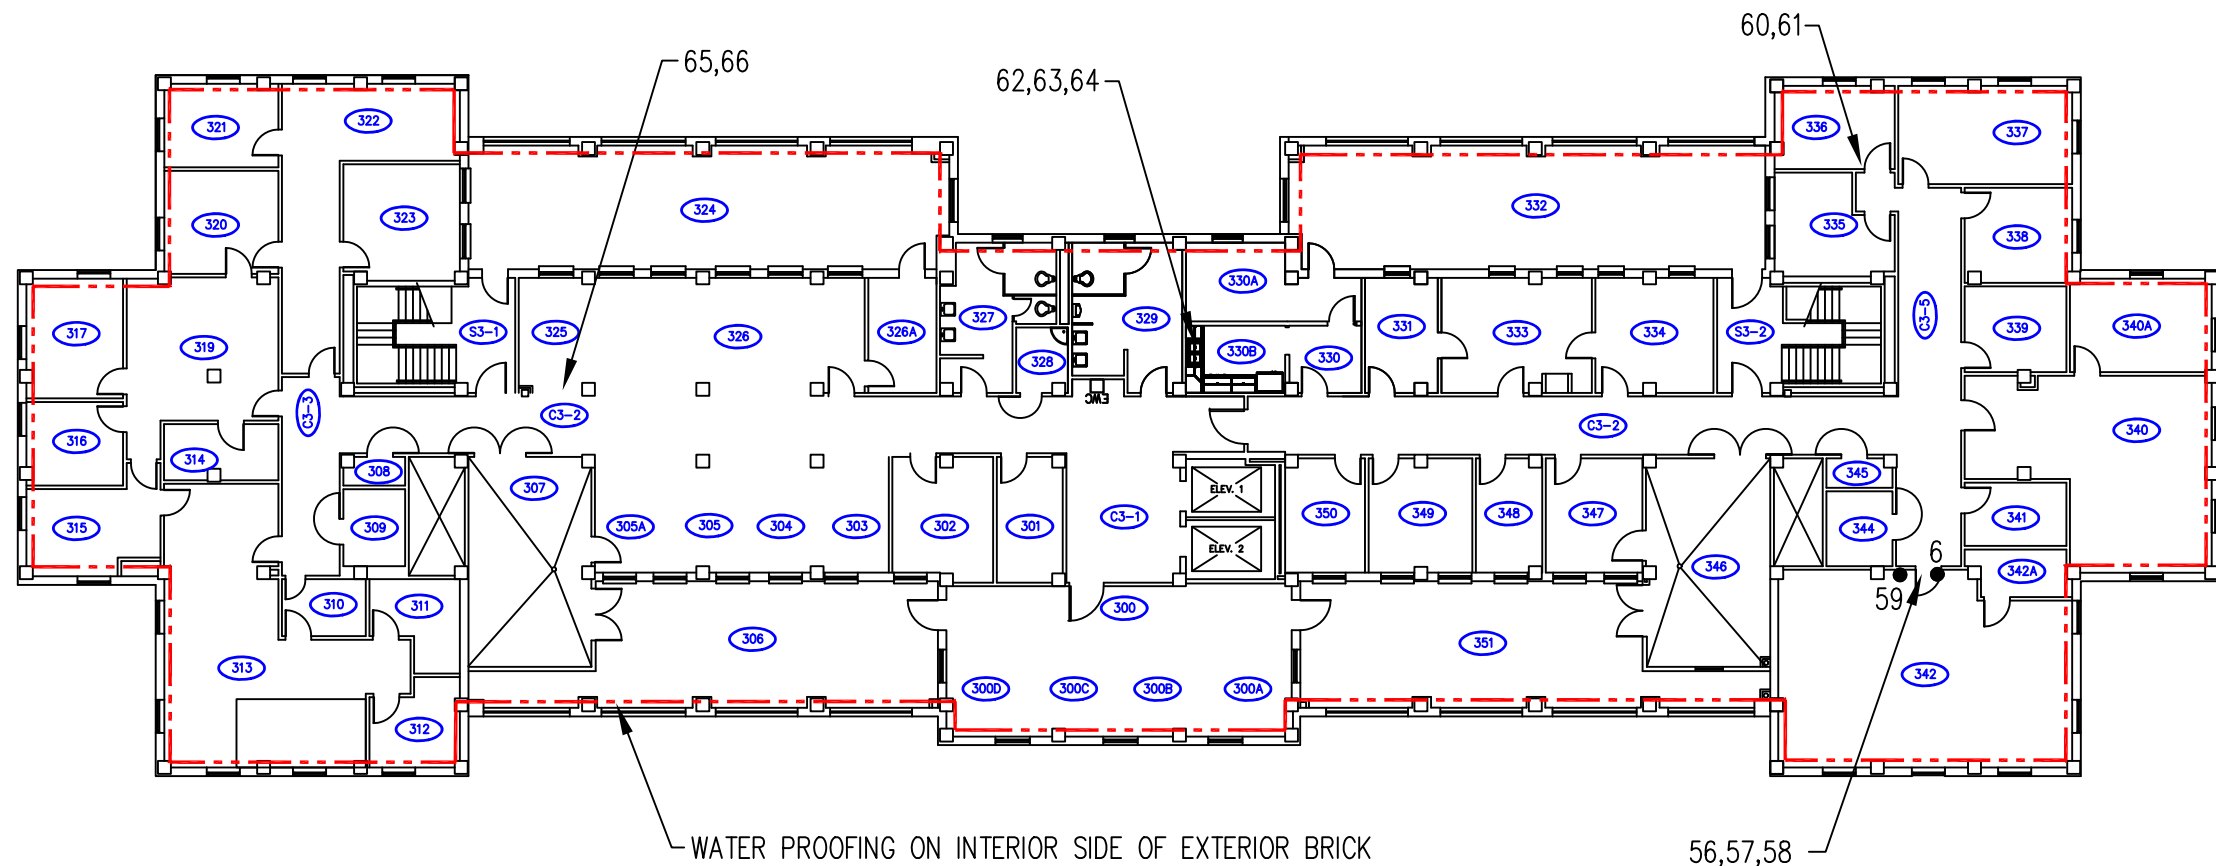
- 1,2 APPROXIMATE SAMPLE LOCATION
- 25 SAMPLE GREATER THAN 1% ASBESTOS
- 25* STOP POSITIVE SAMPLE FOR ASBESTOS
- 25 NO ASBESTOS DETECTED (NAD)
- HATCHED AREAS INDICATE POSITIVE DETECTION OF ASBESTOS CONTAINING BUILDING COMPONENTS
- WATER PROOFING ON EXTERIOR BRICK

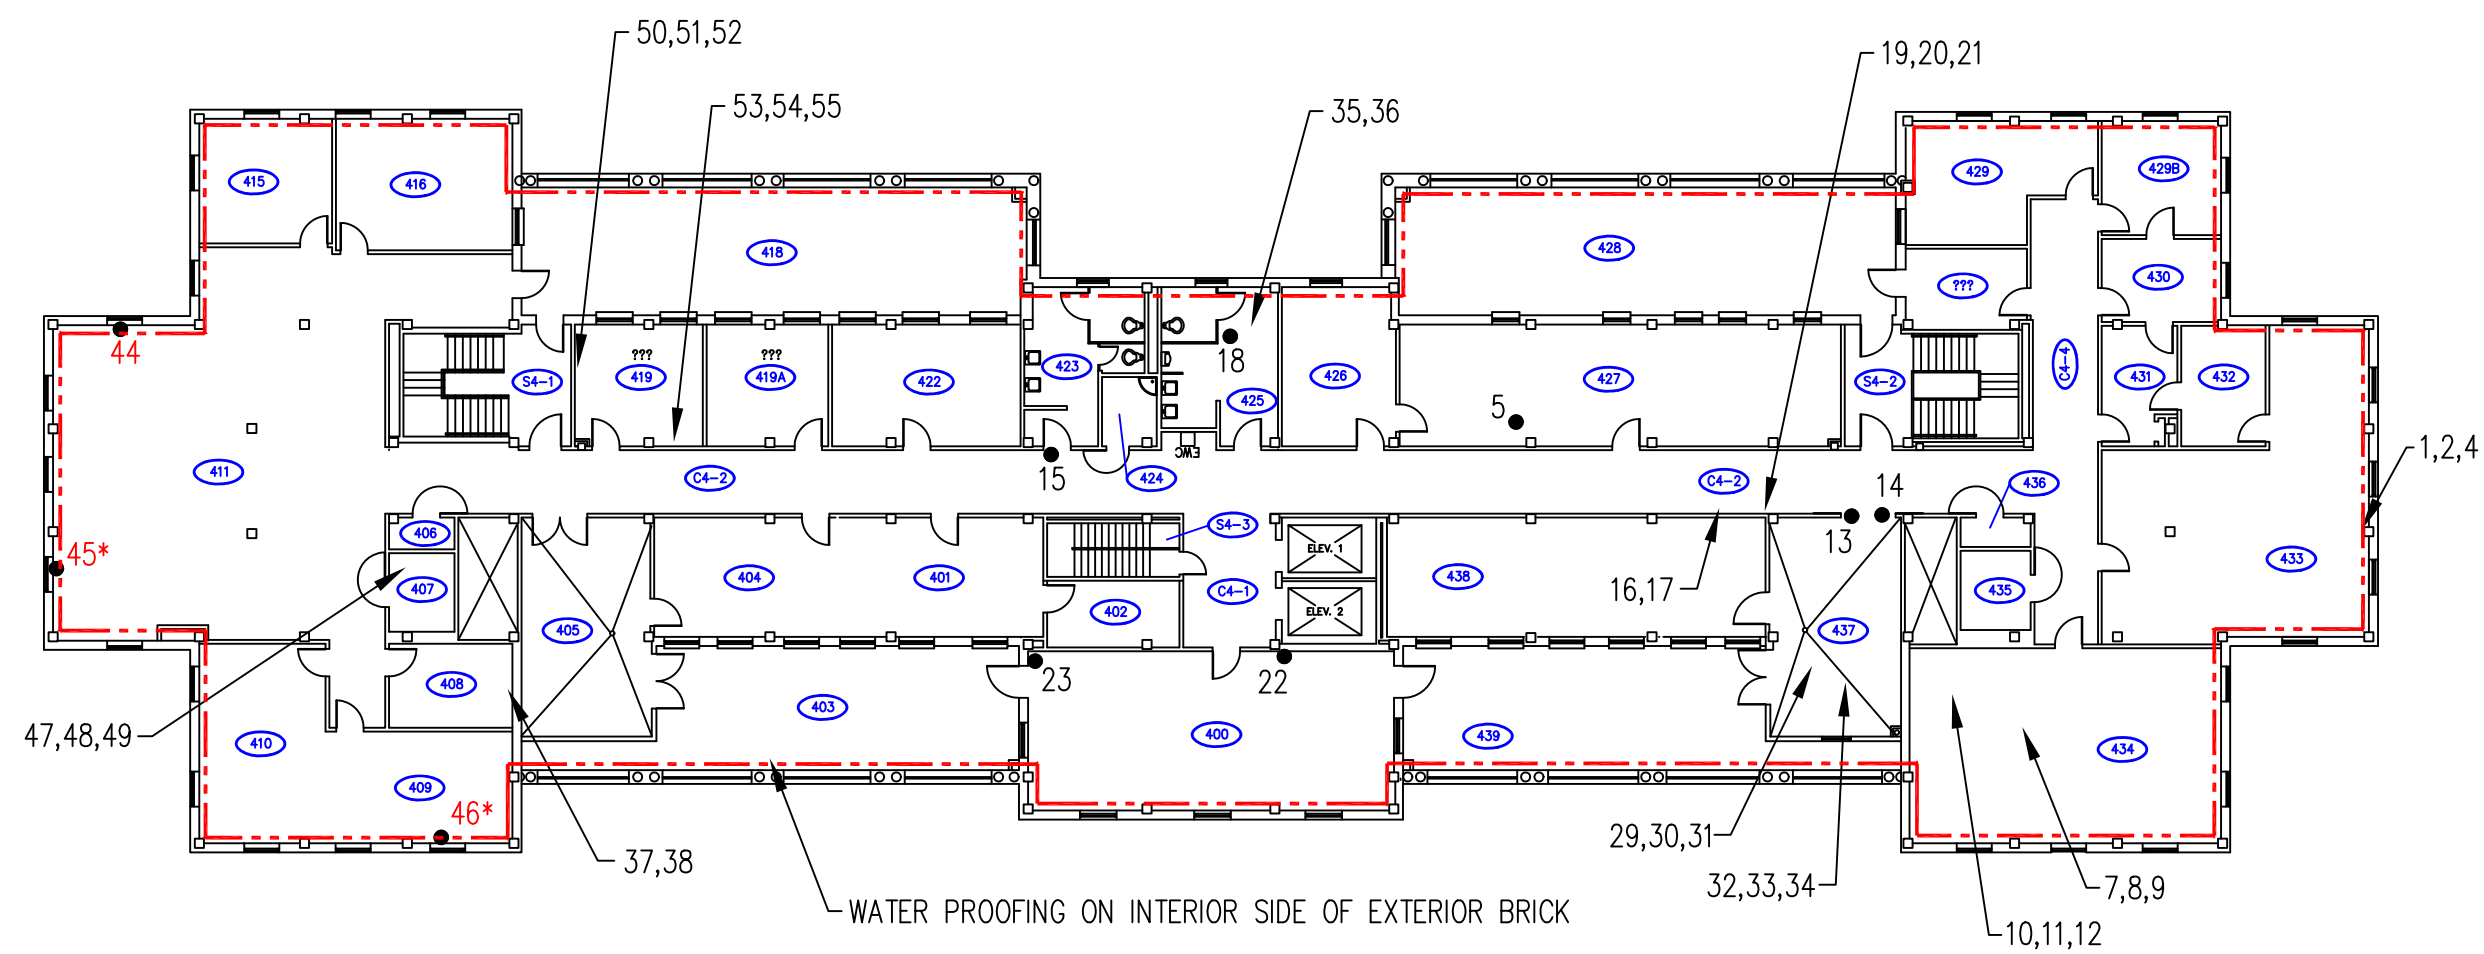
- LEGEND
- 1,2 APPROXIMATE SAMPLE LOCATION
- 25 SAMPLE GREATER THAN 1% ASBESTOS
- 25* STOP POSITIVE SAMPLE FOR ASBESTOS
- 25 NO ASBESTOS DETECTED (NAD)
- HATCHED AREAS INDICATE POSITIVE DETECTION OF ASBESTOS CONTAINING BUILDING COMPONENTS
- WATER PROOFING ON EXTERIOR BRICK
