Client: VAMC Providence, Rhode Island
830 Chalkstone Ave
Providence, RI 02908

Report: Fire Barrier Wall - Large Opening
VA 241-15-C-0127
PO 650-C58125

Providence VA Medical Center - Fire Barrier Wall Large Opening (Holes) Report

Providence VA Medical Center - Fire Barrier Wall Large Opening (Joints) Report

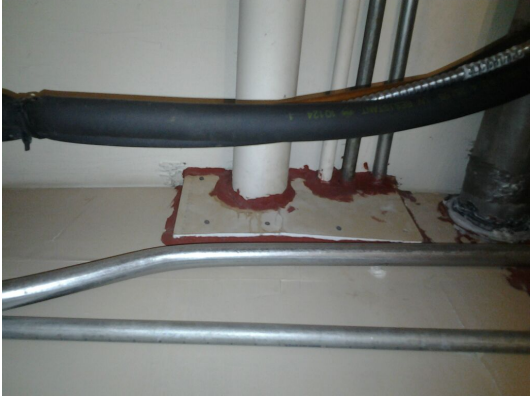
Date Created	EOC ID #	Punch #	Room Number	Type	Item	Wall Material	Fire Rating	Comments	Width (ft.)	Height (ft.)	Sides
  <p>4/5/16 02:49 PM</p>											
4/5/16	307404	221	Mechanical room D009	z-other	Large Opening	Gypsum	1HR Fire Barrier	1ft x 1ft Scab Patch	1	1	1
  <p>4/5/16 02:50 PM</p>											
4/5/16	307405	222	Mechanical Room D009	z-other	Large Opening	Gypsum	1HR Fire Barrier	1ft x 1ft Scab Patch	1	1	1
  <p>4/5/16 02:53 PM</p>											
4/5/16	307406	223	Mechanical Room D009	z-other	Large Opening	Gypsum	1HR Fire Barrier	1ft x 1ft Scab Patch	1	1	1

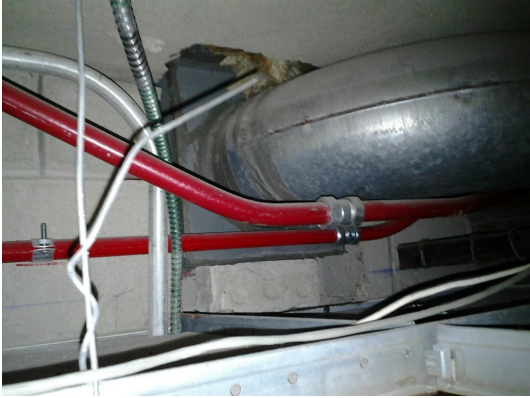
<p>11/10/15 10:36 AM 11/10/15 10:37 AM</p>											
4/6/16	307880	235	Oxygen Storage D144	Sections of walls missing	Large Opening	Concrete	1HR Fire Barrier	Section of block missing with penetration 16in x 16in	2	2	1

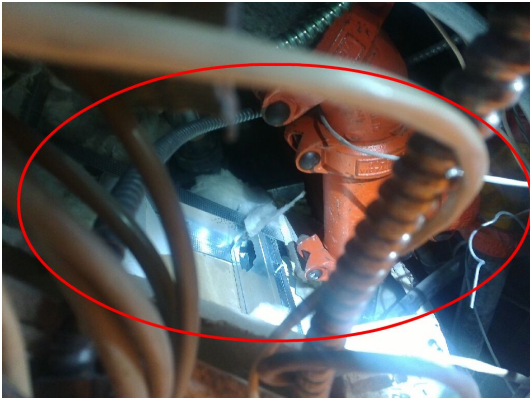
<p>10/30/15 10:39 AM 10/30/15 10:40 AM</p>											
10/30/15	268624	150	Soiled and O2 215B	Sections of walls missing	Large Opening	Gypsum	1HR Fire Barrier	Gypsum board missing. Metal studs in place. Top of wall joint will be needed also.	3	3	1

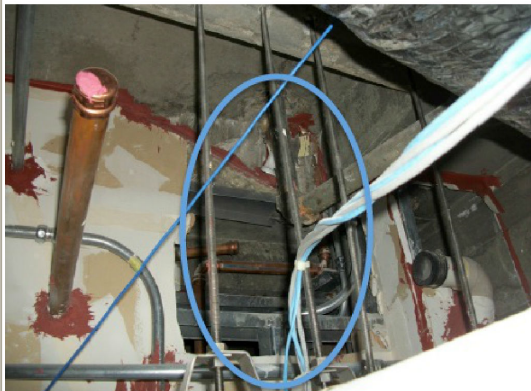
Date Created	EOC ID #	Punch #	Room Number	Type	Item	Wall Material	Fire Rating	Comments	Width (ft.)	Height (ft.)	Sides
11/6/15	269891	180	Surgical Residence Office 698	Sections of walls missing	Large Opening	Gypsum	30min Smoke Barrier	Room on PFI. No PFI # listed. Room 698	2	3	2

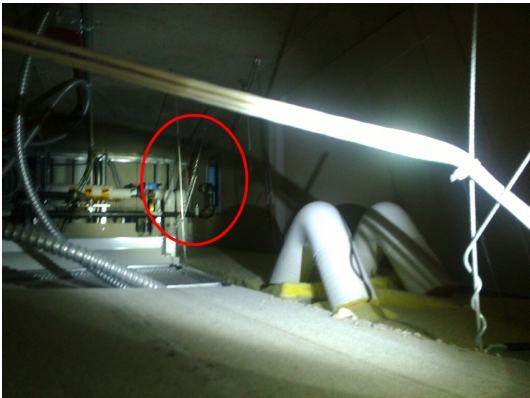
<p>11/2/15 04:09 PM</p>											
11/2/15	269668	172	Conference Room 703	z-other	Large Opening	Gypsum	2HR Fire Barrier	Section of wall missing and needs to be protected.	2	2	1

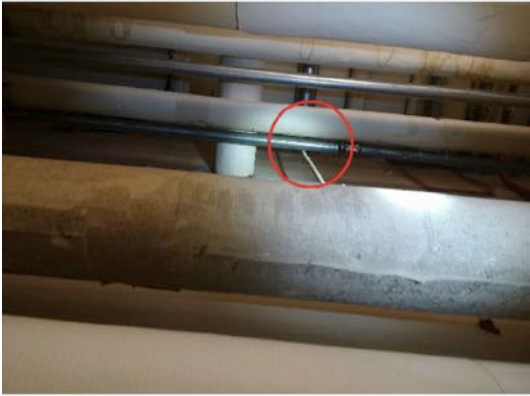
</div> <div>10/28/15 02:15 PM</div>										
11/16/15	272253	210	D009	Joints	Large Opening	Concrete	1HR Fire Barrier	Room on PFI. No PFI # listed. No access due to mechanicals. Room D009	.5	1
