VAMC MEDICAL CENTER NATIONAL SOLDIERS HOME HISTORIC DISTRICT BUILDING 2: STABILIZATION OF B-WING

PROJECT INFORMATION AND SUMMARY OF EXISTING CONDITIONS

SCOPE OF WORK

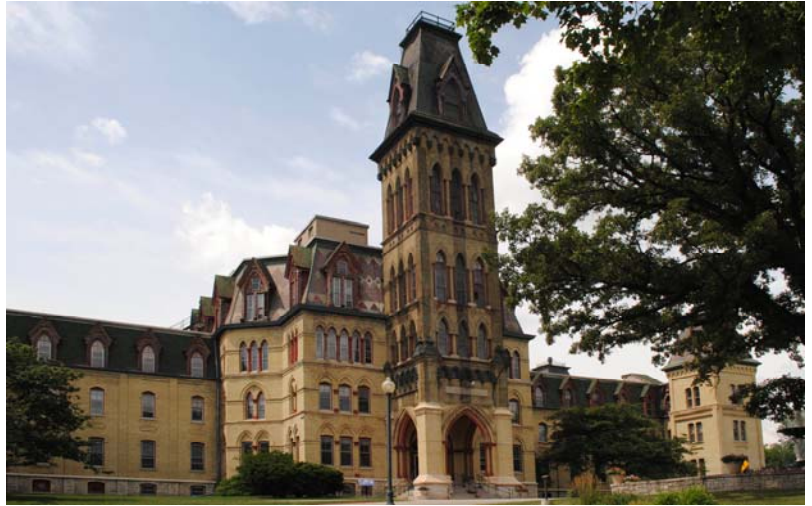
BUILDING 2: MAIN HALL, FROM THE SOUTHWEST

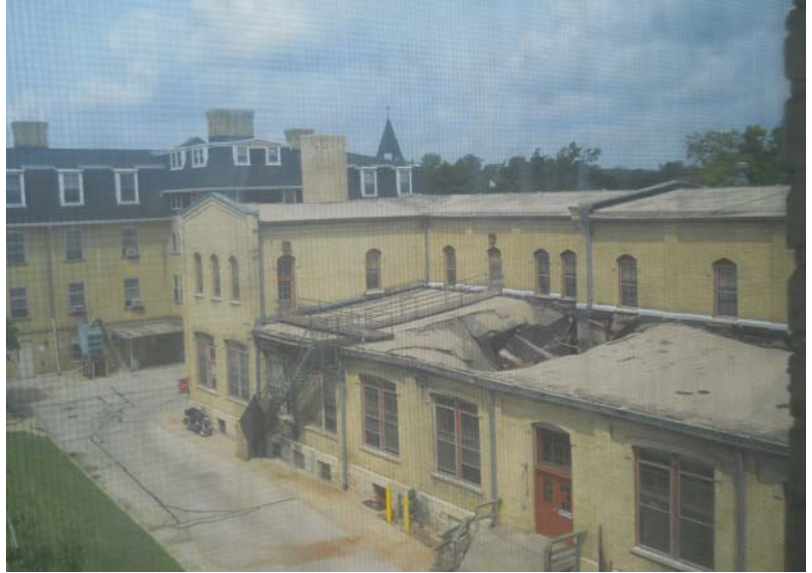
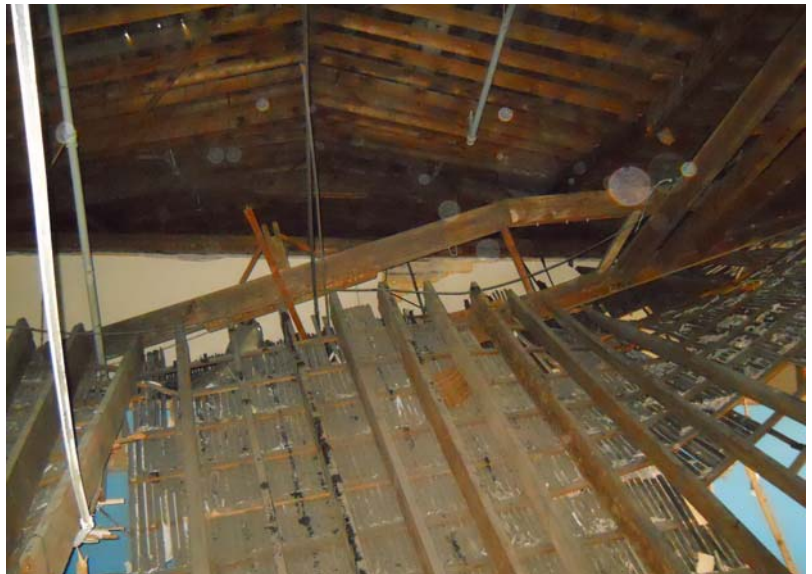
This project is confined solely to the B wing, which is in need of immediate stabilization. The primary emphasis will be the two areas of the roof structure that have collapsed and an adjacent area that has partially collapsed. As a result of the collapses, portions of the masonry walls, particularly on the first floor, were damaged by the outward thrust of the falling roof trusses.

Repair brick wall damaged by thrust of collapsing trusses, reinstall bricks where beam pockets were opened, and repair other parts of brick cornice that exhibit deflection or damage. Bricks will be repaired using original or salvaged, matching brick and mortar no harder than ASTM, Type O, using white Portland cement and river sand to match the appearance of the original.
