Main Entrance – North East - outbound Side Lane

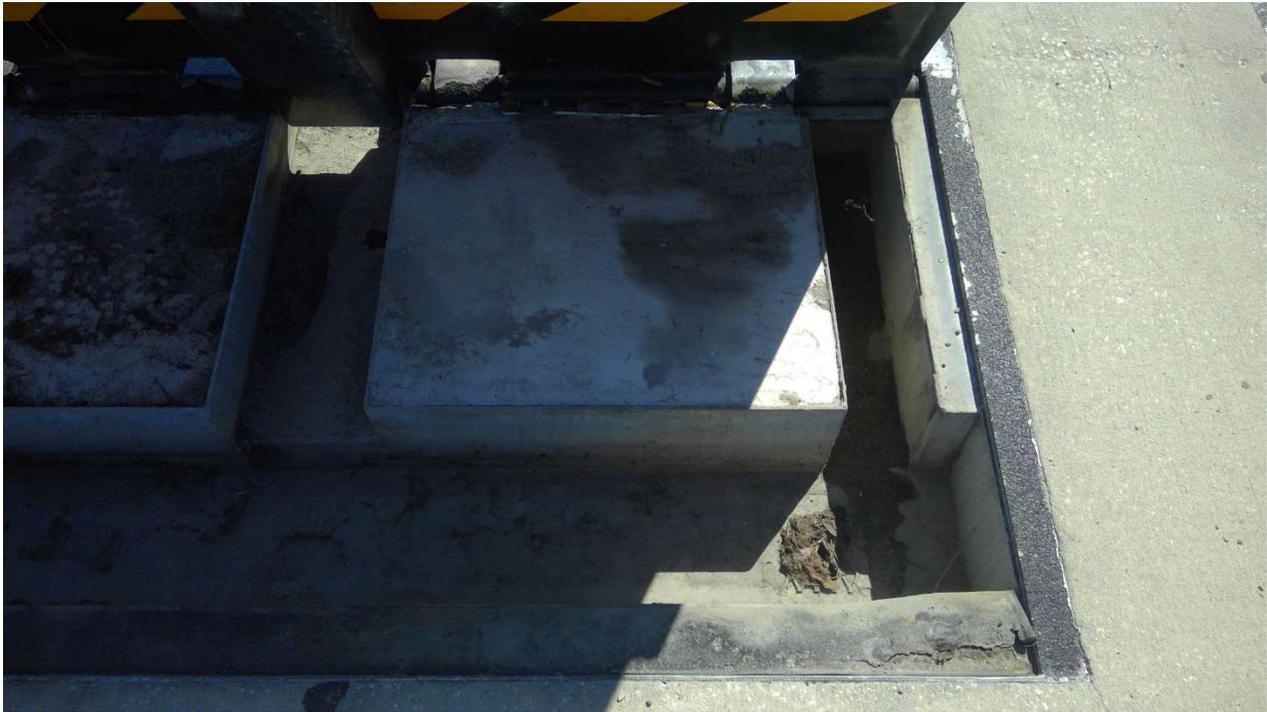
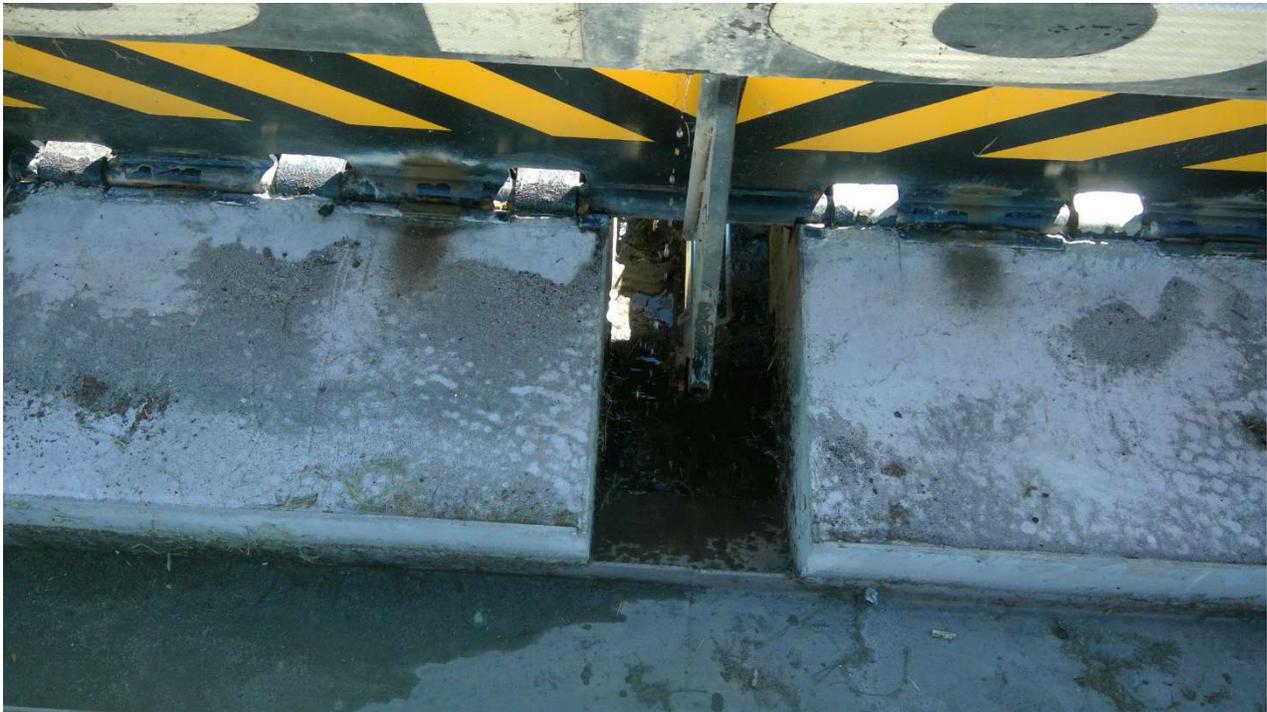
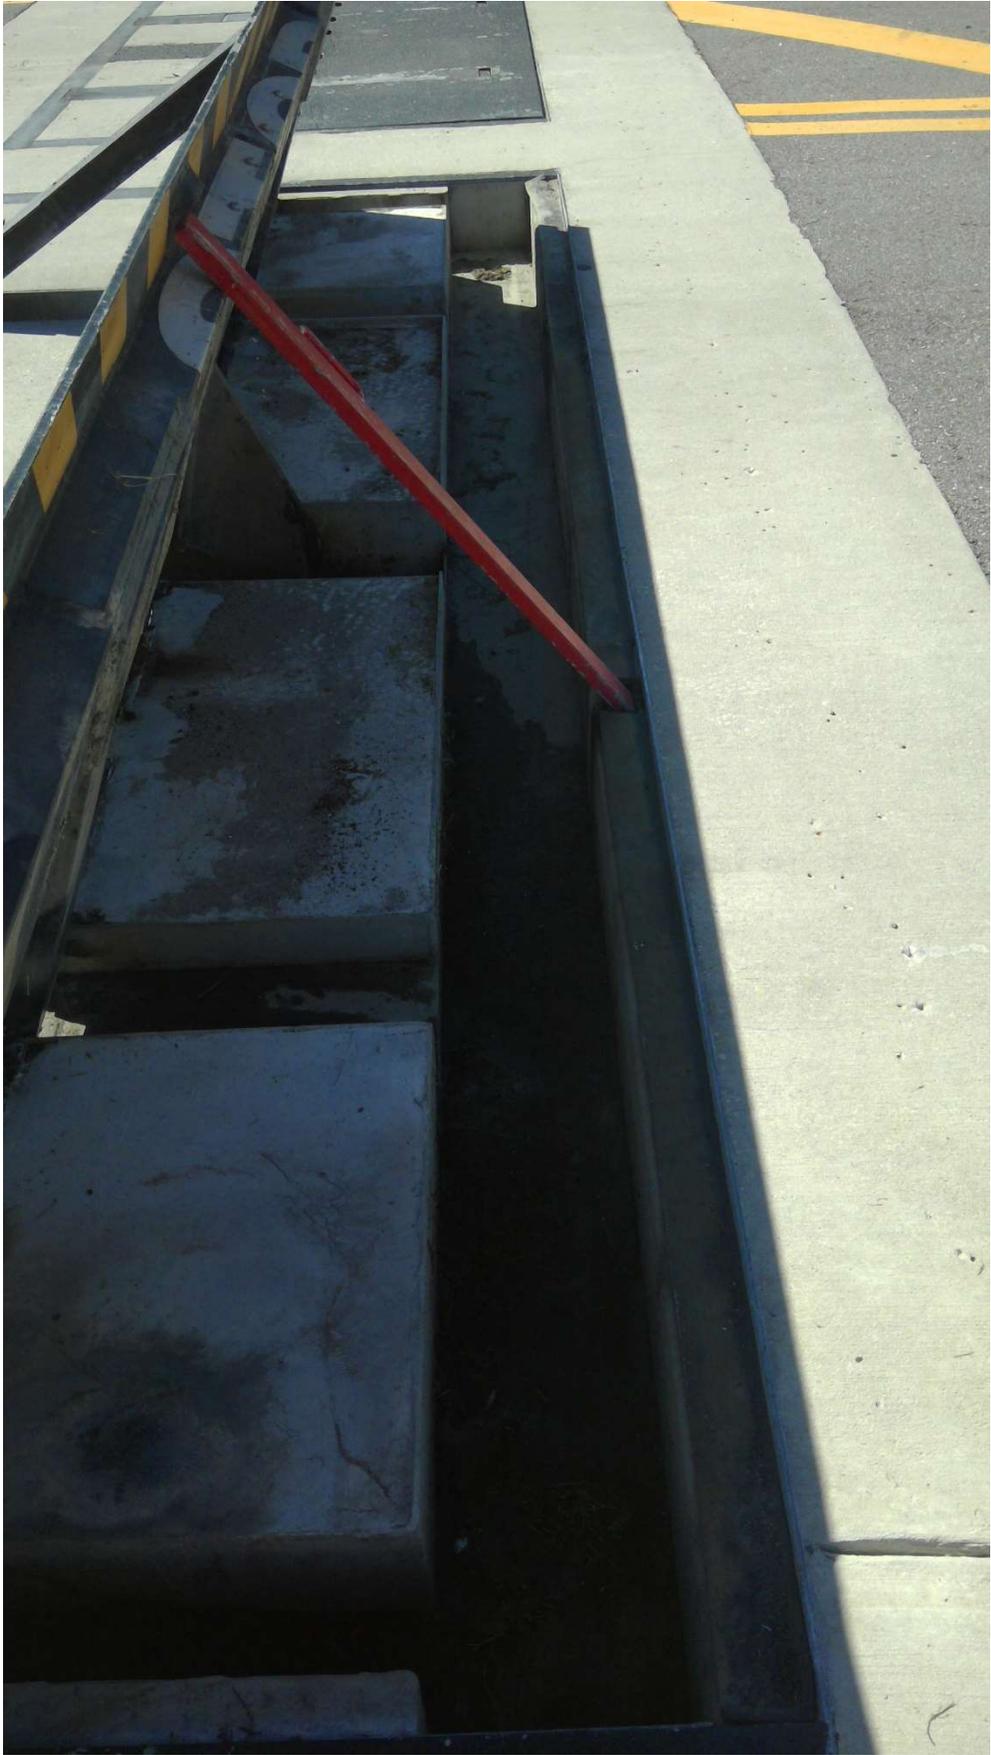
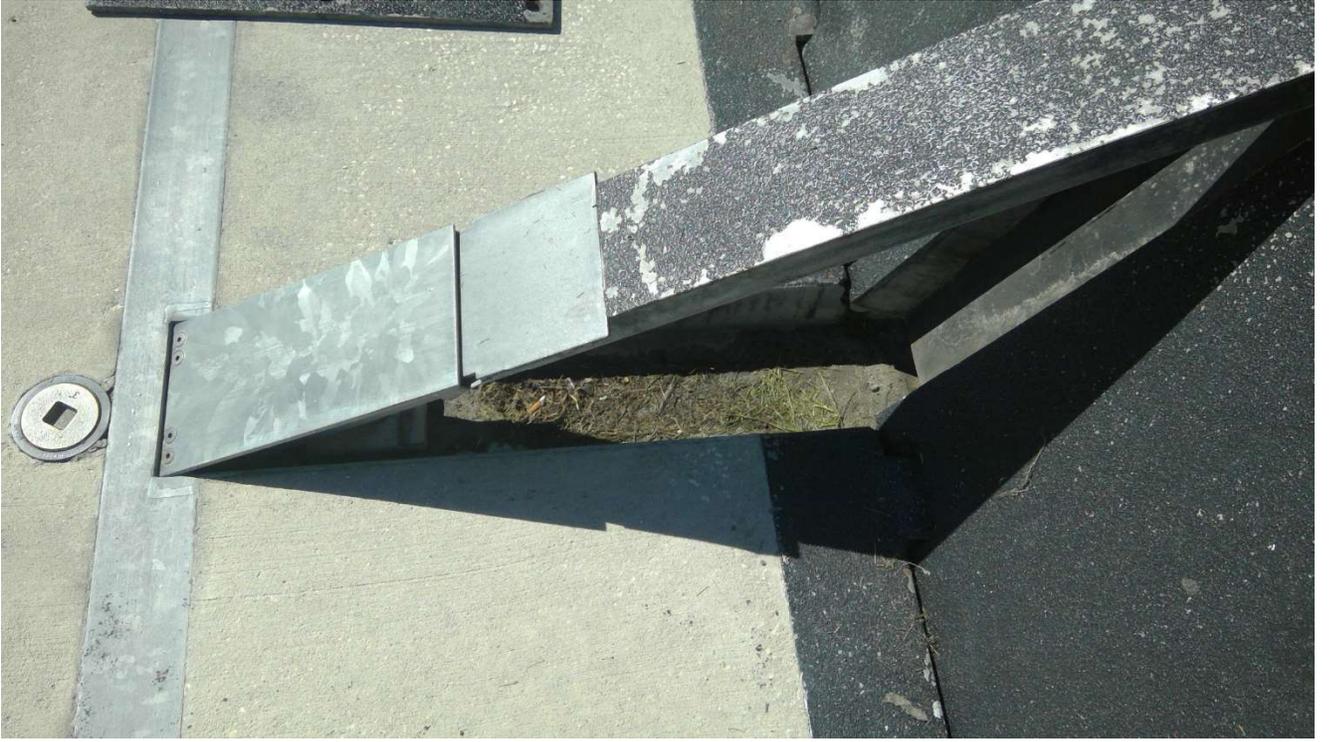
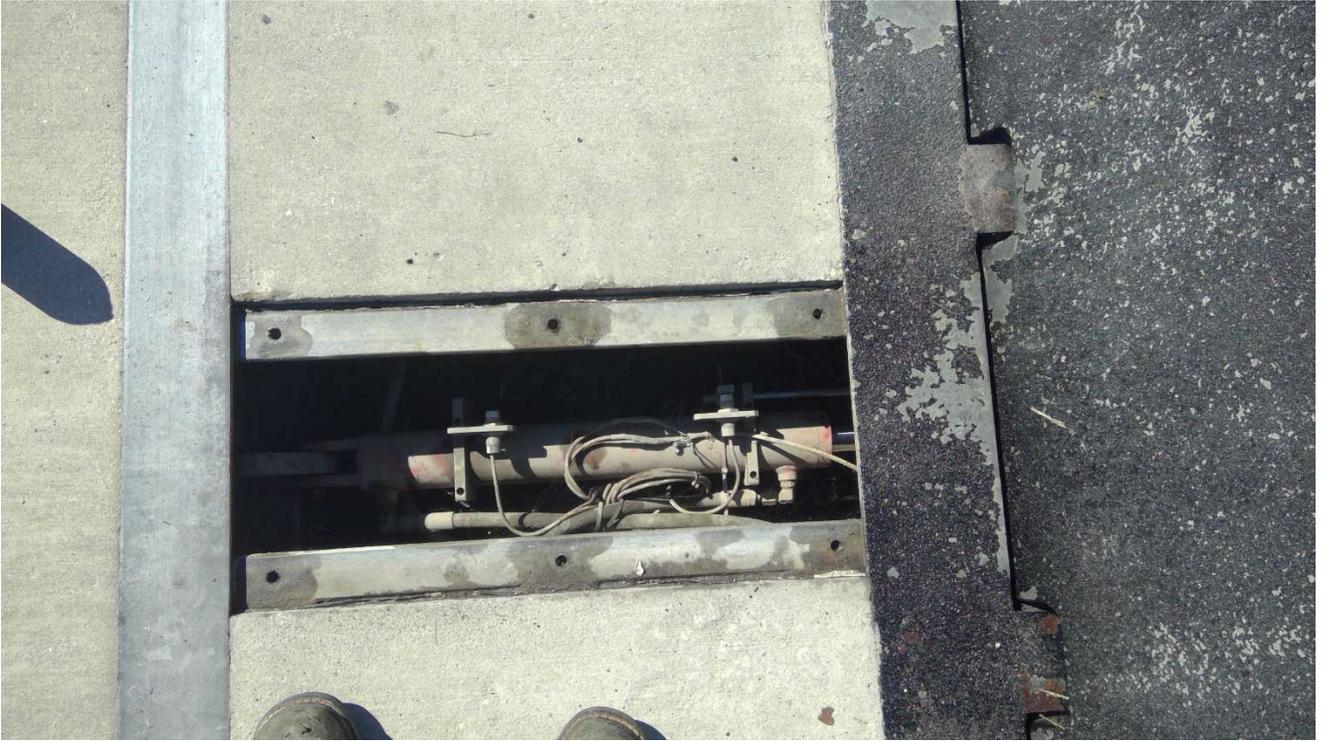
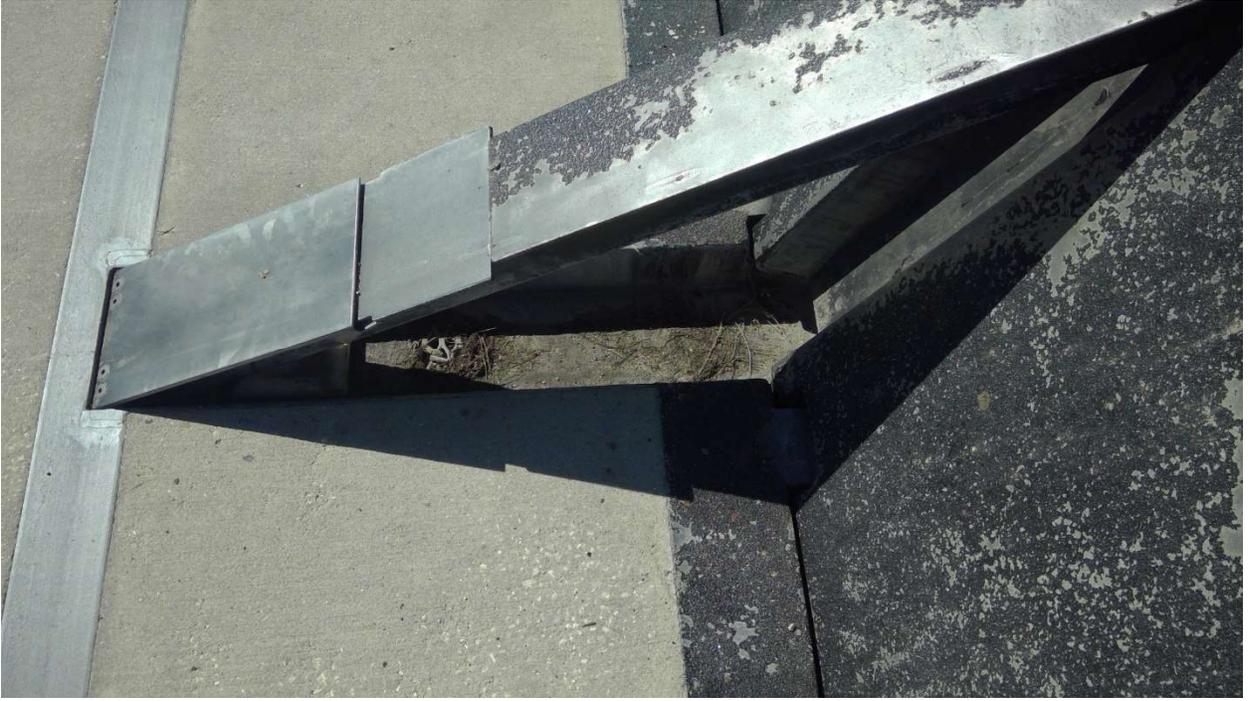
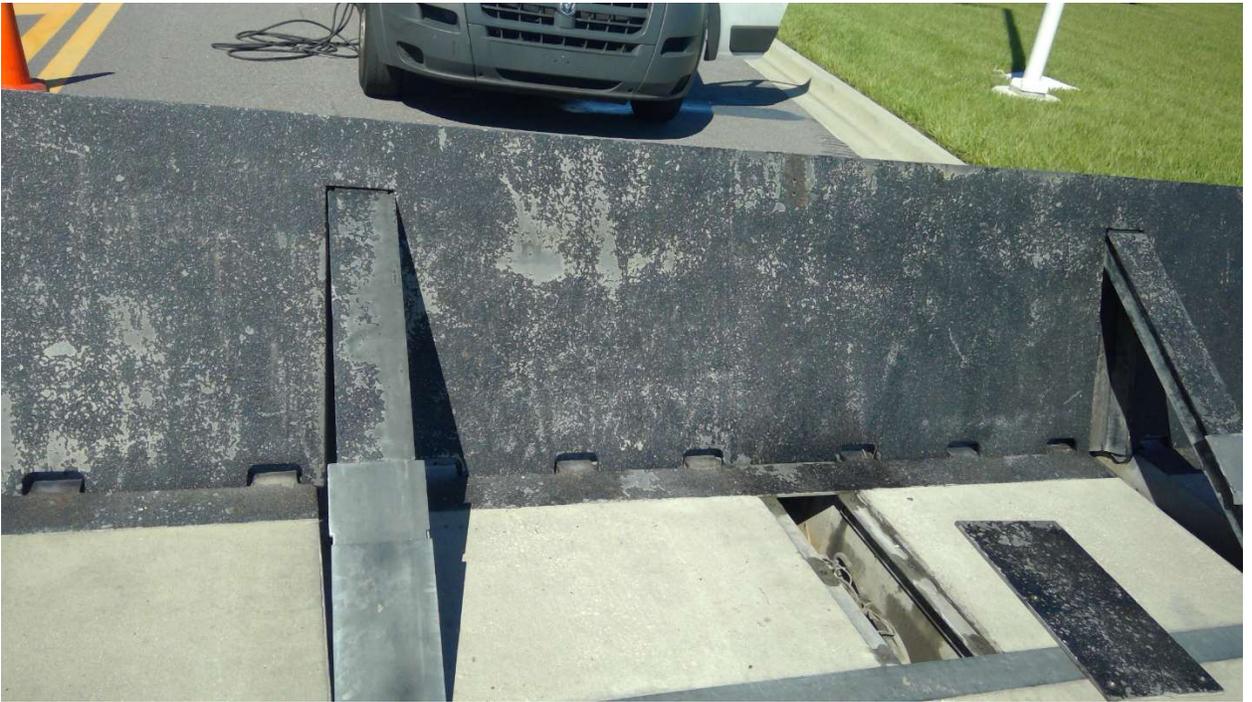
Concrete was poured too high during installation resulting in the plate not resting properly in the down position and also damaging the paint and the galvanizing coating

Resolution: grind the concrete down, touch up paint with yellow and black paint

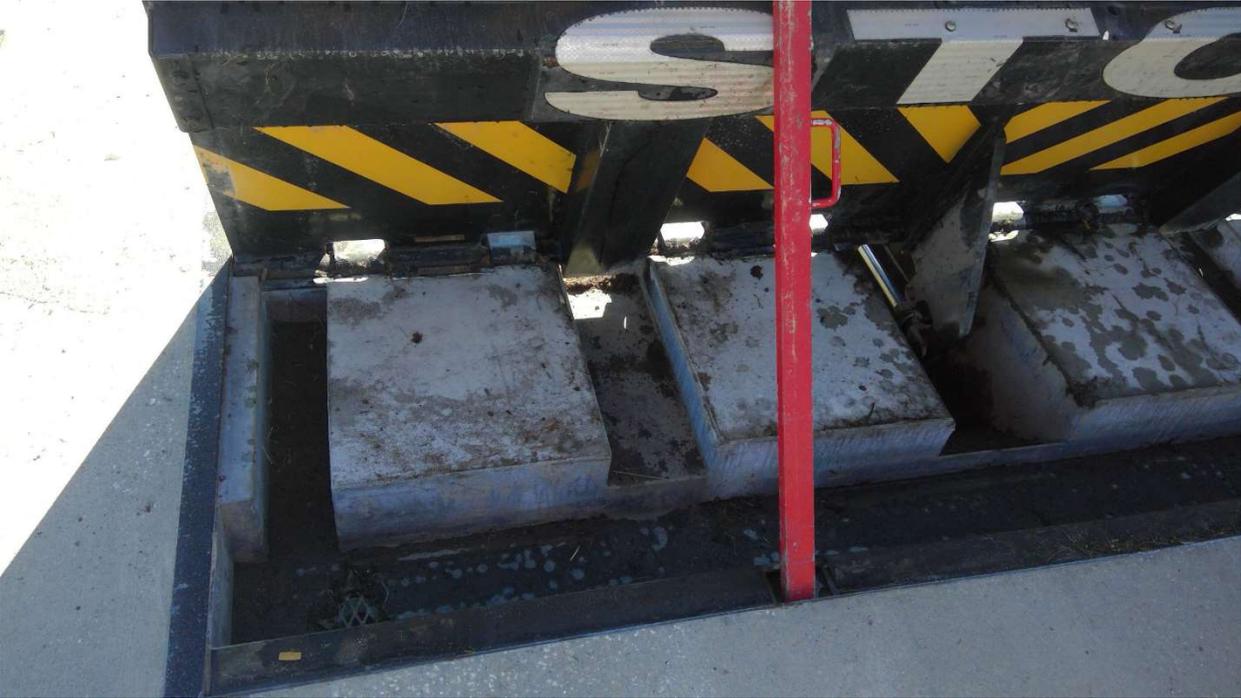
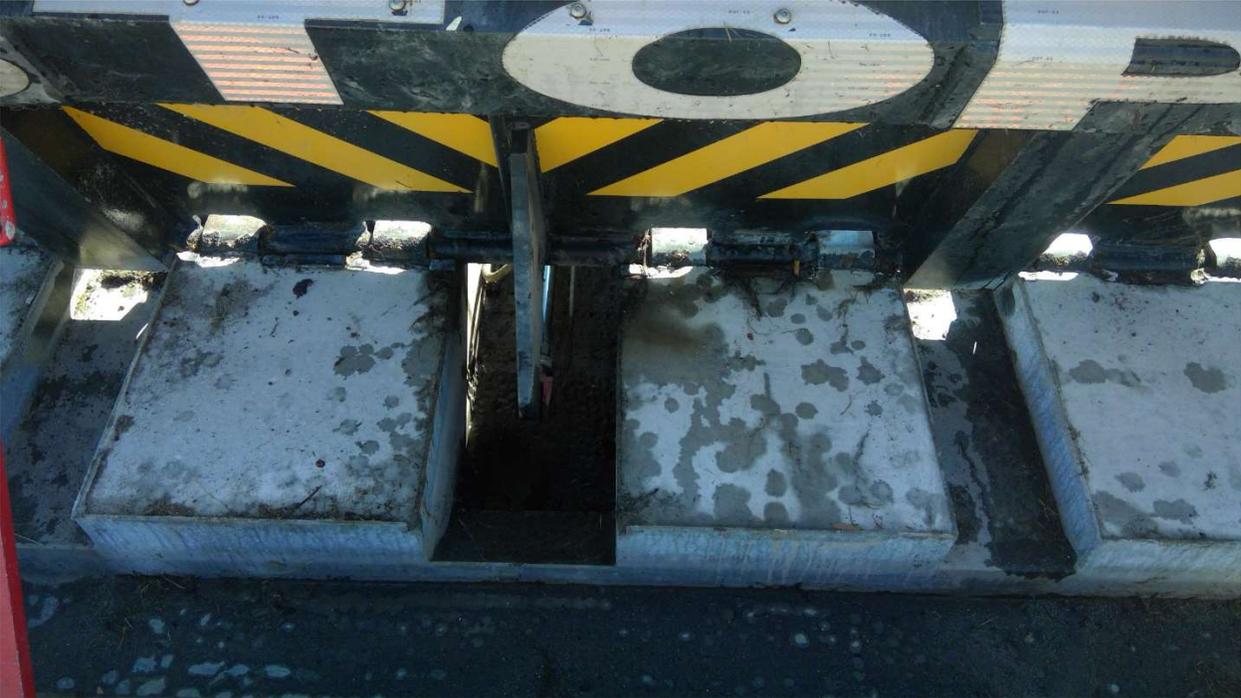
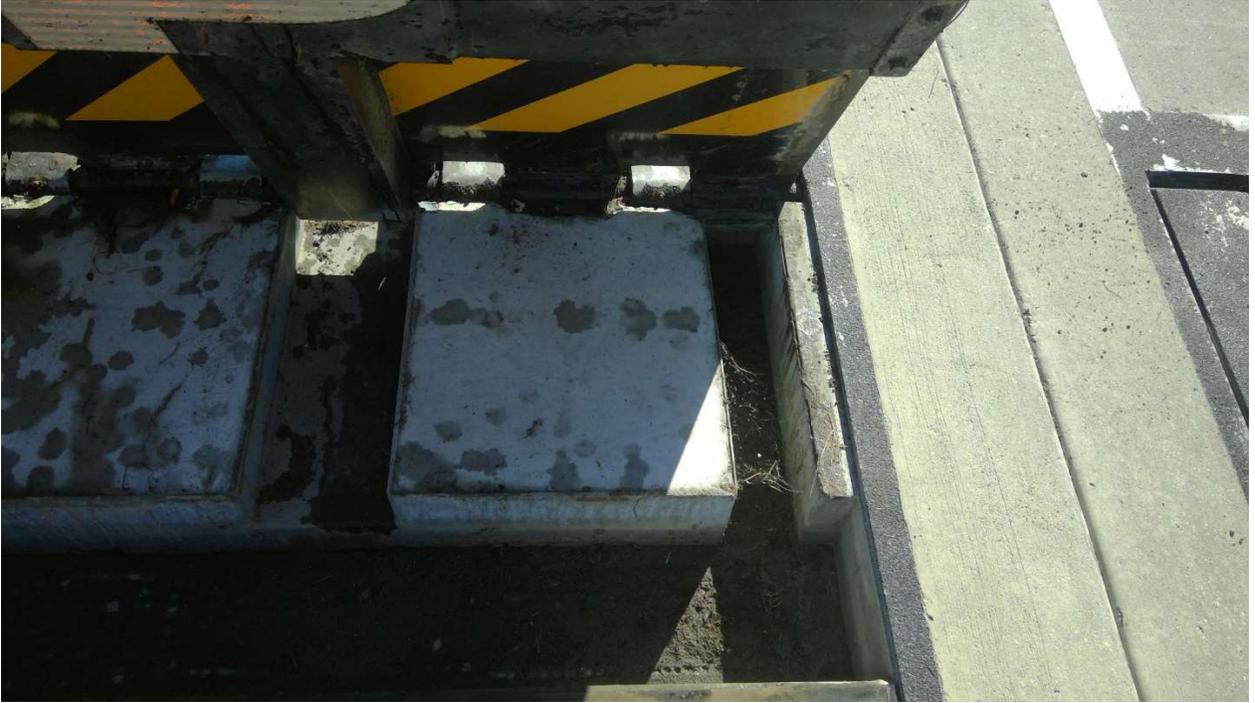
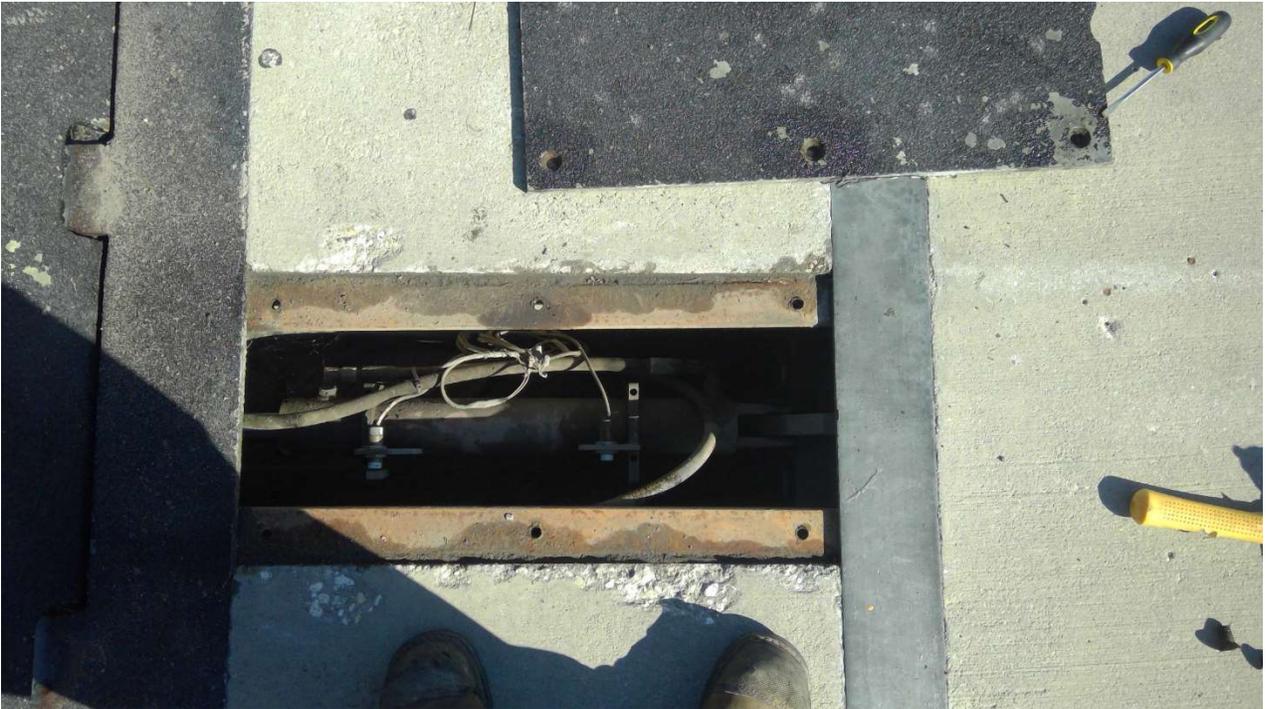
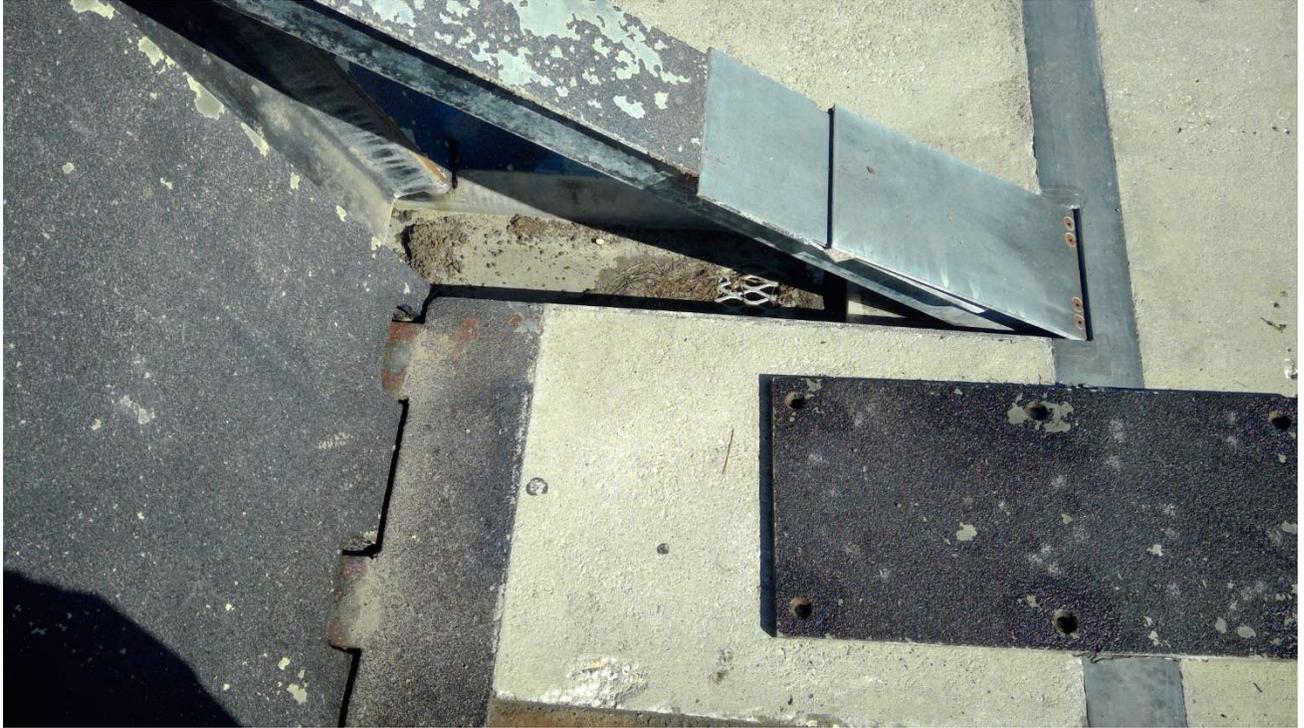
Main Entrance - Left side - Middle Lane

-Limit Sensors wiring is not properly terminated for below grade application. The cable should be shortened, terminations should be soldered, adhesive heat shrunk, and cable sleeved

Rubber pads on the front of the barrier needs to be replaced

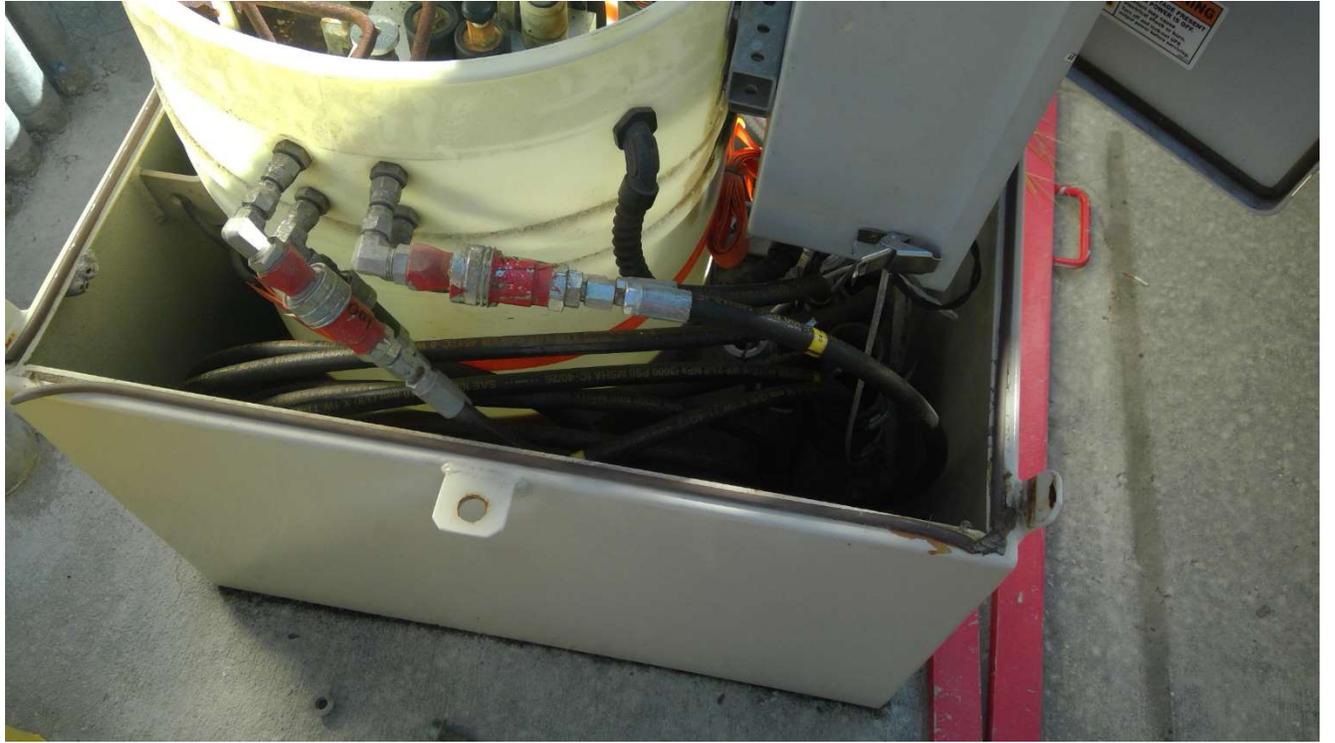
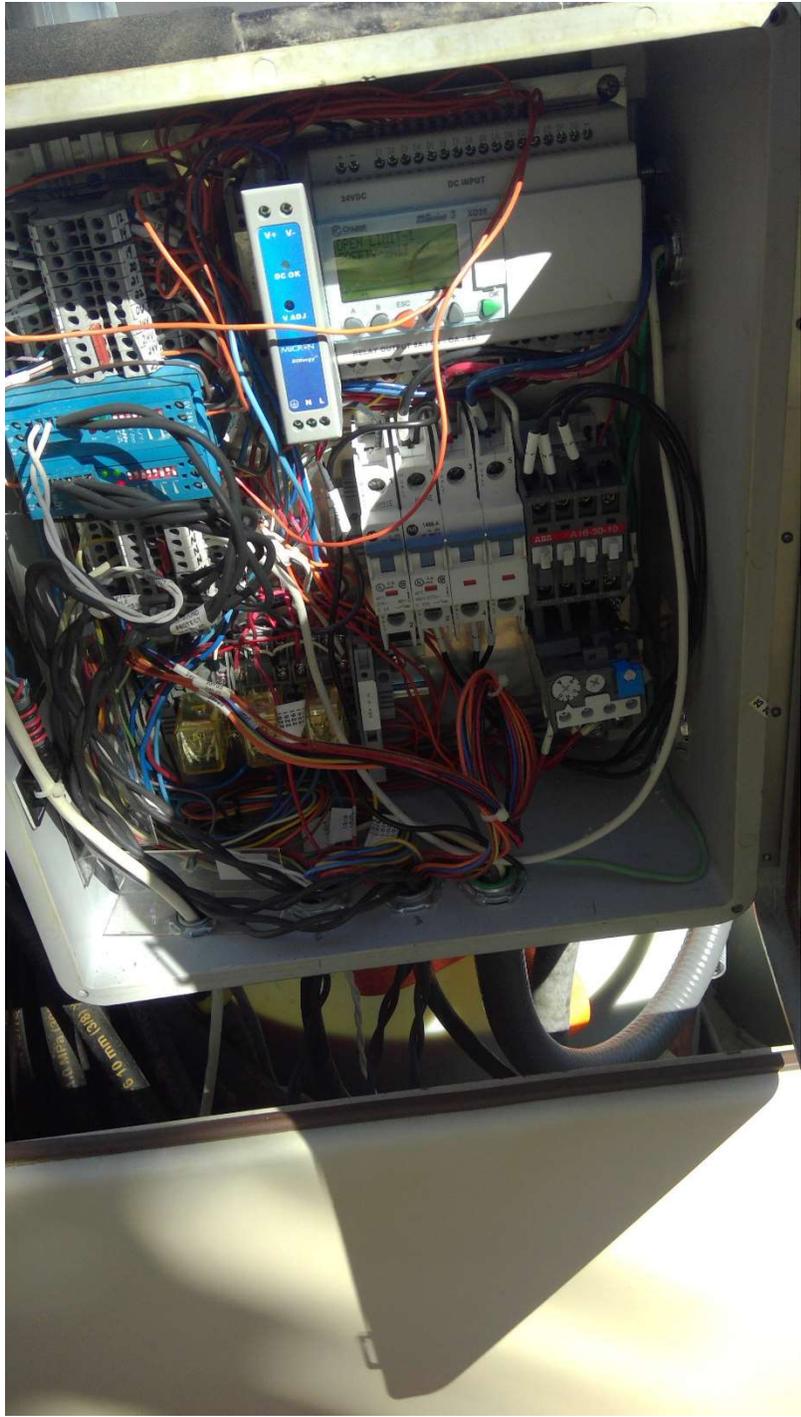
Main Entrance - Side/Middle – Power Unit

Hydraulic unit is complete disrepair. All the lines, hand pump, mounting, fitting are in a major state of degradation. It is suggested to replace the entire power unit before putting the barrier system into operation. The hydraulic lines should be replaced. The hydraulic cylinder needs to be taken apart and cleaned also.

- Hydraulic unit needs complete replacement
- This PLC panel needs to be removed and functionality migrated to master panel
- Noticeable rusting and paint chipping is on the outdoor enclosure. Full painting is suggested.

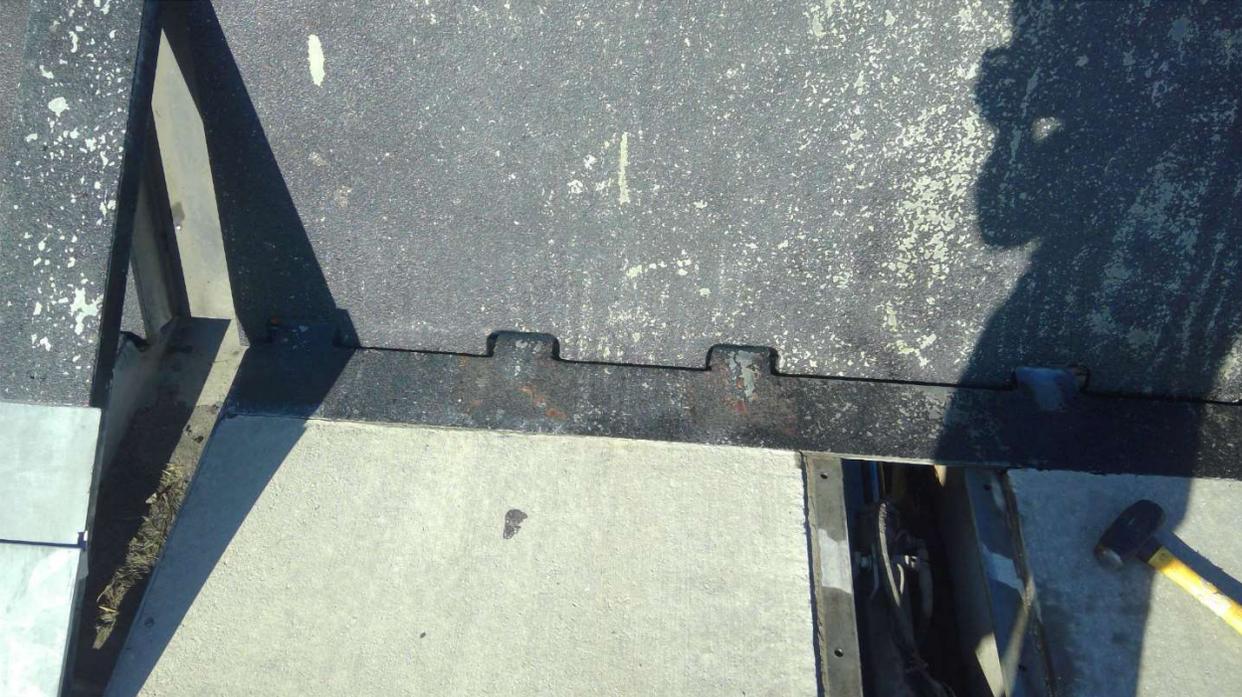
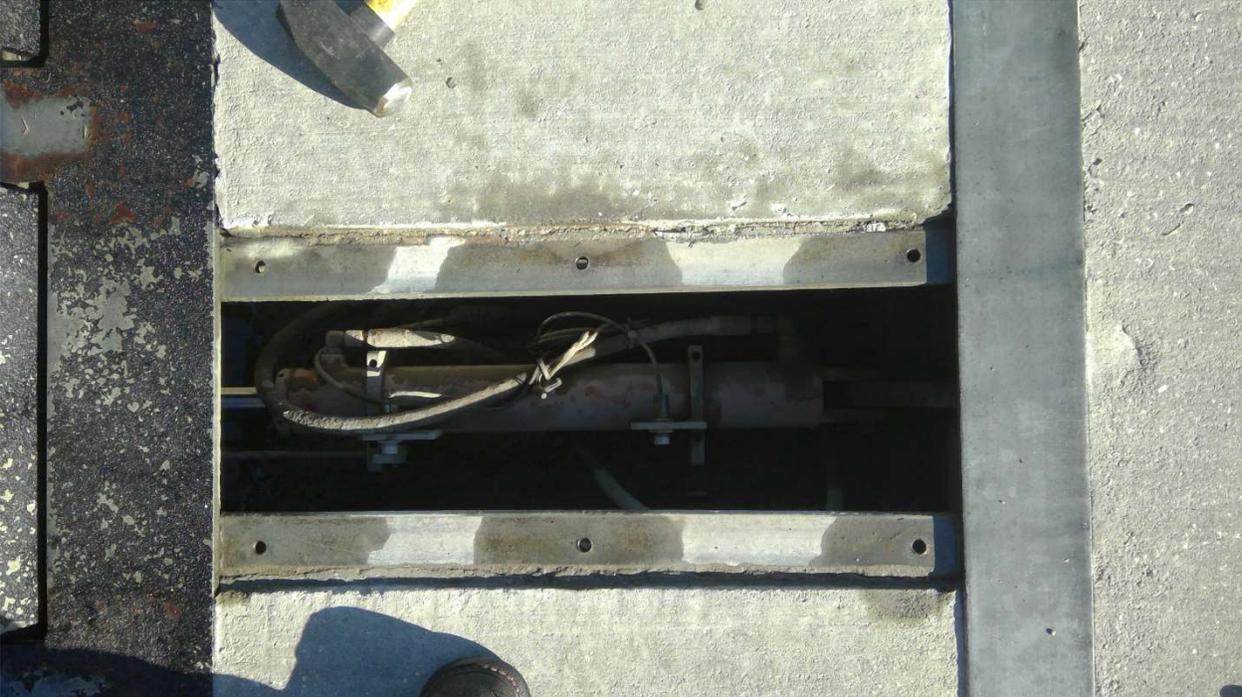
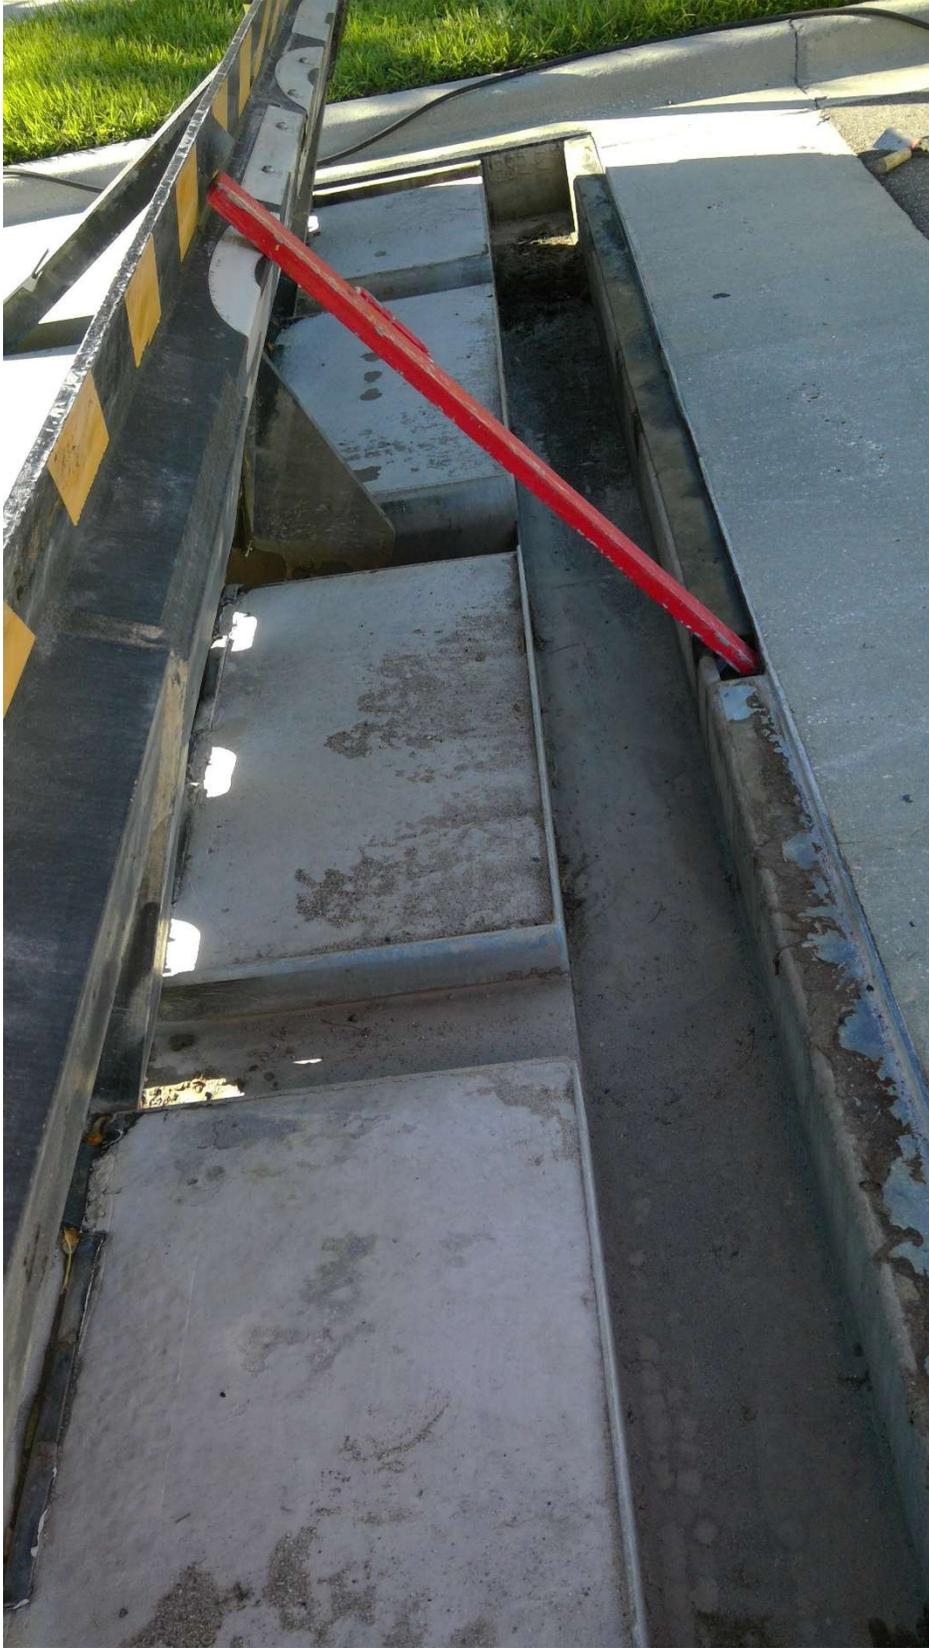
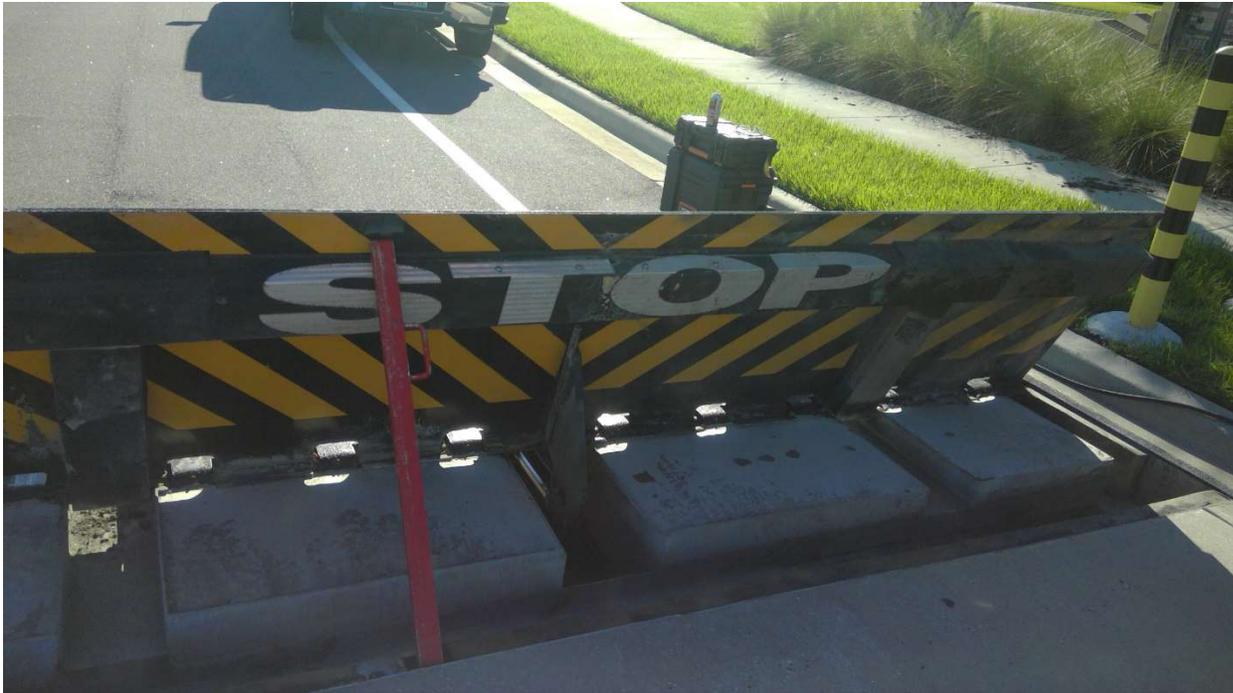
Main Entrance - Left side - Inbound Side Lane

Concrete was poured too high during installation resulting in the plate not resting properly in the down position and also damaging the paint and the galvanizing coating

Resolution: grind the concrete down, touch up paint with yellow and black paint

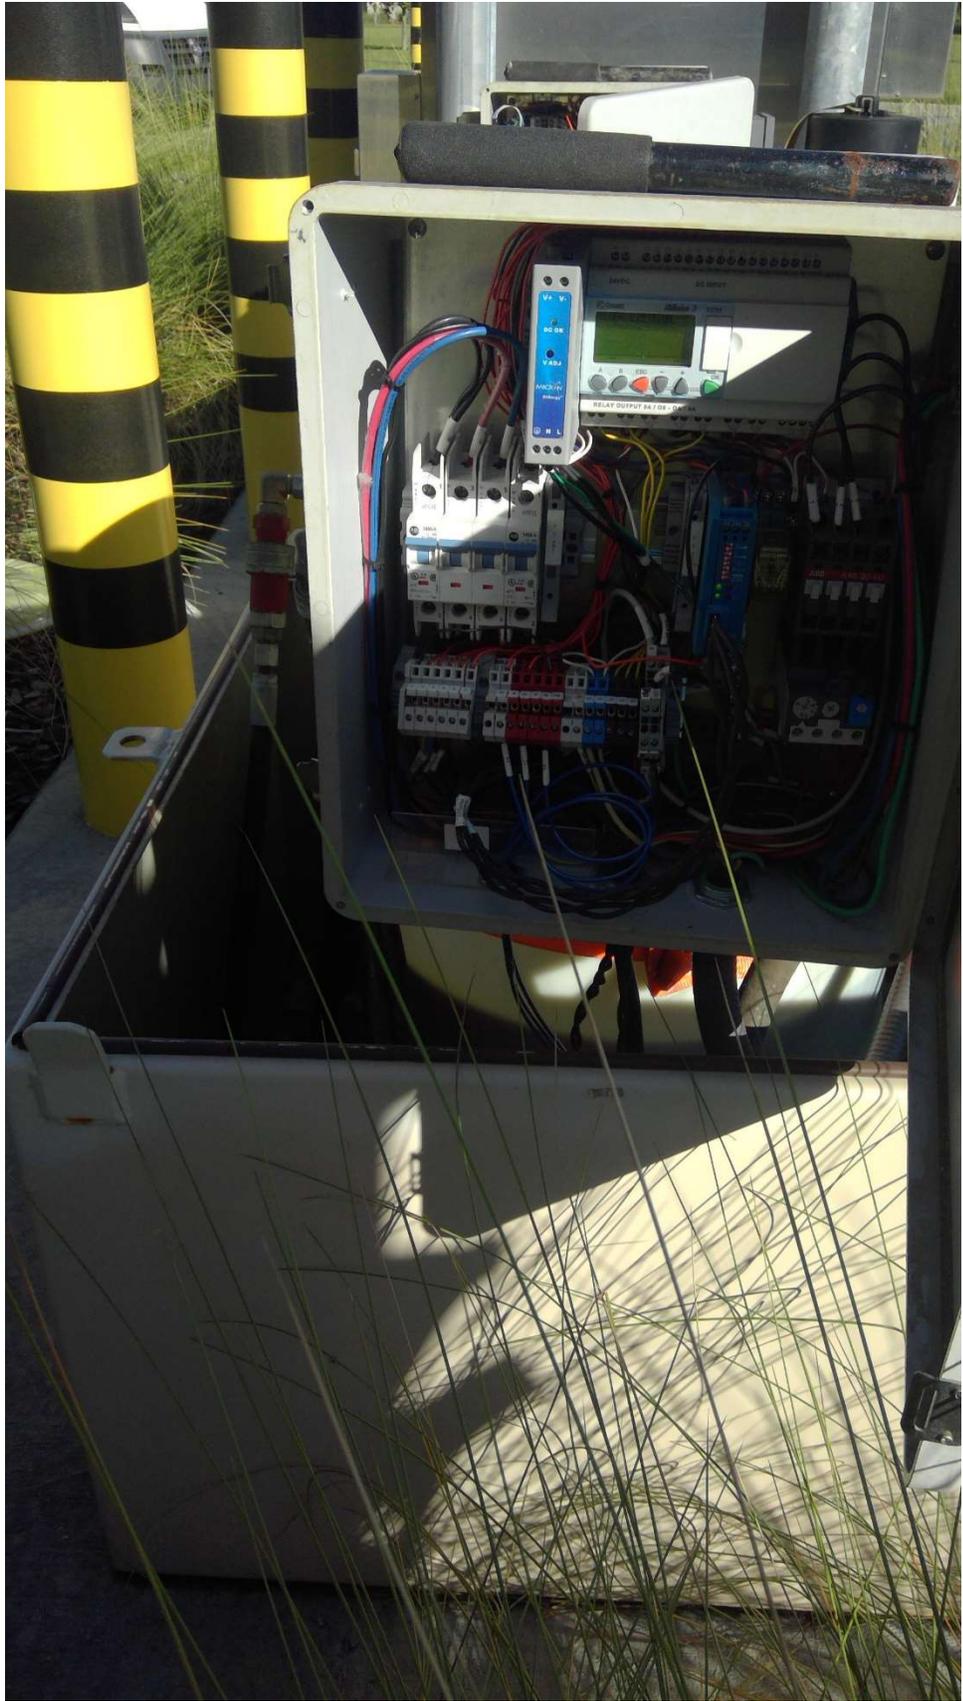
-Limit Sensors wiring is not properly terminated for below grade application. The cable should be shortened, terminations should be soldered, adhesive heat shrunk, and cable sleeved

-Hydraulic oil is extremely dirty. The oil, suction strainer needs to be replaced. The hydraulic hoses need to be blown out and flushed. The hydraulic drum needs to be wiped and cleaned thoroughly

-Noticeable rusting and paint chipping is on the outdoor enclosure. The chipping spots at a minimum needs to be touched up. Full painting is suggested.

-Two areas of concrete need to be repaired

-Front rubber pad needs to be replaced
