SURVEY

## exterior survey

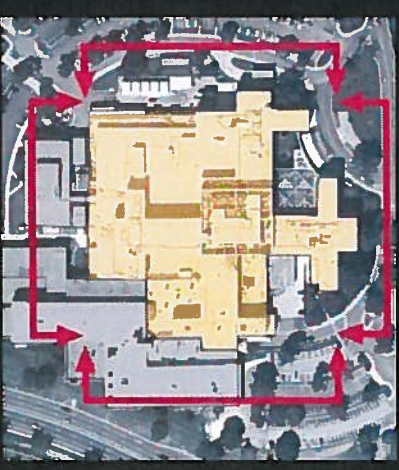
- Generally good condition
- Varying uniformity in joints creates illusion of bulges
- Minimal instances of mortar spalling

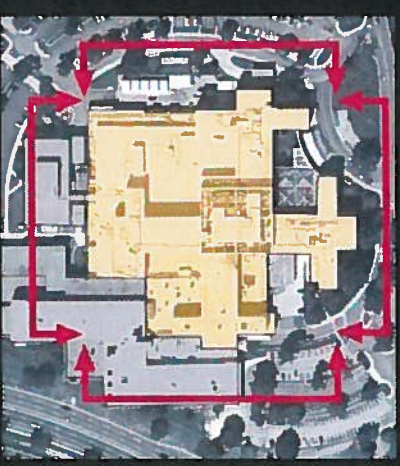
- Façade in need of cleaning
- Staining at corners of sills

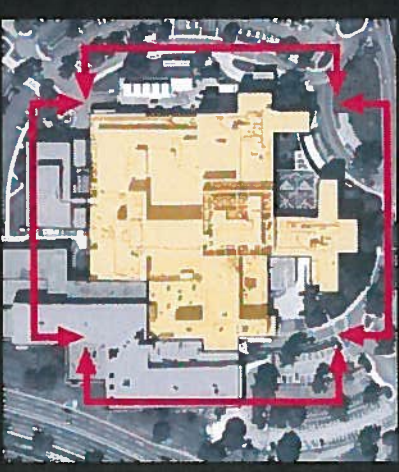
- Vertical cracks at some corners of masonry veneer:
- too few relieving angles
- self weight transfer to bottom
- not a safety concern
- Pits and holes from former exterior attachments

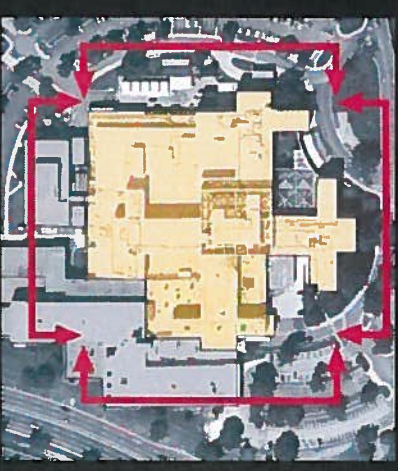
- Step cracking in penthouse façade
- Requires further investigation

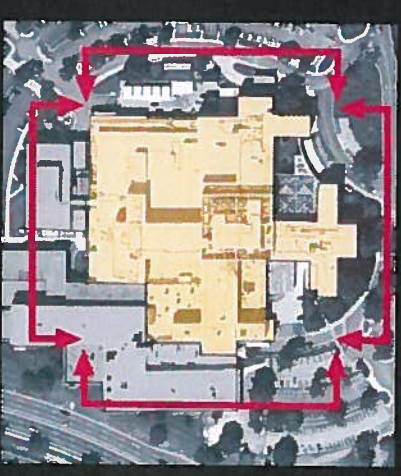
- Typical 5' -6" x 4' masonry opening
- Aluminum frame
- Single pain glass
- Exterior screen
- Interior vertical blinds

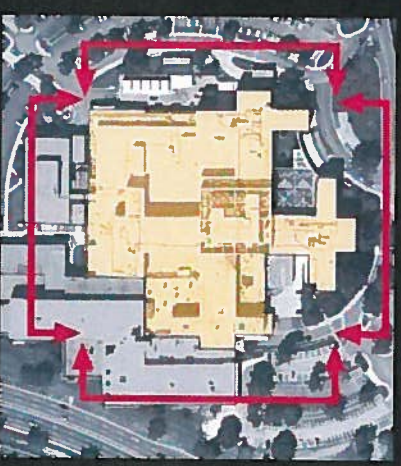
- Caulking is pulling away – exposing gaps in some instances
- Water drainage is creating staining
- Interior water damage is currently being assessed

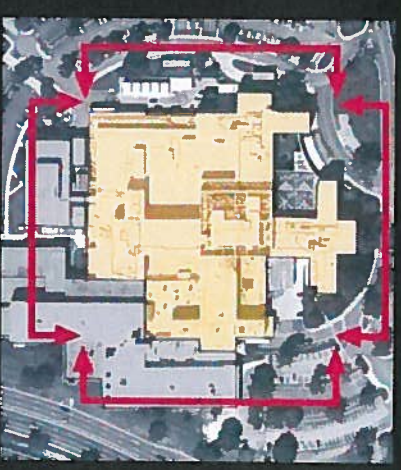
- Screens are frequently torn or missing

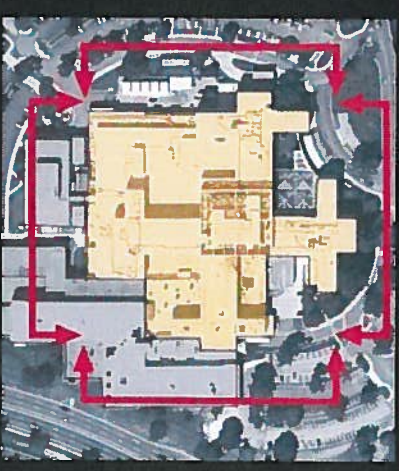
- Lack of uniformity in window replacement

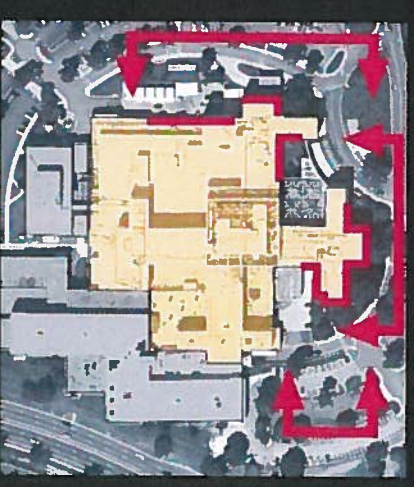
- Flashing shows signs of buckling
- Flashing shows signs of rusting / staining
- Staining / streaking onto tile at base
- Single pain glazing
- Vertical blinds

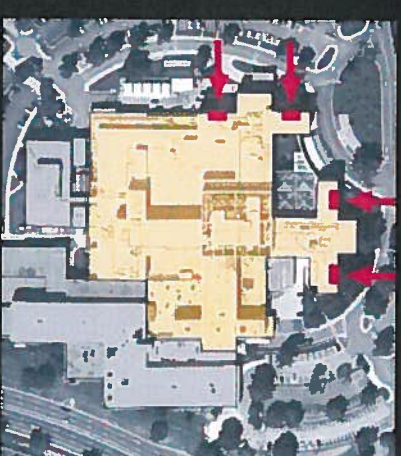
- Precast sunscreen is spalling
- Flaking and cracking of exterior glaze due to moisture penetration and seismic event
- Cracks do not appear to be into tile units themselves
- Integral system would make spot replacement difficult

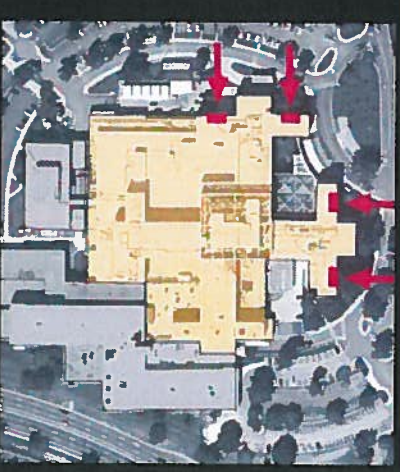
- Interior ponding / moisture build-up on interior beam
- Interior paint has signs of blistering due to humidity
- Some cracks in glass
- Single pain glazing
- Maintenance / cleaning difficulties due to accessibility
