## Limited Asbestos Inventory Summary

To:	Michael A. Ciofani AIA NCARB
From:	Jeff Senn and Robert Peschel – Sigma
Project Number:	13205
Date:	May 22, 2012
RE:	VA Medical Center – Milwaukee, WI VA Project 695-12-119 Building 113 Replace Switchgear

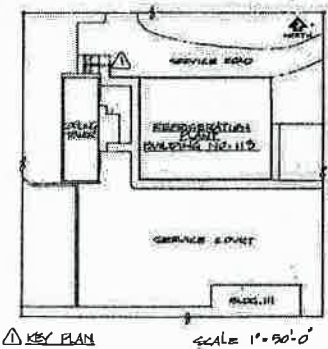
Limits of Inspection

Sigma inspected areas within Building 113 as indicated on Figure 1 provided in Attachment 2 for suspect ACBMs. The following materials were evaluated by Sigma for the presence of asbestos.
