FIRE BARRIER PLAN - FIRST FLOOR  
BUILDING 1 EAST

FIRE SAFETY UPGRADES

Location: **GEORGE E WAHLEN**  
500 FOOTHILL DR. SALT LAKE CITY, UT

Project Number:  
660-14-104

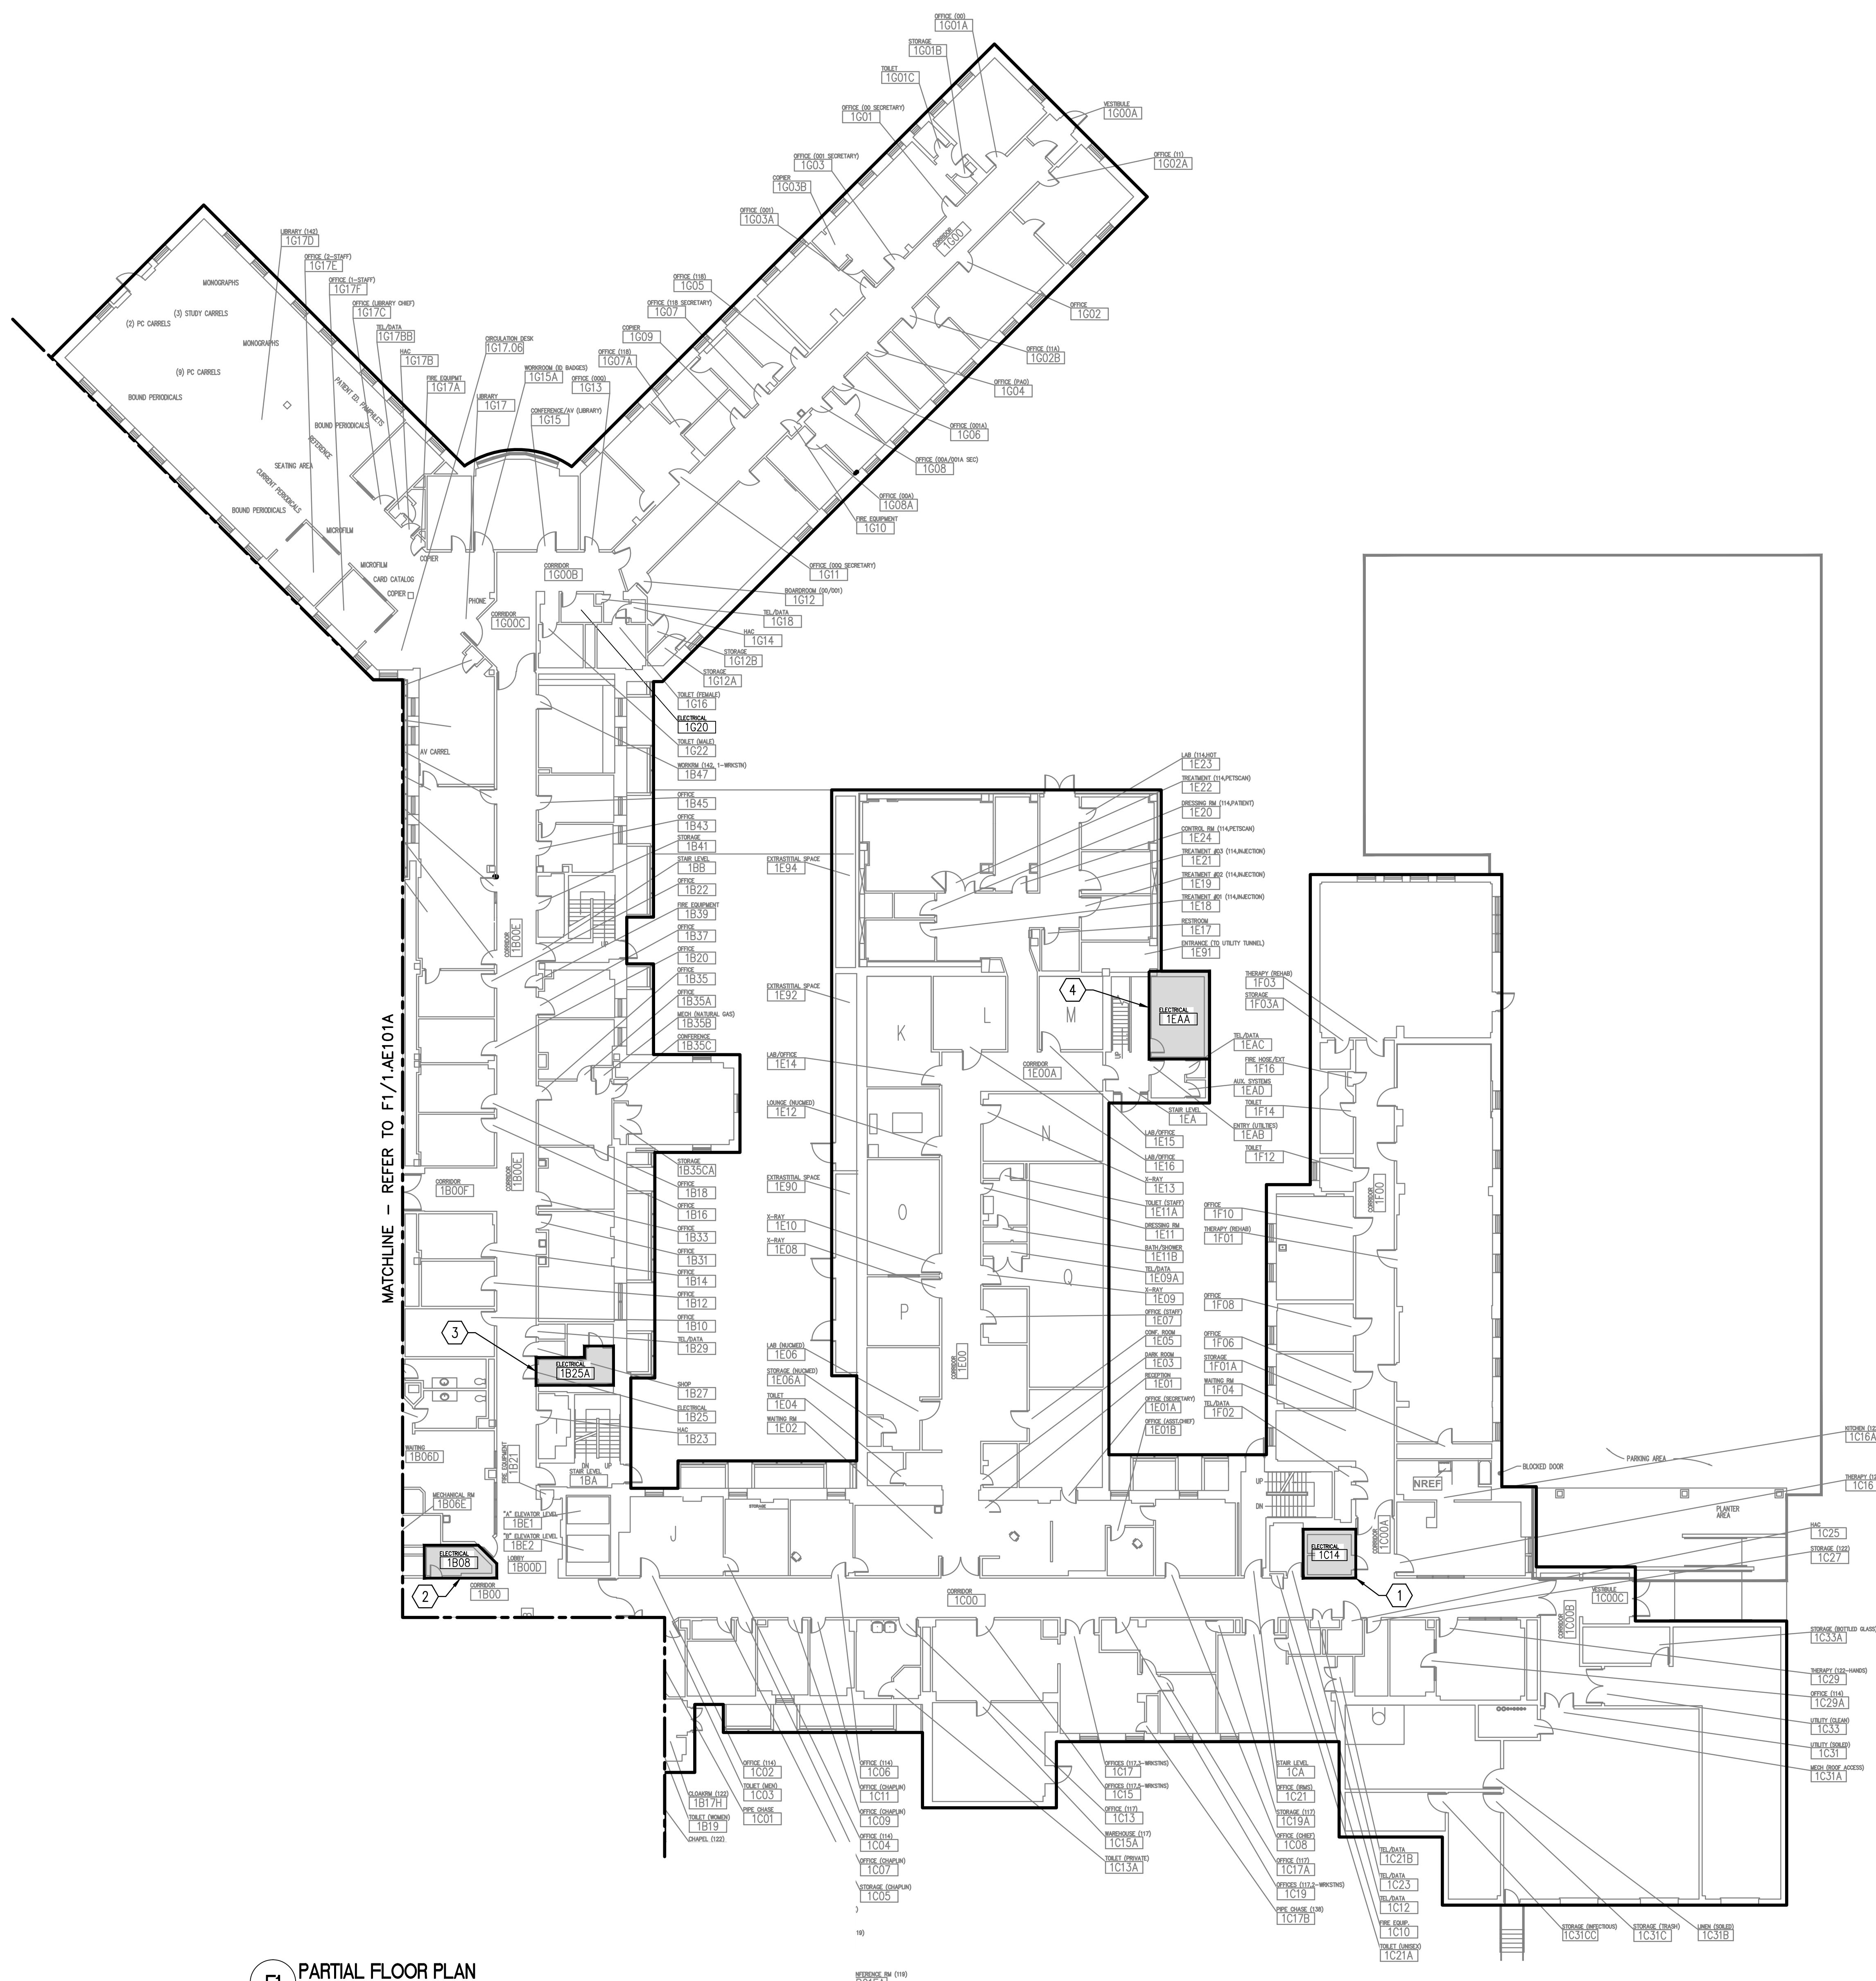
**F1 PARTIAL FLOOR PLAN**  
1/16" = 1'-0"

- 1 CORRECT GYPSUM BOARD WALL DEFICIENCIES TO ACHIEVE A SMOKE BARRIER RATING OF THE EXISTING WALL IN ROOM 1C14 TO MEET NFPA101-18.3.6.2.3 "TO FORM A BARRIER TO LIMIT THE TRANSFER OF SMOKE." IN ADDITION, CORRECT AND FIRESTOP ALL PENETRATIONS TO MEET THESE CODE REQUIREMENTS. THE VA ARCHITECTURAL DESIGN MANUAL SECTION 4.2.4.5 ALLOWS "FOR SMOKE BARRIERS, EXTEND ONE LAYER OF GYPSUM BOARD FROM FLOOR TO UNDERSIDE OF STRUCTURE ABOVE ON PARTITIONS, AND FIRESTOP JUNCTURE OF GYPSUM BOARD AND ADJOINING MATERIAL TO PREVENT THE PASSAGE OF SMOKE." EXISTING PHOTO ON A1/1.AE601 PROVIDES TYPICAL DEFICIENCY CONDITION.

- 2 CORRECT GYPSUM BOARD WALL DEFICIENCIES TO ACHIEVE A SMOKE BARRIER RATING OF THE EXISTING WALL IN ROOM 1B08 TO MEET NFPA101-18.3.6.2.3 "TO FORM A BARRIER TO LIMIT THE TRANSFER OF SMOKE." IN ADDITION, CORRECT AND FIRESTOP ALL PENETRATIONS TO MEET THESE CODE REQUIREMENTS. THE VA ARCHITECTURAL DESIGN MANUAL SECTION 4.2.4.5 ALLOWS "FOR SMOKE BARRIERS, EXTEND ONE LAYER OF GYPSUM BOARD FROM FLOOR TO UNDERSIDE OF STRUCTURE ABOVE ON PARTITIONS, AND FIRESTOP JUNCTURE OF GYPSUM BOARD AND ADJOINING MATERIAL TO PREVENT THE PASSAGE OF SMOKE." EXISTING PHOTO ON A2/1.AE601 PROVIDES TYPICAL DEFICIENCY CONDITION.

- 3 CORRECT GYPSUM BOARD WALL DEFICIENCIES TO ACHIEVE A SMOKE BARRIER RATING OF THE EXISTING WALL IN ROOM 1B25A TO MEET NFPA101-18.3.6.2.3 "TO FORM A BARRIER TO LIMIT THE TRANSFER OF SMOKE." IN ADDITION, CORRECT AND FIRESTOP ALL PENETRATIONS TO MEET THESE CODE REQUIREMENTS. THE VA ARCHITECTURAL DESIGN MANUAL SECTION 4.2.4.5 ALLOWS "FOR SMOKE BARRIERS, EXTEND ONE LAYER OF GYPSUM BOARD FROM FLOOR TO UNDERSIDE OF STRUCTURE ABOVE ON PARTITIONS, AND FIRESTOP JUNCTURE OF GYPSUM BOARD AND ADJOINING MATERIAL TO PREVENT THE PASSAGE OF SMOKE." EXISTING PHOTO ON A4/1.AE601 PROVIDES TYPICAL DEFICIENCY CONDITION.

- 4 CORRECT GYPSUM BOARD WALL DEFICIENCIES TO ACHIEVE A SMOKE BARRIER RATING OF THE EXISTING WALL IN ROOM 1EA4 TO MEET NFPA101-18.3.6.2.3 "TO FORM A BARRIER TO LIMIT THE TRANSFER OF SMOKE." IN ADDITION, CORRECT AND FIRESTOP ALL PENETRATIONS TO MEET THESE CODE REQUIREMENTS. THE VA ARCHITECTURAL DESIGN MANUAL SECTION 4.2.4.5 ALLOWS "FOR SMOKE BARRIERS, EXTEND ONE LAYER OF GYPSUM BOARD FROM FLOOR TO UNDERSIDE OF STRUCTURE ABOVE ON PARTITIONS, AND FIRESTOP JUNCTURE OF GYPSUM BOARD AND ADJOINING MATERIAL TO PREVENT THE PASSAGE OF SMOKE." EXISTING PHOTO ON C2/1.AE601 PROVIDES TYPICAL DEFICIENCY CONDITION.
