Project No. 600-15-102
Morgue Renovation for Family Access,
Department of Veterans Affairs,
Long Beach Healthcare System (VALBHS)

TRIENNIAL ASBESTOS REINSPECTION REPORT

BUILDING 2 - CANTEEN, CHAPEL, LIBRARY & CLINICS

TRIENNIAL ASBESTOS REINSPECTION REPORT
BUILDING 2 – CANTEEN, CHAPEL, LIBRARY & CLINICS

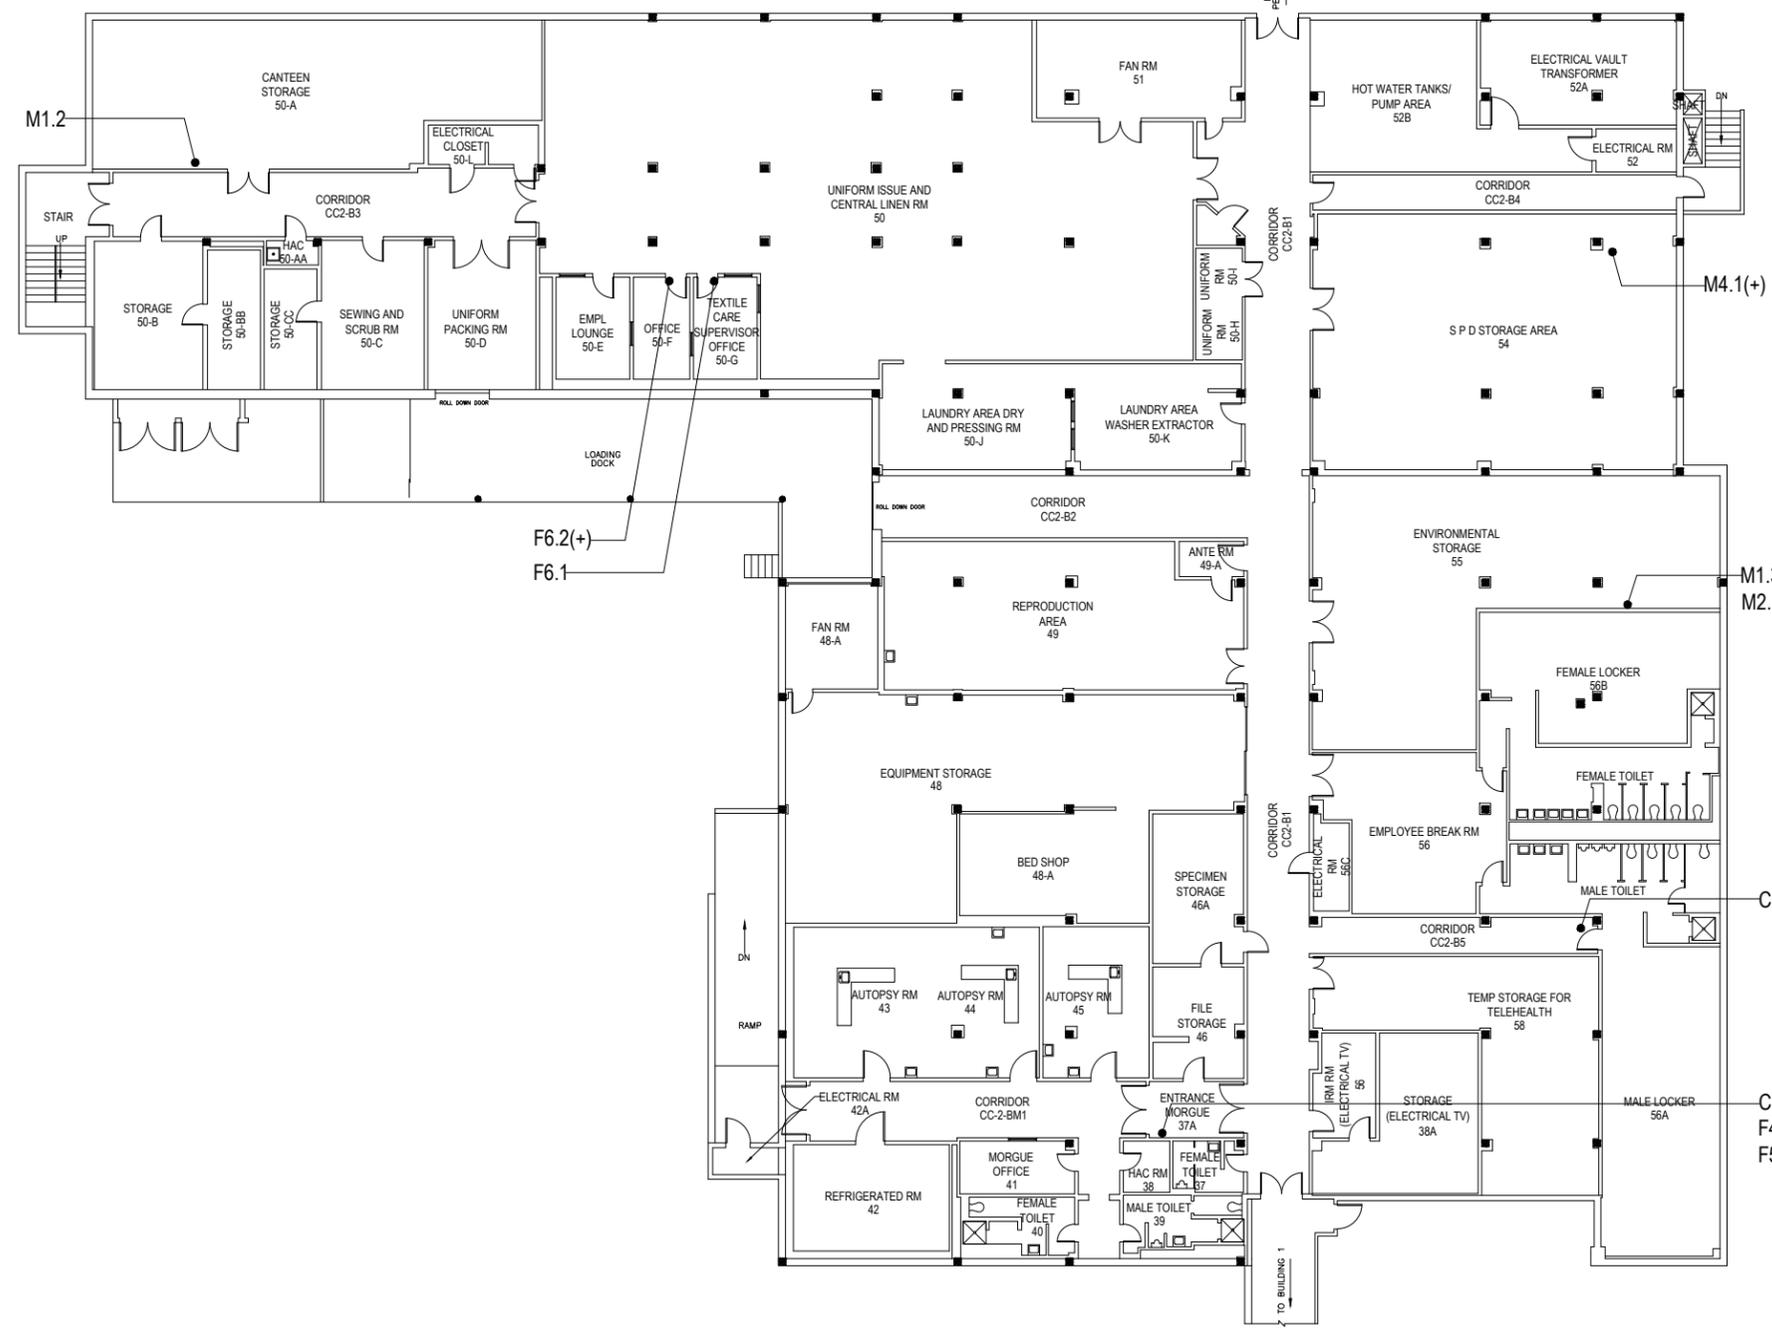
Architects/Engineers/Consultants MILLENNIUM CONSULTING ASSOCIATES <small>A MEGA Consulting, Inc. Company</small>		Drawing Title BUILDING 2 BASEMENT FLOOR PLAN ASBESTOS SAMPLE LOCATION MAP		Project Title LONG BEACH ACM SURVEY		Project Number: 22015.2033		Office of Facilities Management
Professional Seal		Approved Project Director:		Location: VA MEDICAL CENTER 5901 EAST 7TH STREET		Building Number: 2		
Final Submission Revisions		Date 06-23-2014		Date: 07-24-2015		Checked: Drawn: JR3		
						Drawing Number: 2-B		Dwg. 1 of 4

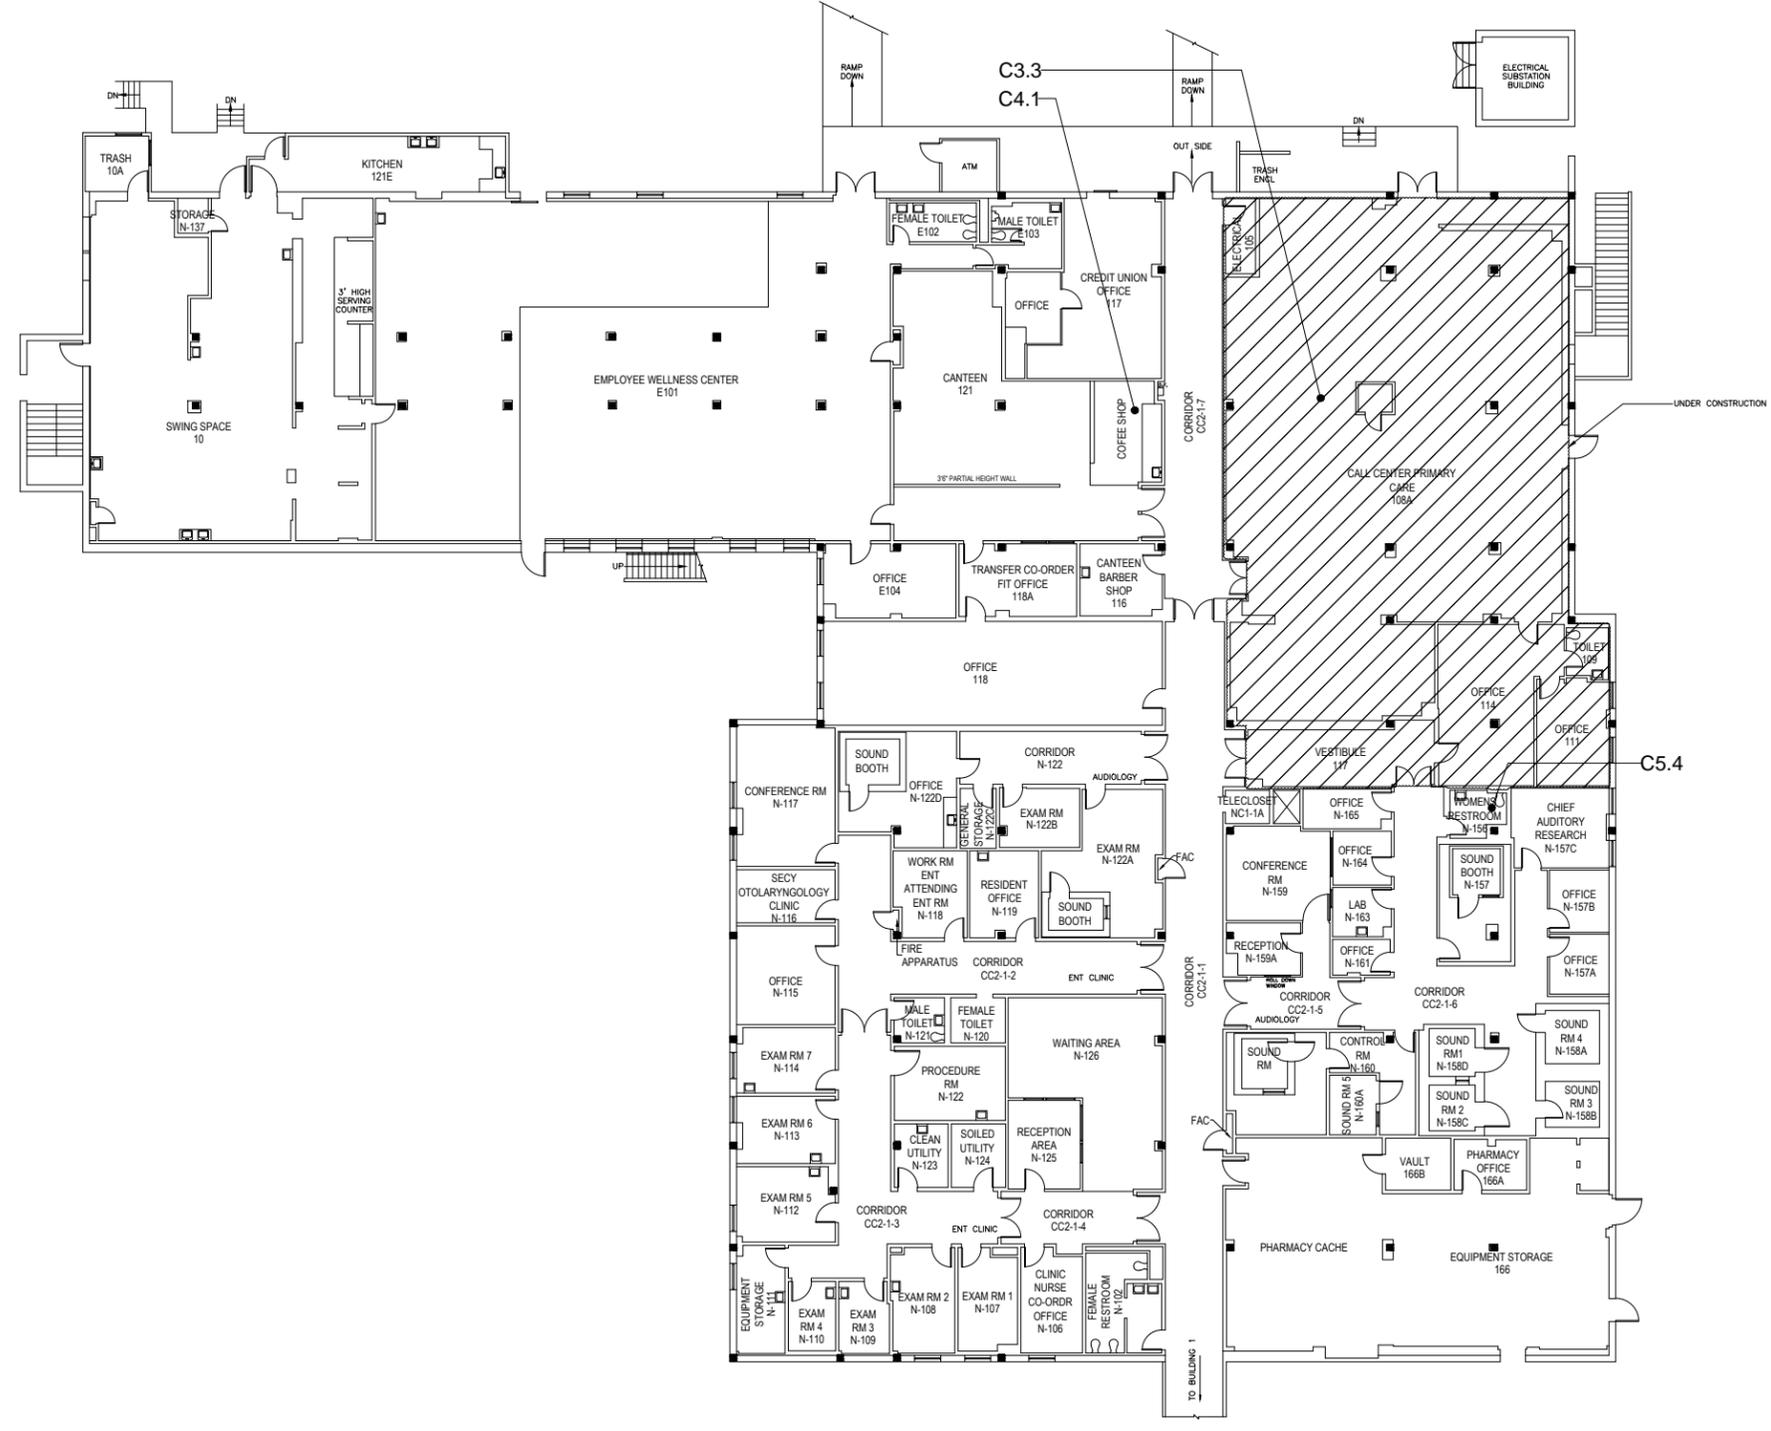
Architects/Engineers/Consultants MILLENNIUM CONSULTING ASSOCIATES <small>A MEGA Consulting, Inc. Company</small>		Drawing Title BUILDING 2 FIRST FLOOR PLAN ASBESTOS SAMPLE LOCATION MAP		Project Title LONG BEACH ACM SURVEY		Project Number: 22015.2033	
Final Submission Revisions		Approved Project Director:		Location: VA MEDICAL CENTER 5901 EAST 7TH STREET		Building Number: 2	
Date 06-23-2014		Checked: JR3		Date: 07-24-2015		Drawing Number: 2-1 Dwg. 2 of 4	
Professional Seal		Office of Facilities Management
