**GEOTECHNICAL INVESTIGATION:  
AMARILLO VA HEALTH CARE SYSTEM  
EXPAND LODGE  
AMARILLO, TX**

**REQUESTED BY:  
CARLA KAUFMAN  
SBBL ARCHITECTURE + PLANNING**

**REPORT NO. 15688  
FEBRUARY 28, 2011**

June 15, 2011  
Broderick Engineering Project No. 10111  
**DRAINAGE REPORT**  
**FOR**  
**AMARILLO VA HEALTHCARE SYSTEM – AMARILLO, TEXAS**

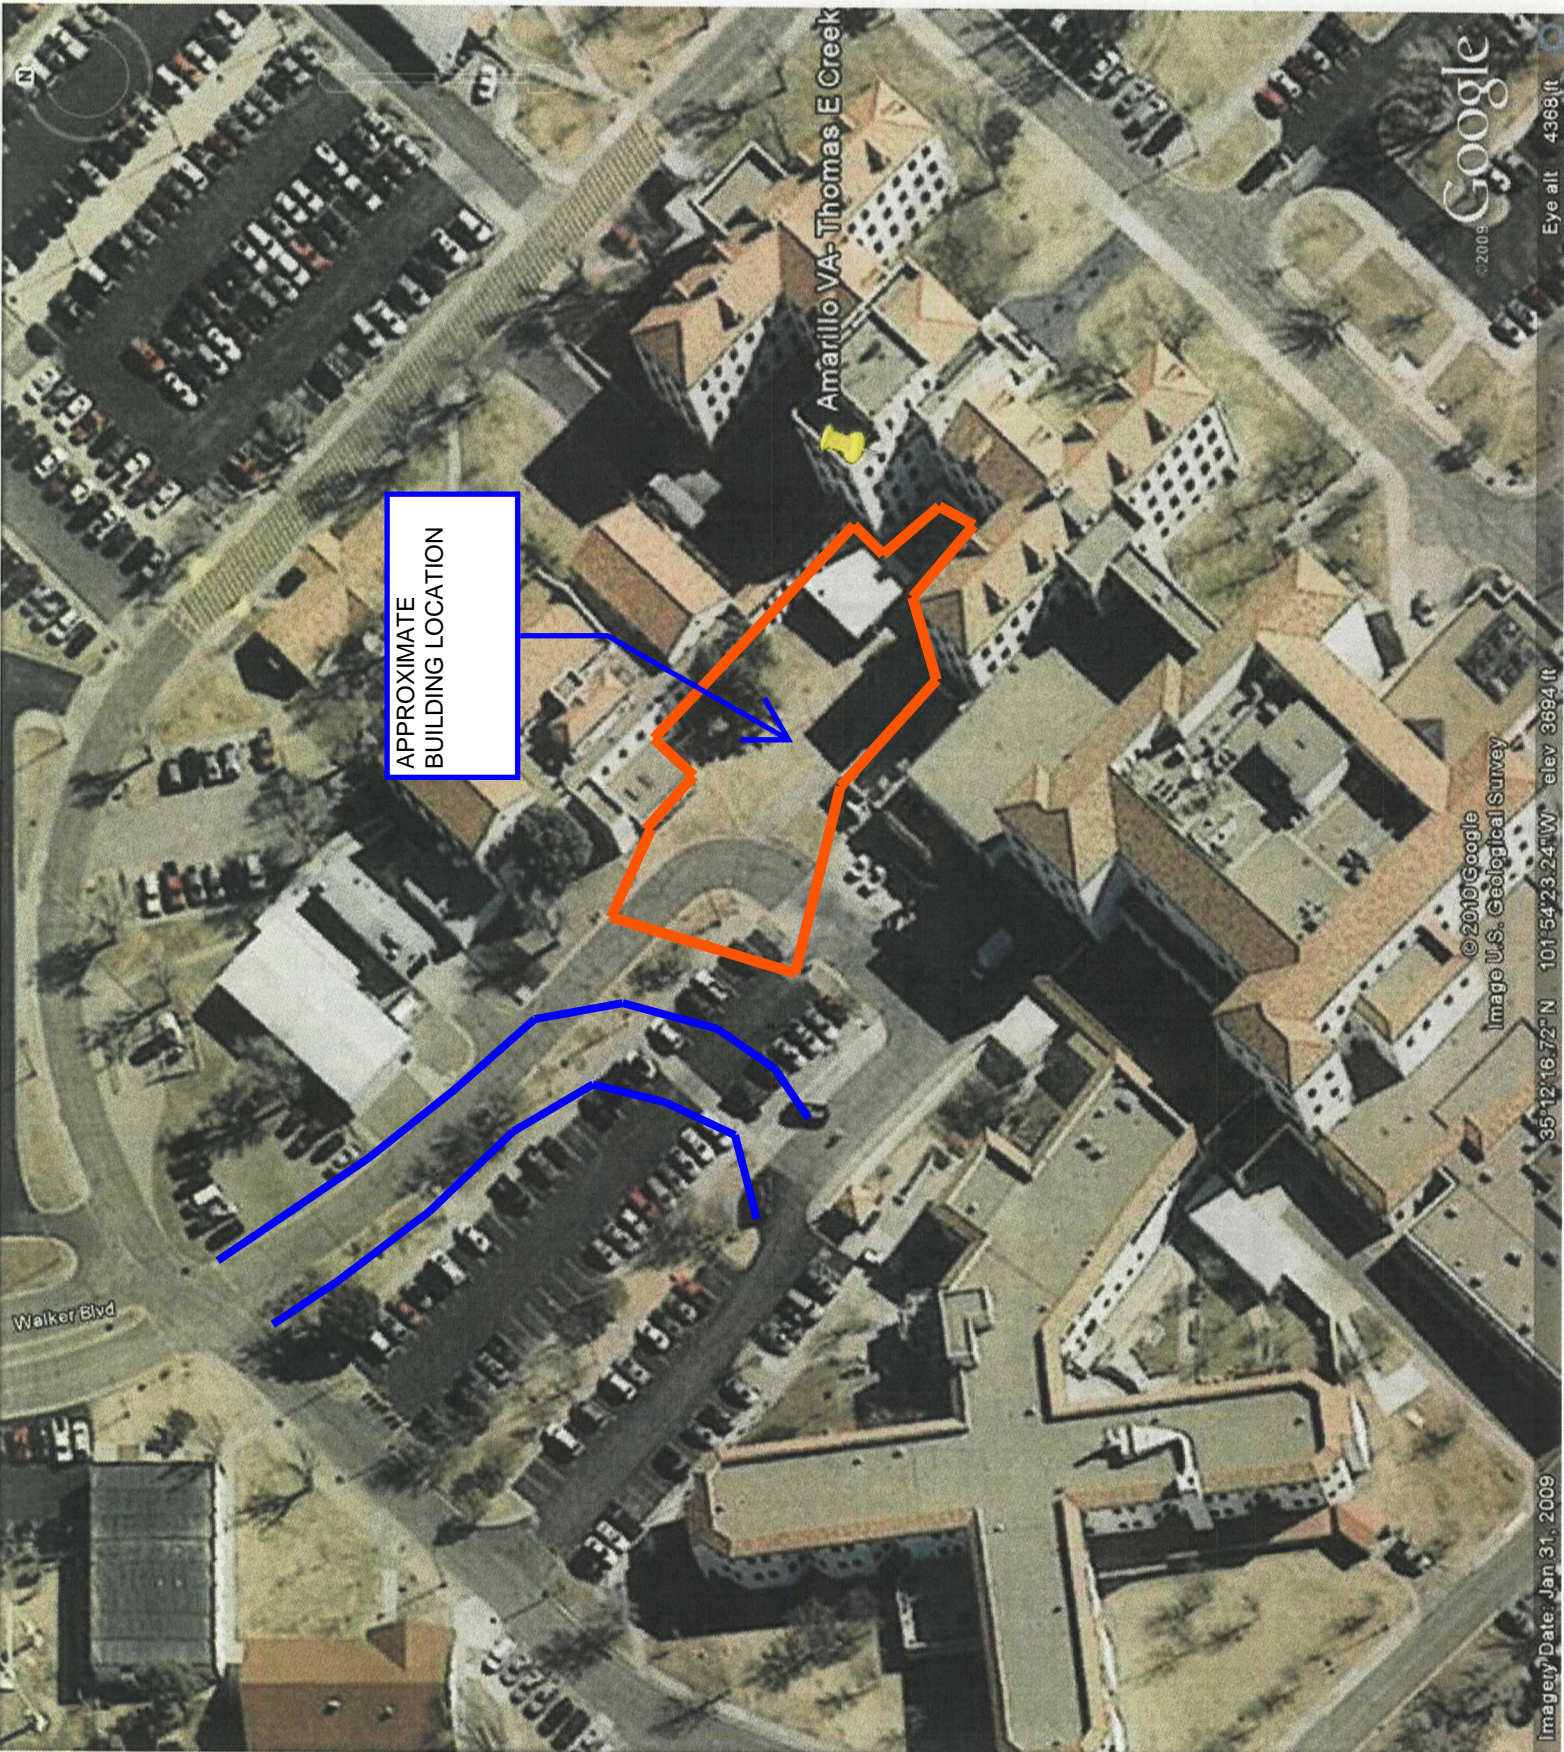
Imagery Date: Jan 31, 2009

Walker Blvd

This Amarillo VAHCS Emergency Department Building No. 48 improvement project number VA258-P-0196 is an important project for the patients, staff and visitors of the Amarillo VA Medical Campus. The campus is located in the City of Amarillo, Potter County, Texas. It is situated southwest of Amarillo Boulevard and 9<sup>th</sup> Avenue. The project includes the improvements to create a new parking Emergency Department building to be located adjacent to existing buildings 1 and 4. The building will also cause the modification to existing parking and minor changes to existing drainage patterns. The area where the building will be located is relatively flat and slopes gradually to the northwest. The site design will utilize the existing under ground storm drain systems. (See Site Map, Figure 1).
