1. REFER TO DRAWING HA-101 FOR ASBESTOS ABATEMENT NOTES.
2. THE MAJORITY OF THE EXPOSED ASBESTOS PIPE INSULATION HAS BEEN REMOVED. ASBESTOS CONTAINING MATERIAL (ACM) AND PIPE INSULATION IS ASSUMED TO EXIST BEHIND WALLS AND IN ENCLOSED PLUMBING CHASES.

ASBESTOS DRAWING NOTES:

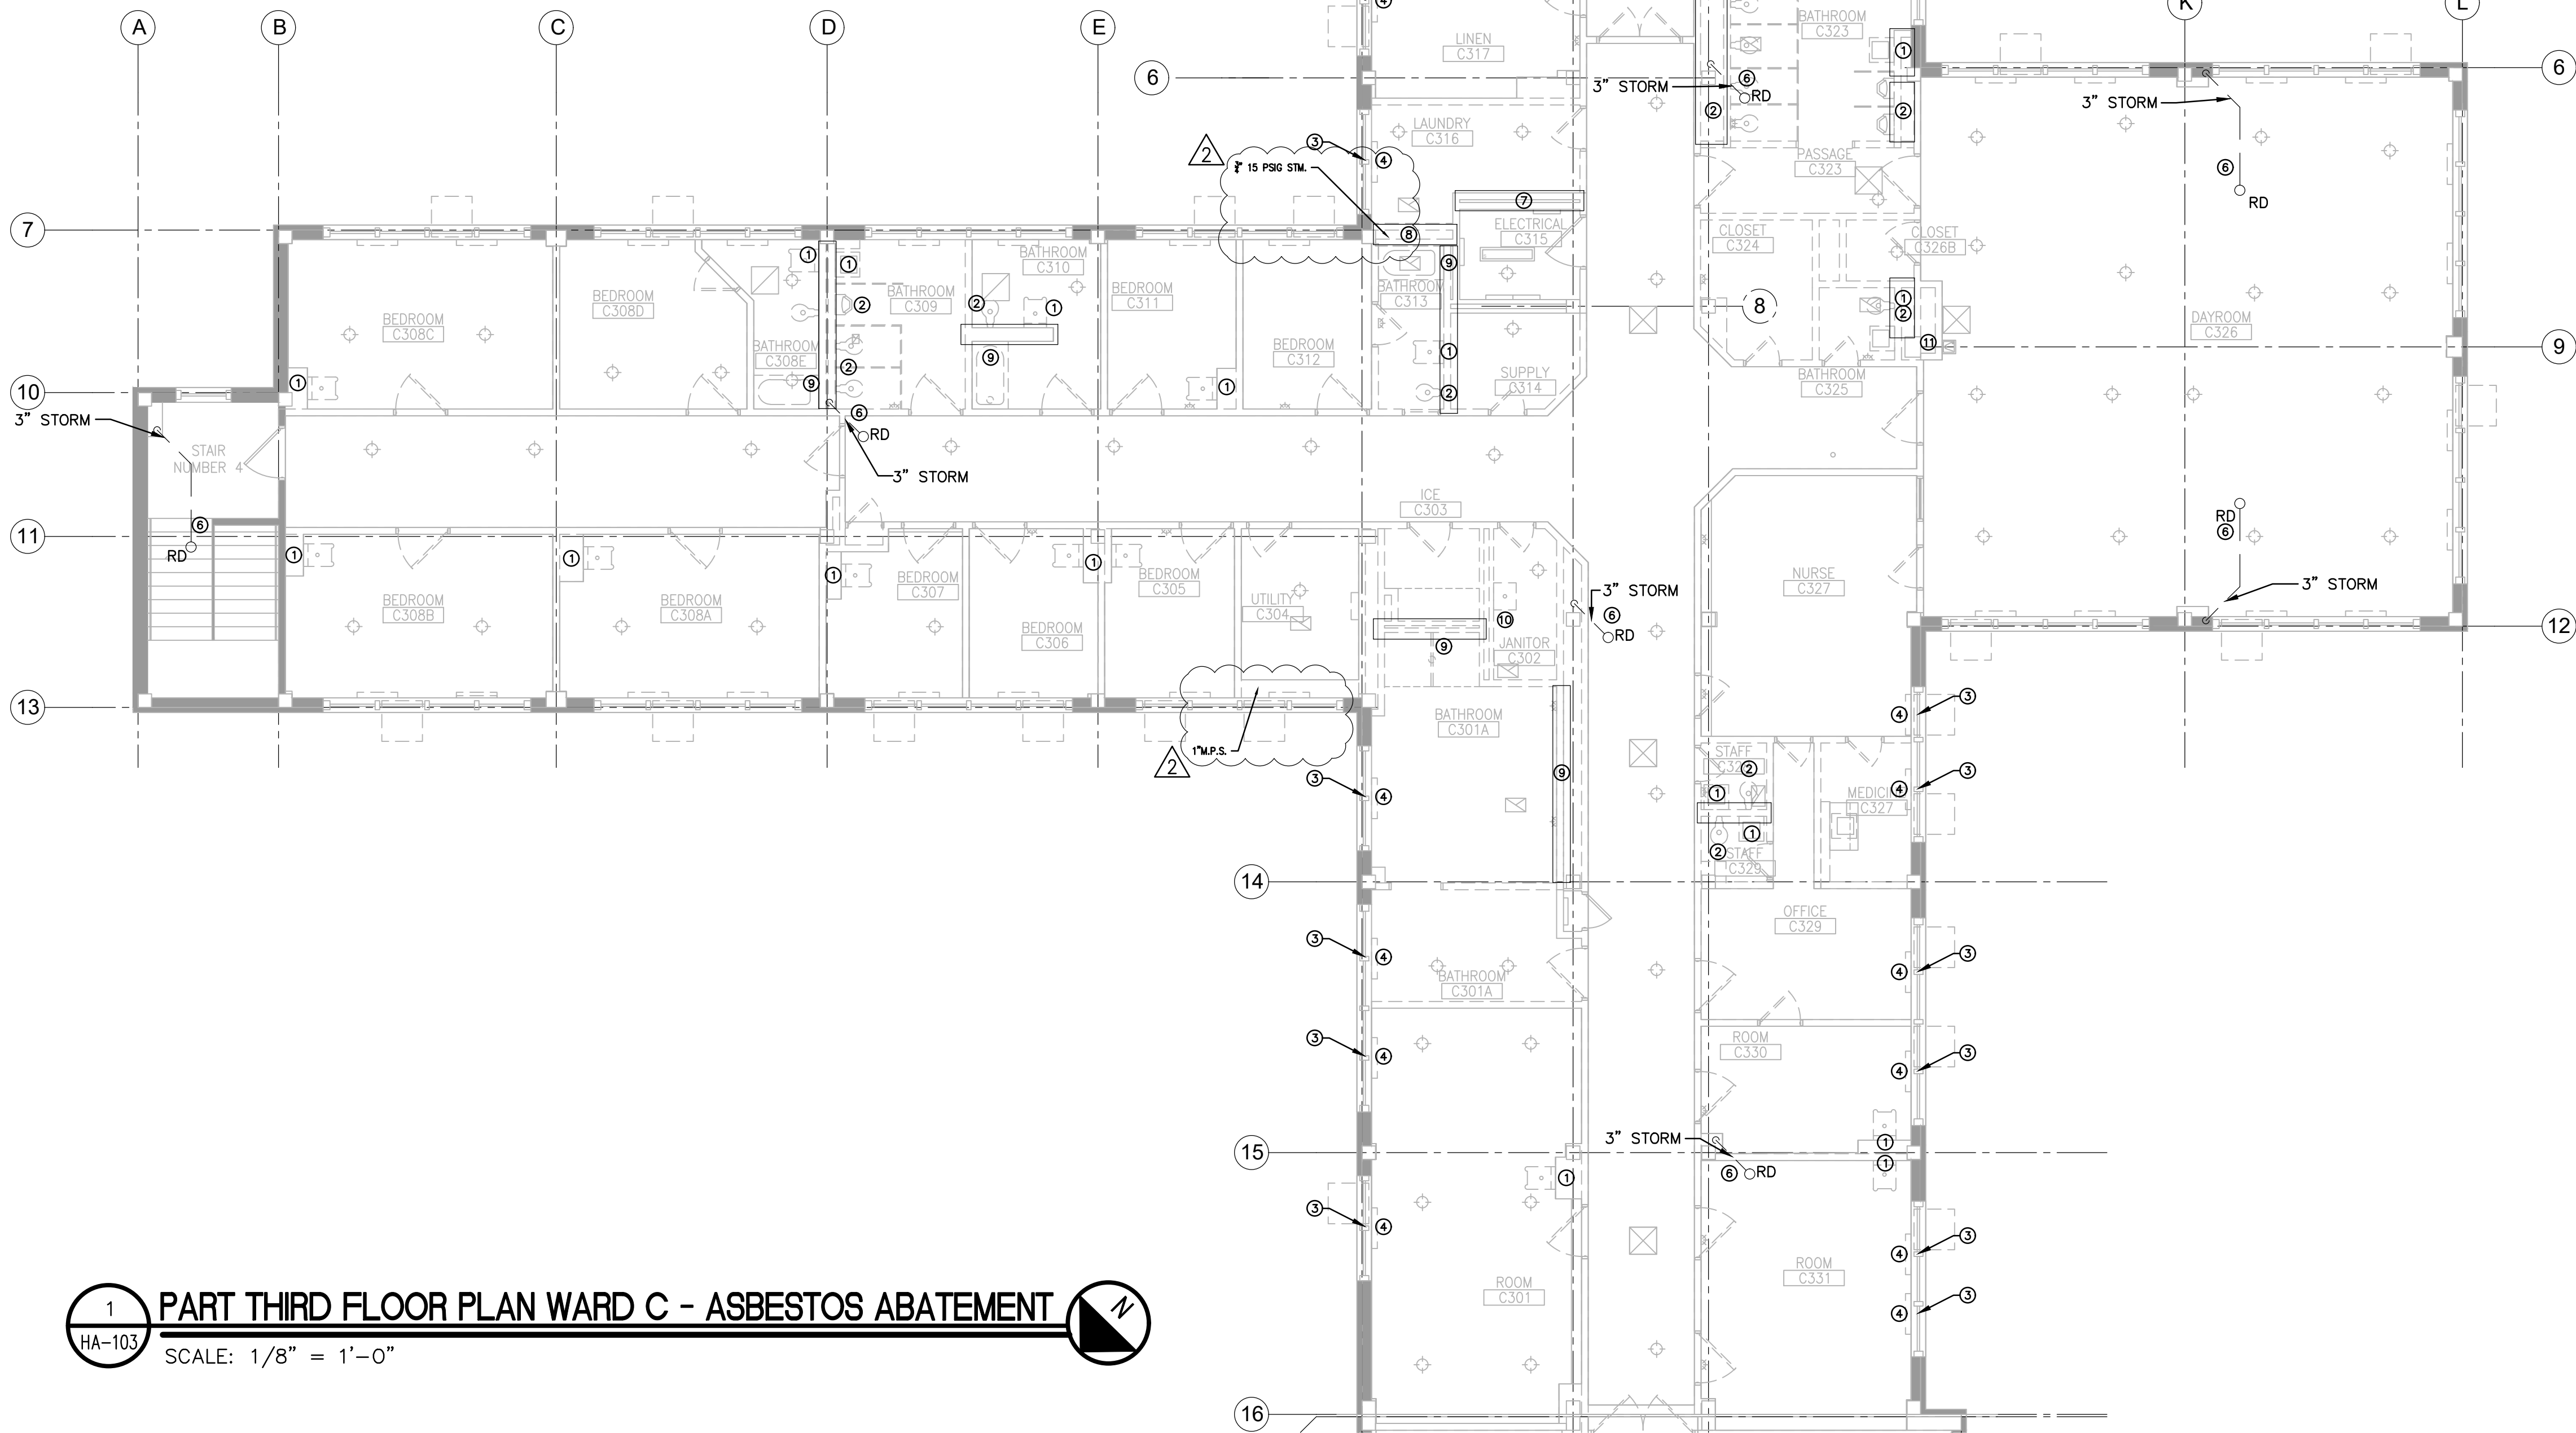
- 4 NO ASBESTOS MATERIALS OBSERVED ON RADIATOR CASE, FRAME OR COIL EXCEPT AS NOTED IN 3 ABOVE.
- 5 NO ASBESTOS MATERIALS OBSERVED ON AHU EXCEPT HARD FITTINGS ON PIPING TO AHU COIL.

- 8 REMOVE ASBESTOS MATERIALS AS REQUIRED; HARD FITTINGS ON SUPPLY PIPES TO BEDPAN WASH.
- 9 REMOVE ASBESTOS MATERIALS AS REQUIRED; HARD FITTINGS ON SUPPLY PIPES TO SHOWER/BATHTUB.

- 10 REMOVE ASBESTOS MATERIALS AS REQUIRED; HARD FITTINGS ON SUPPLY PIPES TO JANITOR/HAC SINK.
- 11 REMOVE ASBESTOS MATERIALS AS REQUIRED; HARD FITTINGS ON SUPPLY PIPE TO DRINKING FOUNTAIN.
